Pacific Gas and Electric Company

EPIC Final Report

| Project | <i>EPIC 3.46 – Advanced Electric Inspection Tools – Wood Poles</i> |

| Reference Name | <i>Radiography of Utility Wood Poles</i> |

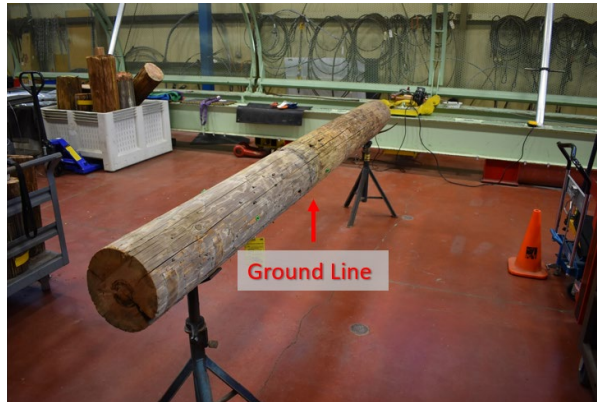
The PTT results for all the poles is provided in Table 1, below. The sample #1 pole assessment indicated it did not Pass and had shell rot/decay.

*Figure 1 - Sample 1 As Received Photo*RT Imaging Setup:

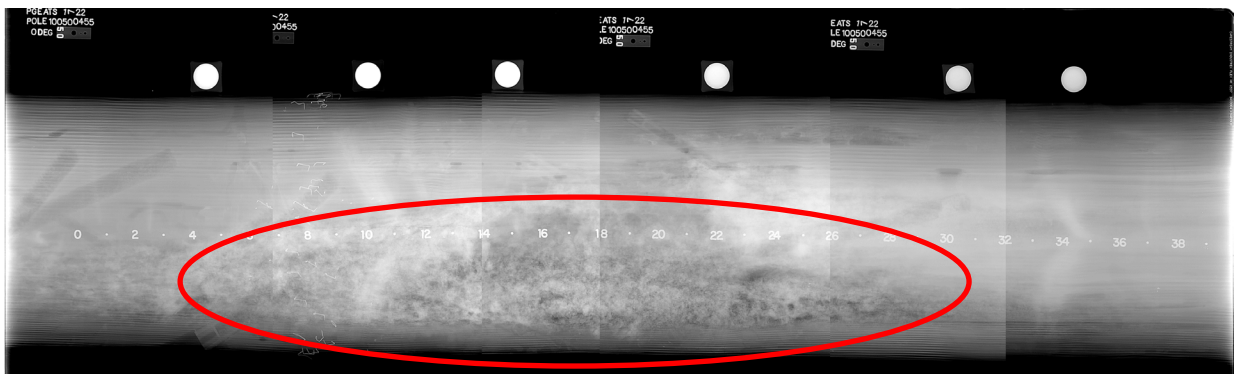
Figure 3 - Stitched Radiographic Image

When viewing x-ray images, the less dense areas will appear darker, and the denser areas will appear lighter. In reviewing Figure 3 below, it is apparent that there is a void at the bottom half of the pole, circled in red.

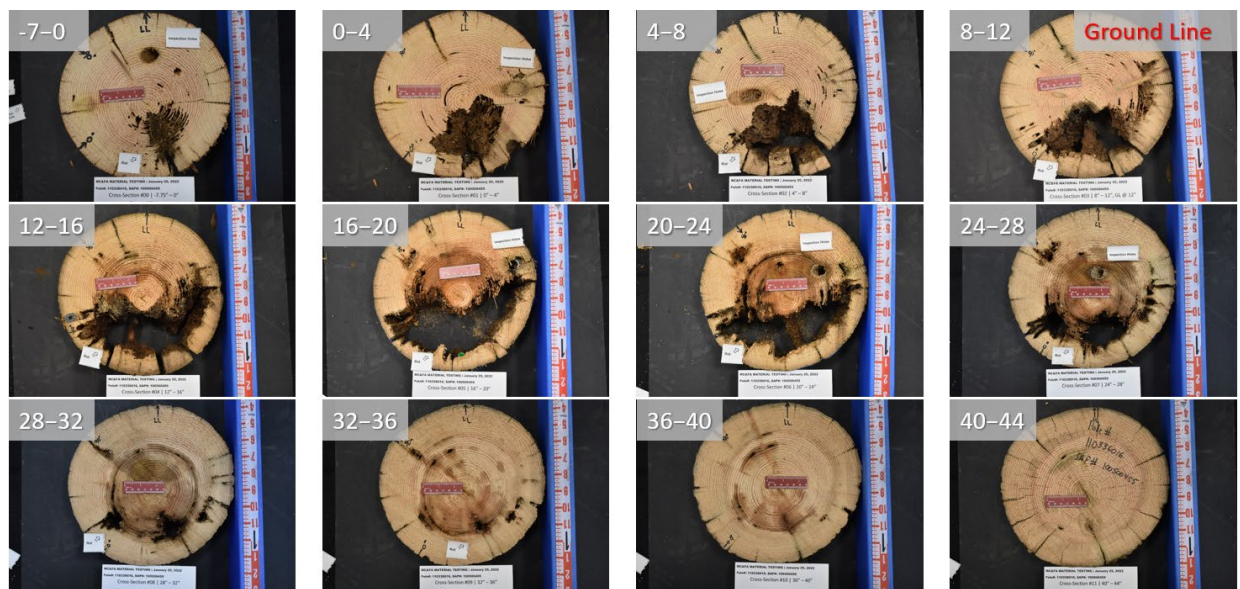
Figure 4 - Pole Dissection

The samples were then dissected circumferentially into 4-inch sections to validate the voids detected within the x-ray image. Figure 4 shows the cross-sections; the numbers in the upper left are inch designations to identify each cut section of the Sample #1 wood pole. The -7-0 is the above ground section, 0-4 is the first 4 inches below ground, then 4-8 is the next 4-inch section and so on. These identifiers are used to track the locations and compare to the x-ray imagery. Upon comparing the x-ray images to the dissected cross-section of the wood pole samples, ATS confirmed that there was a good correlation.

In evaluating the sample pole 1, an observer can visually see the variations of grey shade in the x-ray image, Figure 3, as compared to Figure 4 of the dissected sections of the same pole.

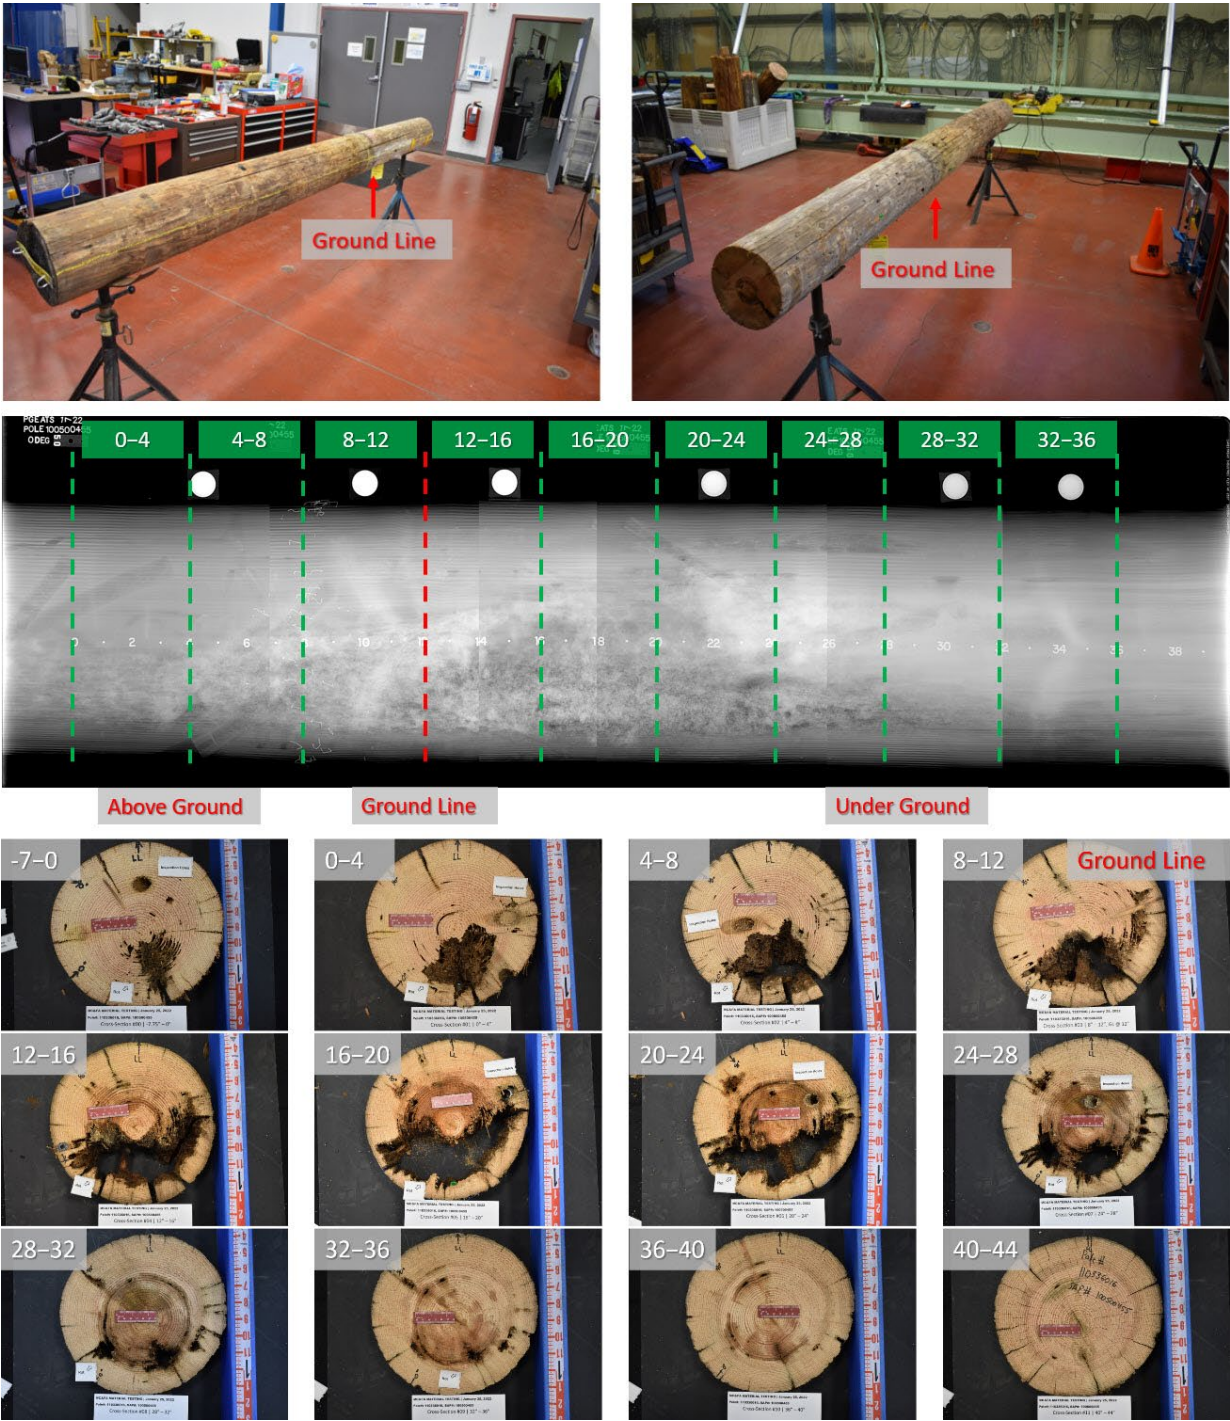
Figure 5 - Sample Pole 1 Summary Image

To bring the analysis together, the three data sets have been stacked to better show the correlations. As can be seen in Figure 5 below, the correlation between the x-ray image and the dissections is readily seen. This view has been created for each of the sample poles and is presented in Appendix B.

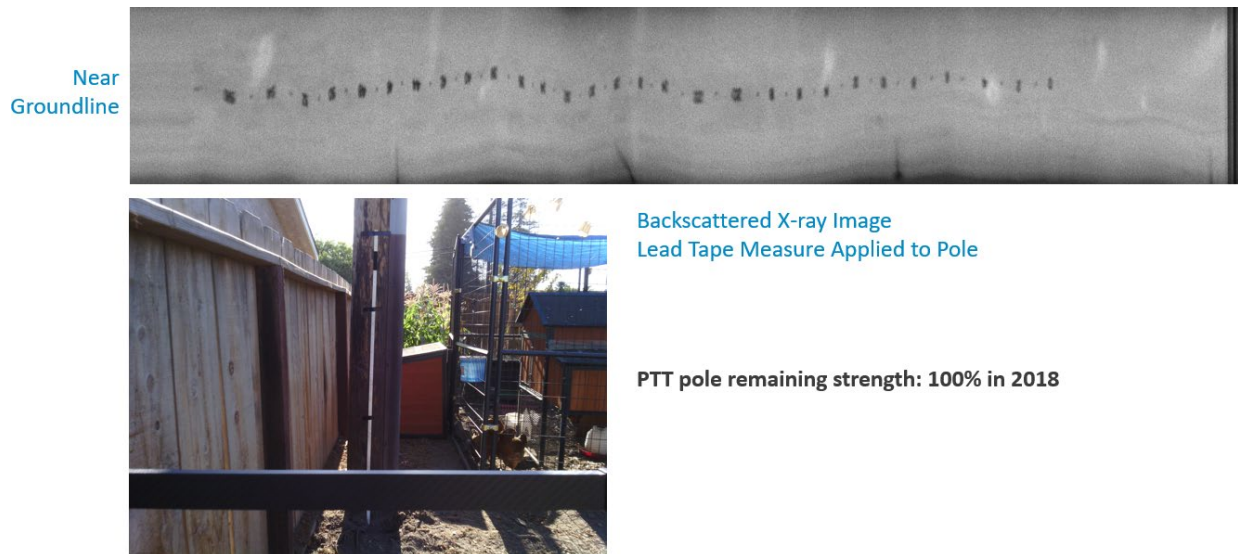
Figure 8 - Sample 1 Field Pole

Figure 8, Sample 1 Field Pole, was easily accessible to scan from any quadrant. However, it is evident from the image that the scan rate of the wood pole was not consistent. This resulted in the spacing of the lead belt numbers to not be uniform. The operator, PG&E ATS Radiographer, attempted to scan at the recommended 6 inches per second. The challenge is managing the 10-pound device from above the shoulders to groundline in a consistent manner. The waviness of the image originates from left and right drift during scanning.

At the conclusion of field testing, the operator recommended a roller attachment to be designed and mounted to the device. This would lessen the impact of the challenges of scanning.

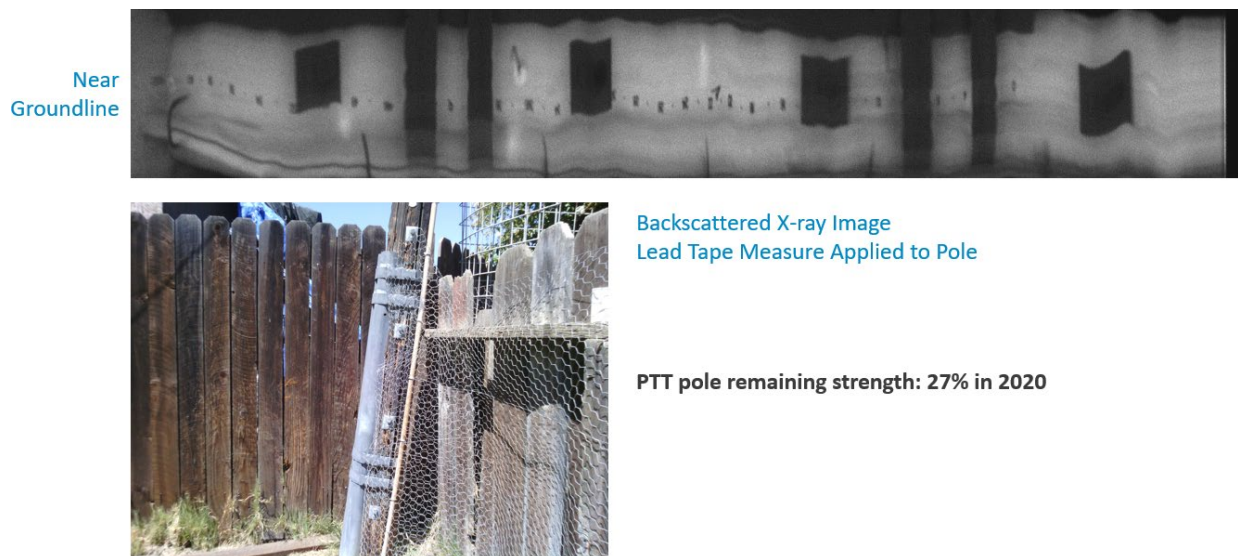
Figure 9 - Sample 2 Field Pole

Figure 9, Sample 2 Field Pole, challenges with scanning the sample 2 field pole consisted of obstructions due to steel climbing hardware, stub (brace) and banding as seen in the site image. The steel results in the dark/black areas associated with the obstructions. These obstructed areas limit the visibility of the presence of decay.

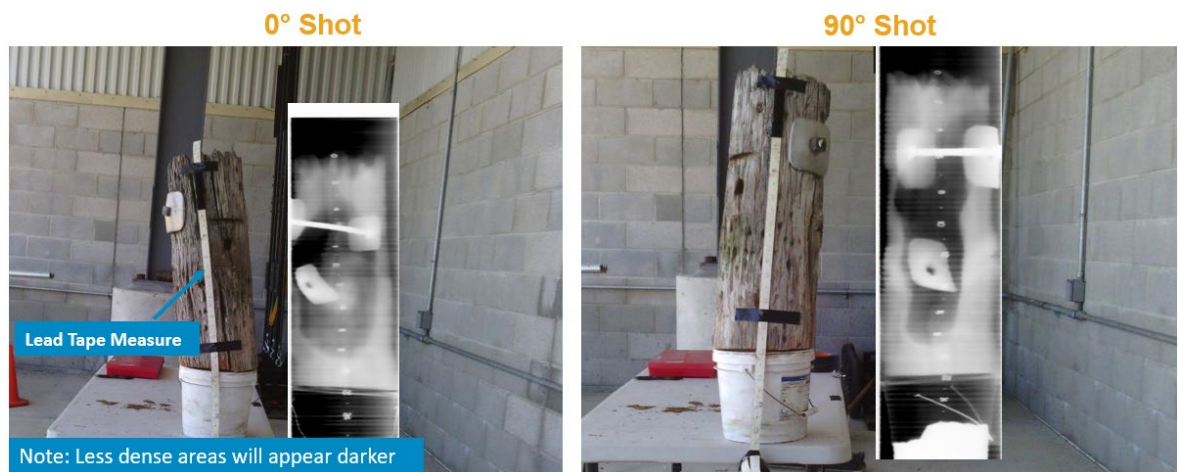
Figure 111 - Sample 1: Damaged Pole

Testing with the new 3D printed attachment was performed on seven (7) received damaged poles where real-time x-ray images were taken at 0 and 90 degrees. The first of which is shown in Figure 11. The x-ray images were noticeably better in comparison to all prior handheld x-ray images. The usability was also significantly improved as the operator x-rayed all damaged samples collecting 14 x-ray images with higher efficiency. The remaining sample pole images can be seen in Appendix D. In reviewing all of the x-ray images, it was apparent that the images had a consistent brightness variation throughout the scan, seen as horizontal lines. The variations were due to the wheels traveling along the uneven wood surface. In addition, some x-ray images had a waviness due to the wheels interacting with the wood pole. Although the bracket wheels improved the x-ray images, they were not comparable to computed radiography.

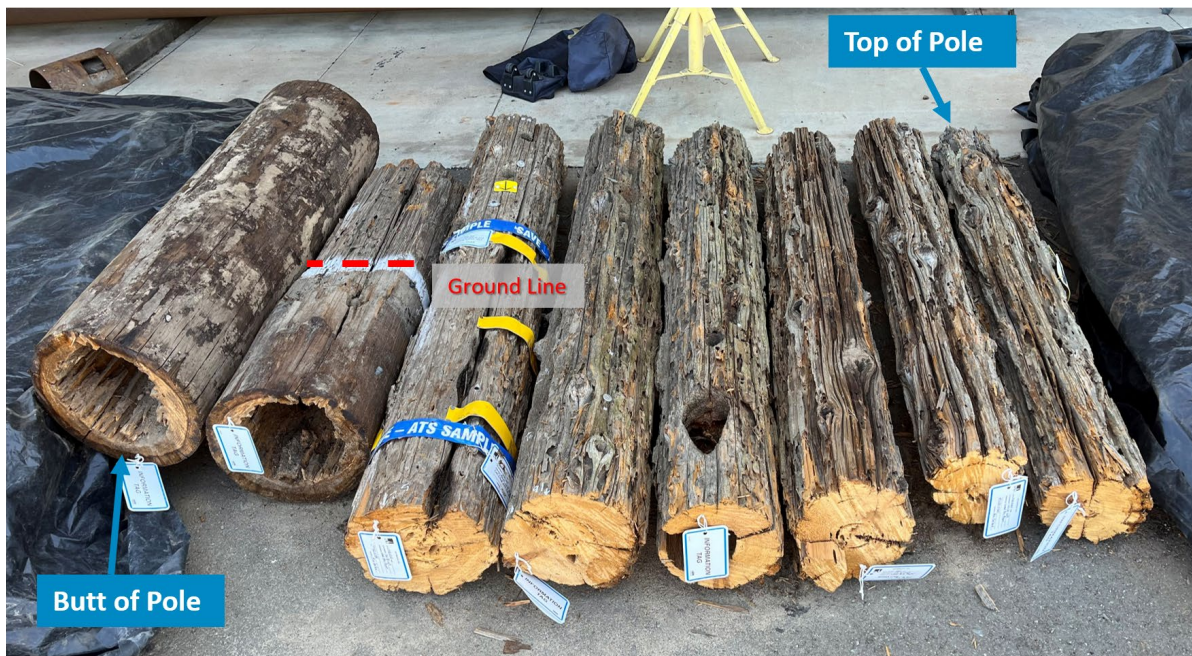
Figure 144 - Pole Sample with Groundline Decay and Woodpecker Hole Damage

The track system was tested on a pole with below groundline decay and significant woodpecker damage. The pole was cut into eight sections (Figure 14) for ease of transport and handling. Seven of the eight sections were x-ray imaged with the track system. The top section of the pole was not x-ray imaged as there were no evident signs of internal defects. In review of all the x-ray images,

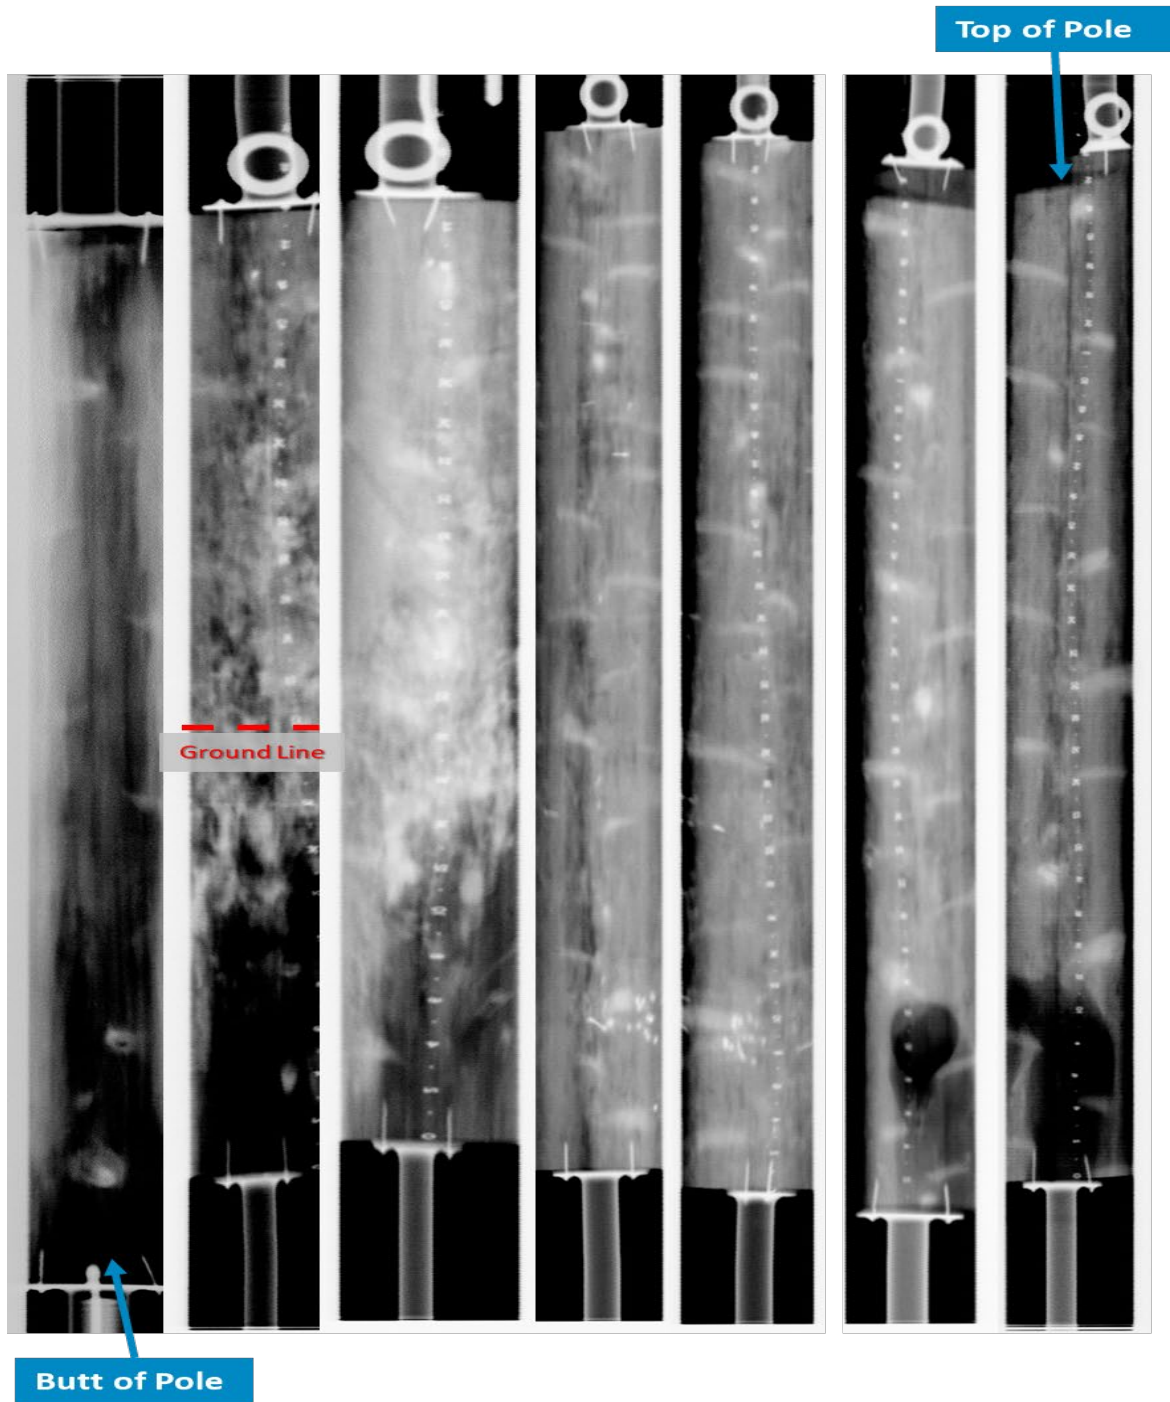
Figure 155 - X-Ray Images of Sampled Pole with below and above grade defects

the team confirmed that the track system produced comparable image quality to conventional radiography. As shown in Figure 15, the location and overall size of the voids can be clearly seen.

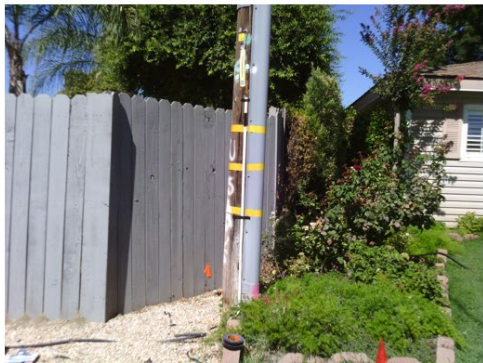
Figure 266 - Sample 5 Field Pole

PTT pole remaining strength: N/A

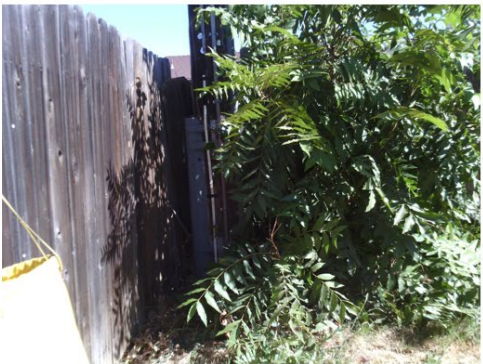
Figure 2727 - Sample 6 Field Pole

PTT pole remaining strength: 100% in 2018

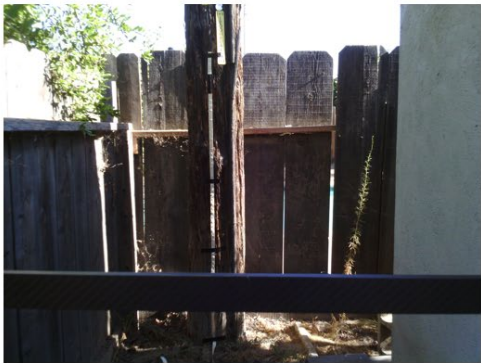
Figure 28 - Sample 7 Field Pole

PTT pole remaining strength: 56% in 2019
