## **Appendix E2. Hayward and Chabot Fault Location Uncertainty Evaluation for a Utility Corridor**

Date: January 30, 2024

**SUBJECT: Hayward and Chabot Fault Location Uncertainty Evaluation for a Utility Corridor – Oakland, CA**

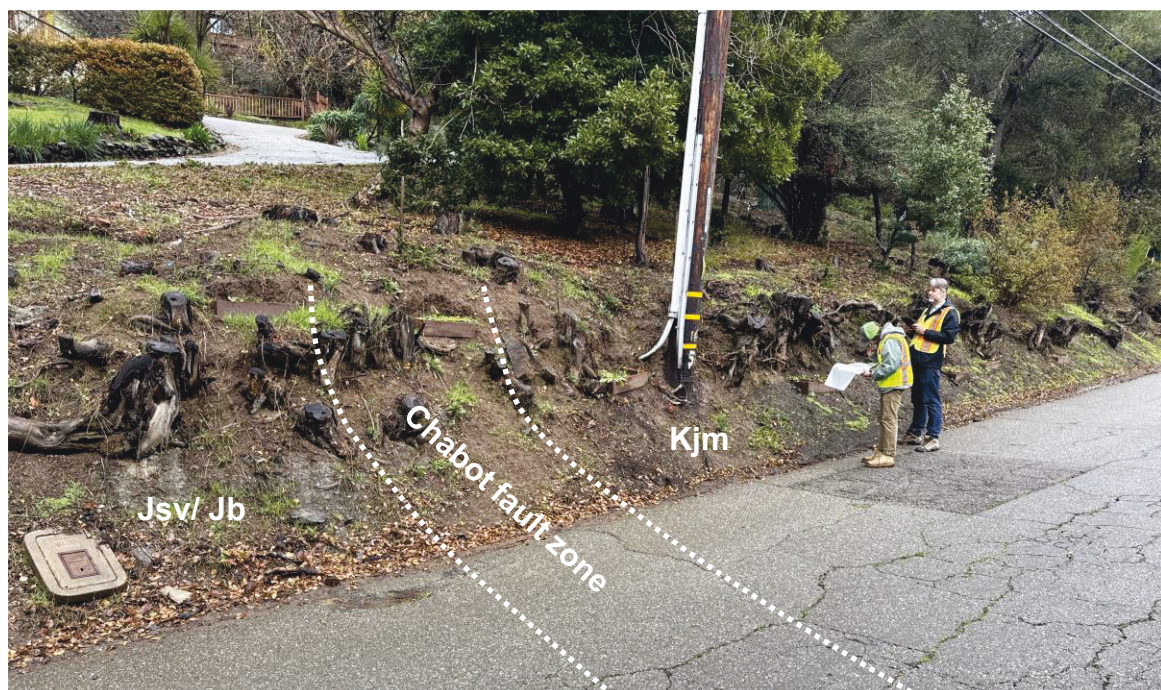
To the southwest along the Chabot fault (Field Locality 6), we mapped the Chabot fault based on juxtaposition of bedded sedimentary rocks of the Cretaceous Great Valley units (Kjm) on the east juxtaposed against diabase-basalt and graywacke on the west (Photos1 and 2). The faulted

Photo 1. Field Locality 6 – fault contact between Jurassic and Cretaceous units along Scout Rd.

contact is aligned with a topographic saddle to the northwest and a drainage deflection, and a northwest-trending linear drainage to the southeast. This fault location is 66 ft (20 m) east of the Graymer (2000) strand (Figure 1) but is consistent with geologic map relationships shown by the author.

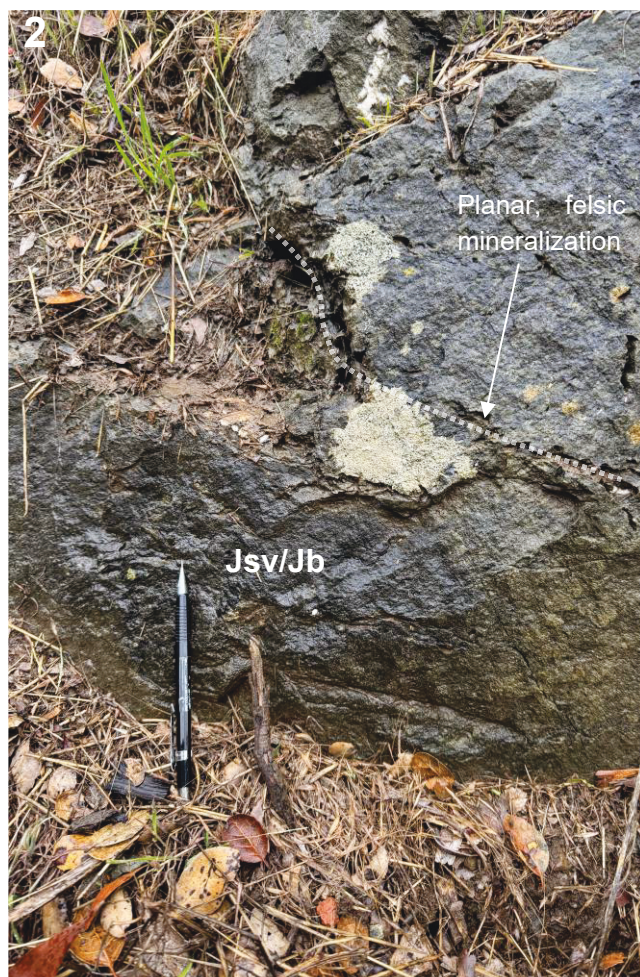
At Field localities 4 and 5, LCI confirmed a steep break in slope associated with the eastern Hayward fault trace and outcrops of rock comprising Jurassic units (i.e., basalt, diabase, graywacke, mélange or Jsv/ Jb – see Photo 2).

Photo 2: Field Locality 6 – Jurassic diabase/ basalt or graywacke (Jsv/ Jb) with planar, secondary felsic mineralization;  
Photo 3: Field Locality 7 – dipping beds in the Cretaceous unit (Kjm) directly northeast of linear drainage.

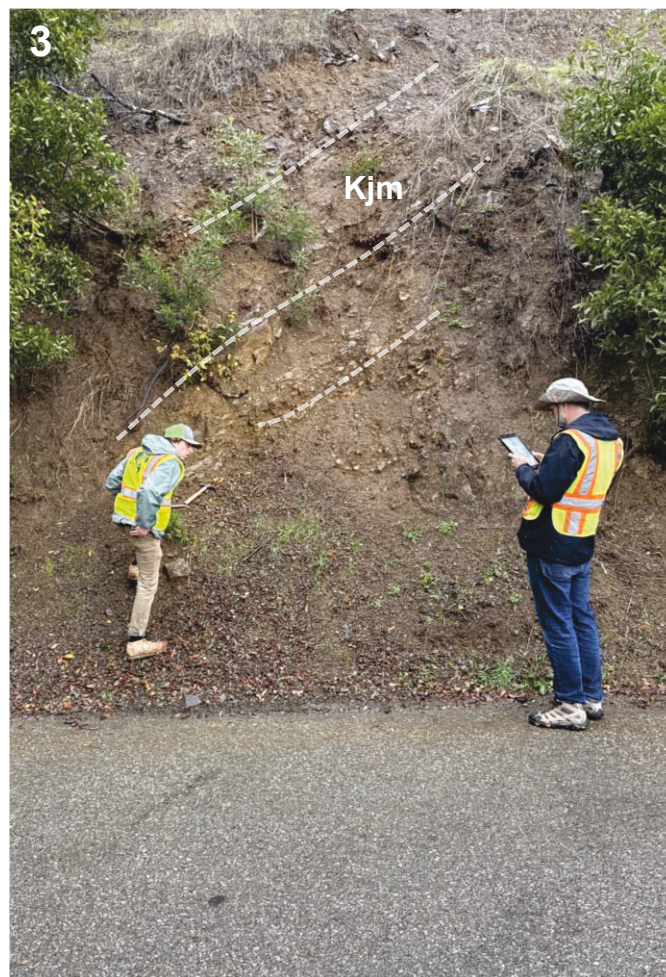
Field locality 7 is further southeast along Scout Rd. and consists of dipping shale beds of the Cretaceous sedimentary unit (Kjm; Photo 3). This road cut exposure is a near vertical wall located on the north side of Scout Rd. directly northeast of Montera School and the linear drainage that runs along Scout Rd.

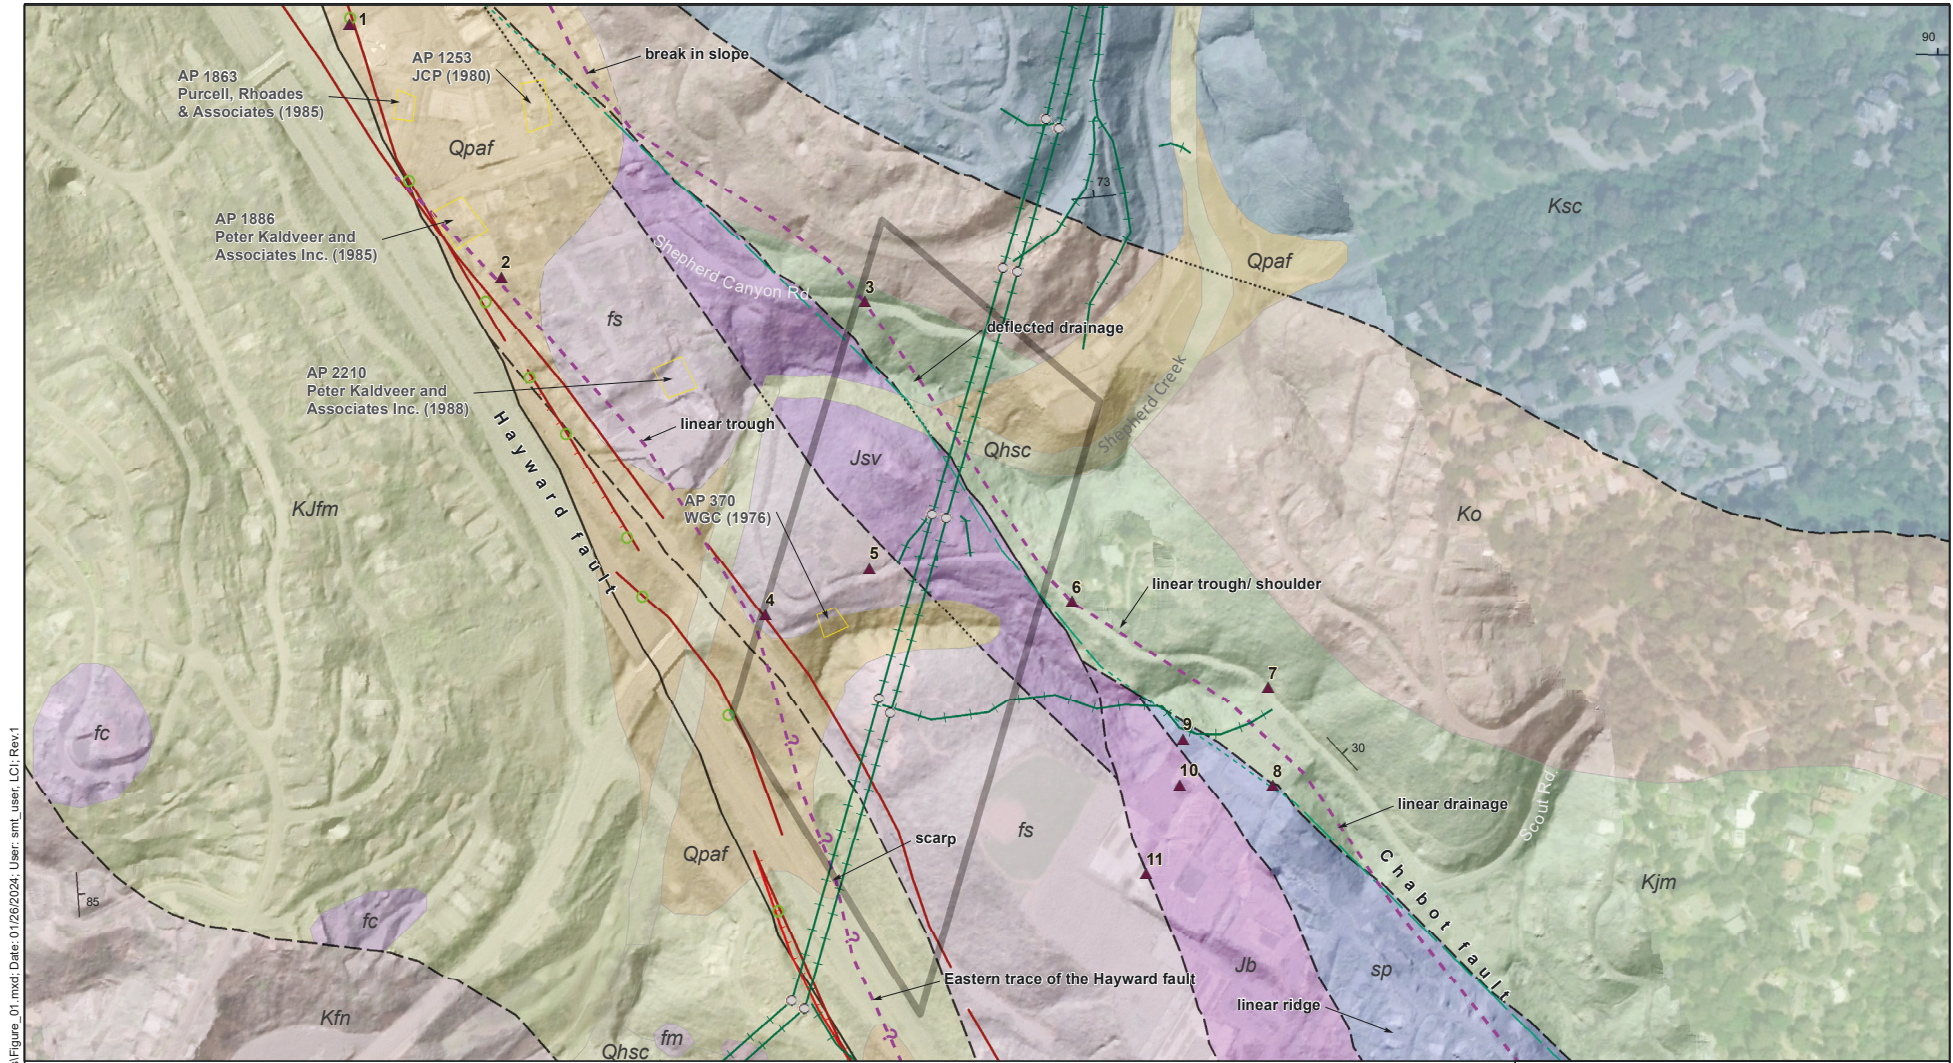
#### Hayward-Chabot Utility Corridor Geologic Data and Revised Fault Mapping

At the site, several traces of the Hayward and the Chabot faults are mapped intersecting the Moraga-Oakland utility corridor (Figure 1). In the southwestern portion of the study area, an eastern and western trace of the Hayward fault are mapped by PG&E (2022), Lienkaemper (2008), and Graymer (2000).

At Field Locality 3, LCI mapped the location of the Chabot fault (Figures 1 and 2) on Shepard Canyon Road near the Oakland Fire Station No. 24, where a roadcut exposure of dark gray basalt/mélange rocks (Jsv/ Jb units) on the west were observed juxtaposed against thinly to moderately bedded brown shale (Kjm unit) on the east side. This contact zone was semi-obscured by slope wash material; however, the contact occurred as a narrow zone (3 to 6 m or roughly 10 to 20 ft). This fault location is generally consistent with tectonic geomorphic lineaments mapped during our desktop analysis and is 92 ft (28 m) east of the Graymer (2000) mapping.

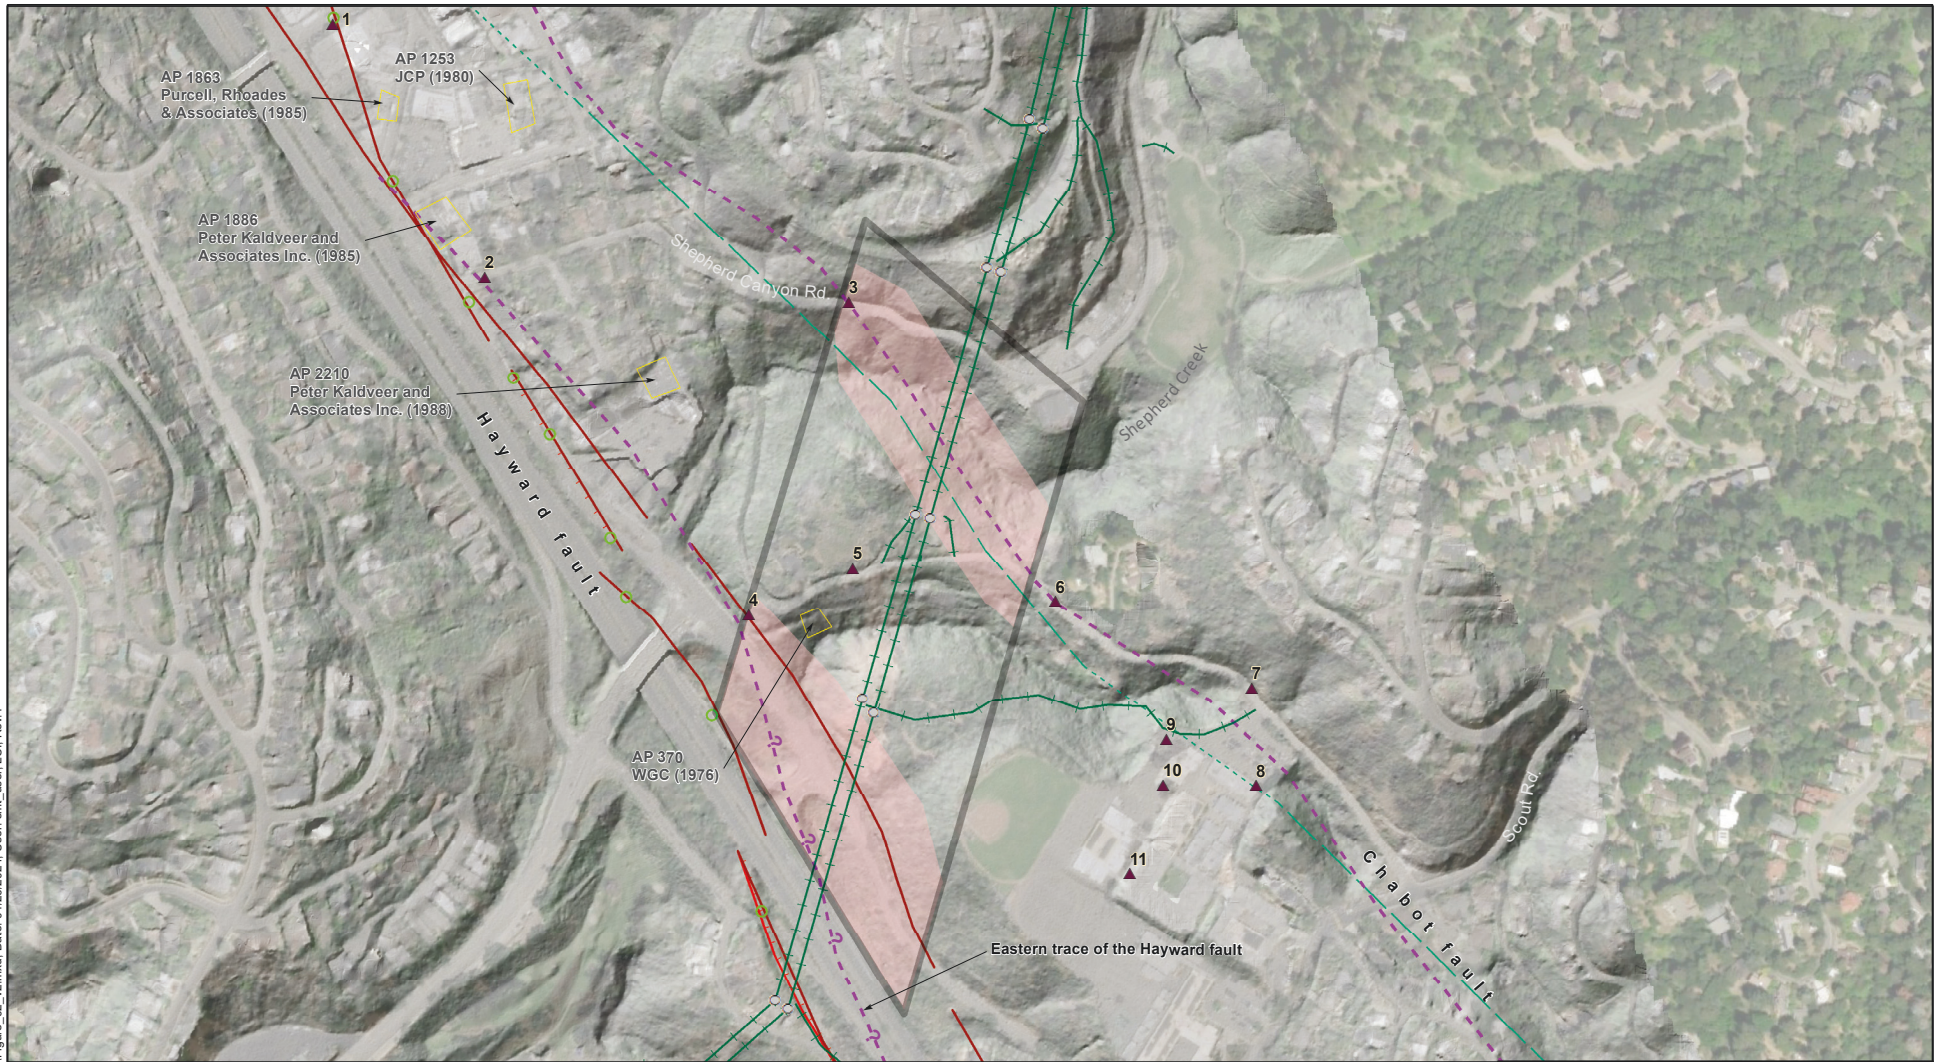
On the basis of these findings, LCI developed an approximately 279 to 335-ft-wide (85 to 102-m-wide) wide fault location uncertainty zone that parallels the western creeping strand and the eastern strand (PG&E, 2022) of the Hayward fault encompassing the western portion of the Moraga-Oakland utility corridor (Figure 2). This zone was developed based on a starting fault buffer ~289-ft-wide (88-m-wide) because the more prominent, western strand is approximately located (i.e., one standard deviation is ~44-m-wide; Table 1). This initial width was reduced so that the easternmost limit of the zone generally coincides with the break in slope observed at field locality 4. This topographic feature represents the eastern limit of the break in slope associated with the eastern Hayward fault strand (Figure 2). East of this break in slope bedrock forms broadly sloping surfaces that appear unfaulted and provide a reasonable maximum limit for the fault location uncertainty zone.

To assist with the utility alignment, LCI developed a 289-ft-wide (88-m-wide) wide fault location uncertainty zone that parallels the revised Chabot fault trace study (Figure 2). This zone was developed based on a starting fault buffer 545-ft-wide (166-m-wide) because the here is mapped as strands approximately located (i.e., one standard deviation is ~44-m-wide; Table 1). This initial width was reduced was reduced to a buffer width ~88-ft-wide (44-m-wide) for a total width of 289-ft-wide (88-m-wide) based on surface constraints from combination of the geomorphology along the fault and exposures along road cuts (Field Locality 6; Figure 1). The fault zone is also tapered based on our judgment where the fault is constrained through surface mapping (Field locality 3).
