**SF X (Mission)  
Substation Outage Event  
December 20, 2025**

**Direct Cause Evaluation**

Pacific Gas and Electric Company  
300 Lakeside Drive  
Oakland, California 94612

May 5, 2026

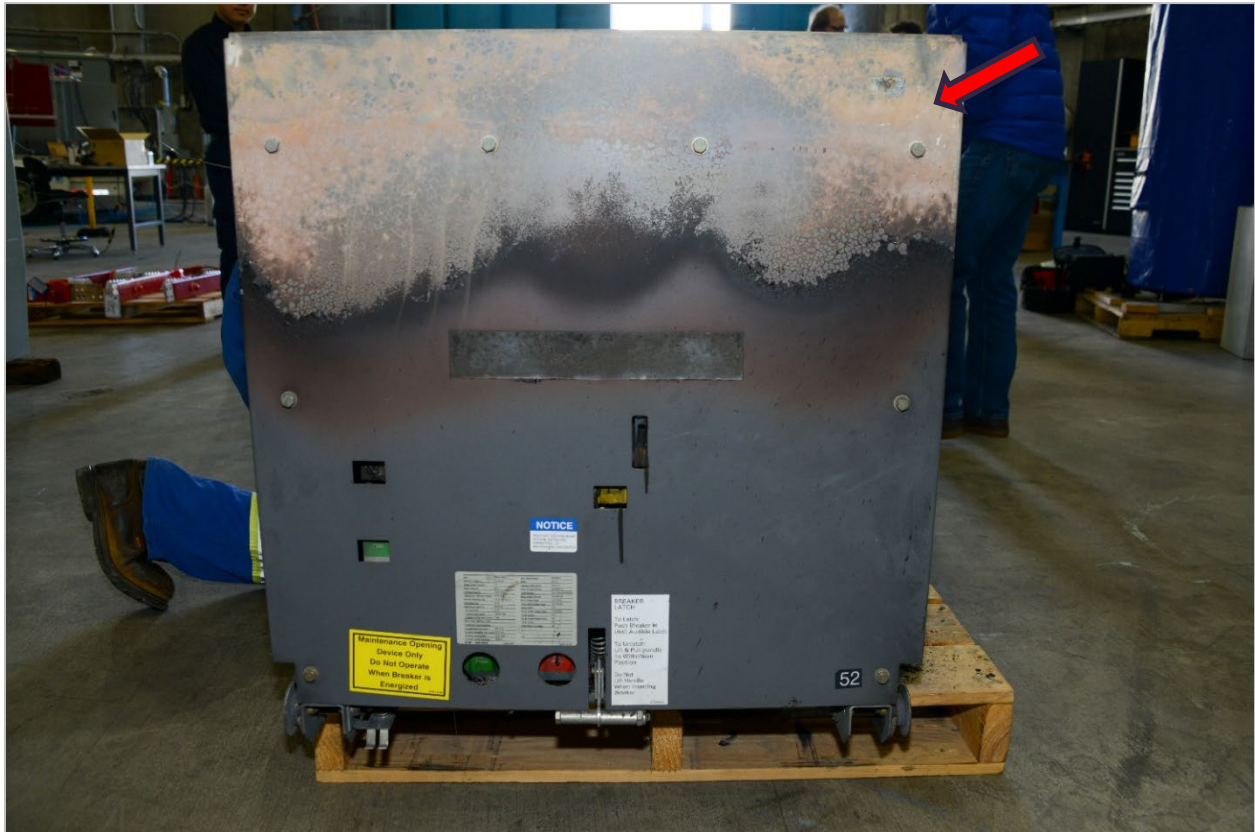
Incident Breaker No. 52 suffered significant thermal damage. On the front face, there is smoke deposition just above the midplane of the breaker. Discoloration and clean burn patterns can be observed on the top third of the front face (see Figure 13).

Figure 13. Discoloration and clean burn patterns on the top third of the front face on Incident Breaker No. 52 (red arrow).

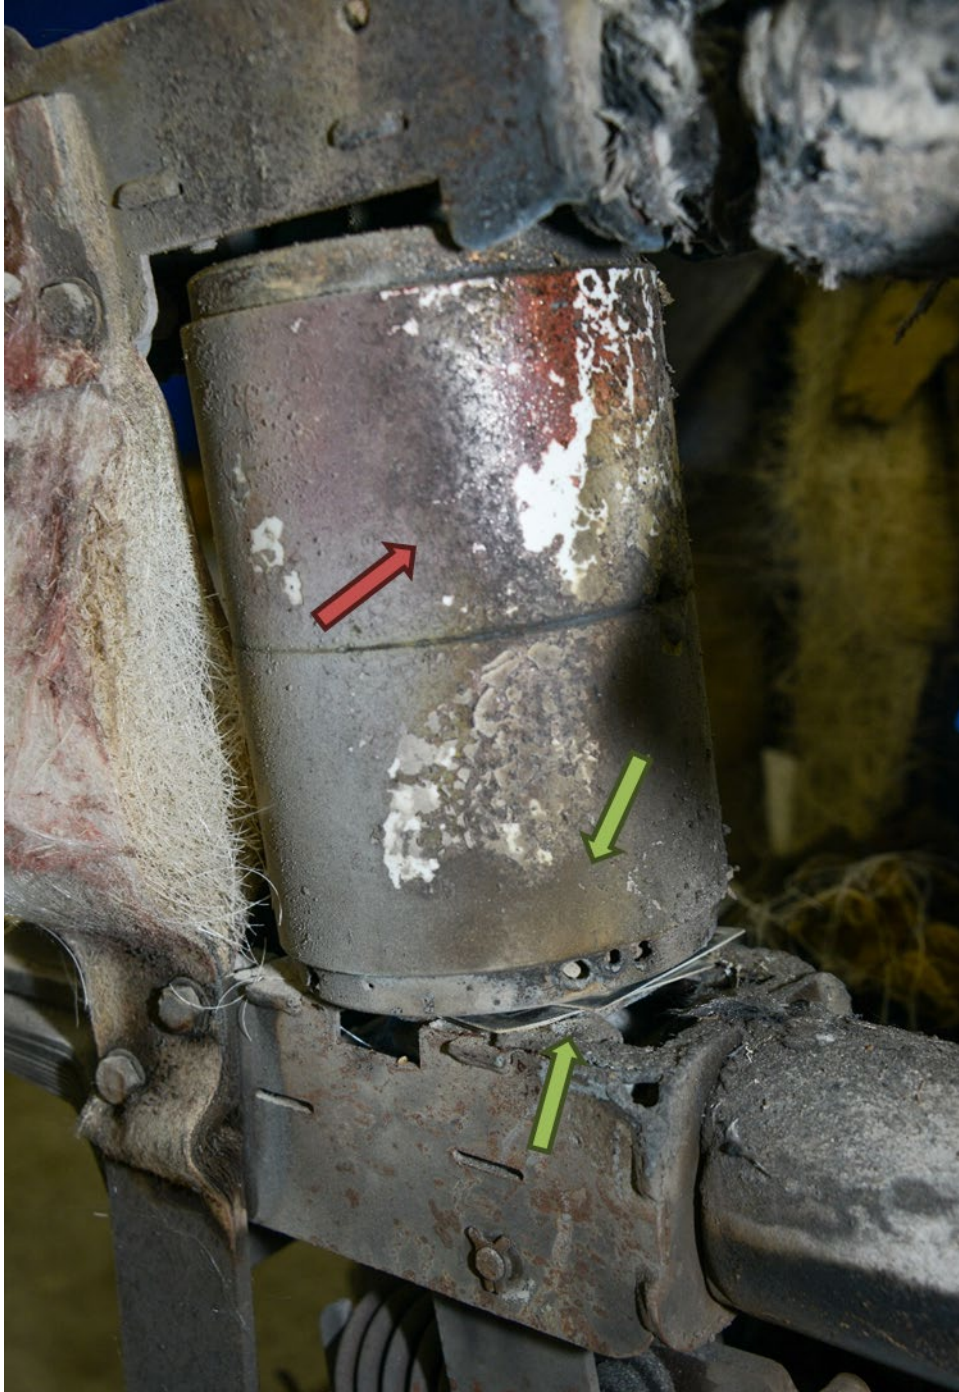
Figure 16. A-phase vacuum bottle detached from the top insulator. Evidence of arcing to the bottom metallic cap and connecting arm (green arrows). Clean burn pattern on the front-facing side (red arrow).

Significant metal erosion and melting were observed at all three phases of the breaker arms and at the outer ends of the vacuum bottles (Figure 16), while the front grounded plates exhibited substantially less damage. The steel connecting arms were damaged above and below the vacuum bottles, showing melting damage and mass loss. The top B-phase connecting arm showed the most significant melting damage and mass loss. Damages to the connecting bolts, washers, and surrounding area on the top were particularly severe on all three phases, with washers missing and bolt heads melted. The A, B, and C phase vacuum bottles also had mass loss and melting spots on the bottom metallic cap and corresponding evidence of arcing on the bottom connector arms nearby. Melting and mass loss were also observed on the back side of the top B-phase metallic cap. There was no evidence of beading on the steel teeth that connect to the bus work on any phase.

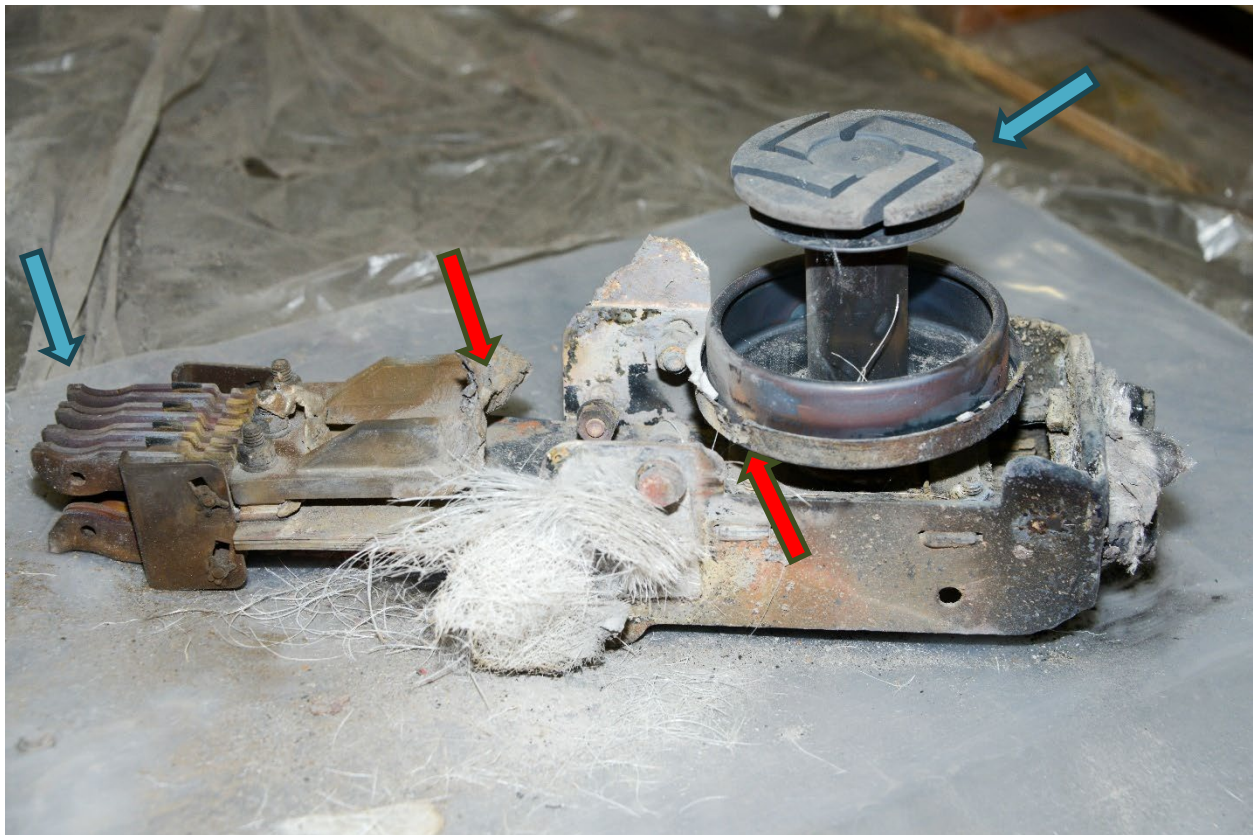
Figure 17. Detached top B-phase connecting arm showing evidence of arcing on the arm and metallic cap of the vacuum bottle (red arrows). No evidence of arcing on connecting teeth or vacuum bottle contacts (blue arrows).

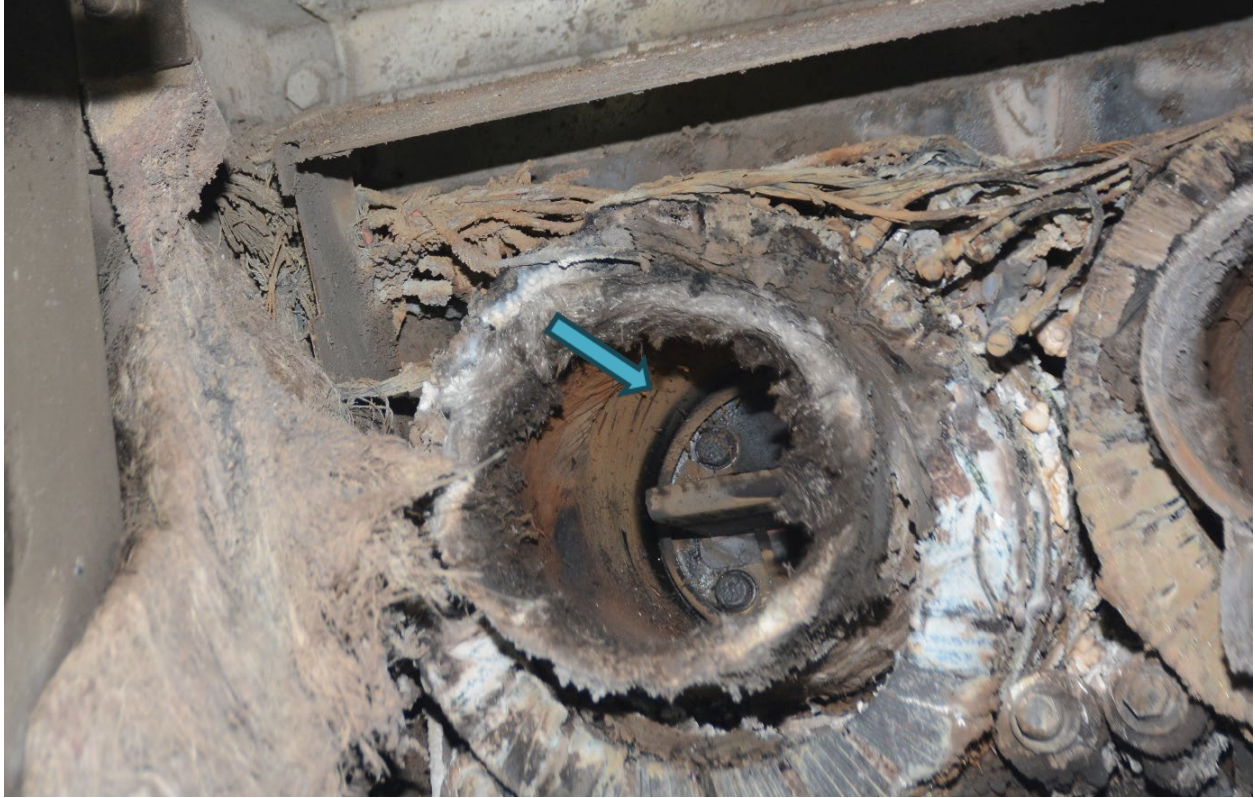
Figure 24. Back, top, A-phase side of Cell No. 5 with most severe damage. No evidence of arcing on bus work connections (blue arrow).

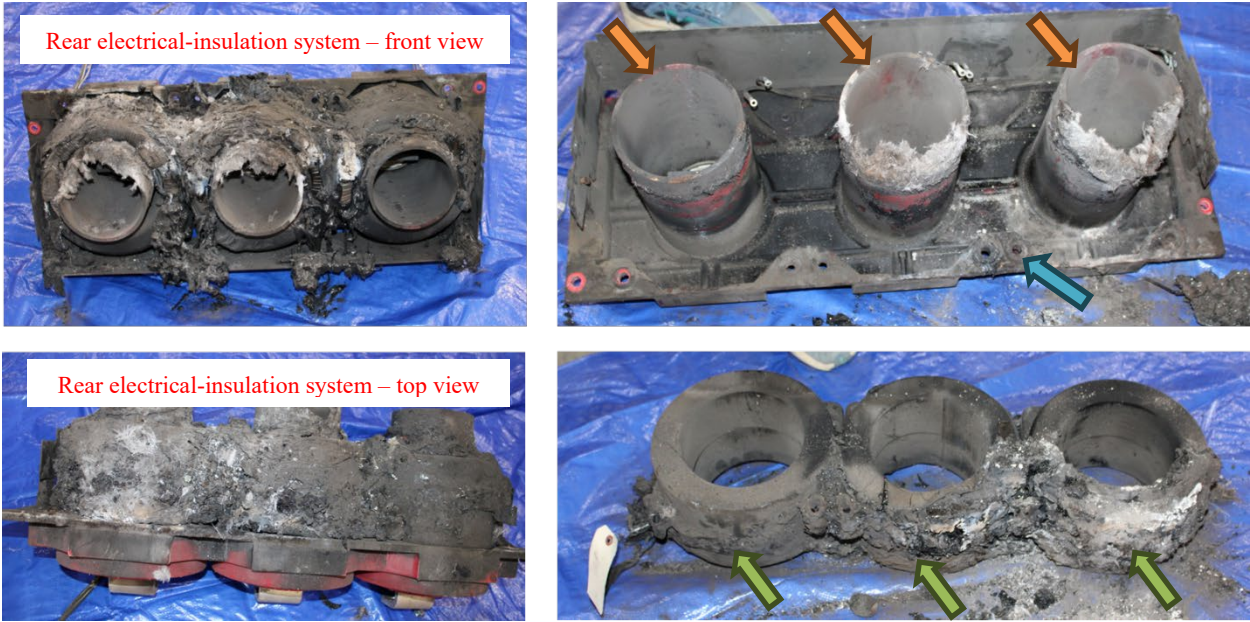
Figure 27. Cubicle’s rear electrical-insulation system and components (lower row) showing CT insulating tubes (orange arrows), busbar penetration wall (blue arrow), and current transformers (green arrows).

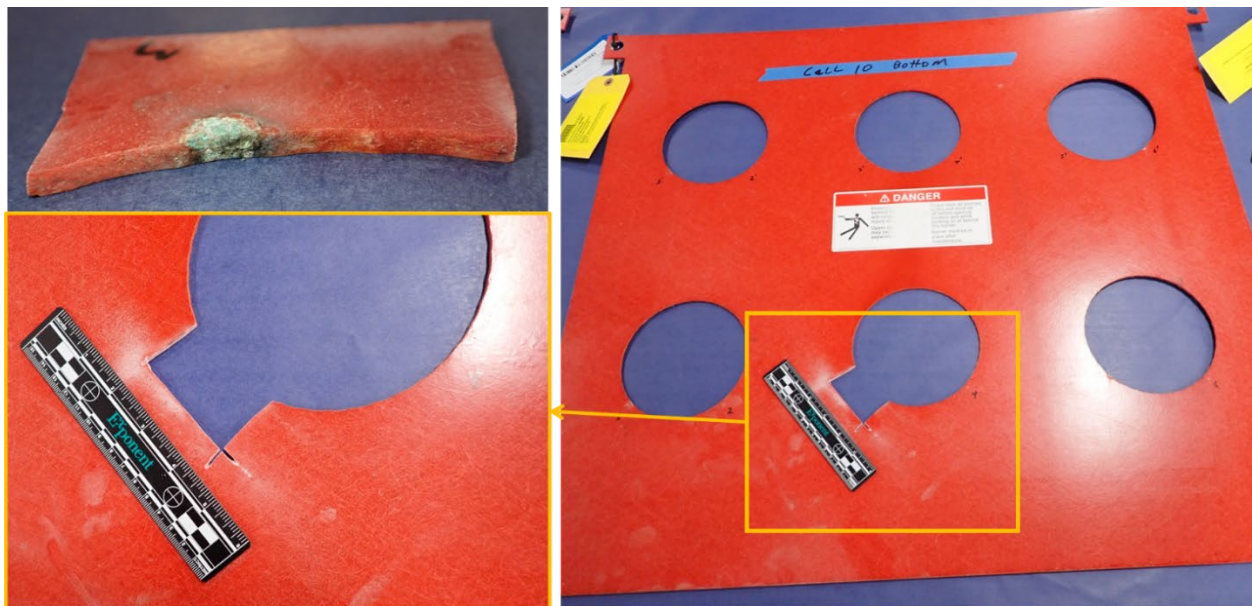
Next, the areas with the most visible damage at the edges of the through-holes on the barrier insulating boards from Cell No. 6 and Cell No. 10 were carefully cut out of the boards. The cuts were made sufficiently far from the visible damage locations to preserve the integrity of the damaged regions within the extracted samples (Figure 35 and Figure 36). No visible carbonization channels or internal material charring indicative of insulation degradation were observed at the cut edges (Figure 37). This suggests that the insulation failure at the Incident Insulating Board was external to the board rather than within its width.

Figure 35. Area with most damage cut from the Cell No. 10 (bottom) barrier insulating board

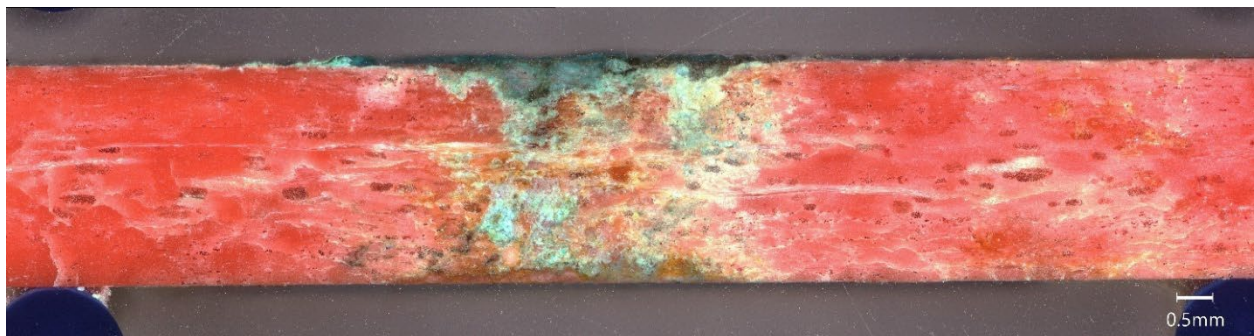
Figure 40. Mounted samples of the barrier insulating board from Cell No. 10 (bottom), showing cross section of the damaged area.
