## Preliminary Ignition Investigation Report

Ignition Database Index:	20241408
Electric Incident Investigation (EII) Number:	N/A
Incident Name:	Owl
PG&E Facility Ignition?	Yes
CPUC Reportable Ignition?	Yes
Date & Time of Incident:	September 28, 2024 @ 1527 hours
Street Address:	Owl Mine Road and Highway 96, near Owl Gulch
City:	Orleans
County:	Humboldt
Latitude/Longitude:	41.29546, -123.57196
State Responsibility Area (SRA) / Local Responsibility Area (LRA) / Federal Responsibility Area (FRA)	Federal Responsibility Area (FRA)
PG&E Division:	Humboldt
High Fire Threat District (HFTD):	Tier 2
High Fire Risk Area (HFRA):	Yes
EPSS Buffer:	No
Fire Index Area (FIA):	112
Fire Potential Index (FPI) Rating: FIA	R3
Fire Potential Index (FPI) Rating: Circuit	R3
Was there a PSPS event at the time of ignition?	No
Suspected Initiating Event:	Vegetation
Failure Driver:	Contact from Object
Failure Sub-driver:	Contact - Vegetation
Circuit:	Hoopa 1101
Circuit Protection Zone:	Hoopa 11013174

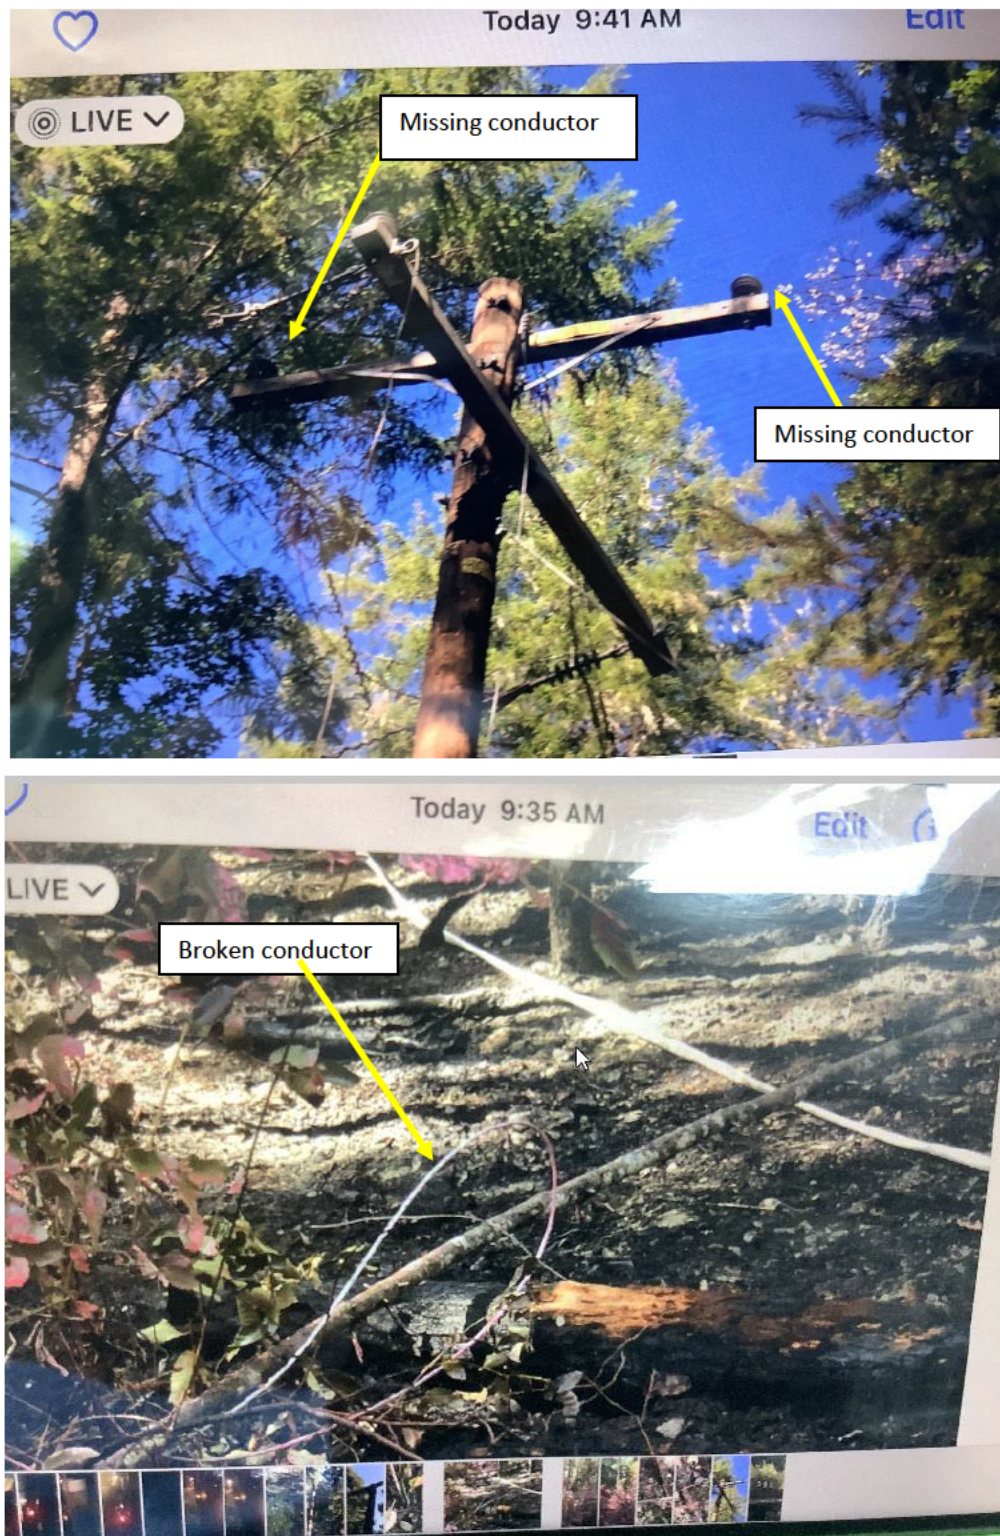
Figure 4 Photographs of top of Incident Pole showing missing conductors and missing insulator. Source: Troubleshooter, taken on September 29, 2024.

At 1202 hours, DCC closed LR 3174 returning service to 482 customers. At 1243 hours, PG&E dispatched a repair crew to the Incident Location. By 1813 hours, both phases of 4-ASCR conductor had been replaced in the Incident Span. At 1818 hours, the repair crew closed FUCO 3283, restoring power to the remaining five customers.

Corrective Notification EC 129603627 was created to replace both phases of 4-ACSR conductor within the Incident Span. This work was completed on September 29, 2024.

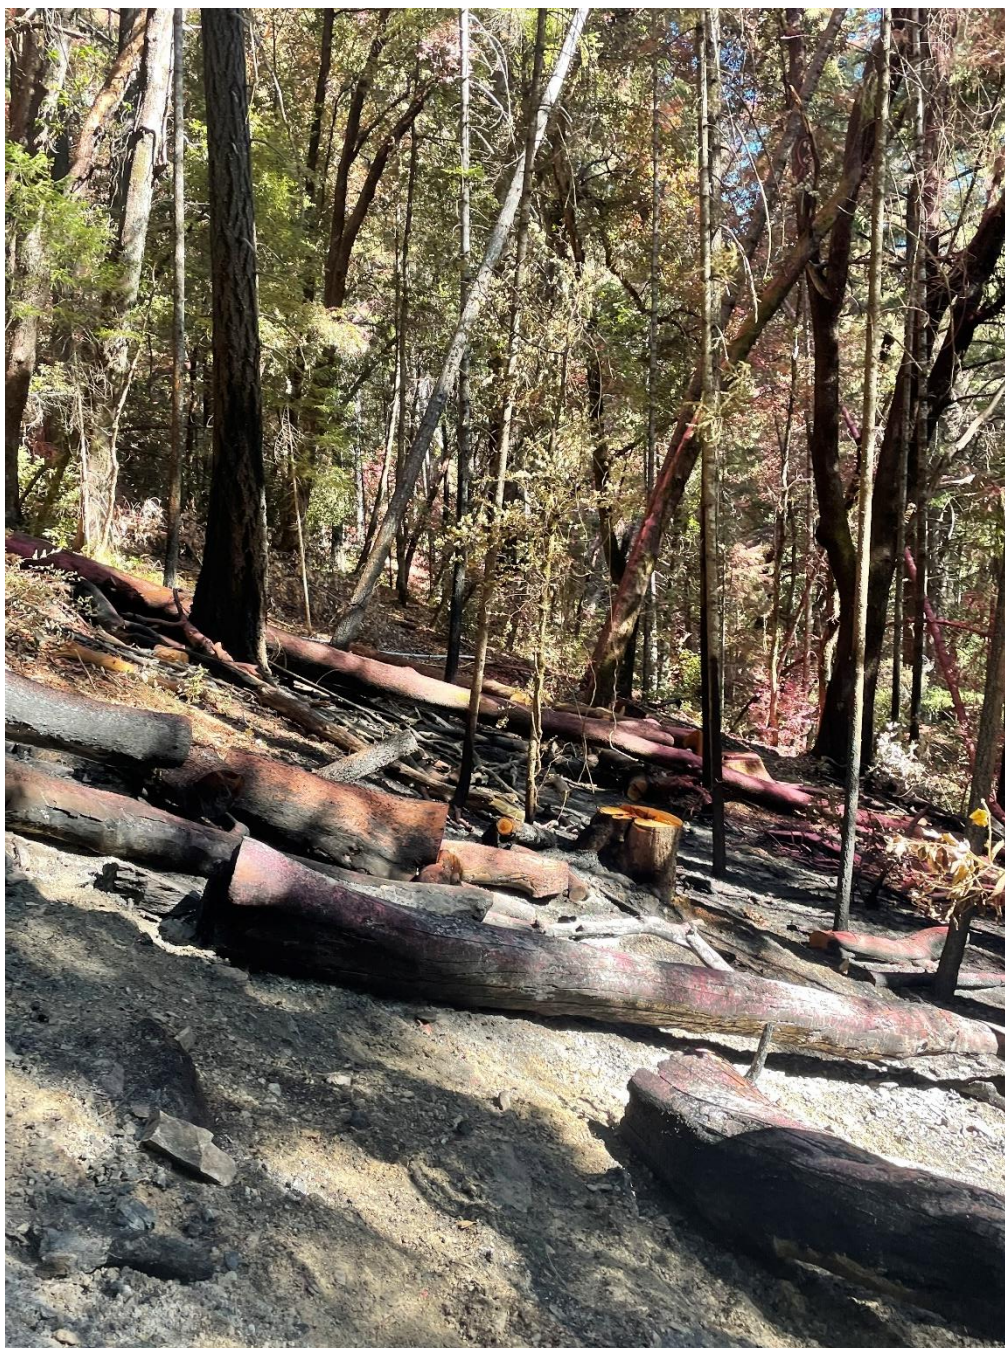
<sup>9</sup> VM noted that trees in the area consisted of Douglas firs and Pacific madrones, some of which were burnt at the base as well as others removed above the base. Mid-canopies of the Douglas firs and Pacific madrones in the area exhibited signs of scorching mid-span and more on the northern side of the lines. The report does not provide evidence to conclude the uprooted Douglas fir caused the wire down incident. Tree trimming and removal was performed within the Incident Span two-days and approximately three weeks prior to the incident, some of the tree remnants in the scar area may be related to these efforts.

*Figure 5 Cut trees within burn scar. Note the fire retardant (pink discoloration) on some of the trees indicating they were cut prior to the ignition. Source: VM Incident Investigation Report (attached photograph).*

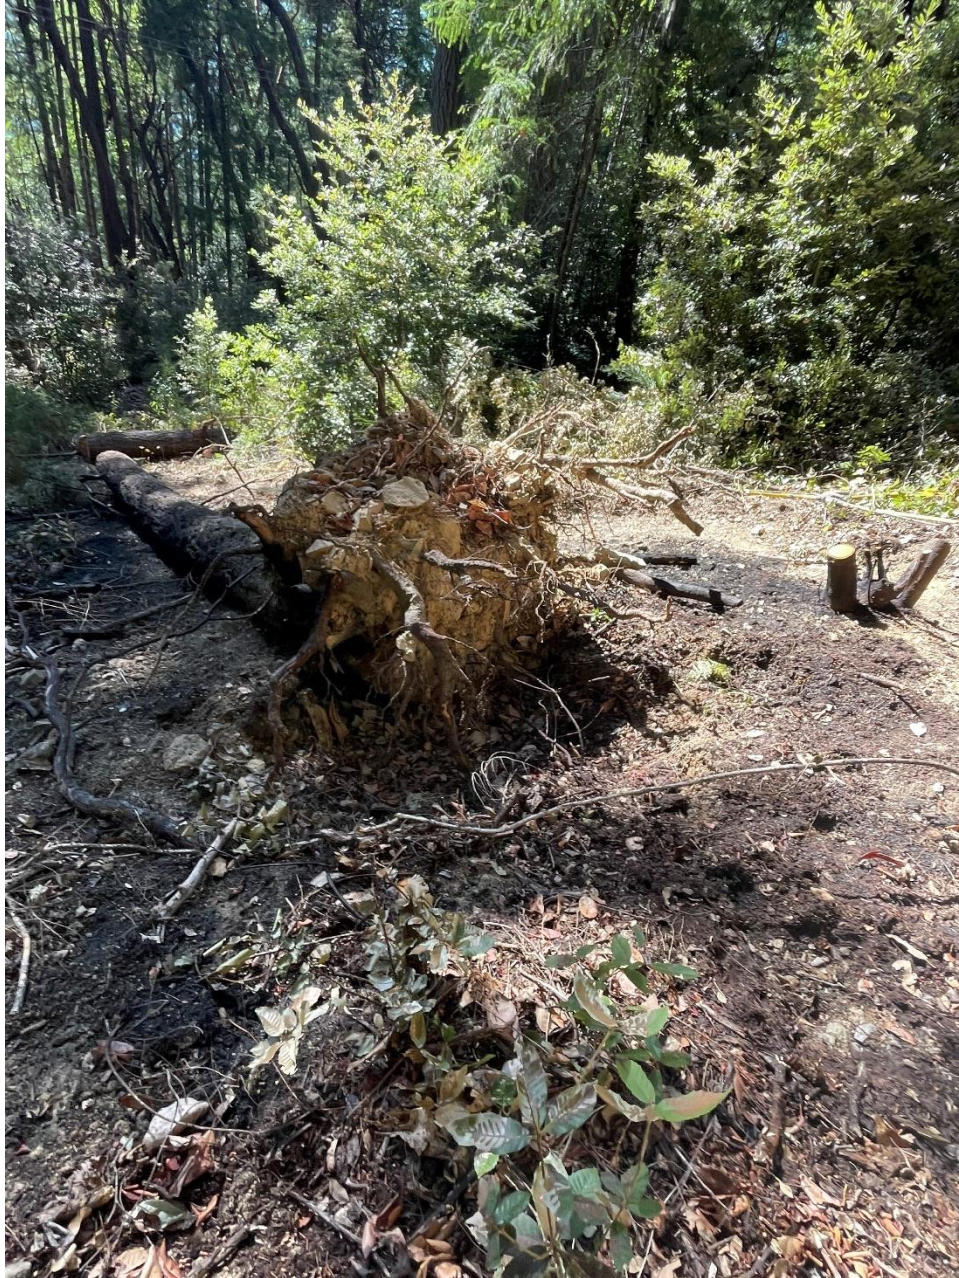
On October 3, 2024, PG&E Vegetation Management (“VM”) patrolled the Incident Location and observed a 100-foot-tall Douglas fir (*Pseudotsuga menziesii*) north of the right of way that had uprooted and failed downhill to the southwest (Figure 6). VM did not identify any branches showing indications of direct contact, however noted there was a splice observed directly above the fall path of the tree. VM speculated the uprooted Douglas fir may be the Incident Tree.<sup>9</sup> However, likely due to post ignition firefighting and possible material retention activities performed by USFS, VM was unable to conclusively identify the location and species of the Incident Tree.<sup>10</sup> Also on October 3, 2024, VM performed an Extent of Conditions (XoC) Patrol covering five distribution spans in all (three) directions from the Incident Span. No immediate additional hazards were identified.

Based on information available as of the date of this report, this ignition was likely caused by a tree, or portion thereof, falling onto the conductors causing them to fall to the ground and ignite ground vegetation. However, specifics of the Incident Tree (location, species, condition at time of incident, inspection history, etc.) are currently unknown. Additional information may be available upon receipt of the USFS investigation report. Upon receipt and review of the USFS report, this record of events will be revised, as needed.

*Figure 6 Uprooted Douglas-fir, located on north side of the right of way, that failed downhill, to the southwest. Source: VM Incident Investigation Report (attached photograph).*

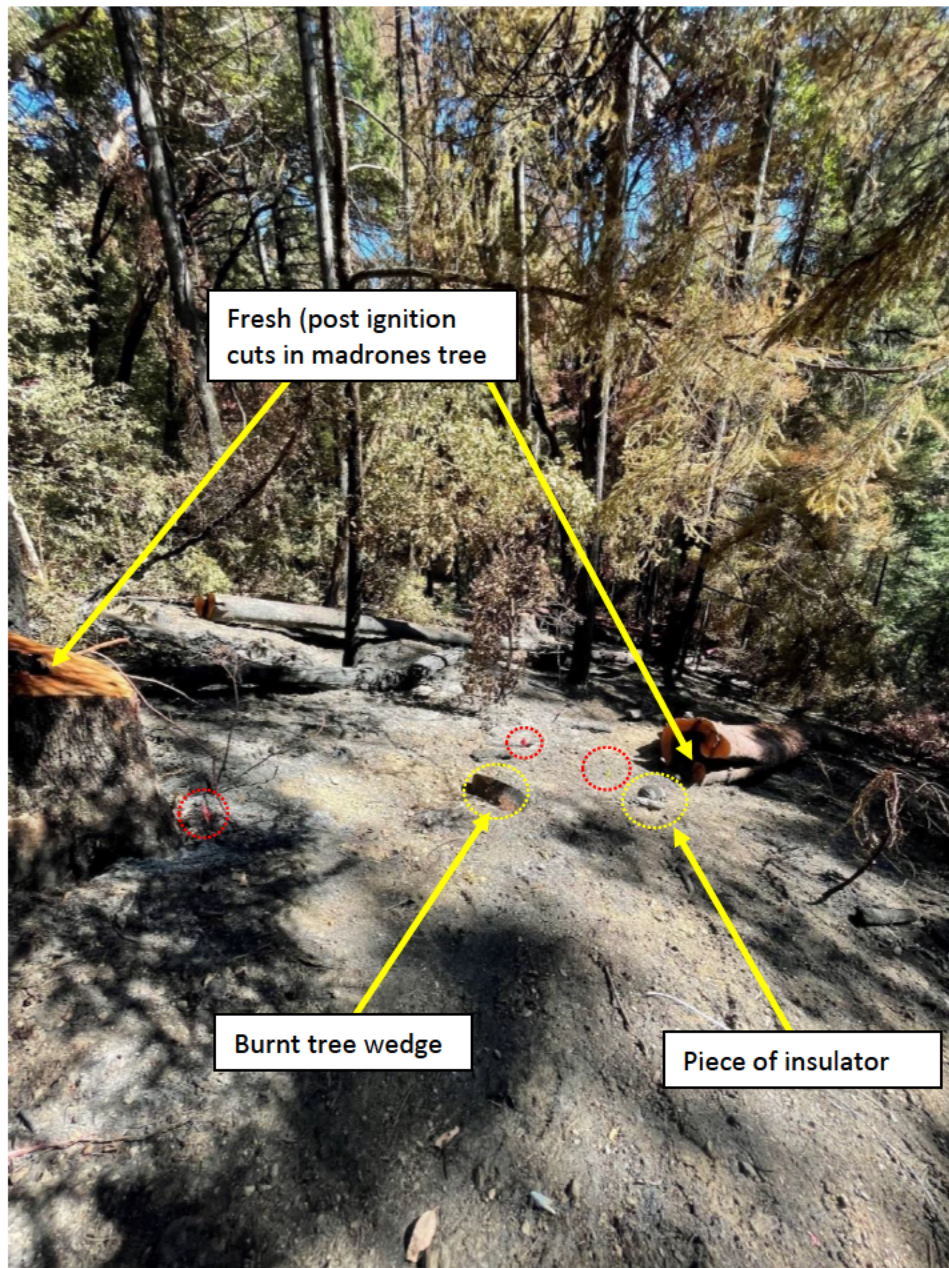
<sup>10</sup> Within the burn scar area, a section of a freshly cut (post ignition) madrone tree appeared to be missing; there were three flags and part of a broken insulator in the space between the intact trunk and upper portion of the tree (Figure 7). It is speculated, this may be the area where USFS removed material for retention.

Figure 7 View of cut madrone (*Arbutus menziesii*) tree, with apparent section missing, and surrounding burnt vegetation. Note the investigation flags (two red and one yellow, indicated by red circles, placed by others) between the madrone tree sections. A piece of insulator and burnt wedge are present on the ground. Source: VM Incident Investigation Report (attached photograph).
