## Preliminary Ignition Investigation Report

| Incident Name: | Holly |
| Circuit: | Mirabel 1102 |

## Executive Summary

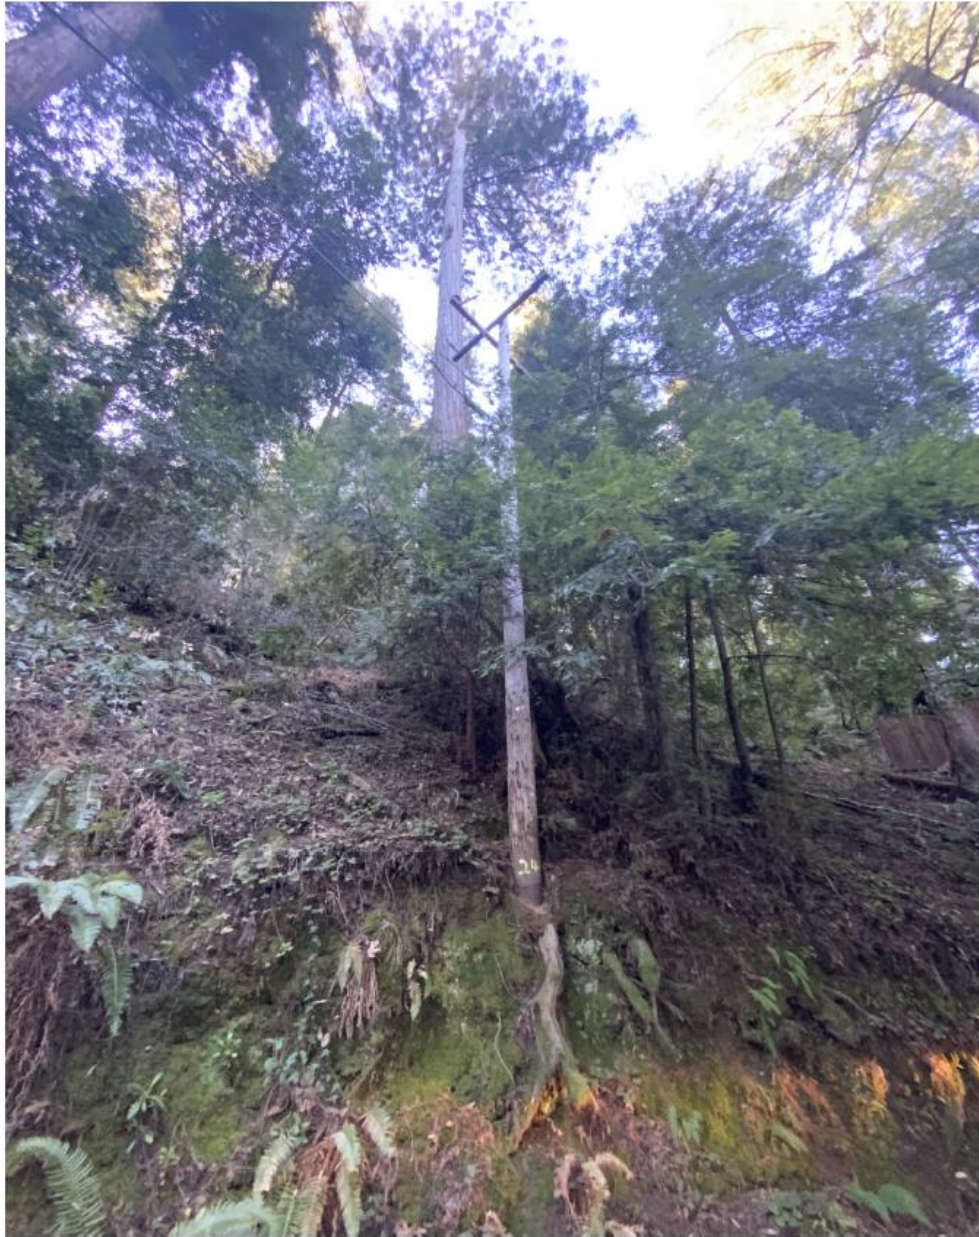
Notification #: 122928554

| Load Side Structure* | SAP ID # 102300476 | |
|---|---|--|
| Inspections: | July 10, 2022 | GO165 Detailed Enhanced Inspection: Anchor is graded and needs to be dug and exposed more. Climbing space obstructed, bank where pole is eroding. Down guy above insulator is overgrown with vegetation and needs trimming. Notes EC tag # 122928554 is pending for similar conditions. No other abnormal or compelling conditions identified. |
| Corrective History: | February 6, 2022 | EC # 122928554, Priority E. Climbing space obstructed by trees – needs trimmed around the pole. June 2022 FSR added “add bank where pole is eroding.” All tree work completed on June 21, 2024. Location: 942 Esther Drive. |

*Figure 3 View of Pole #1 at most recent (February 6, 2022) GO165 inspection. Source: EC # 122928554*

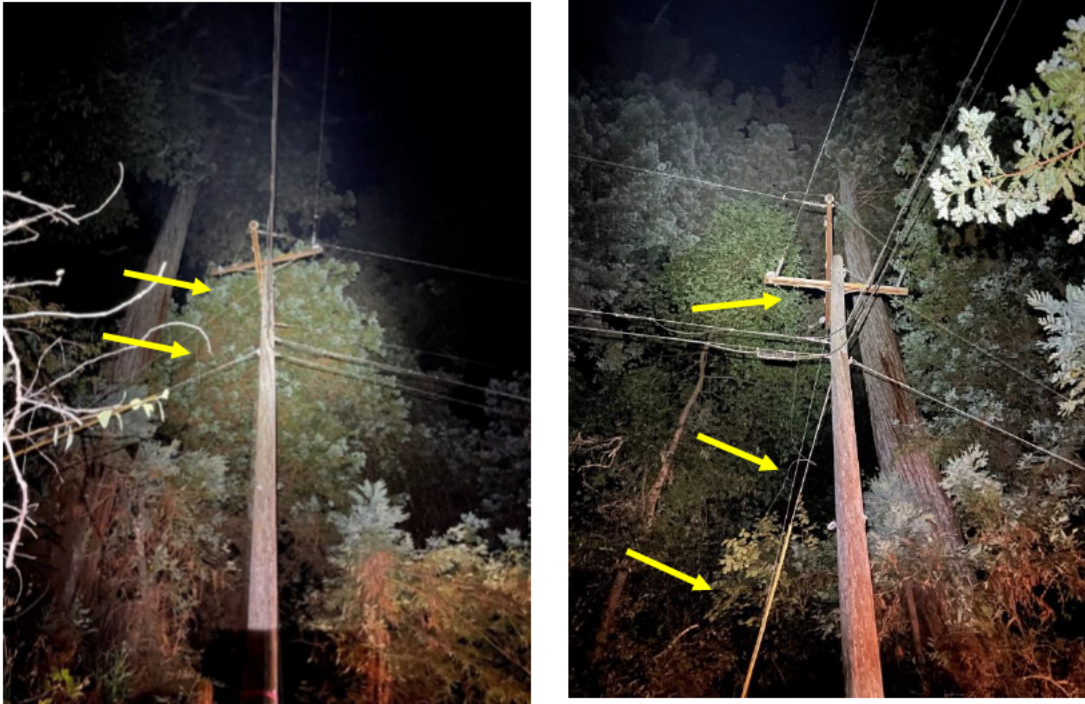
The tree falling on the conductors caused one phase of #6 solid copper conductor to break and a vegetation fire of approximately 400 square-foot.<sup>13</sup> There was no fire related damage to other PG&E or third-party assets, no individuals were injured, and there was no reported media exposure. The outage associated with this event affected 1,239 customers for approximately two hours and four customers for approximately eleven and a half hours.

Figure 5 Photographs of top of Pole #1 showing broken conductor (indicated with arrows). Source: Troubleshooter, taken on October 4, 2024.

Corrective Notification EC 129630581 was created to repair one phase of #6 solid copper conductor within the Incident Span. This work was completed on October 4, 2024.

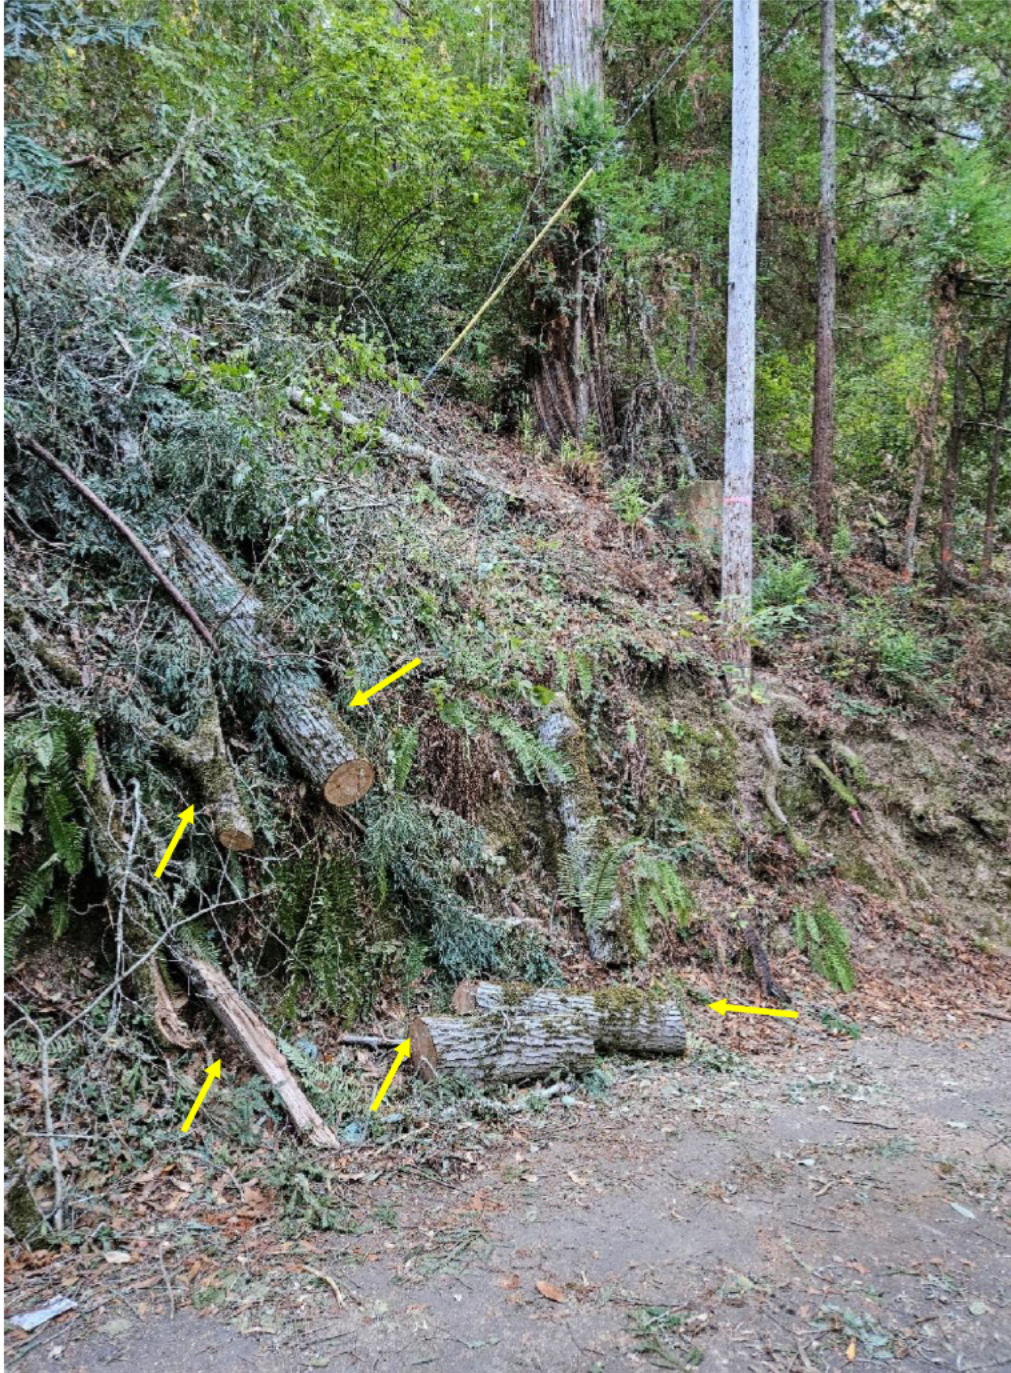
On October 4, 2024, PG&E Vegetation Management (“VM”) patrolled the Incident Location and observed the remaining trunk of the Incident Tree. The trunk was broken approximately six feet above ground and located within approximately “62-feet horizontally” from the closest primary conductor, uphill, with a 25 degree lean downhill towards the Incident Span. The identified portions of the 85-foot-tall Incident Tree had been cut into sections and stacked on the side of the road.

Figure 6 Remnants of Incident Tree on side of road (indicated with arrows). Source: Troubleshooter, taken on October 4, 2024.

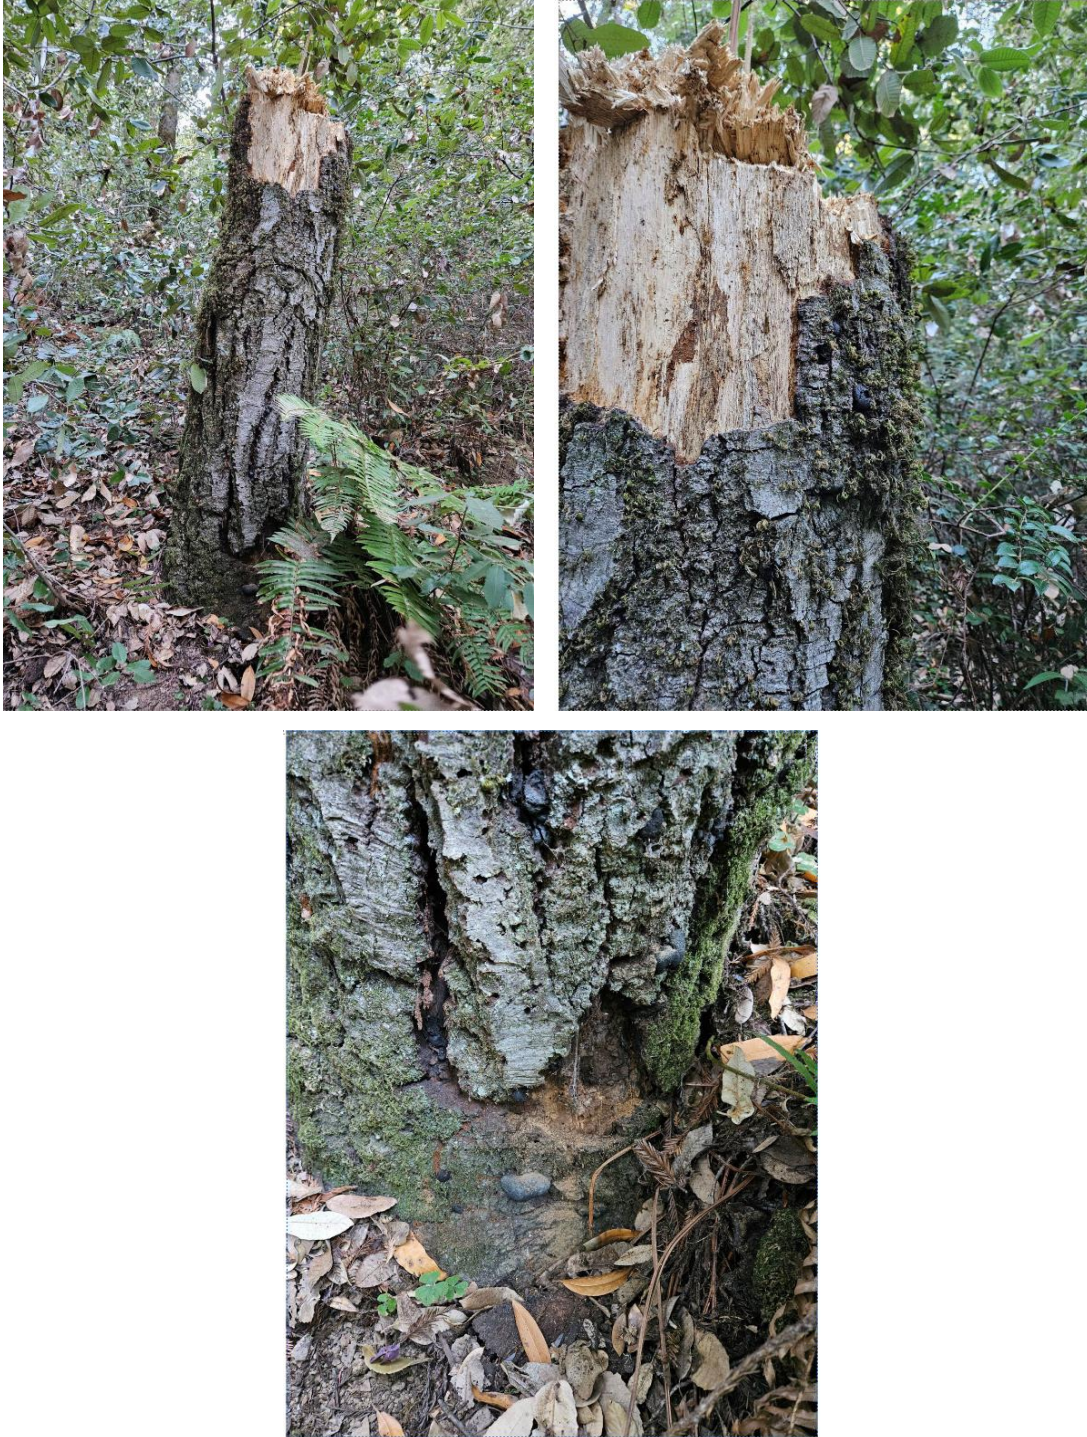
VM observed the remaining portion of the standing trunk had hypoxylon (*Hypoxylone sp.*) fungal fruiting bodies and signs of wood rot at the base (Figure 7). The top portion of the Incident Tree was laying across the slope, beneath the conductors, and the failed tree top and branches were devoid of any live or dead leaves (Figure 8). On October 5, 2024, VM performed an Extent of Conditions (XoC) Patrol covering one span to the west, to the

| Hazard | Vegetation Contact | Sub-Hazard | Fallen Tree |
|---|--|---|---|
| Tree Risk Assessment - Basic Assessment (Level 2)<br><br>Document:<br>TD-1470P-01 | Expected Performance:<br>Identify vegetation conditions or obvious defects of concern.<br><br>Observed Performance:<br>Barrier did not exist | N/A | A Level 2 inspection likely would have identified the hypoxylon fungus, an indicator of declining tree health. Annual and second patrols (Level 1 inspections) likely would not have identified this condition. |

*Figure 7 View of remaining six-foot height of trunk of failed tree (top, left) and close-up of trunk failure location showing hypoxylon and wood rot (top, right and bottom). Source: VM Incident report and associated photographs, 10/4/2024.*

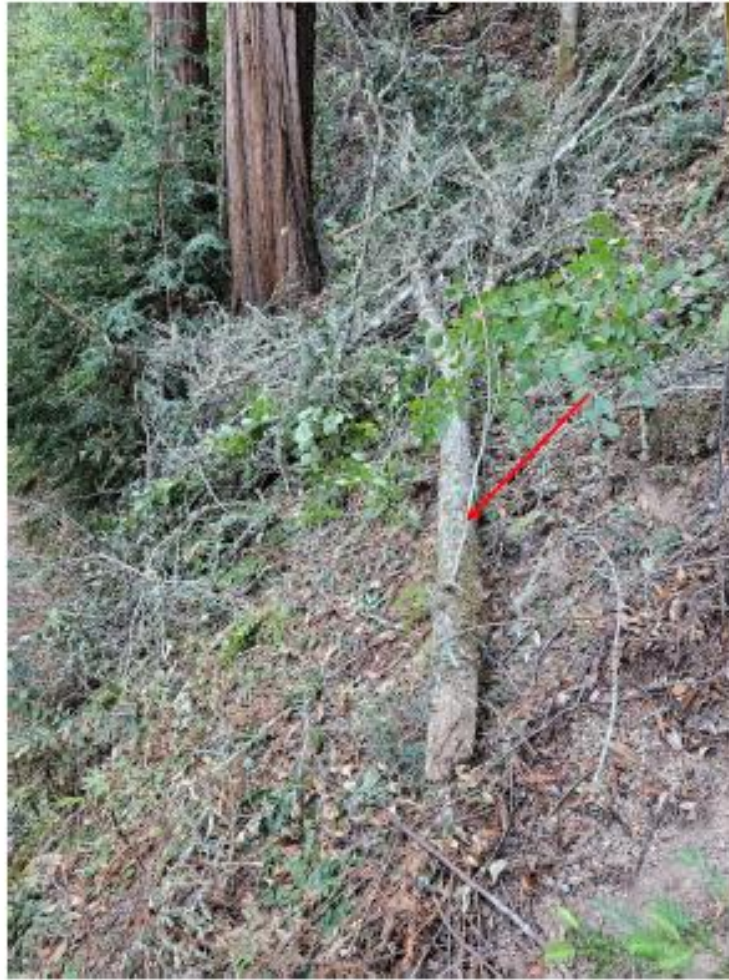
### #7 Subject tree top under lines

| Hazard | Vegetation Contact | Sub-Hazard | Fallen Tree |
|--|---|---|---|
| Distribution Second Vegetation Patrol<br><br>Document:<br>TD-7102S | Expected Performance:<br>Identify declining/dead vegetation that may fall into or contact PG&E assets.<br><br>Observed Performance:<br>Unknown | | Dead tree with no leaves was not identified during August 29, 2024 Second Vegetation Patrol. Tree fell into conductors. |

*Figure 8 Top of failed tree showing trunk and branches devoid of any live or dead leaves. Source: VM Incident report and associated photographs, 10/4/2024.*
