Preliminary Ignition Investigation Report

Ignition Database Index:	20240177
Electric Incident Investigation (EII) Number:	N/A
Incident Name:	N/A
PG&E Facility Ignition?	Yes
CPUC Reportable Ignition?	Yes
Date & Time of Incident:	March 15, 2024 at approximately 1400 hours
Street Address:	Near [REDACTED]
City:	Woodside
County:	San Mateo
Latitude/Longitude:	[REDACTED]
State Responsibility Area (SRA) / Local Responsibility Area (LRA) / Federal Responsibility Area (FRA)	SRA
PG&E Division:	Peninsula
High Fire Threat District (HFTD):	Tier 3
High Fire Risk Area (HFRA):	Yes
EPSS Buffer:	No
Fire Index Area (FIA):	518
Fire Potential Index (FPI) Rating: FIA	R1
Fire Potential Index (FPI) Rating: Circuit	R1
Was there a PSPS event at the time of ignition?	No
Suspected Initiating Event:	Vegetation
Failure Driver:	Contact from Object
Failure Sub-driver:	Contact - Vegetation
Circuit:	Woodside 1101, 02425-1101
Circuit Protection Zone:	Woodside 1101 LR 8974
Nominal Voltage:	4kV

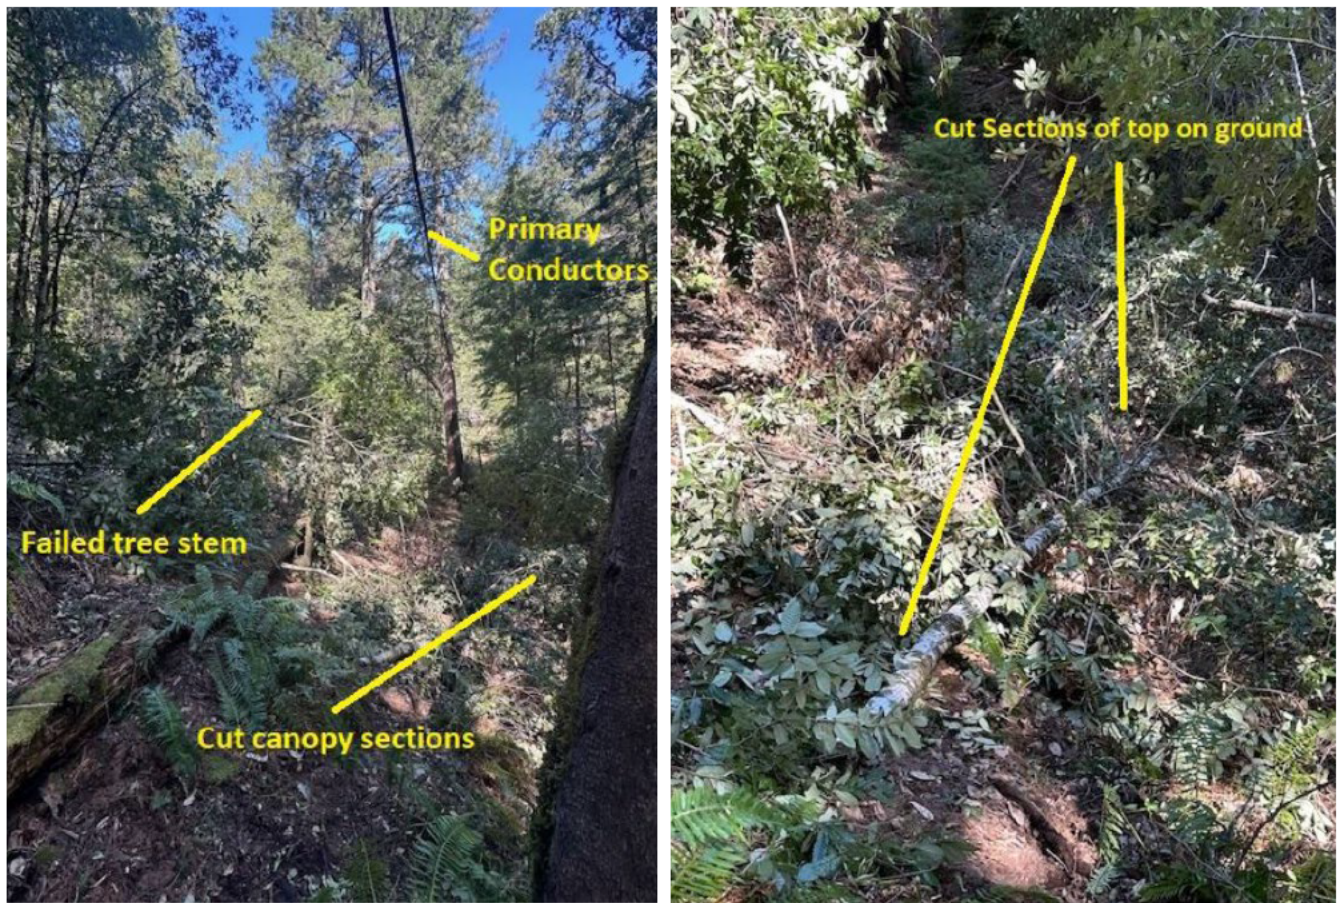
Figure 2 – Incident tree in relation to wire post-ignition event. Photos taken by the VM team.

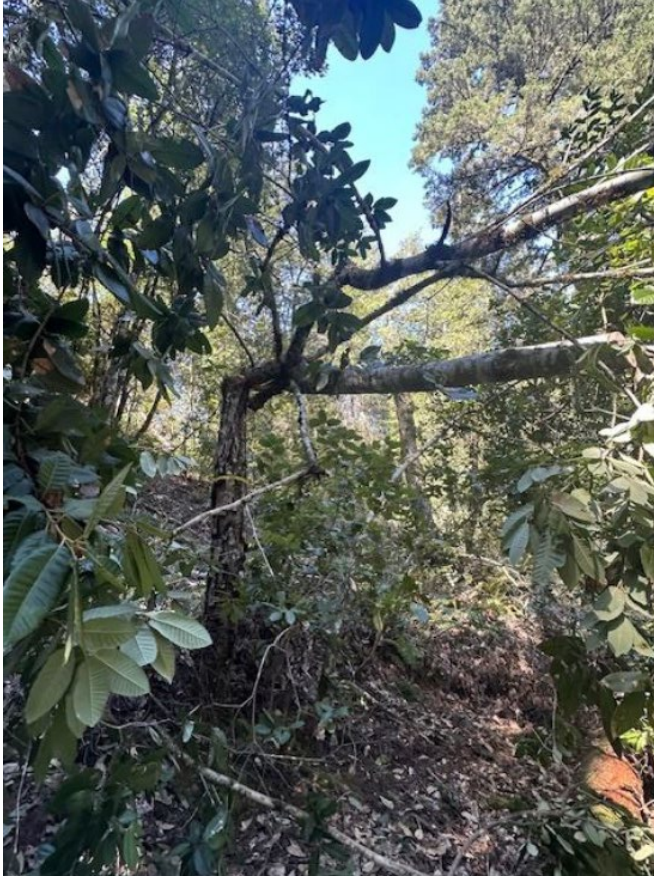
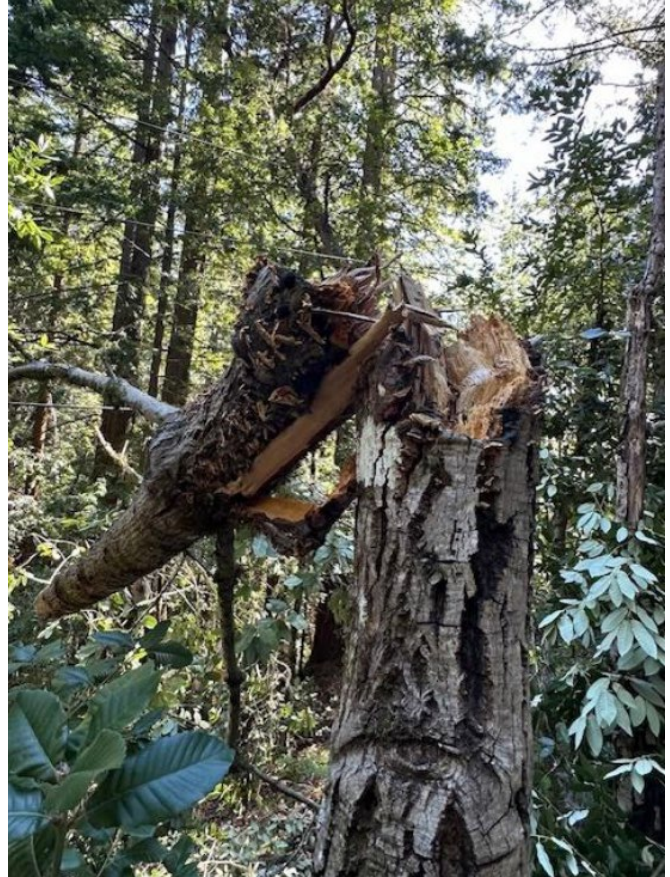
The Vegetation Management (VM) team conducted a post-incident investigation on March 15, 2024. The incident tree identified by the VM investigator is a 50-foot tanoak with green canopy and a seven-inch diameter at breast height (DBH) located 15 feet west of the conductor. The tanoak experienced a complete trunk failure approximately six feet above ground level and fell eastward into the wire. The VM investigator noted that the tree had been cut into three large sections prior to his arrival. Although the foliage in the canopy is green, it is sparse. Additionally, an area of cubicle rot was observed in the main stem at the failure point (see Figure 5). It is unknown if the rot was visible externally, however, some hypoxylon² is present externally.

Figure 3 – Incident tree. Photos taken by the VM team.

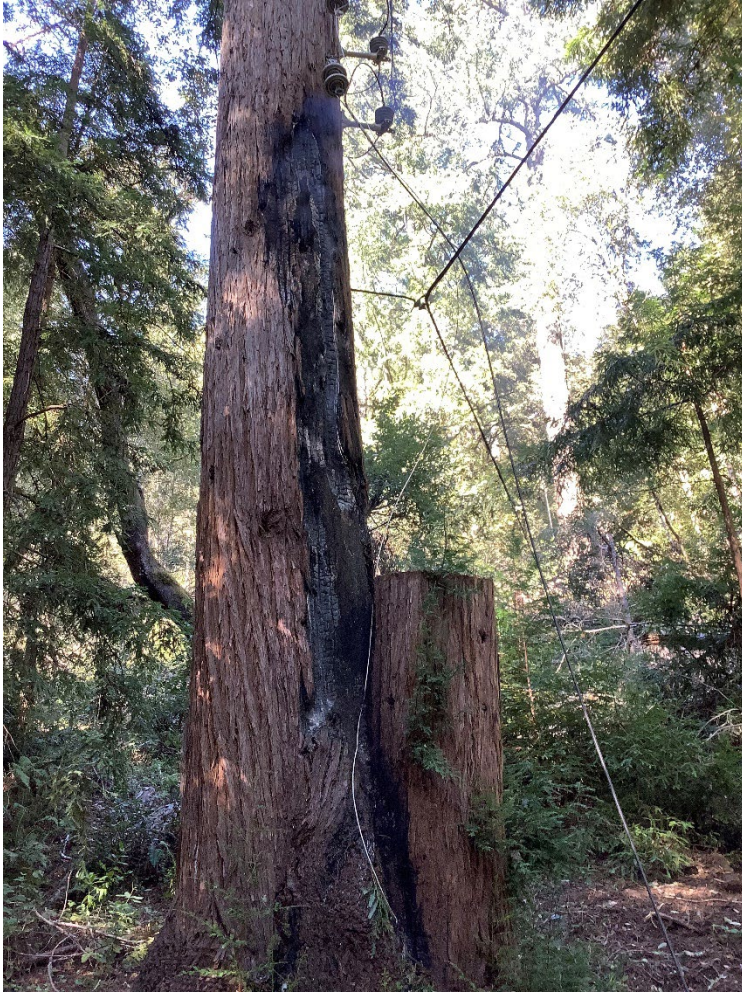
The troubleshooter was the PG&E first responder to arrive on scene at approximately 1452 hours. In order to isolate this section of the circuit for patrol and eventual remediation, the troubleshooter, upon his arrival, requested and was approved by the Distribution Operations (DO) operator to open Fuse 10265. After de-energizing and making the scene safe, the troubleshooter patrolled multiple spans of tree connects¹ and observed a broken tree leaning into a broken 4 ACSR tree wire midspan between tree connect SAP ID 103489594 and 103493985 (Incident Location) (see Figure 2 and 3). One end of the broken tree wire came to rest onto source side tree connect SAP ID 103493985 and ignited a fire that was contained to the tree connect. The burn scar left on the tree connect measured approximately between one and three meters (see Figure 4) and was extinguished by the San Mateo County Fire Department.

Figure 4 – Photo of tree connect SAP ID 103493985 and fire damage. Photo taken by the troubleshooter.

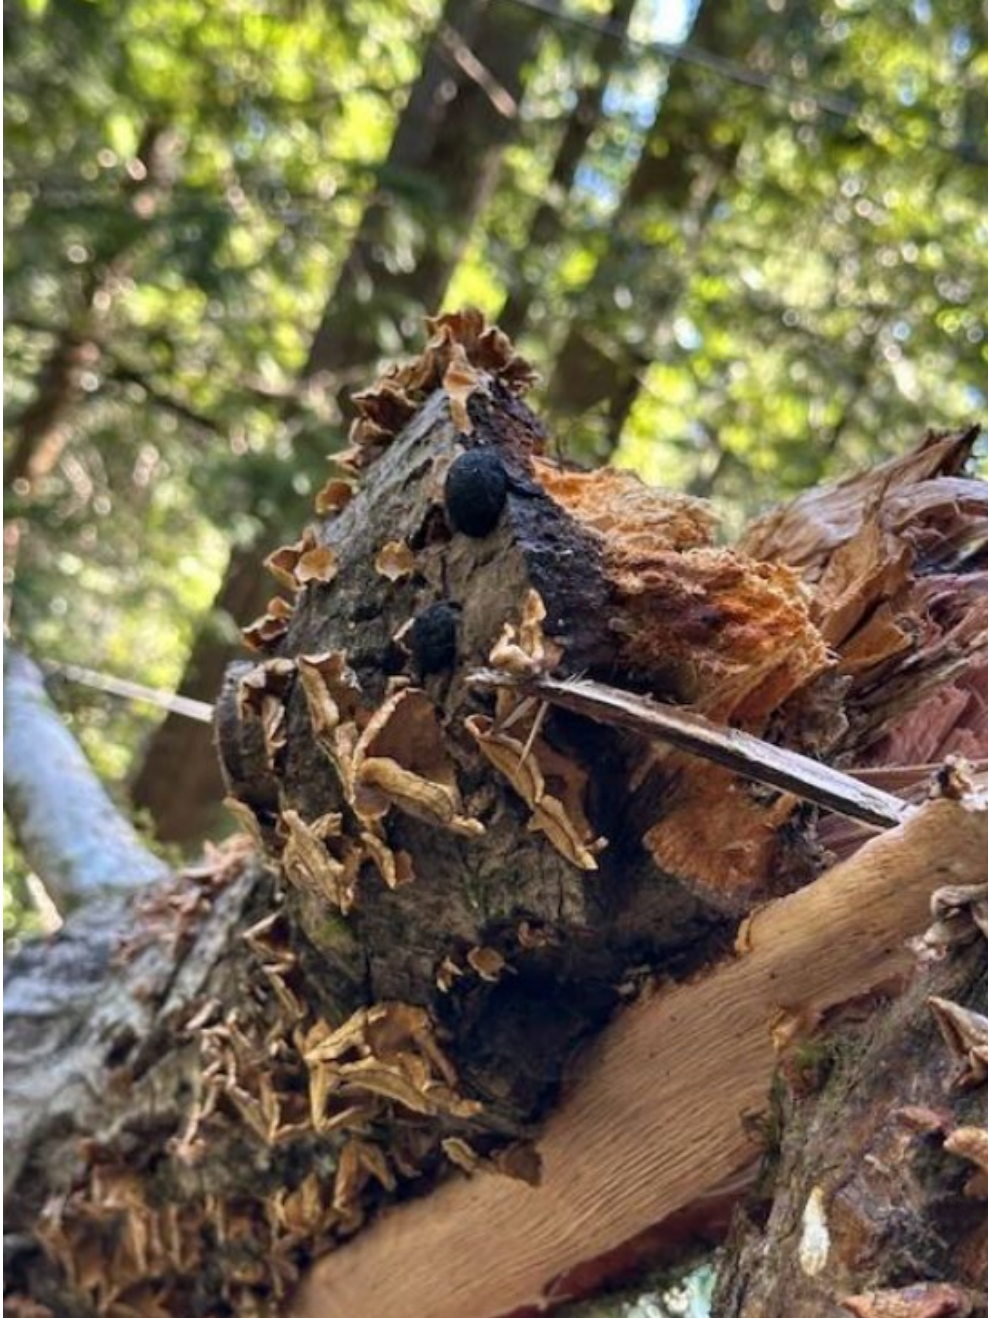
Figure 5 – Close-up view of interior rot on incident tree with visible external fruiting bodies of wood decay fungus. Photo taken by the VM team.

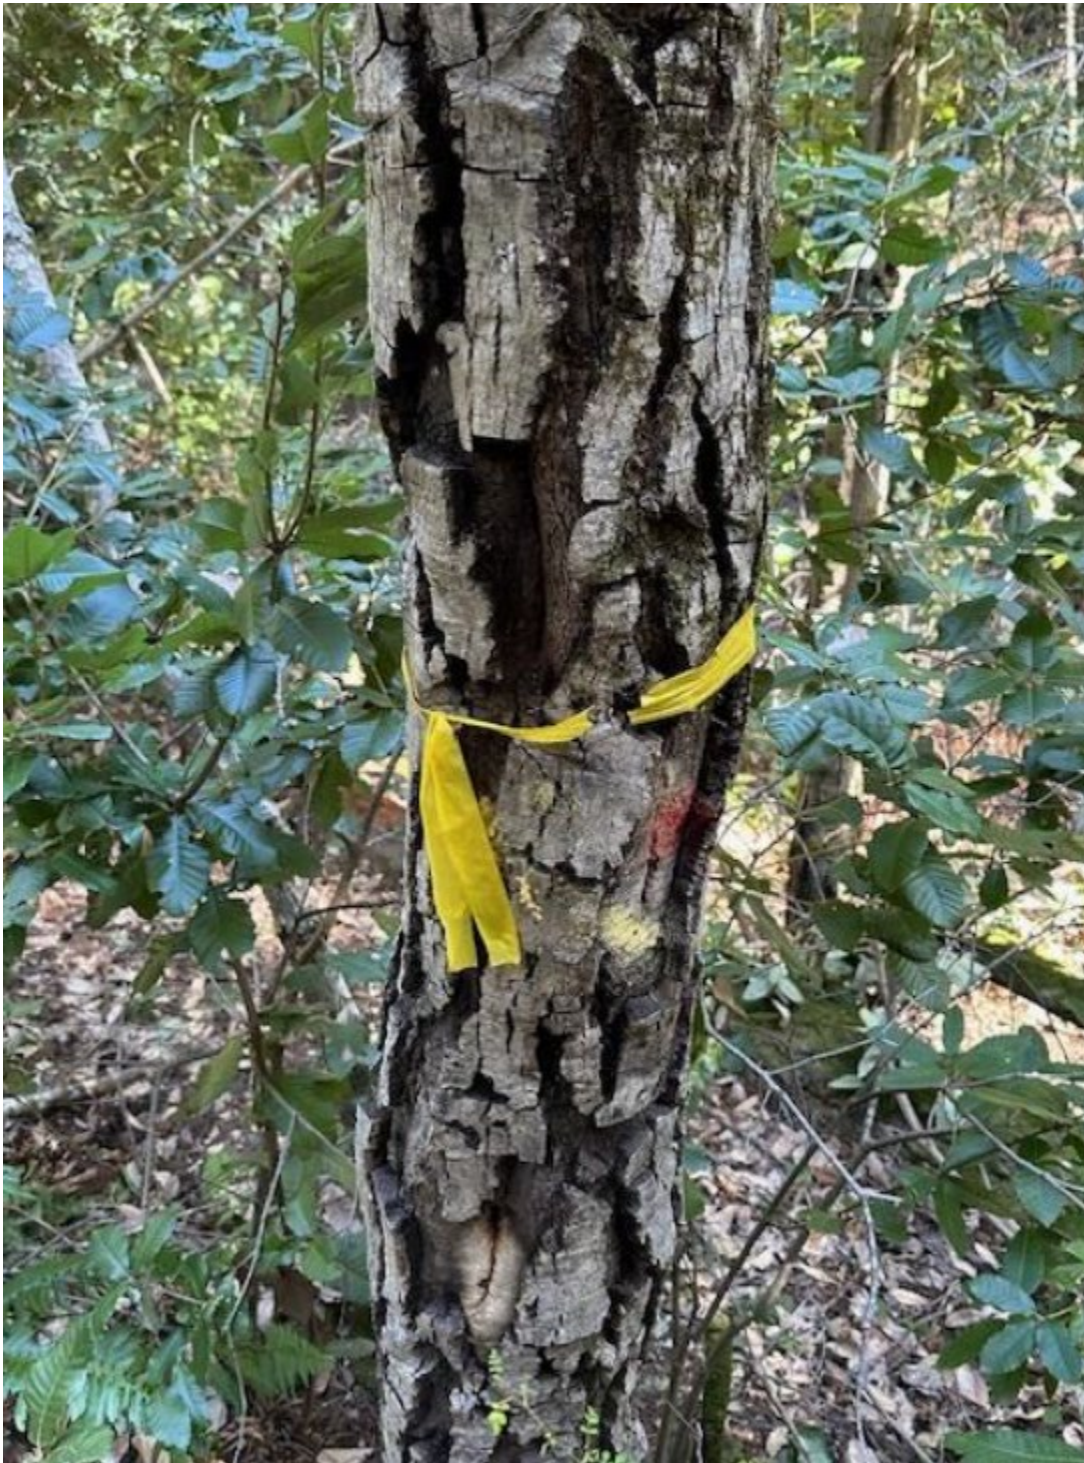
The trunk of the incident tanoak is marked with yellow paint, flagged (see Figure 6) and was identified for work in the third quarter of 2019 under the Enhanced Vegetation Management (EVM) program. With the EVM program concluding near the end of 2022, the tree was listed for the Tree Removal Inventory (TRI)³ program. However, risk modeling did not yet scope in the tree for the 2023 or 2024 work plan.⁴ With regards to the circuit, both VM records from the Project Management Database (PMD) and OneVM⁵ shows that the Woodside 1101 last completed and projected completion of the following:

Figure 6 – Yellow paint and flag on incident tree. Photo taken by the VM team.
