Preliminary Ignition Investigation Report

Ignition Database Index:	20240347
Electric Incident Investigation (EII) Number:	N/A
Incident Name:	Bucks Fire
PG&E Facility Ignition?	Yes
CPUC Reportable Ignition?	Yes
Date & Time of Incident:	May 1, 2024, at 1348 Hours
Street Address:	Silver Lake Road and Bucks Lake Road
City:	Meadow Valley
County:	Plumas
Latitude/Longitude:	39.928003, -121.083794
State Responsibility Area (SRA) / Local Responsibility Area (LRA) / Federal Responsibility Area (FRA)	Federal Responsibility Area (FRA)
PG&E Division:	North Valley
High Fire Threat District (HFTD):	Tier 2
High Fire Risk Area (HFRA):	Yes
EPSS Buffer:	No
Fire Index Area (FIA):	285
Fire Potential Index (FPI) Rating: FIA	R1
Fire Potential Index (FPI) Rating: Circuit	R1
Was there a PSPS event at the time of ignition?	No
Suspected Initiating Event:	Contact- 3 rd Party
Failure Driver:	Contact from Object
Failure Sub-driver:	Vegetation Contact
Circuit:	GANSNER 1101
Circuit Protection Zone:	GANSNER 11012006

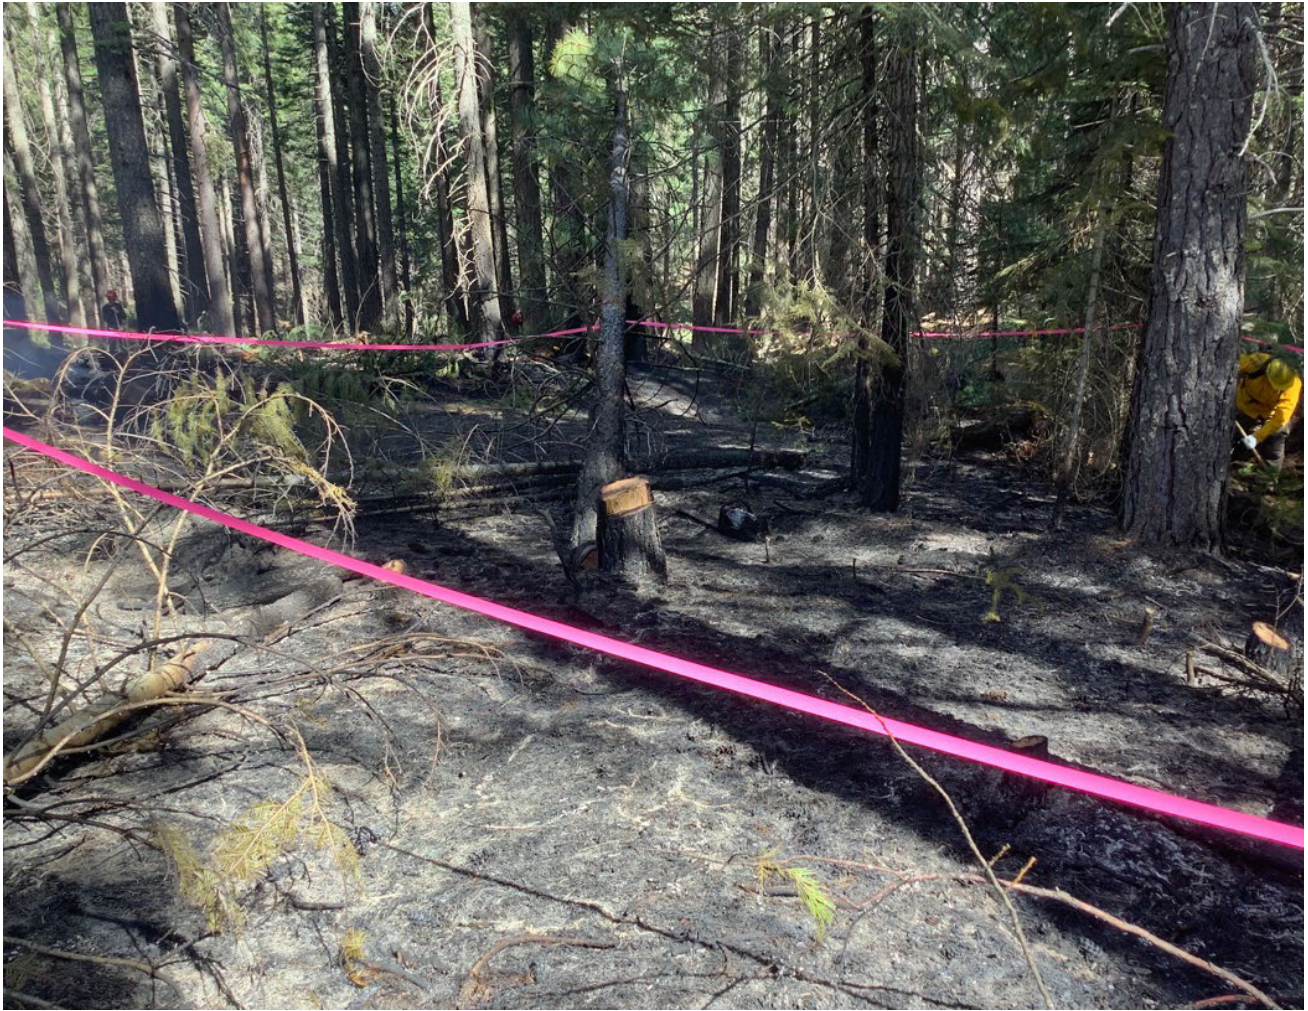
By analyzing phone calls made to the Distribution Call Center (DCC), it was determined the troubleshooter arrived at the Incident Location at approximately 1434 hours. Once at scene, the troubleshooter located a third-party tree cutting contract crew on-scene standing by observing a large tree leaning against both spans of 2-aluminum conductor steel reinforced (ACSR) primary overhead (OH) conductor in-between the 40-foot wood poles and an active fire on the ground below (SAP 100438785 and 100391188). The automated upstream protective device, Line Recloser 2006 (SAP 40172574), was manually opened at 1434 hours.

Figure 5 – Image of area of origin with subject tree in picture taken by troubleshooter

A priority 'B' EC tag #128718742 was created on May 6, 2024, to remove a dead or dying Fir tree that is within striking distance from a 12kV primary conductor in a fire area. The tree is approximately 32-feet from the conductor and is approximately 65-feet tall. The tree has a split growth 3-feet above the ground line. This priority 'B' EC tag is scheduled to be completed by November 6, 2024.

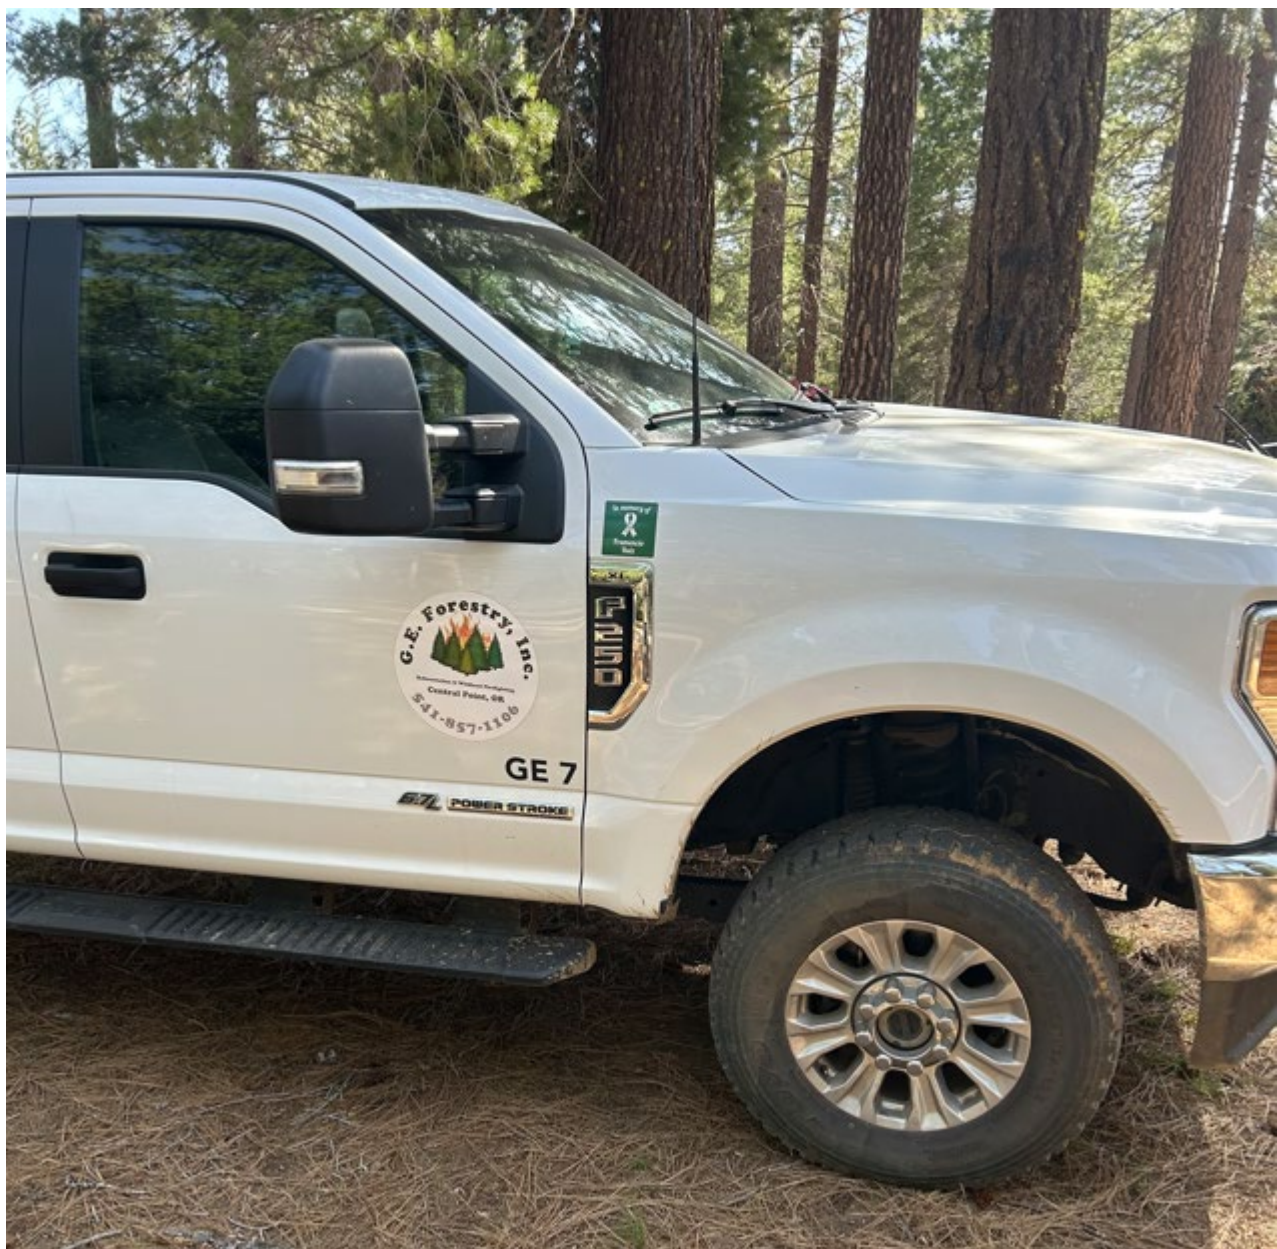
Figure 6 – Image of contractor vehicle, G E Forestry, Inc., responsible for cutting subject tree that caused ignition.

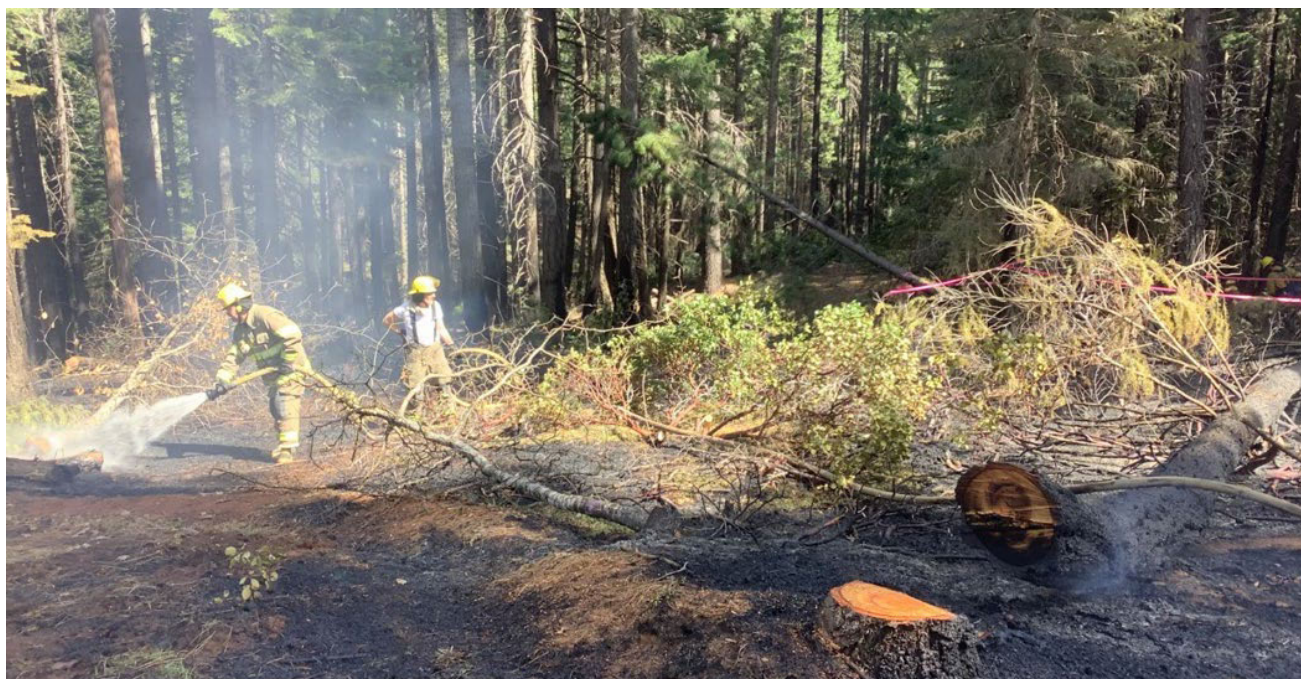
Figure 7 – Image of Meadow Valley Volunteer Firefighters conducting mop up operations on fire.

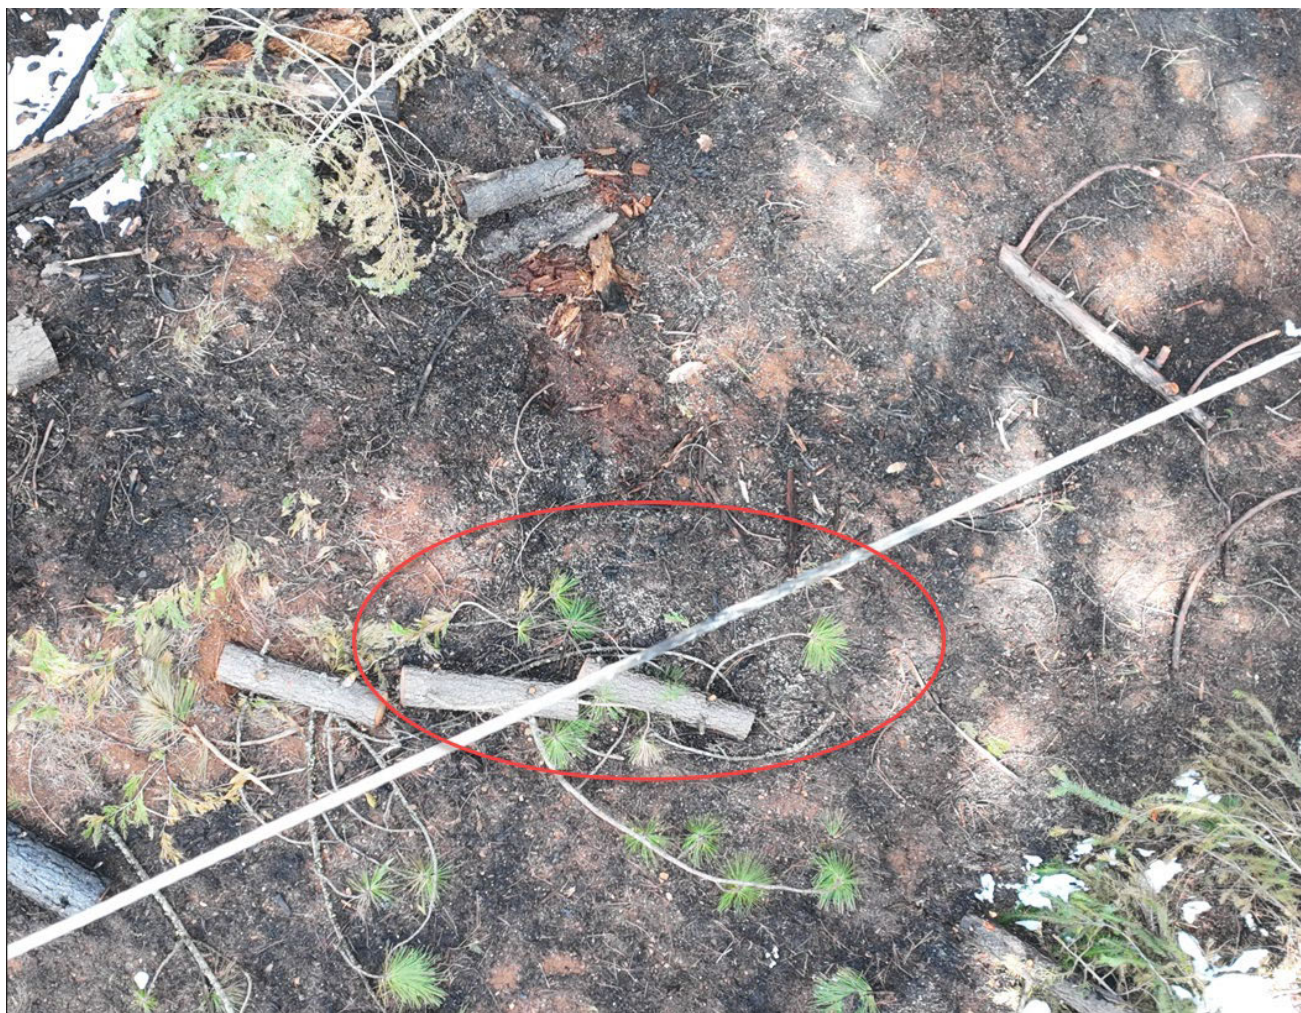
Initial analysis indicates the ignition was caused by a tree that was cut and fell into the lines via the Non-PG&E third-party logging contractors (G E Forestry, Inc.), working on behalf of the USFS. The tree fell and made contact with both energized phases, which resulted in arcs, sparks, and ignited a fire on the ground below.

Figure 8 – Image of conductor where tree made contact with the conductor, resulting in the ignition of the fire.

A priority 'B' EC tag #128719146 was created on May 6, 2024, to replace a section of burnt 2-ACSR conductor. This priority 'B' EC tag is scheduled to be completed by August 6, 2024.
