Preliminary Ignition Investigation Report

Ignition Database Index:	20240458
Electric Incident Investigation (EII) Number:	N/A
Incident Name:	Shafer
PG&E Facility Ignition?	Yes
CPUC Reportable Ignition?	Yes
Date & Time of Incident:	May 22, 2024 at approximately 0911 hours
Street Address:	Near [REDACTED]
City:	Willits
County:	Mendocino
Latitude/Longitude:	[REDACTED]
State Responsibility Area (SRA) / Local Responsibility Area (LRA) / Federal Responsibility Area (FRA)	SRA
PG&E Division:	Humboldt
High Fire Threat District (HFTD):	Tier 2
High Fire Risk Area (HFRA):	Yes
EPSS Buffer:	No
Fire Index Area (FIA):	154
Fire Potential Index (FPI) Rating: FIA	R1
Fire Potential Index (FPI) Rating: Circuit	R1
Was there a PSPS event at the time of ignition?	No
Suspected Initiating Event:	Utility Work/Operation
Failure Driver:	Utility Work/Operation
Failure Sub-driver:	Improper Construction
Circuit:	Willits 1104
Circuit Protection Zone:	Willits 1104 LR 341020
Nominal Voltage:	12kV

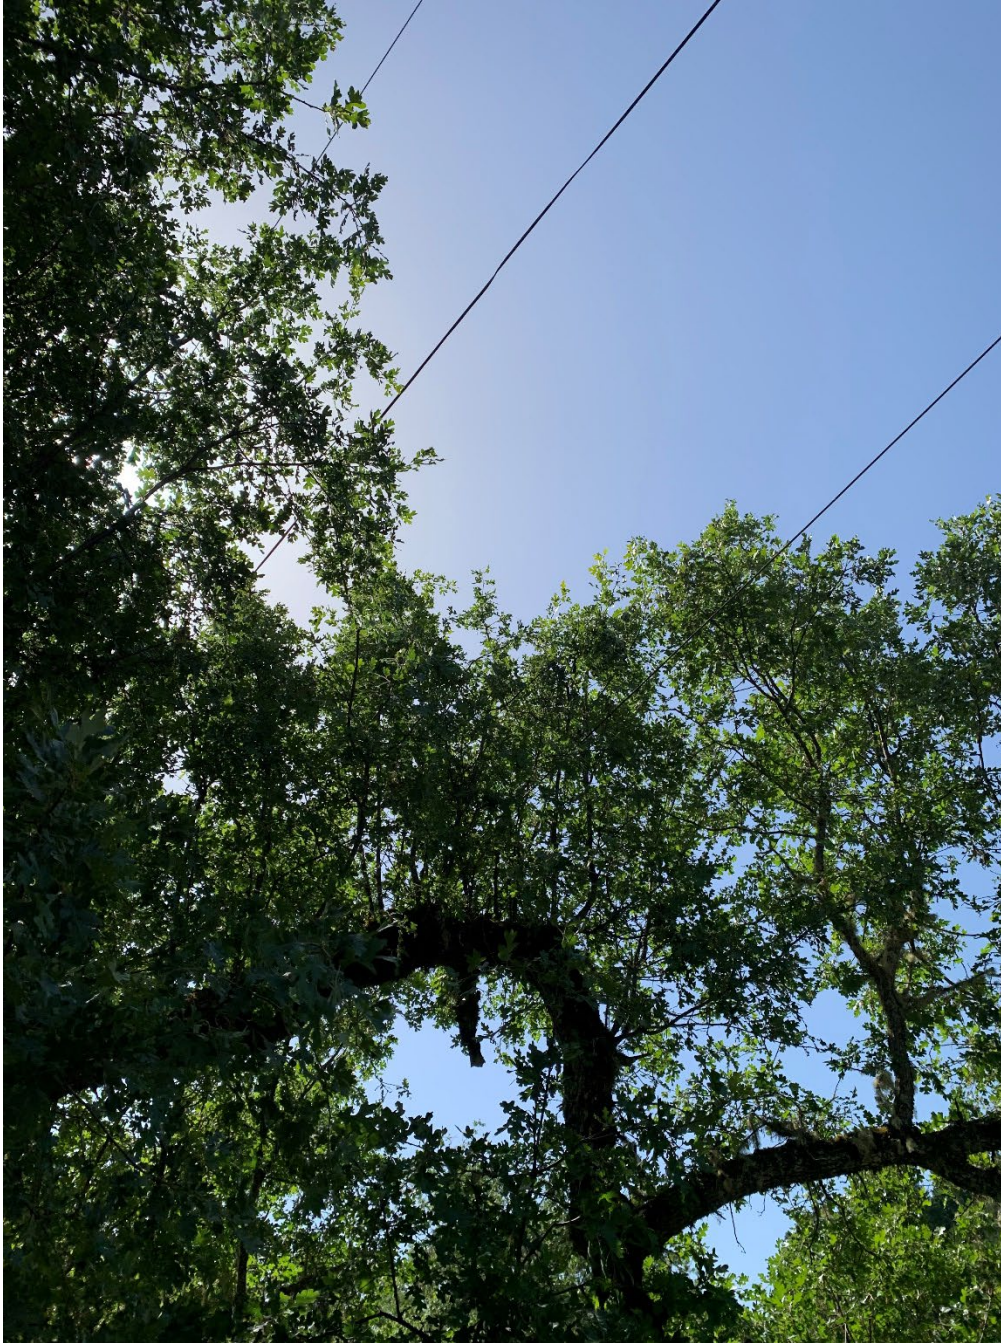
On May 22, 2024 at approximately 0911 hours, PG&E received a call from CAL FIRE requesting assistance with a small vegetation fire with reports of a wire-down. Shortly after, PG&E dispatched a troubleshooter to the two-phase primary overhead segment of the Willits 1104 12kV distribution circuit (See Figure 1) near Shafer Ranch Road in the Community of Willits. At approximately 0950 hours, the troubleshooter was onsite and found all fuses closed at Fuse 1355.¹ The troubleshooter opened Fuse 1355 to de-energize and make the location safe. The troubleshooter observed a phase of 2 ACSR dangling and in contact with a nearby oak tree (See Figure 2) and a small, extinguished vegetation fire measuring approximately 10 x 10-feet in size underneath the tree (See Figure 3) between Pole SAP ID 104203511 (Incident Pole) and towards SAP ID 102176104 and transformer CGC 216236961975. Upon further patrol, the troubleshooter identified the dead-end shoe associated to the Incident Pole had failed and that the wire had popped out (See Figure 4) and was only being held up by the jumper. The troubleshooter had no additional findings or observations as to what else could have contributed to the failure of the dead-end shoe. Per CAL FIRE, it is probable that the powerline arcing on the tree limb caused embers to drop and ignite a moss-covered rock.²

Figure 2 – Wire dangling in oak tree. Photo taken by the troubleshooter.

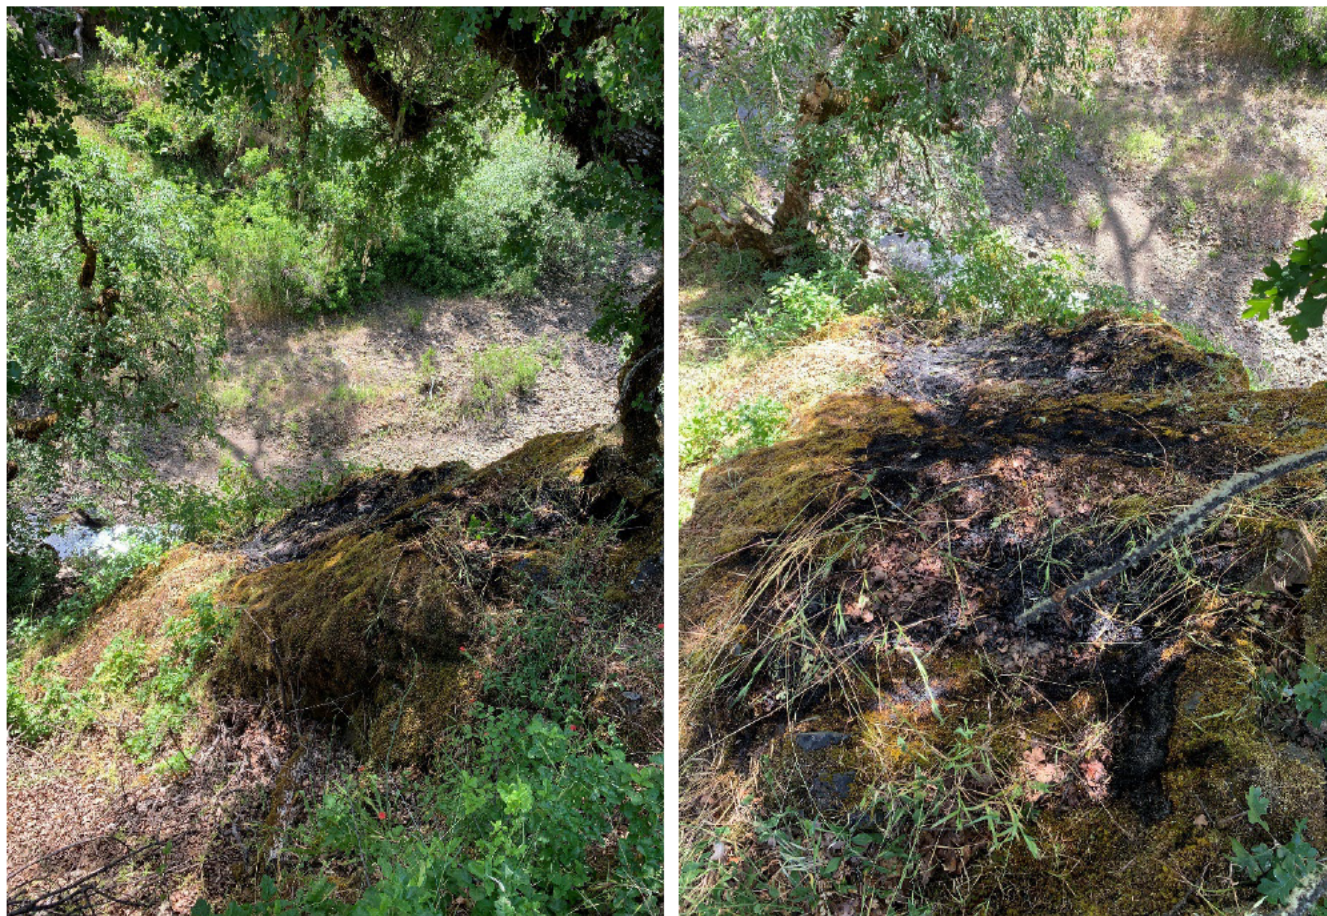
The ignition event on May 22, 2024 resulted in a small fire measuring approximately 10 x 10-feet in size. For the duration of the repair process by a PG&E crew, a total of 147 customers were de-energized for a total of 79 minutes. There were no reported injuries, fatalities, property damages or significant media attention associated to this event.

Figure 3 – Fire footprint below oak tree. Photo taken by the troubleshooter.

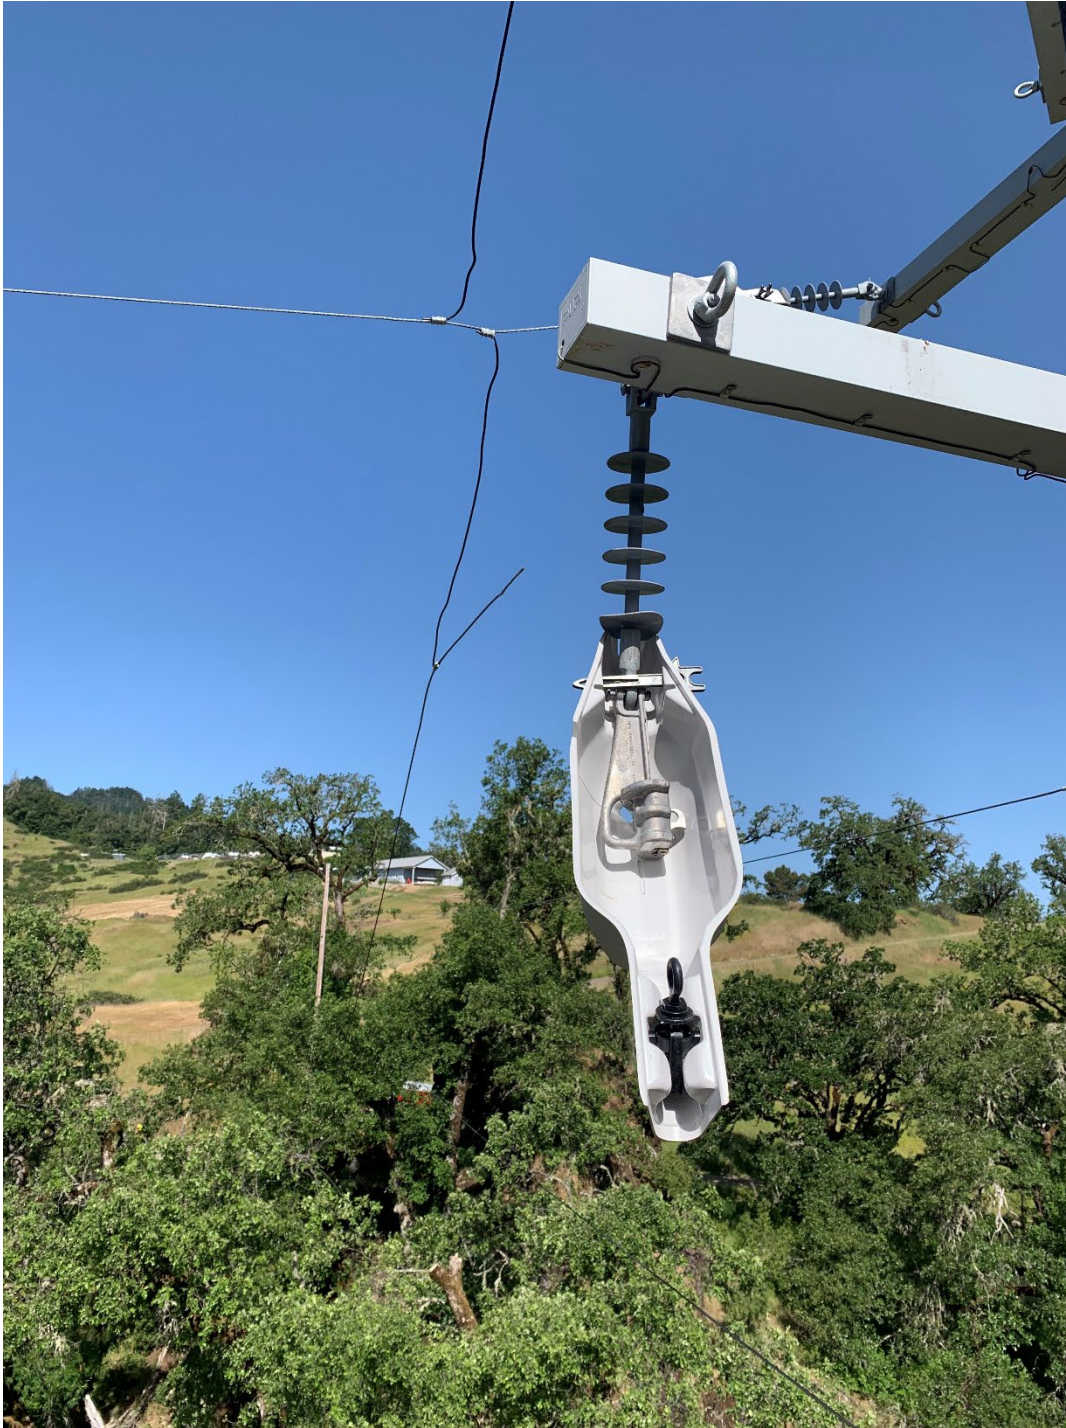
Figure 4 – Incident span shown with wire detached from dead-end shoe. Photo taken by the troubleshooter.

As a result of this incident, a priority “A” Electric Corrective (EC) tag (#128839263) was created to replace the dead-end shoe, make repairs to the burnt section of the 2 ACSR and to re-sag. All work was completed by a PG&E crew later that morning.

A priority “A” EC tag (#128839263) was created to repair/re-sag the conductor and to replace the dead-end shoe. The newly installed dead-end shoe is a like for like wedge-type shoe replacement.

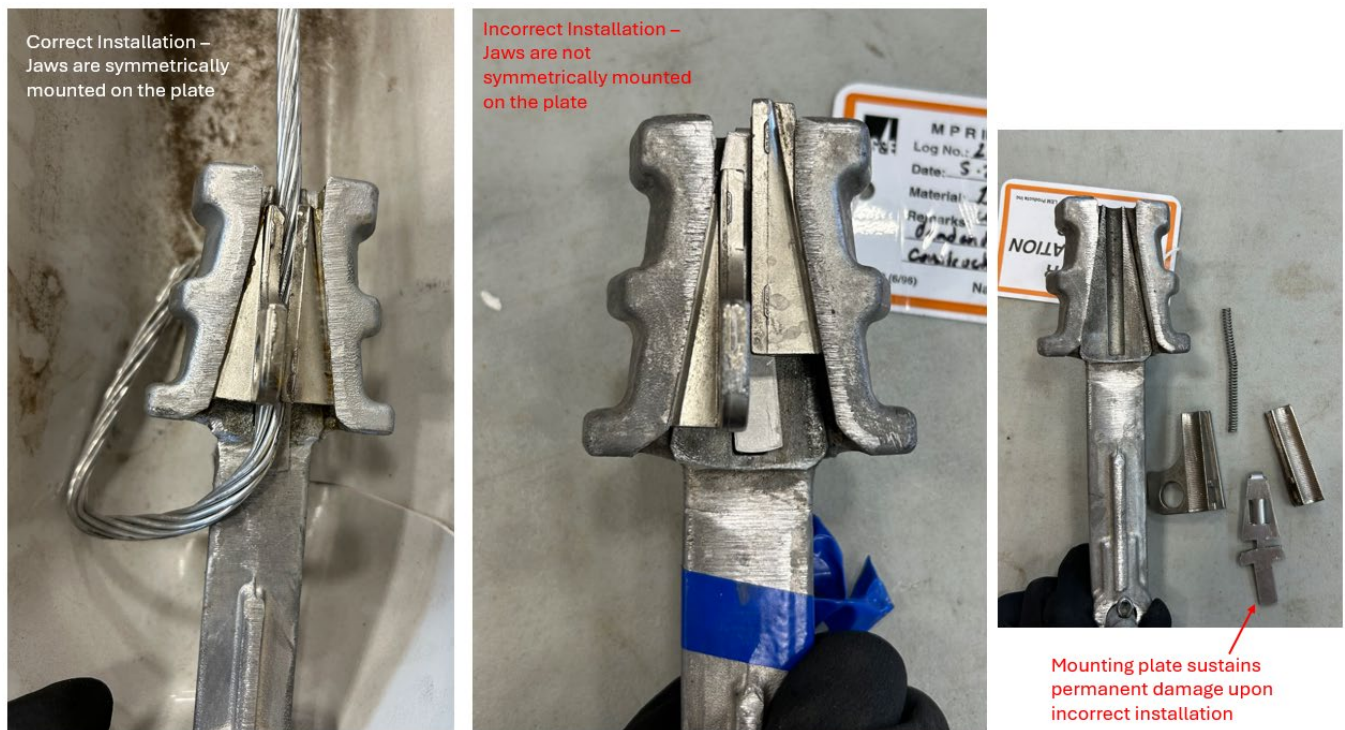
The incident dead-end shoe was retained by the field and sent over to PG&E Applied Technology Services (ATS) along with a replicated sample of the shoe for further failure analysis on June 27, 2024. ATS engineering confirmed that the replicated sample was properly constructed. The replicated sample has the conductor held in place with jaws symmetrically mounted on the plate. Comparatively, the incident dead-end shoe was received at ATS with the jaws, mounting plate and spring disassembled from the shoe. Visibly, the mounting plate and spring from the incident shoe has noticeable bend and deformity. Per ATS, the mounting plate sustained permanent damage likely due to incorrect installation of the incident shoe. Incorrect installation of the mounting plate and misalignment of the jaws can produce varying degrees of weaker tension, hold and grip of the conductor comparative to if the jaws were aligned evenly in a proper construction. Proper construction of the shoe should have the same mechanical strength of the type of conductor it holds. ATS reconstructed the incident shoe with its component to show how the equipment was potentially installed prior to the failure (See Figure 5).

The Asset Failure Analysis (AFA) team investigated the history of the Incident Pole. Prior to the ignition event, the ancestor pole was recently replaced on January 12, 2024 by a PG&E crew under EC tag (#119367560) due to rotting/decay of the pole top. Additionally, there were issues with a missing high voltage sign as well as a loose guy wire that were all identified in July 2020. Within the construction package for the installation of the new pole, the materials list included the installation of two automatic dead-end shoes. However, wedge-type dead-end shoes were installed instead. Wedge-type dead-end shoes are subjected to a manual process that is capable of errors. Errors include the asymmetrical installation of the components (that make up the shoe) which can

cause permanent damage on the wedge that would then lessen the force holding a conductor in place. Per AFA review, there is not a significant record of this type of issue that would lead to a failure or an ignition. Although there is a precedent of conductors falling out from dead-end shoe connections without a known cause, the majority of cases are due to corrosion of the shoe, burnt connections to the shoe, or external factors such as a tree or vegetation strike. Wind is not identified as a common cause for conductors to disengage from a dead-end shoe.

Figure 5 – Replica sample with proper installation (left), incident dead-end shoe assembled by ATS to intentionally show misalignment of components (middle), and mounting plate shown with permanent damage (right). Photos taken at ATS.

A PG&E Standards and Work Methods Specialist opined that this ignition event may have potentially been avoided if an automatic dead-end shoe was installed instead of a wedge-type shoe. However, there is no current PG&E directive or program to remove wedge-type shoes. Per *Document 028851*, wedge-type shoes can be installed but are not to be installed within a corrosion district. The Incident Pole and its associated equipment is located within a non-corrosion area.
