## Preliminary Ignition Investigation Report

Ignition Database Index:	20240602
Electric Incident Investigation (EII) Number:	NA
Incident Name:	Novato
PG&E Facility Ignition?	Yes
CPUC Reportable Ignition?	Yes
Date & Time of Incident:	June 07, 2024, at 0750 hours
Street Address:	West of Bowman Canyon Rd on Novato Blvd. Nearest address 2756 Novato Blvd. Novato, CA, Marin County.
City:	Novato
County:	Marin
Latitude/Longitude:	38.126218, -122.626308
State Responsibility Area (SRA) / Local Responsibility Area (LRA) / Federal Responsibility Area (FRA)	State Responsibility Area (SRA)
PG&E Division:	North Bay
High Fire Threat District (HFTD):	Tier 2
High Fire Risk Area (HFRA):	Yes
EPSS Buffer:	No
Fire Index Area (FIA):	190
Fire Potential Index (FPI) Rating: FIA	R1
Fire Potential Index (FPI) Rating: Circuit	R1
Was there a PSPS event at the time of ignition?	No
Suspected Initiating Event:	Vegetation
Failure Driver:	Contact from object
Failure Sub-driver:	Contact – vegetation

Circuit:	Stafford 1102
Circuit Protection Zone:	Stafford 1102-361952
Nominal Voltage:	12kV
Pole SAP Equipment ID:	102221971
Subject to PRC 4292 Veg Pole Clearance:	No
PG&E Equipment associated with ignition:	Crossarm
EP

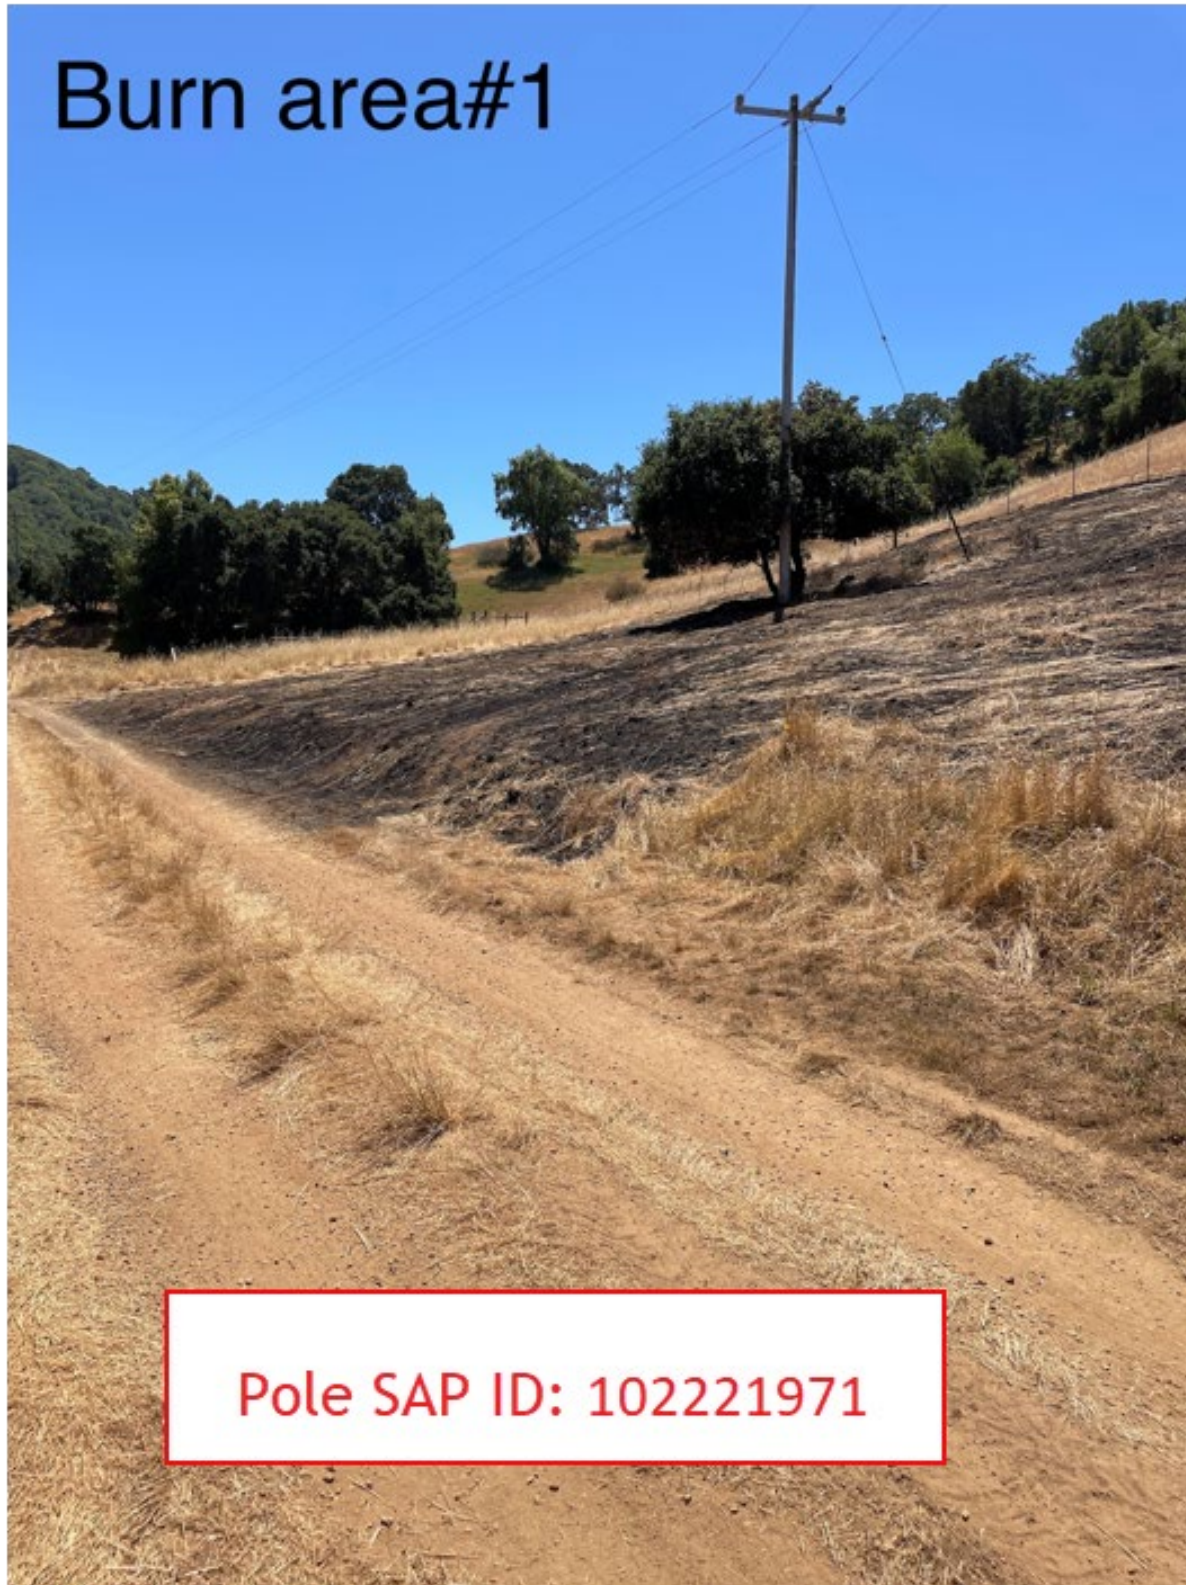
Figure 2: Burn Area #1 - Pole SAP ID: 102221971 (Pole #3) – Photos taken Post Repair

According to the troubleshooter, a tree fell into the conductors causing the outage along one span of tree wire that was installed over a creek. When the tree came down it did not cause a wire down on the span where the tree made contact with the conductor (potentially due to the resiliency of the tree wire). The tree fell between SAP ID 102221958 (Pole #1) and SAP ID 102221965 (Pole #2) (See Figure 1). When the tree fell, it put tension on the infrastructure and caused a wire down two spans south of the tree at pole SAP ID 102221971 (Pole #3). The tension caused the crossarm to twist perpendicular from its normal direction and one of the conductors came down and started a vegetation fire (see Figure 4). The troubleshooter helped the farmer put out the fire and it was extinguished by the time the fire department arrived. The vegetation fire started on a hillside burning an area of approximately 8,000 square feet and jumped across a dirt road, burning an area of flat grass land next to the top of the creek. The second burnt area was about 2,000 square feet in size (see Figure 1, 2 and 3).

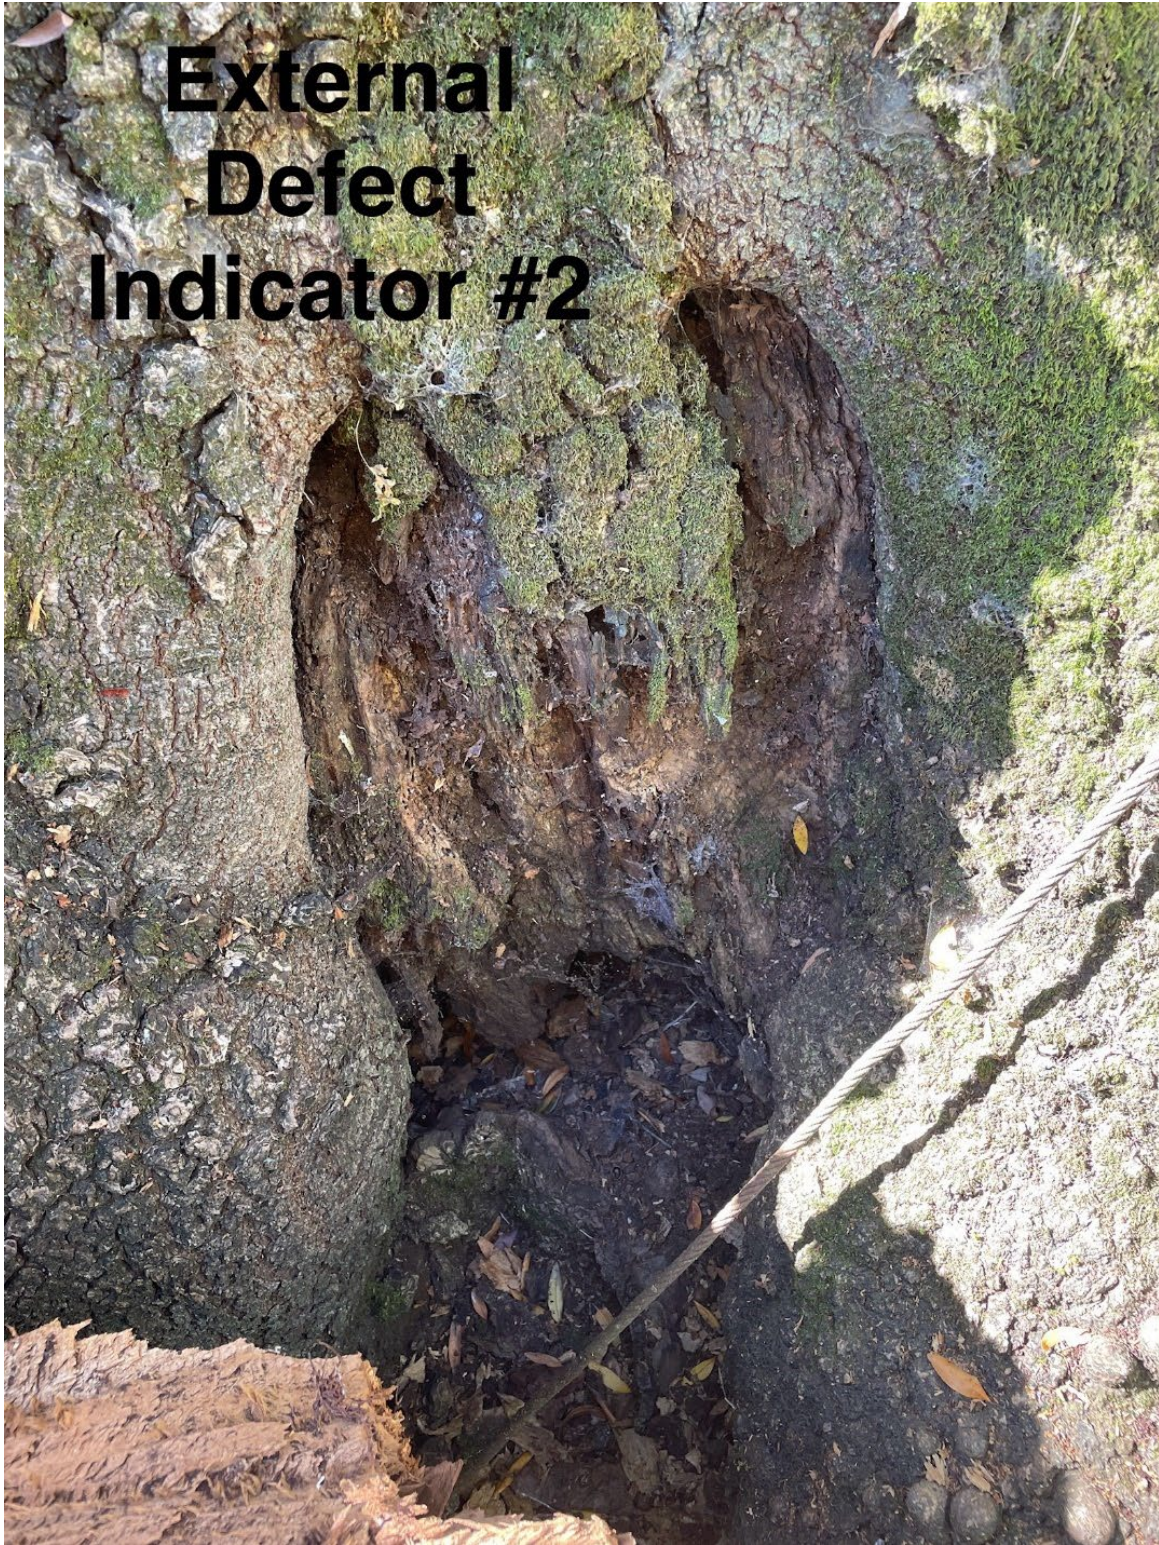
Figure 6: External Defect Indicator #2 (VM)

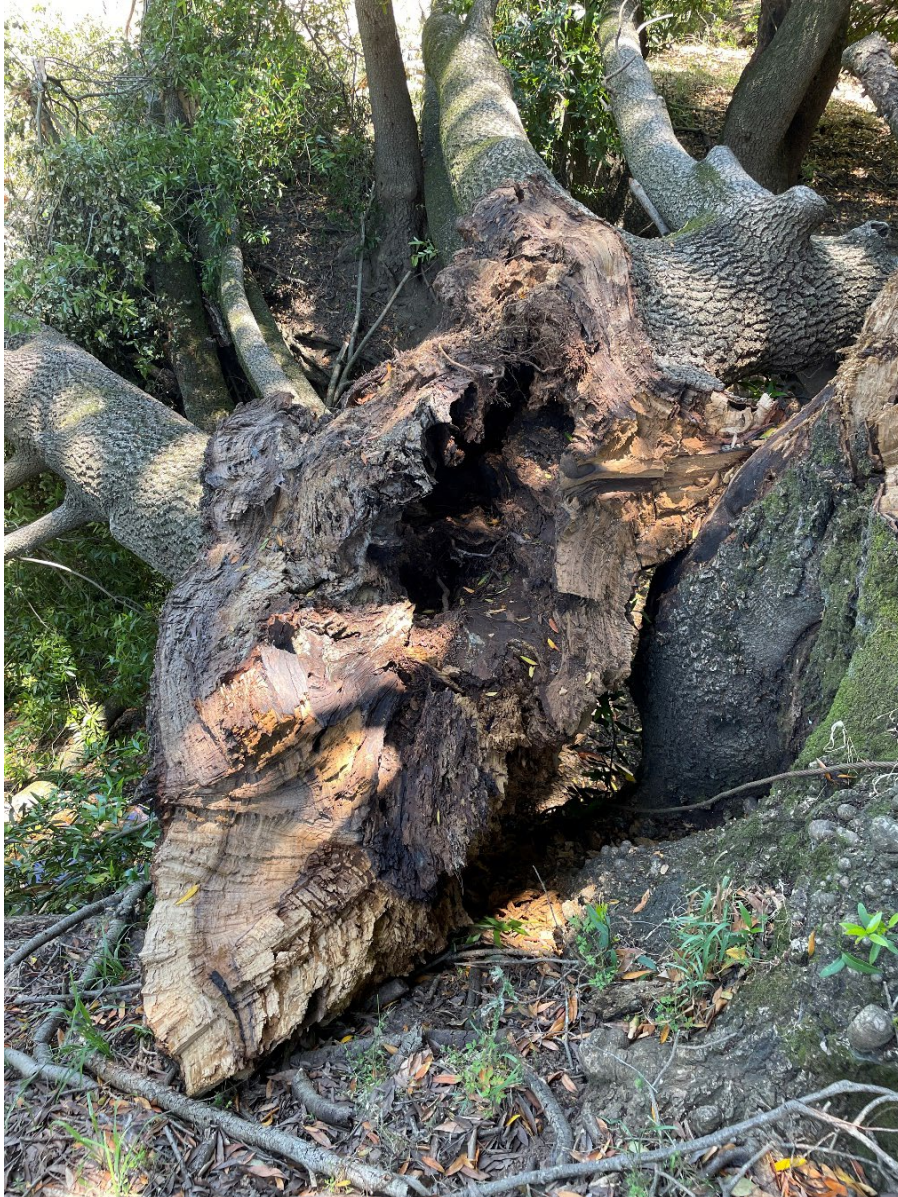
PG&E's Vegetation Management (VM) conducted a Fire Incident Investigation on June 12, 2024. The vegetation management inspector (VMI) identified partial failure of an alive 85-foot high, large diameter at breast height (DBH) California bay laurel (*Umbellularia californica*) "subject tree" (see Figure 7). The subject tree was listed in the OneVM Database as tree number VP-08233705. The subject tree failed at stem union eight feet above ground and impacted PG&E's distribution facilities. The VMI observed the subject tree as hollowed out at its base with extensive rot present (see Figures 5 and 6). The last inspection of the subject tree occurred on March 4, 2024, which prescribed a priority 2 (P2) trim but failed to list the tree for removal warranted by the external defect indicators present. VM work was last performed on the tree on May 7, 2024 to obtain radial clearance for and overhanging limb (work request MANB1032154). The subject tree had never been identified for work by VM's Second Patrol program.

Figure 7: Subject Tree - California bay tree

- Four California Bay trees on the outage span listed for removal due to overhang with questionable root integrity. All four additional tree work was completed by September 18<sup>th</sup>, 2024.
