Preliminary Ignition Investigation Report

Ignition Database Index:	20240630
Electric Incident Investigation (EII) Number:	N/A
Incident Name:	Cement Hill Rd/Peabody Rd
PG&E Facility Ignition?	Yes
CPUC Reportable Ignition?	Yes
Date & Time of Incident:	June 11, 2024 @ approximately 1931 hours
Street Address:	near [REDACTED]
City:	Fairfield
County:	Solano
Latitude/Longitude:	[REDACTED]
State Responsibility Area (SRA) / Local Responsibility Area (LRA) / Federal Responsibility Area (FRA)	State Responsibility Area
PG&E Division:	Sacramento
High Fire Threat District (HFTD):	Tier 2
High Fire Risk Area (HFRA):	Yes
EPSS Buffer:	No
Fire Index Area (FIA):	177
Fire Potential Index (FPI) Rating: FIA	R4
Fire Potential Index (FPI) Rating: Circuit	R1
Was there a PSPS event at the time of ignition?	No
Suspected Initiating Event:	Equipment – PG&E
Failure Driver:	Utility work/Operation
Failure Sub-driver:	Improper Construction
Circuit:	Peabody 2113
Circuit Protection Zone:	Peabody 2113-LR873304

Executive Summary

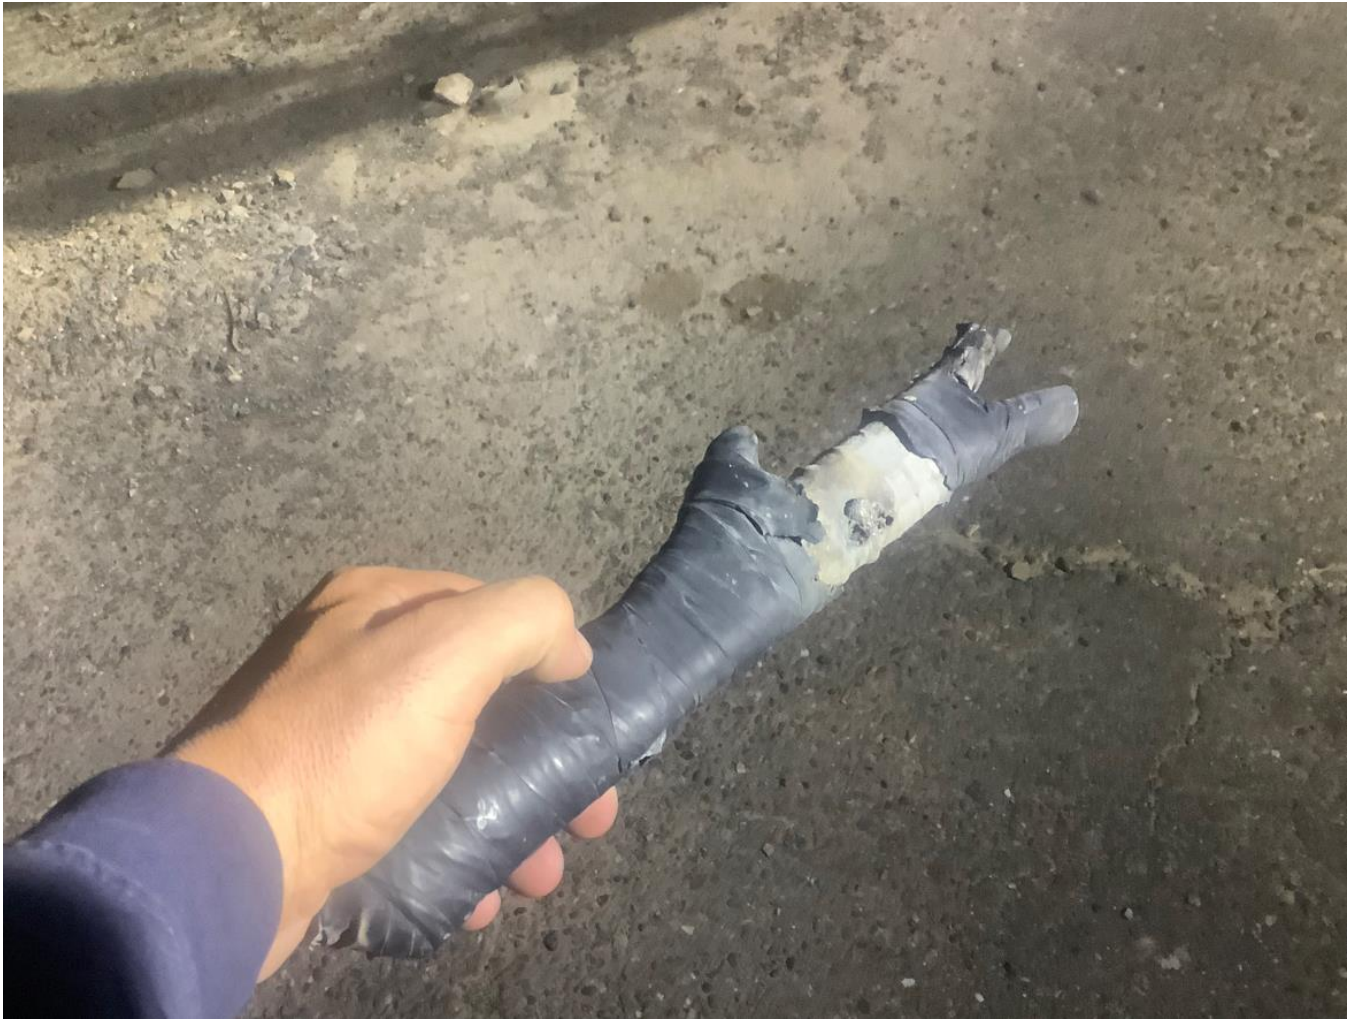
The troubleshooter arrived on scene at approximately 1946 hours and reported a secondary connector failed near pole SAP ID # 101565322, causing a spark, resulting in a grass fire measuring 20x20 feet in size. The fire was extinguished by the nearby property owner who first noticed the flames. Prior to the incident, the property owner did not experience any power fluctuations and no SmartMeter™ abnormalities were documented. The responding troubleshooter replaced all secondary connections in the field after the incident and restored power on the same day. The failed secondary connector was retained by the troubleshooter and sent to Applied Technology Services (ATS) for failure analysis.

Figure 2 Photo taken by troubleshooter of failed secondary connector.

No corrective tags were created for this event. The responding troubleshooter replaced all secondary connections in the field after the incident and restored power on the same day.

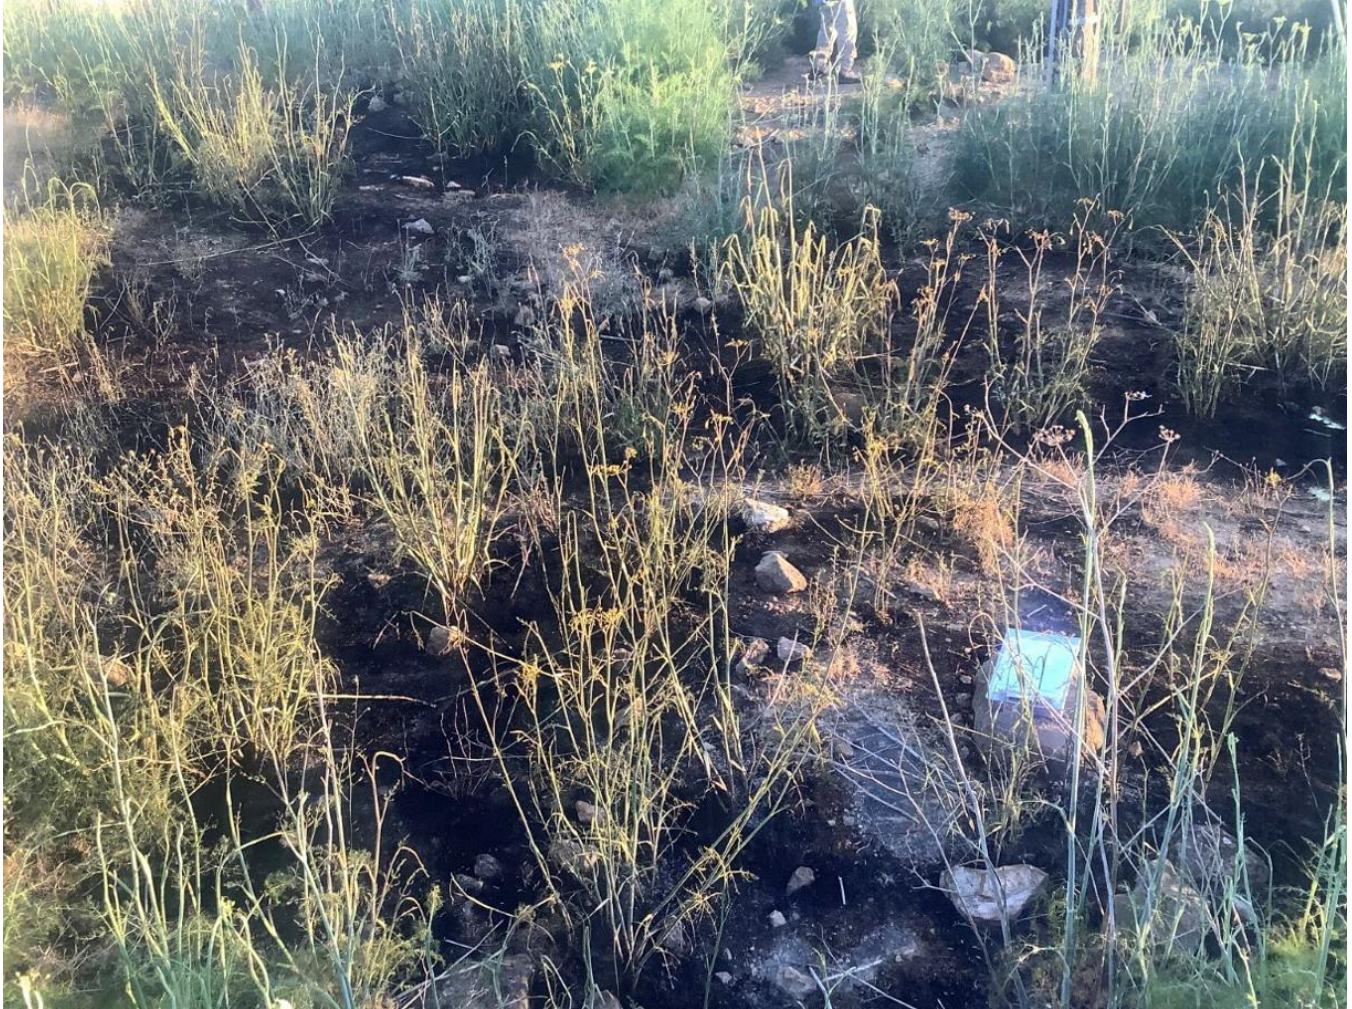
The ignition resulted in a grass fire measuring 20x20 feet in size. A sustained outage lasting 112 minutes occurred, affecting a single customer. No injuries, property damage or media coverage associated with this incident was identified.

Figure 3 Photo depicts burn area at Incident Location taken by troubleshooter.

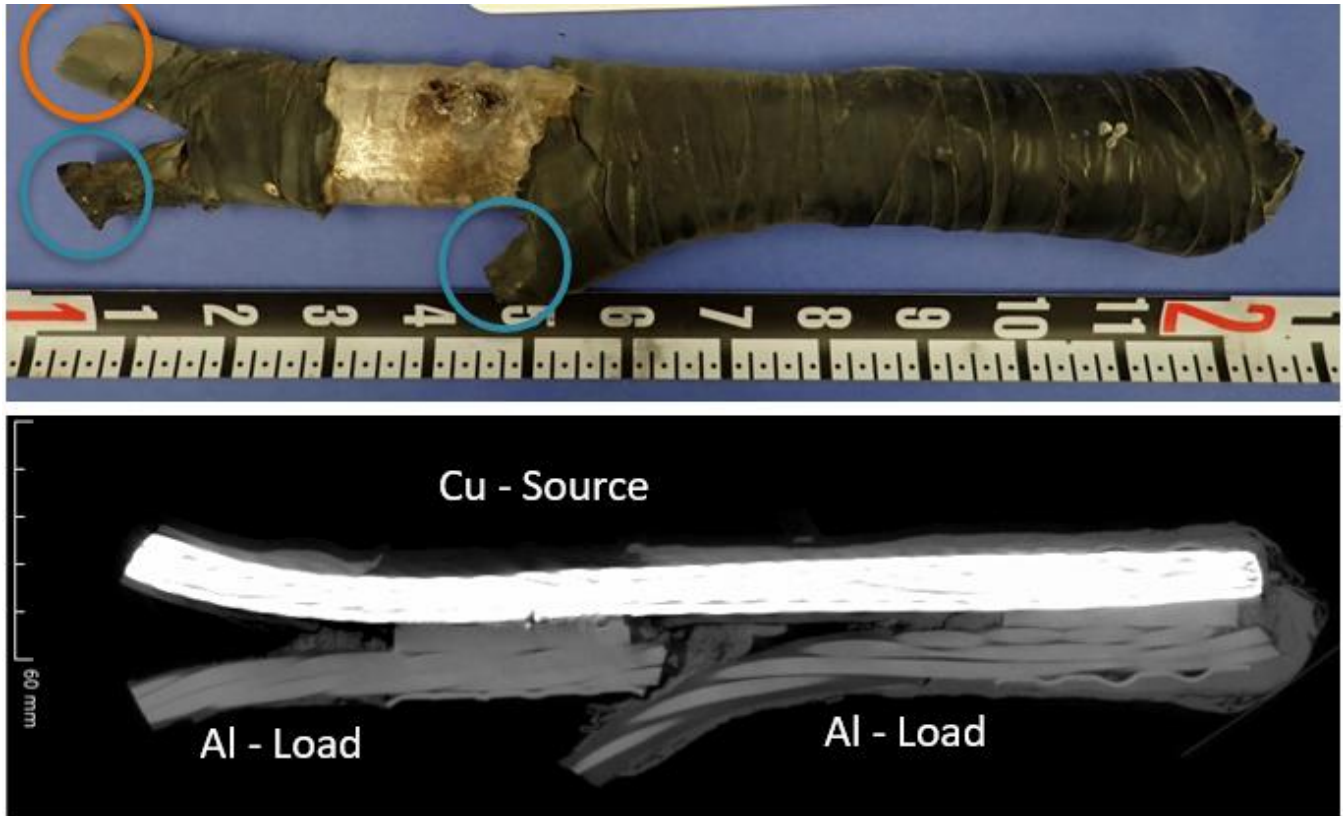
The failed secondary connector was shipped to PG&E's Applied Technology Services (ATS) and received on June 18, 2024 for further analysis. ATS identified the material as an H-connector which joined copper and aluminum conductors (see Figure 4). Per ATS analysis, the ignition was caused by the dripping of hot material from the failed H-connector. ATS visual inspection of the material revealed significant thermal damage to the connector casing and partial damage to the copper strands. CT scan revealed a gap within the H-connector caused by inadequate crimping around the aluminum conductors feeding the customer (see Figure 5). The air gap is likely to have caused high electrical resistance leading to the ultimate failure.

Figure 4 Photos of failed connector taken by ATS. The red circle shows the source copper conductor. The blue circle shows the load aluminum conductor. CT scan image of the connector at the bottom.

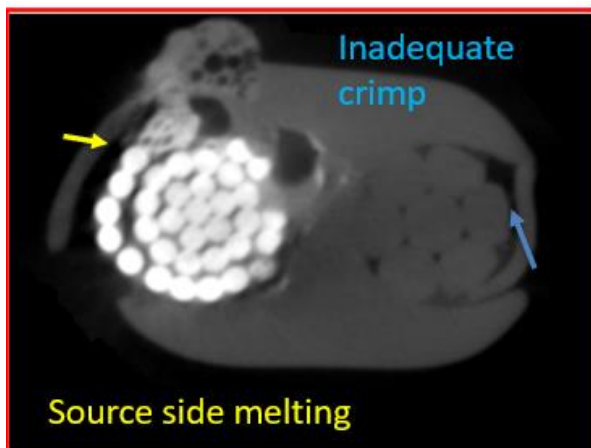
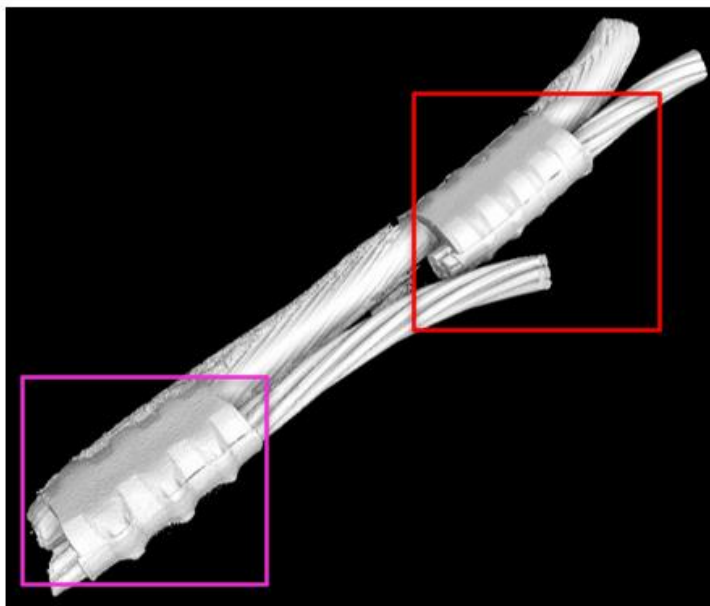
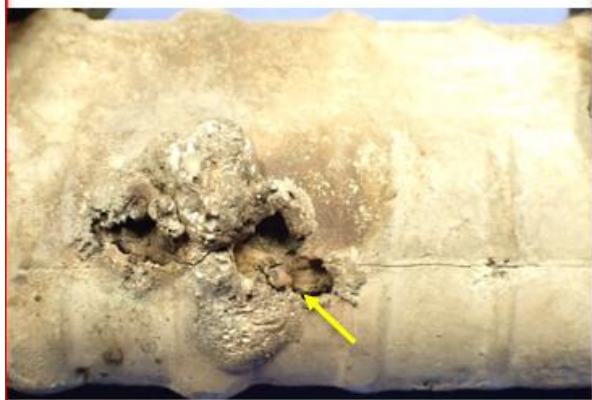
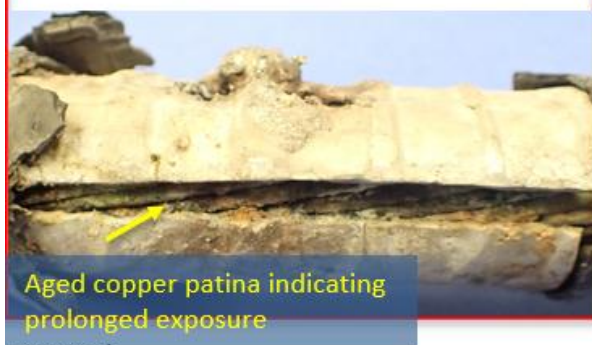
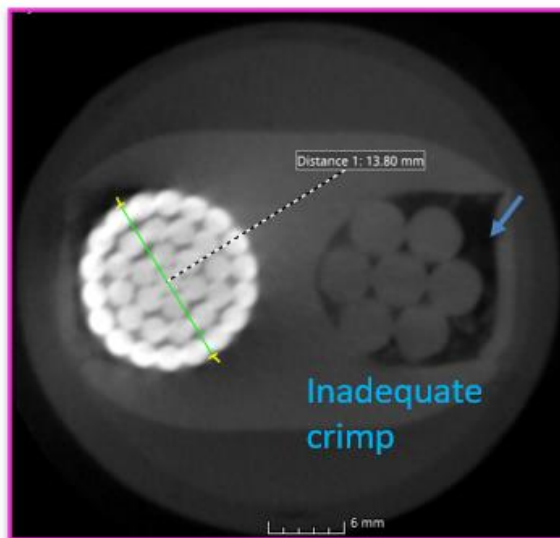
An Asset Failure Analysis (AFA) engineer was assigned to complete an Extent of Condition to analyze this ignition involving an equipment caused CPUC reportable ignition in an HFTD. AFA indicates that the H-type connector in this incident was originally installed on March 30, 2009 and not repaired until the ignition. Like ATS' analysis, AFA indicated that inadequate crimping left a considerable gap within the H-connector around the aluminum conductors. This may have caused improper electrical interface which can create hot spots at operation near rated load capacity.

Figure 5 Images taken by ATS of failed connector. CT scan depicted inadequate crimping. Aged copper patina indicating prolonged heat exposure.

AFA has recommended a tailboard to crews with 5MM to ensure that the entire restoration, construction, and contract teams are aware of the uptick in ignition incidents and some of the misses that led to the ignition regarding H-type connector installation (proper number of crimps), cable preparation, and proper taping. Also, a reminder that the preferred method of connection is fired wedges, per distribution standards 041010 and 028852.

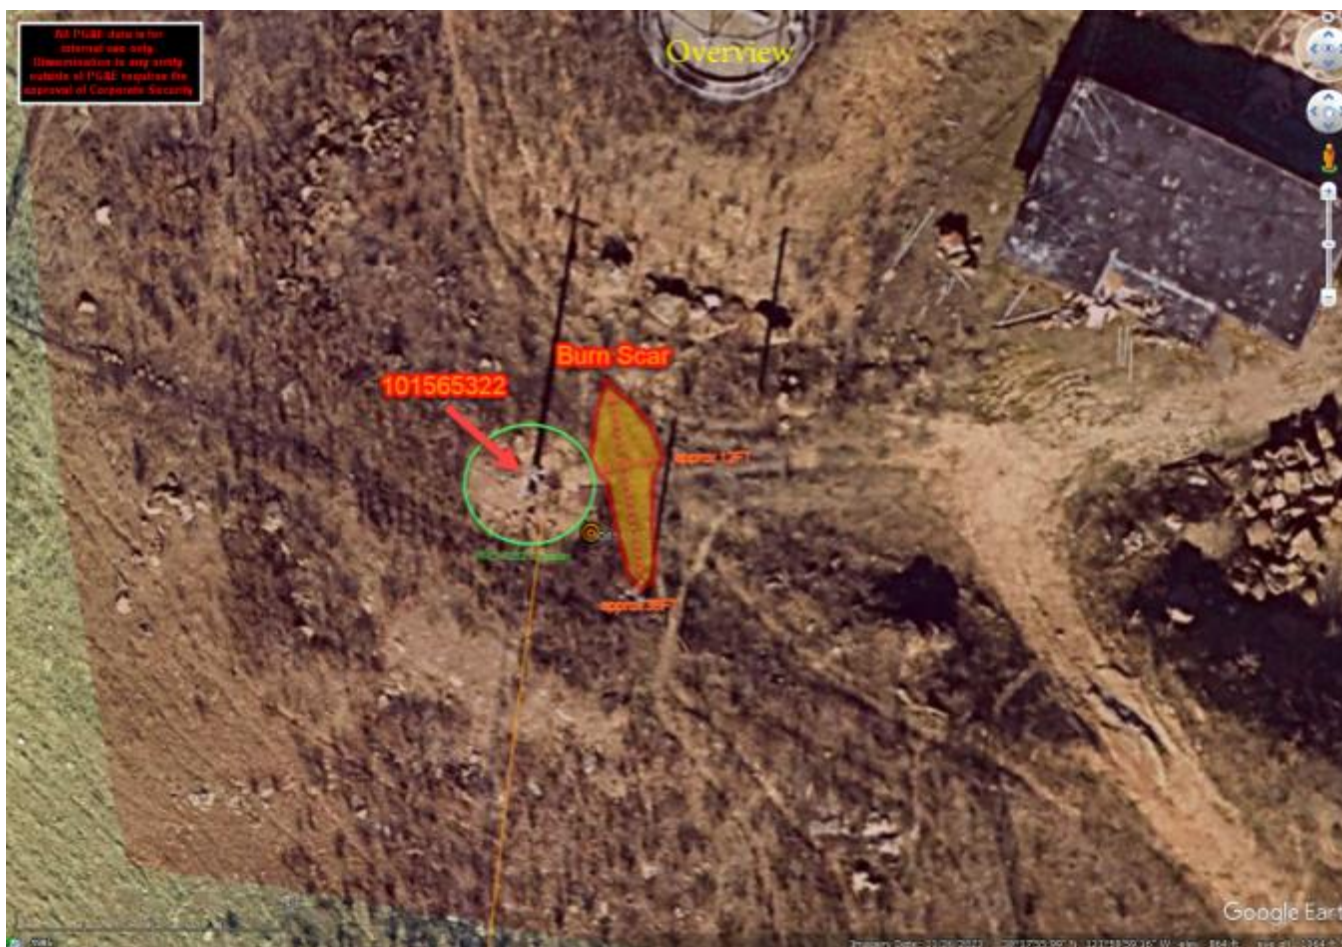
<p>selected poles outside of the regulations of PRC 4292. Clear 10-ft radius around subject poles from 0-8 feet above ground level.</p> <p>Observed Performance: Unknown</p>		<p>approximately 12 feet from the pole, outside of the PRC 4292 10-foot cylinder (see Figure 6). Since there was regrowth found, the location was mechanically cleared and treated with herbicide.</p>
Barriers that were Assessed as Opportunities			
Infrared Inspections	<p>Expected Performance: Infrared inspections to reduce potential for component failures and facility damage.</p> <p>Observed Performance: Unknown</p>	A1B1C2D3 – Fatigue damage not visually apparent	An infrared inspection may have identified the excessive heat from the improper electrical interface.

Figure 6 Image provided by VM inspector depicting burn scar in relation to pole SAP ID # 101565322.

Additionally, non-exempt equipment (lightning arrestor) was identified on the subject pole in a State Responsibility Area. According to Public Resource Code (PRC) 4292, to limit the spread of fire near PG&E poles, property vegetation clearance is needed. Based on my review of the photo taken by the troubleshooter (see Figure 3), a question of clearance was raised to Vegetation Management (VM). On June 18, 2024, a VM inspection was conducted at the Incident Location. The inspector found the burn scar approximately 12 feet from the pole, outside of the PRC 4292 10-foot cylinder (see Figure 6). Since there was regrowth found, the location was mechanically cleared and treated with herbicide.

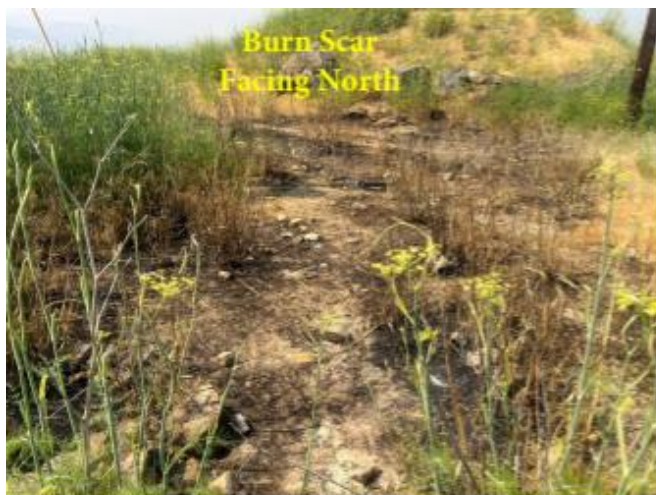
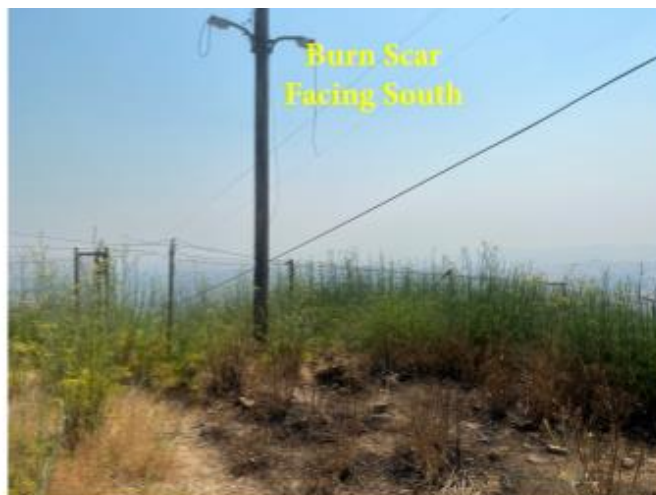
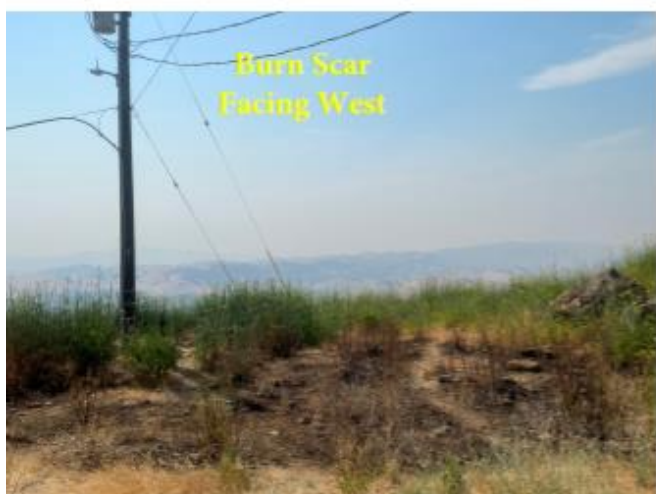
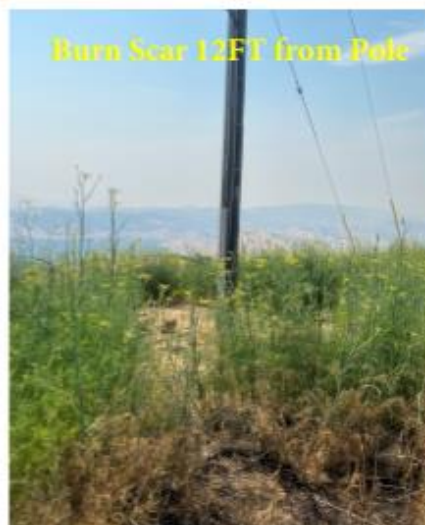
Figure 7 Photos taken by VM inspection of Incident Location depicting burn scar in relation to pole SAP ID # 101565322.
