Preliminary Ignition Investigation Report

Ignition Database Index:	20240655
Electric Incident Investigation (EII) Number:	N/A
Incident Name:	Bald
PG&E Facility Ignition?	Yes
CPUC Reportable Ignition?	Yes
Date & Time of Incident:	June 15, 2024 at approximately 2111 hours
Street Address:	Near [REDACTED]
City:	Auburn
County:	Placer
Latitude/Longitude:	[REDACTED]
State Responsibility Area (SRA) / Local Responsibility Area (LRA) / Federal Responsibility Area (FRA)	SRA
PG&E Division:	North Valley
High Fire Threat District (HFTD):	Tier 2
High Fire Risk Area (HFRA):	Yes
EPSS Buffer:	No
Fire Index Area (FIA):	300
Fire Potential Index (FPI) Rating: FIA	R3
Fire Potential Index (FPI) Rating: Circuit	R4
Was there a PSPS event at the time of ignition?	No
Suspected Initiating Event:	Equipment – PG&E
Failure Driver:	All Types of Equipment/Facility Failure
Failure Sub-driver:	Splice/Clamp/Connector
Circuit:	Wise 1102, 15227-1102
Circuit Protection Zone:	Wise 1102 LR 2054

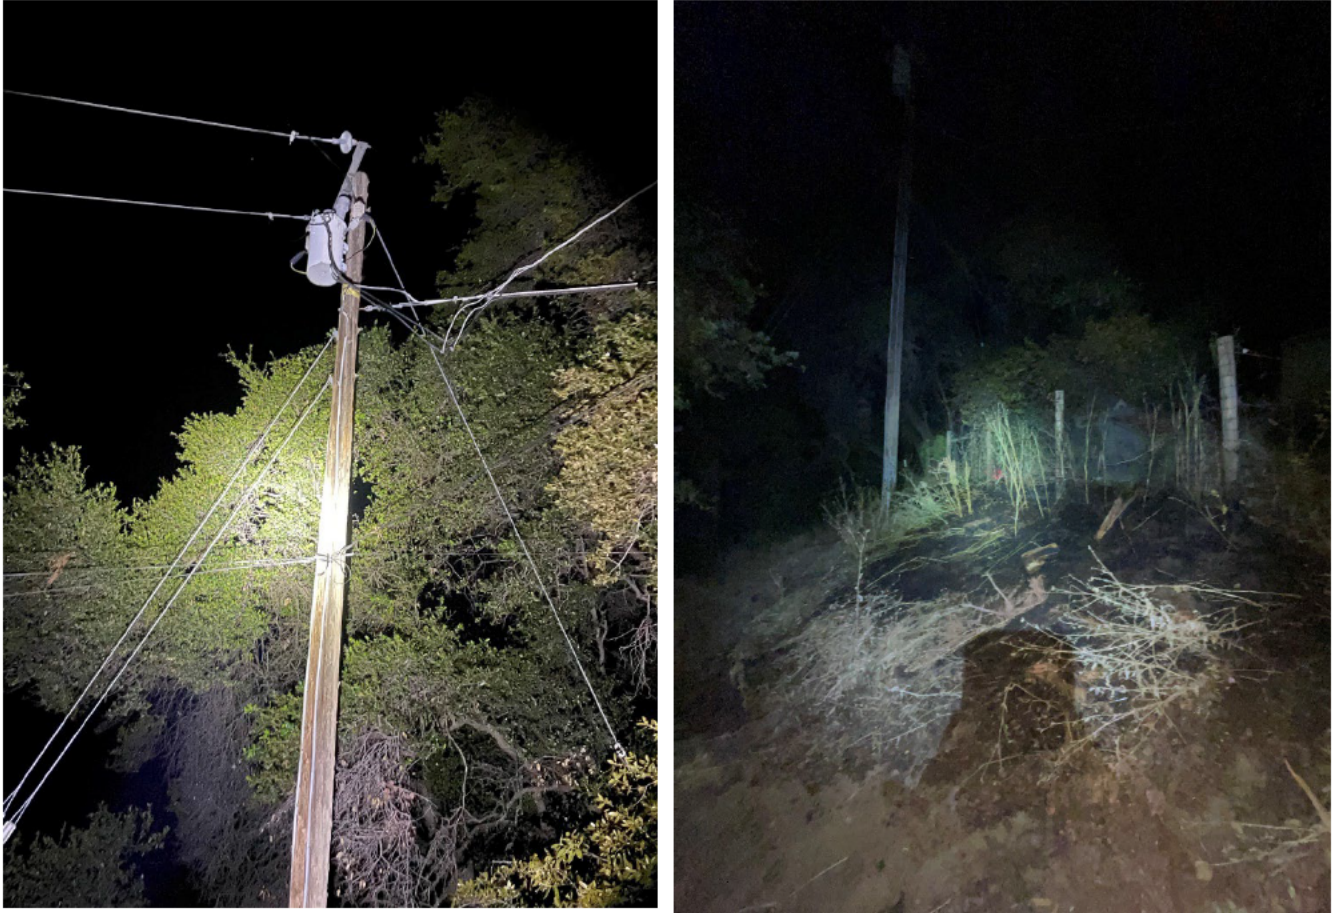
This ignition on June 15, 2024 was a result of the bare neutral directly contacting an insulated but worn secondary at the connector, that sparked a small vegetation fire. The fire measured approximately 20 x 20-feet in size. No customers lost service prior to the event.⁵ Additionally, there were no reported injuries, fatalities, property damages or significant media attention associated to this event.

Figure 2 – Incident Pole (left) and fire footprint near base of pole (right) on June 15, 2024. Photos taken by the troubleshooter.

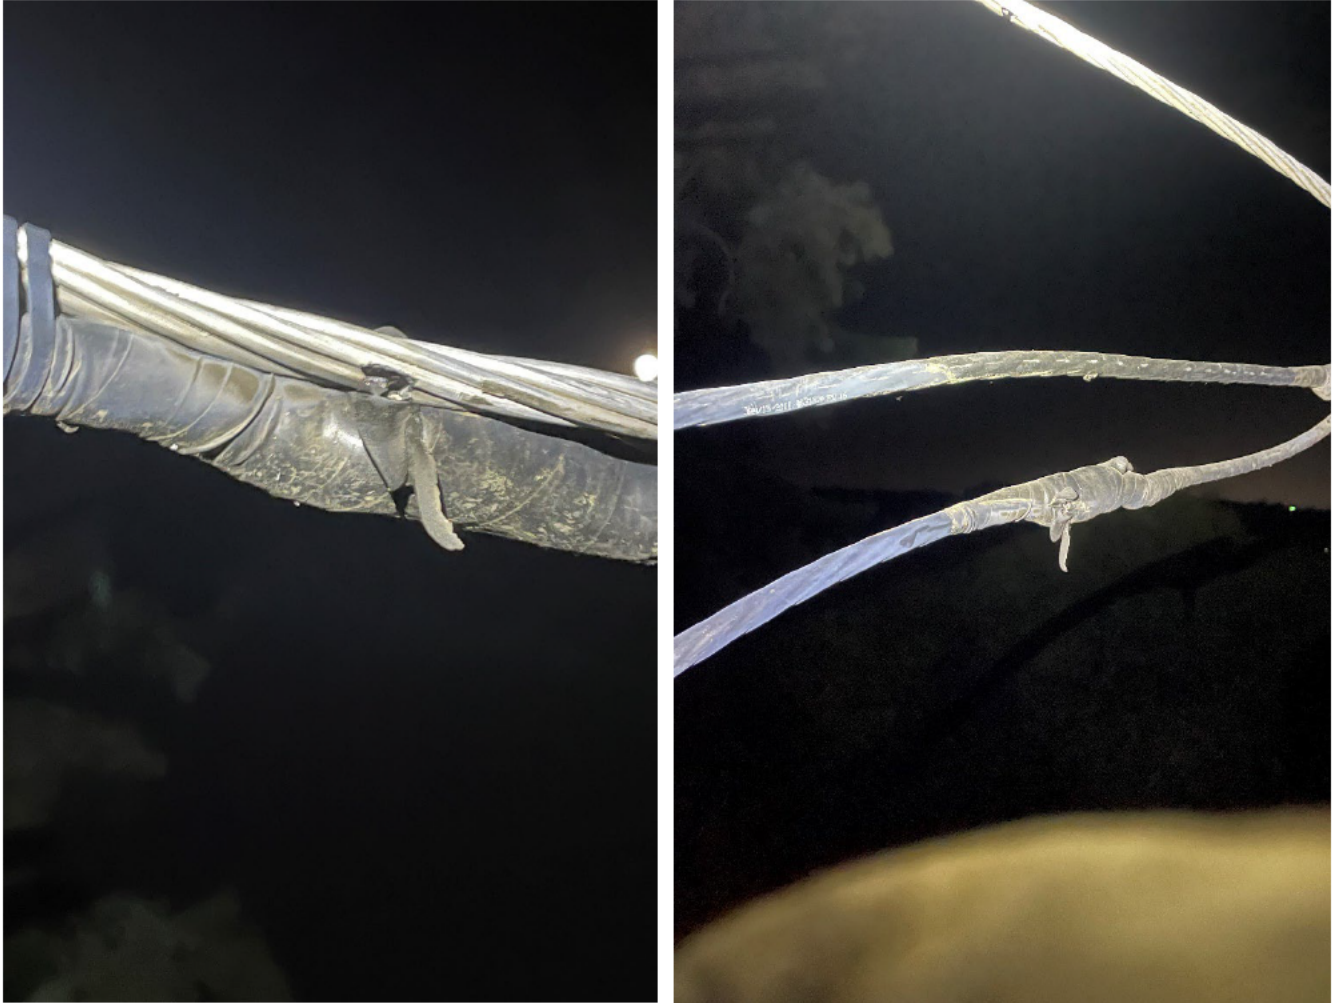
On June 15, 2024 at approximately 2109 hours, PG&E received a 911 standby call from CAL FIRE with a request for an estimated time of arrival of a PG&E first responder. Shortly after, a PG&E troubleshooter was dispatched to the single-phase secondary segment on the Wise 1102 12kV distribution circuit near Bald Hill Road and Wise Road in the City of Auburn (See Figure 1). At approximately 2136 hours, the troubleshooter arrived onsite to an already extinguished fire measuring 20 x 20-feet in size¹ near the base of Pole SAP ID 100050131 (Incident Pole) (See Figure 2). The troubleshooter observed the potential cause of the ignition as that of a zip-tie that held the insulated connector/secondary together with the bare neutral. Per the troubleshooter, it is possible the bare neutral heated and wore out the insulation of the secondary. The resulting exposed wire-to-wire contact then created an arcing event that sparked an ignition to the growing vegetation near the base of the pole.² The troubleshooter safely removed the zip-tie and separated the secondary from the neutral (See Figure 3) No customers lost service during the ignition event.

Hazard	Equipment Failure	Sub-Hazard	Connector Failure (Secondary Distribution)
Target	Grey AWAC Secondary Failure Resulting in 20 x 20-foot Ignition in Tier 2 HFTD		
Barrier	Expected vs. Observed Performance	Why did the barrier not prevent the ignition event? (See ICF Codes)	Opportunity
Barriers that Negatively Affected Ignition			
Distribution Detailed Inspection	Expected Performance: Thorough examination of individual components, structures, and equipment through visual inspection and routine diagnostic test. For connectors, identify burnt, corroded, incorrectly installed, equipment or deteriorated insulation.; Observed Performance: Barrier did not perform as expected	A1B3C1D2 - Ineffective identification of non-conforming equipment	The connector with abrasions to the insulation and the damaged neutral were most likely not visible on the 08/16/23 GO165 enhanced inspection, as the zip-tie prevented adequate visual inspection of the two in connection.

Figure 3 – Zip-tie holding insulated secondary connector with bare neutral (left) and another view after of secondary after zip-tie was removed (right) on June 15, 2024. Photos taken by the troubleshooter.

- Asset Failure Analysis (AFA) is aware of inconsistencies regarding Pole Test and Treat along with pole loading calculations. AFA is working on closing gaps to improve the pole replacement process.
- CAP #000129295785: Replacement of grey AWAC and neutral on pole SAP ID 100050131 when executing the pole replacement work under EC tag (#129208196).
