Preliminary Ignition Investigation Report

Ignition Database Index:	20240771
Electric Incident Investigation (EII) Number:	N/A
Incident Name:	Vegetation in Tulare
PG&E Facility Ignition?	Yes
CPUC Reportable Ignition?	Yes
Date & Time of Incident:	June 28, 2024 @ approximately 0917 hours
Street Address:	Near [REDACTED]
City:	Badger
County:	Tulare
Latitude/Longitude:	[REDACTED]
State Responsibility Area (SRA) / Local Responsibility Area (LRA) / Federal Responsibility Area (FRA)	State Responsibility Area
PG&E Division:	Fresno
High Fire Threat District (HFTD):	Tier 2
High Fire Risk Area (HFRA):	Yes
EPSS Buffer:	No
Fire Index Area (FIA):	440
Fire Potential Index (FPI) Rating: FIA	R3
Fire Potential Index (FPI) Rating: Circuit	R4
Was there a PSPS event at the time of ignition?	No
Suspected Initiating Event:	Utility work / Operation
Failure Driver:	Utility work / Operation
Failure Sub-driver:	Improper Construction
Circuit:	Dunlap 1102
Circuit Protection Zone:	Dunlap 1102-LR7360

Executive Summary

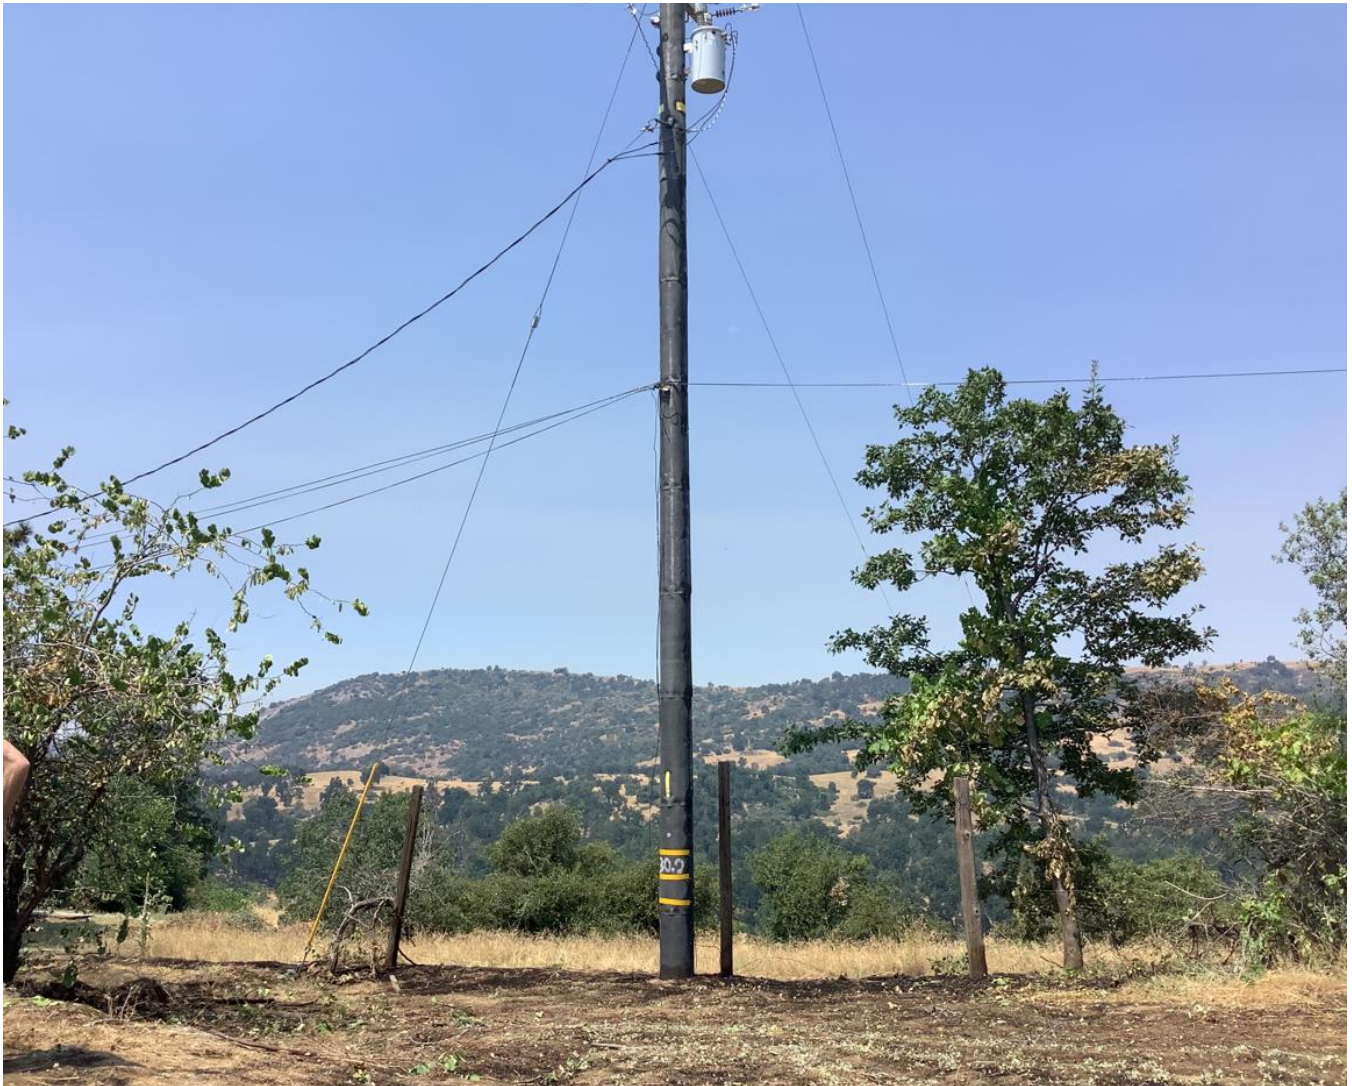
The troubleshooter arrived on scene at approximately 1028 hours and confirmed a fire at the base of pole SAP ID # 104064095. Initial analysis indicates the tape seal separated on the secondary connector resulting in the hot leg hitting the neutral. A spark from the hot leg contacting the neutral resulted in a vegetation fire measuring 3 meters – 0.25 acres in size. CAL FIRE responded to and extinguished the fire. The responding troubleshooter

The ignition resulted in a vegetation fire measuring 3 meters – 0.25 acres in size. A sustained outage lasting 596 minutes occurred, affecting two customers. No injuries, property damage or media coverage associated with this incident was identified.

Figure 2 Burn area at the base of pole SAP ID # 104064095 taken by troubleshooter on date of the incident.

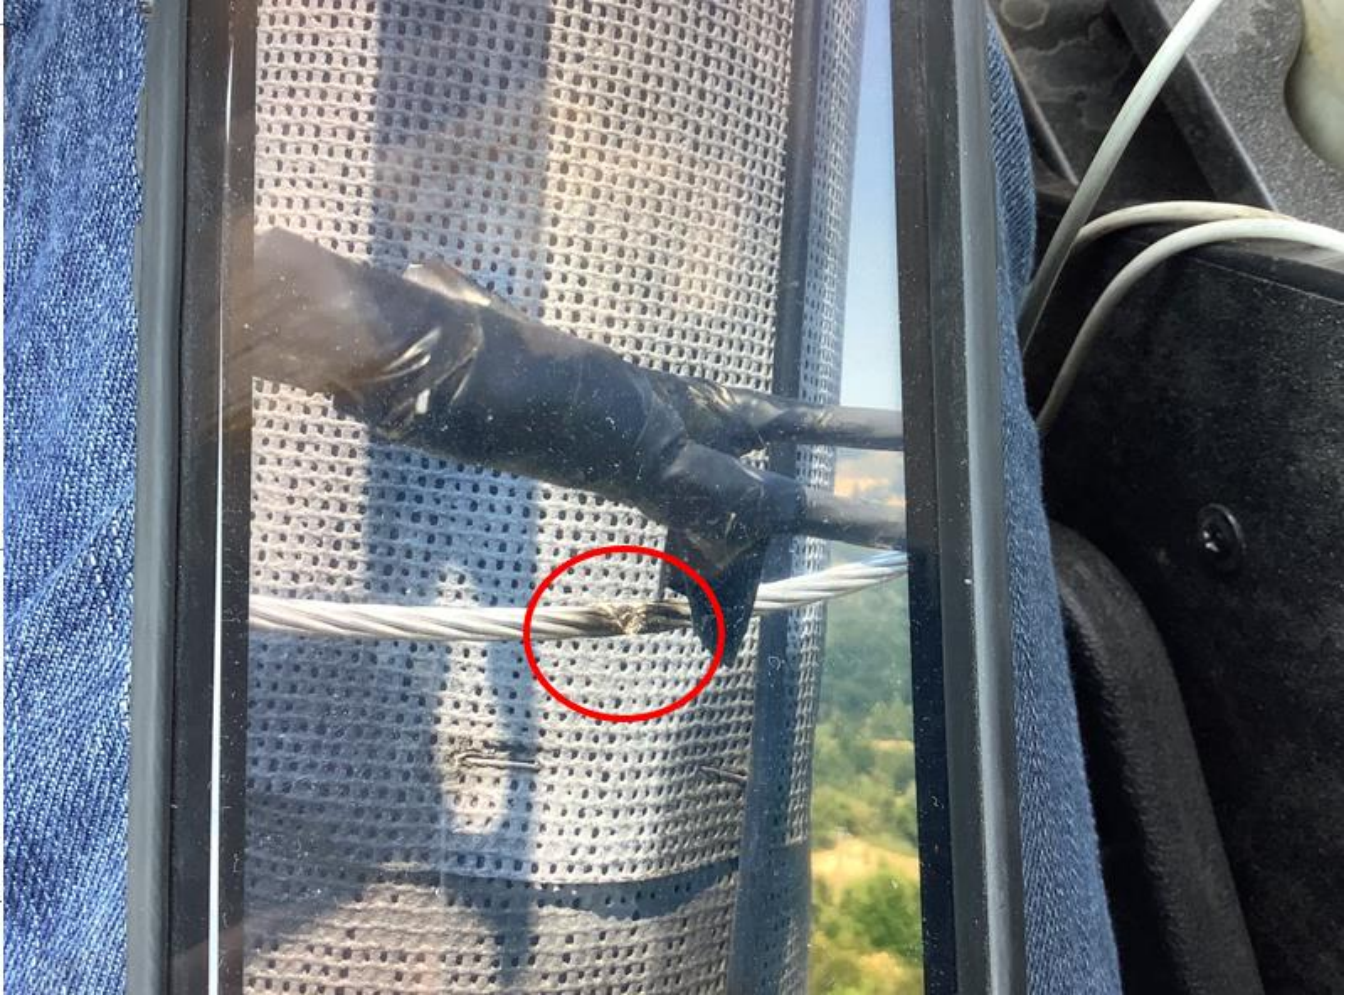
FAS Field Remarks:	Tape and sealer separated on H tap connection, hot leg hit neutral and arced, fire at base of pole started.
HAWC Summary:	Fire resources were dispatched to a report of a small vegetation fire in the area of [REDACTED] Badger. There was a single customer outage reported in OMT of the EPSS Enabled Dunlap 1101 OH circuit (OIS# 2498416), and a PG&E t-man was requested to respond by CAL FIRE post incident. Per the t-man, the potential cause of the ignition was tape and sealer separated on H tap connection, hot leg hit neutral and arced, fire at base of pole started. The fire has been contained prior to the arrival of PG&E resources at the last reported size of 0.01 of an acre per CAL FIRE TUU. The outage remains active at time of incident closure. Final update barring any significant change in the current conditions as advised.
Injuries / Fatalities / Property Damage / Media Attention:	No injuries, fatalities, property damage or media attention reported.

An Asset Failure Analysis (AFA) engineer was assigned to complete an Extent of Condition to analyze this ignition involving an equipment caused CPUC reportable ignition in a HFTD. AFA indicates that pole SAP ID # 104064095 was installed in August of 2021 with no indication that the H-type connector was replaced/alterd prior to the ignition. AFA confirms that the tape and sealer separation led to arcing from the hot leg and secondary neutral contact.

Hazard	Utility work / Operation	Sub-Hazard	Improper Construction
Target	Tape seal separated on the secondary H-type connector resulting in the hot leg hitting the neutral, causing a spark, resulting in a vegetation fire measuring 3 meters – 0.25 acres in size in a Tier 2 HFTD.		
Barrier	Expected vs. Observed Performance	Why did the barrier not prevent the ignition event? (See ICF Codes)	Opportunity
Barriers that Negatively Affected Ignition ³			
Proper Construction & Installation - Document 028852 Rev. 15, Document 022487 Rev. 13	<p>Expected Performance: Follow installation guidelines for connectors, including proper taping and sealing.</p> <p>Observed Performance: Barrier did not perform as expected</p>	A3B1C2D3: Work not performed in accordance to standard	Properly installed tape on hot leg required by Document 028852 would have likely prevented arcing and resulting ignition. Troubleshooter installed aqua seal and tape to hot legs post ignition so they are adequately covered and a 5MM was distributed and tailboard with target personnel.

Prior H-type connector failures have been attributed to inadequate crimping, advanced corrosion, insufficient/thermally damaged tape application.

Figure 3 Photo of burn mark on neutral where hot leg made contact taken by troubleshooter on the date of the incident.

replaced all secondary connections and installed aqua seal and tape to make sure the hot legs were adequately covered, restoring power on the same day.

No corrective notification was created for this ignition. The troubleshooter deenergized the transformer servicing the affected area and replaced secondary connections, retaped and sealed equipment and provided proper spacing. Power was restored to the two affected customers on the same day.

AFA has recommended a tailboard to crews with 5MM to ensure that the entire restoration, construction, and contract teams are aware of the uptick in ignition incident and some of the misses that led to the ignition regarding H-type connector installation (proper number of crimps), cable preparation, and proper taping. Also, a reminder that the preferred method of connection is fired wedges. Distribution standards 041010 and 028852.
