Preliminary Ignition Investigation Report

Ignition Database Index:	20240826
Electric Incident Investigation (EII) Number:	N/A
Incident Name:	Park
PG&E Facility Ignition?	Yes
CPUC Reportable Ignition?	Yes
Date & Time of Incident:	July 3, 2024 @ approximately 1353 hours
Street Address:	Near 2401 Robinson Creek Road
City:	Ukiah
County:	Mendocino
Latitude/Longitude:	39.0917063801, -123.2297306001
State Responsibility Area (SRA) / Local Responsibility Area (LRA) / Federal Responsibility Area (FRA)	State Responsibility Area
PG&E Division:	Humboldt
High Fire Threat District (HFTD):	Yes - Tier 2
High Fire Risk Area (HFRA):	Yes
EPSS Buffer:	No
Fire Index Area (FIA):	154
Fire Potential Index (FPI) Rating: FIA	R4
Fire Potential Index (FPI) Rating: Circuit	R4
Was there a PSPS event at the time of ignition?	No
Suspected Initiating Event:	Vegetation
Failure Driver:	Contact from object
Failure Sub-driver:	Contact – Vegetation
Circuit:	Ukiah 1114
Circuit Protection Zone:	Ukiah 1114-LR408

Executive Summary

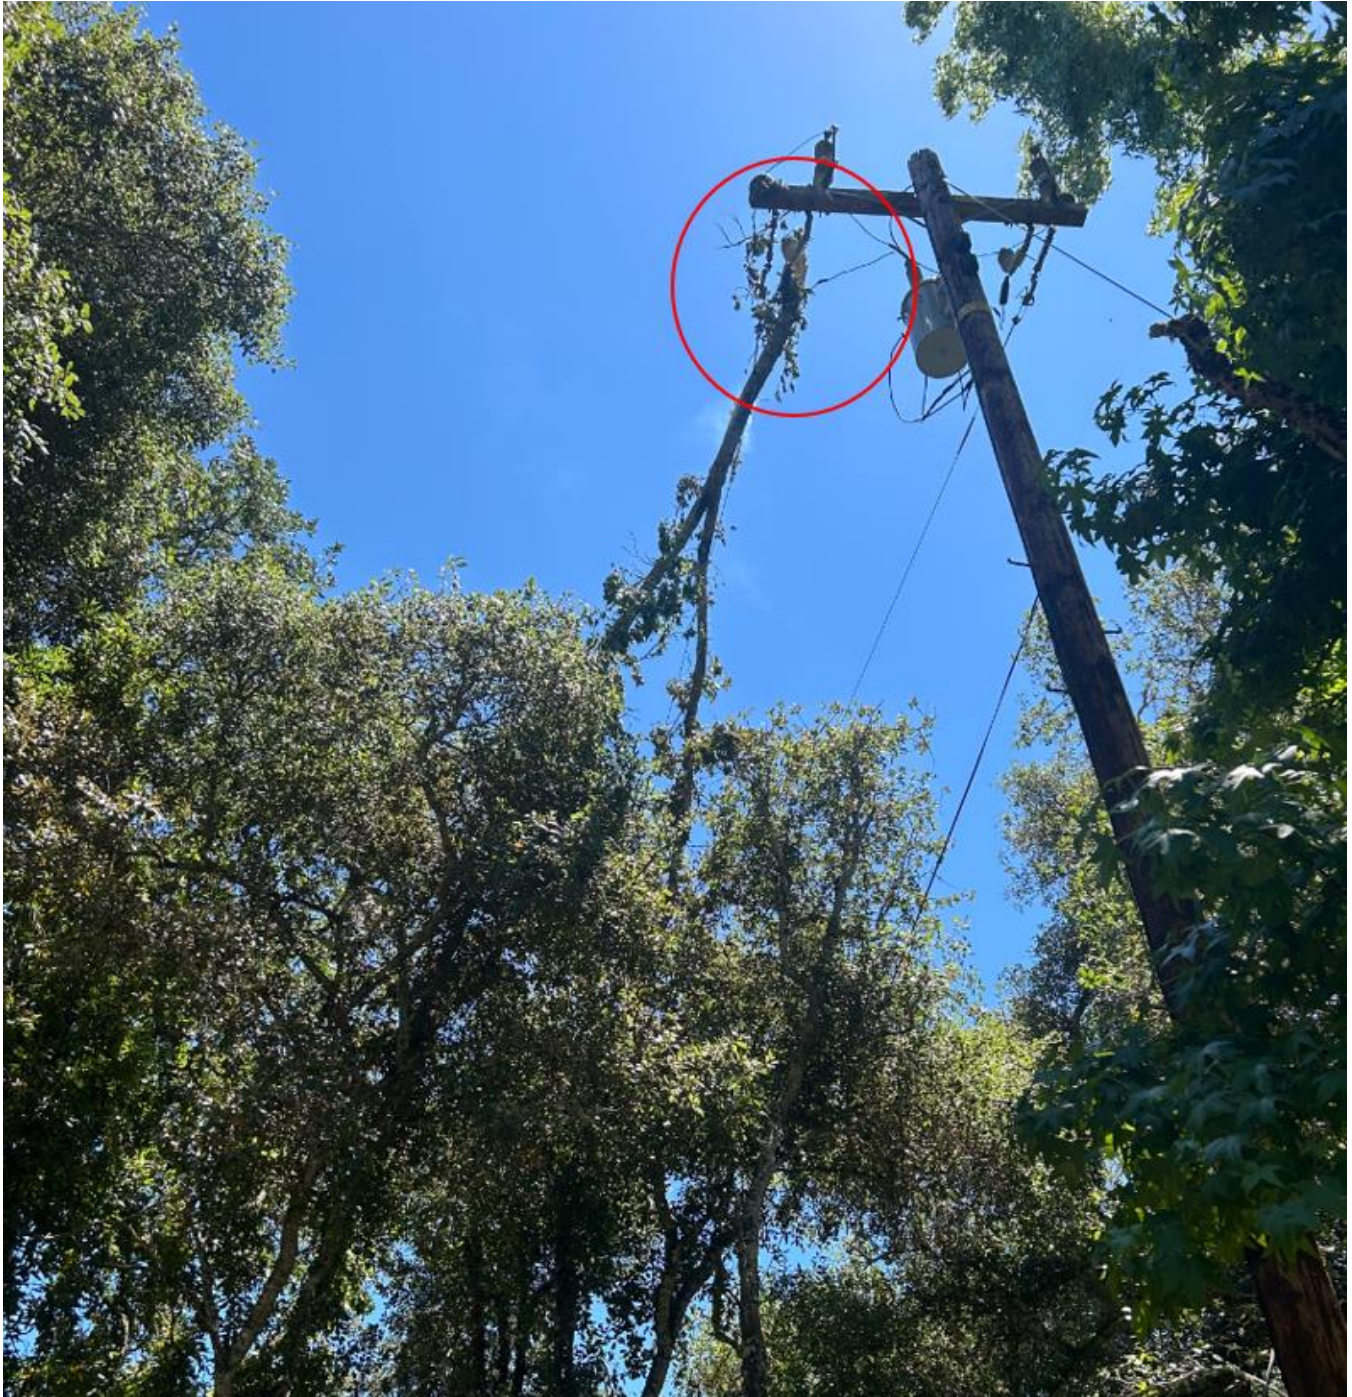
A troubleshooter dispatched to the incident location near pole SAP ID # 102212964 observed a branch had fell into the overhead primary lines. System Distribution Engineering analysis indicates the branch on the conductor caused a high impedance fault, resulting in a vegetation fire. The fault current was not of sufficient magnitude or duration for the LR 408 to operate (SGF set for 15 amps with 15 second delay). No protective devices operated automatically and no partial voltage alarms were received. On July 3, 2024, the troubleshooter deenergized the lines by forcing out Fuse 1971. The EPSS Settings operated as intended for this event.

Figure 3 Photo depicts fallen branch (circled in red) on overhead conductor near pole SAP ID # 102212964 taken by troubleshooter on July 3, 2024.

On July 3, 2024, a priority “A” Electric Corrective (EC) Notification # 129166941 was created because of this incident. A PG&E crew replaced one cutout, two lightning arrestors and 10 feet of primary conductor damaged by the failed tree branch. All associated work was completed and power was restored on the same day as the incident.

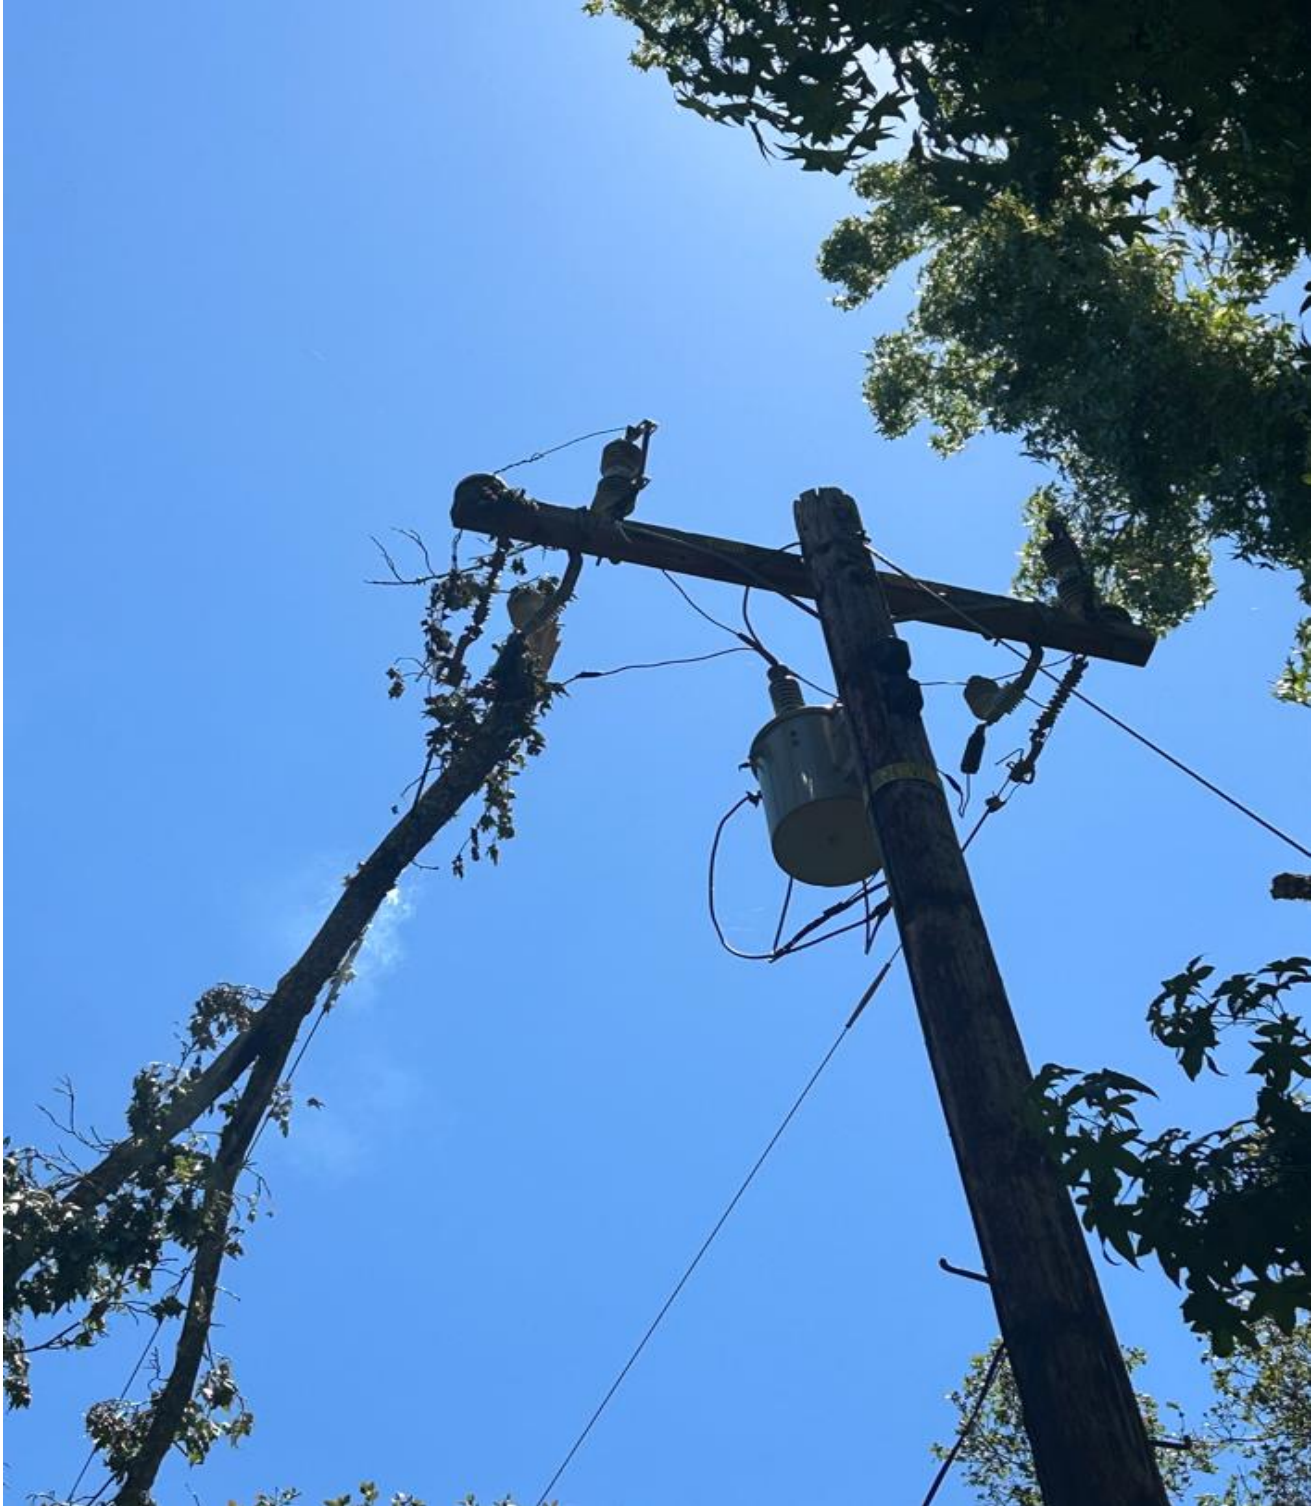
Figure 4 Close up photo of fallen branch on overhead conductor taken by troubleshooter on July 3, 2024.

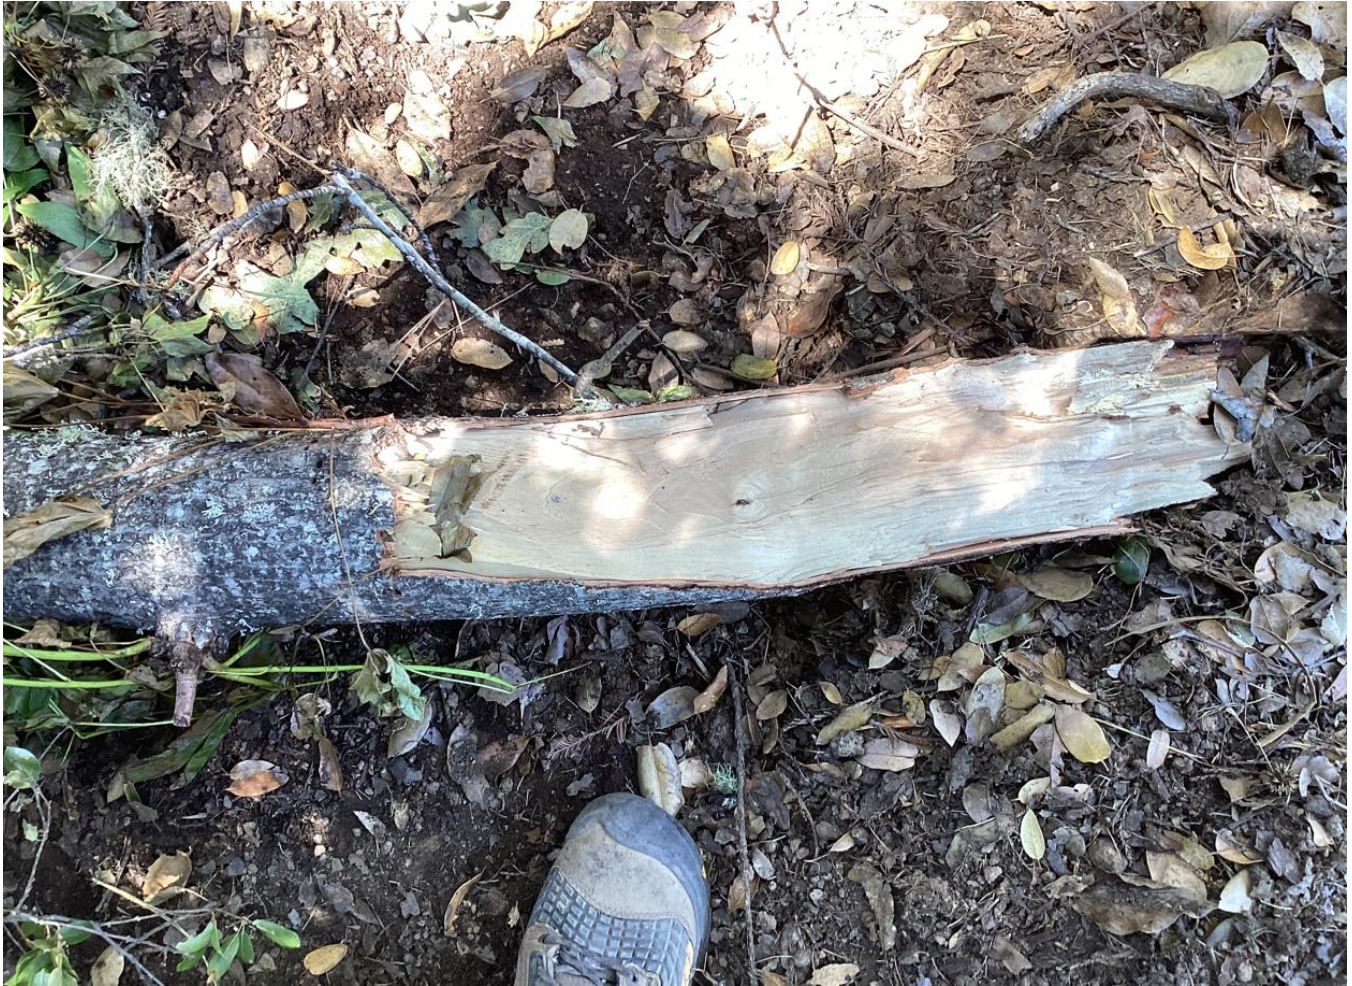
As a result of the incident, Vegetation Management (VM) conducted an inspection of the location on July 5, 2024 and identified the Incident Tree as a 75-foot tall and 20 inches DBH (diameter breast height) Liquidambar (sweetgum). An approximate four-inch limb of the incident tree failed approximately eight feet above the overhead conductors. No defects or decay was observed on the limb. The incident tree was last worked on April 1, 2023 (Work Request # UKNC1040403) by a PG&E contract crew (Family Tree Service), which included a routine trim and clearance above the conductor. The incident tree was last inspected on April 8, 2024 with a next planned inspection on November 1, 2024.

Figure 5 Photo of fallen branch from Incident Tree taken by VM inspector on July 5, 2024.

On July 5, 2024, VM conducted an extent of condition (XoC) inspection of the area, which included five spans in all directions starting with the end pole span at the incident address but no priority trees were identified. The incident tree and one other tree (live oak) were prescribed for removal, however, constrained for refusal by the property owner. Additionally, three other oaks, three bays and one eucalyptus trees were listed for work and completed on August 19, 2024.

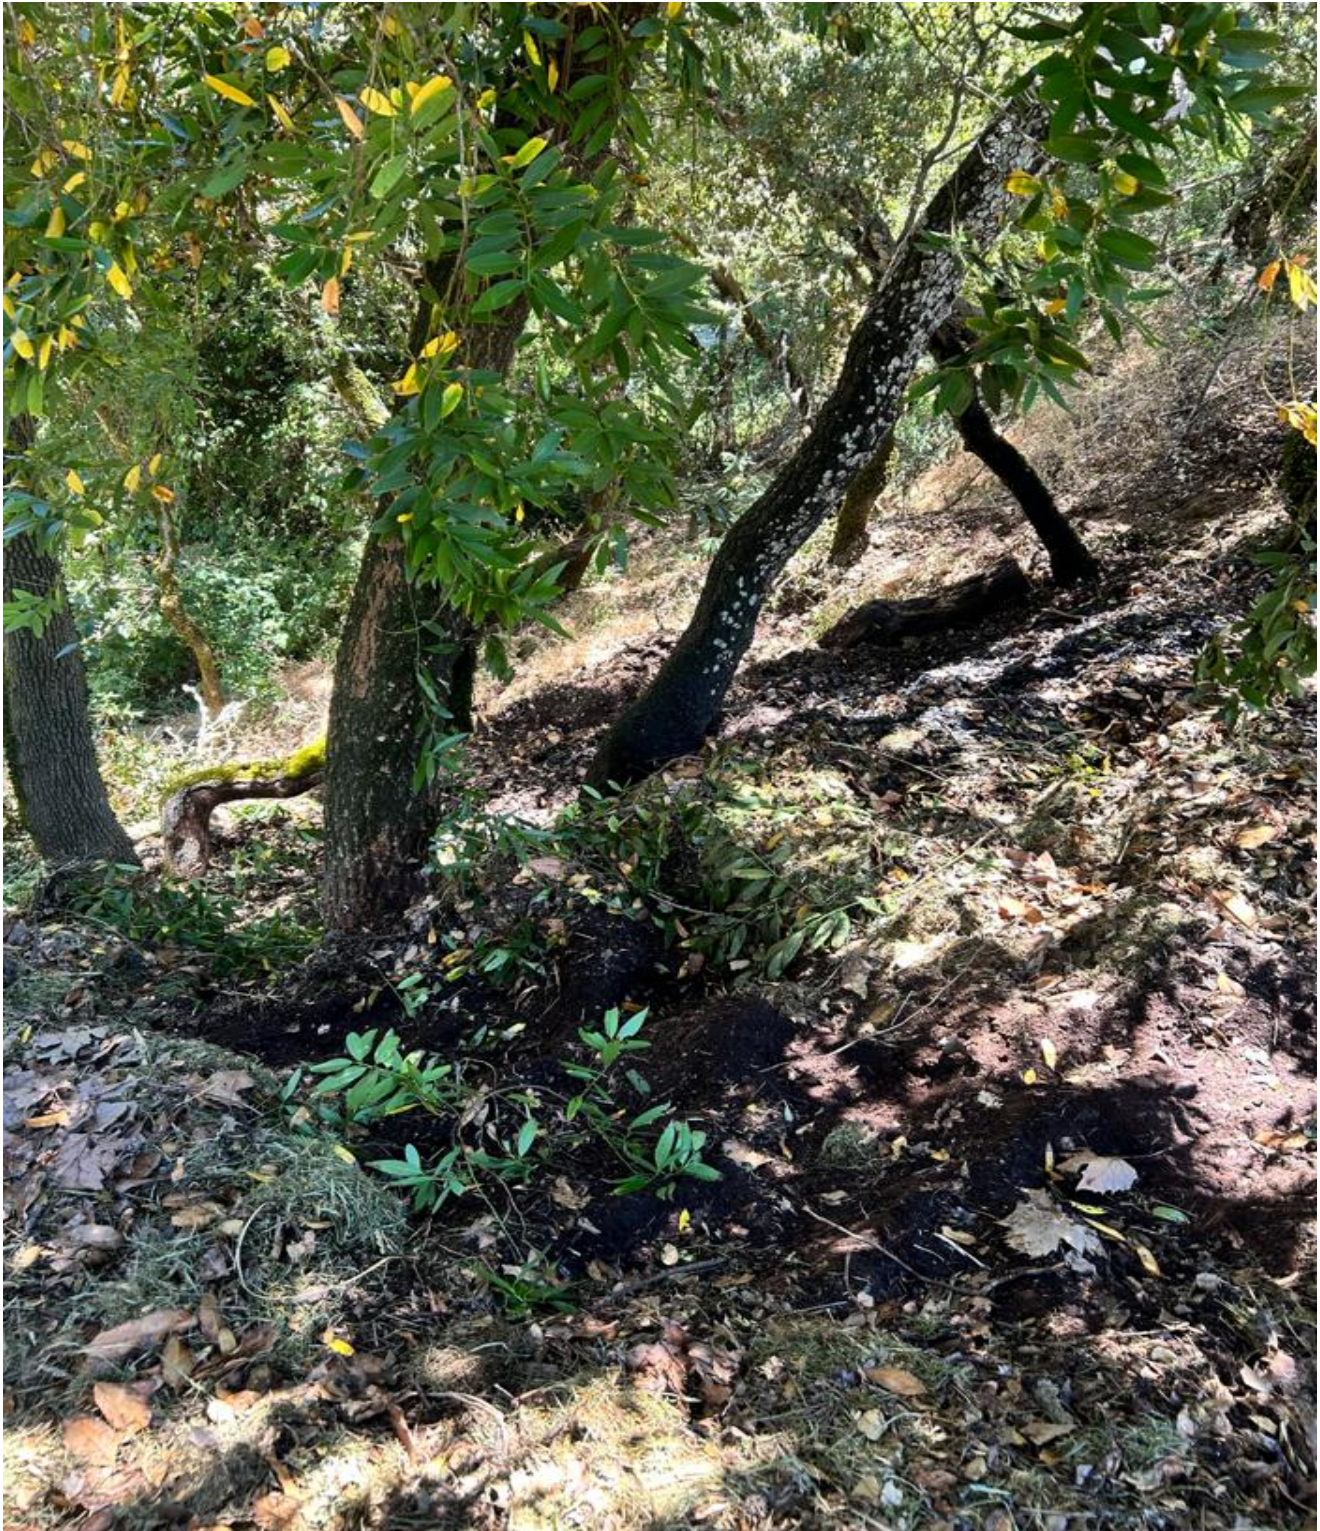
The incident resulted in a vegetation fire between one and three meters in size. A sustained outage lasting 169 minutes occurred, affecting six customers. No injuries, property damage or media coverage associated with this incident was identified.

Figure 6 Photo of burn area facing uphill taken by troubleshooter on July 3, 2024.
