## Preliminary Ignition Investigation Report

<b>Ignition Database Index:</b>	20240866 (Index 866) 20240867 (Index 867)
<b>Electric Incident Investigation (EII) Number:</b>	N/A
<b>Incident Name:</b>	Silverado (866 and 867)
<b>PG&amp;E Facility Ignition?</b>	Yes – 866 and 867
<b>CPUC Reportable Ignition?</b>	Yes – 866 and 867
<b>Date &amp; Time of Incident:</b>	July 5, 2024, at approximately 1134 hours
<b>Street Address:</b>	Near Silverado Trail S and Conn Creek Road – 866 Near Silverado Trail S and Zinfandel Lane – 867
<b>City:</b>	Rutherford – 866 St Helena – 867
<b>County:</b>	Napa – 866 and 867
<b>Latitude/Longitude:</b>	38.485539, -122.408482 – 866 38.497072, -122.423395 – 867
<b>State Responsibility Area (SRA) / Local Responsibility Area (LRA) / Federal Responsibility Area (FRA)</b>	State Responsibility Area (SRA) – 866 and 867
<b>PG&amp;E Division:</b>	North Bay – 866 and 867
<b>High Fire Threat District (HFTD):</b>	Non-HFTD – 866 Tier 2 – 867

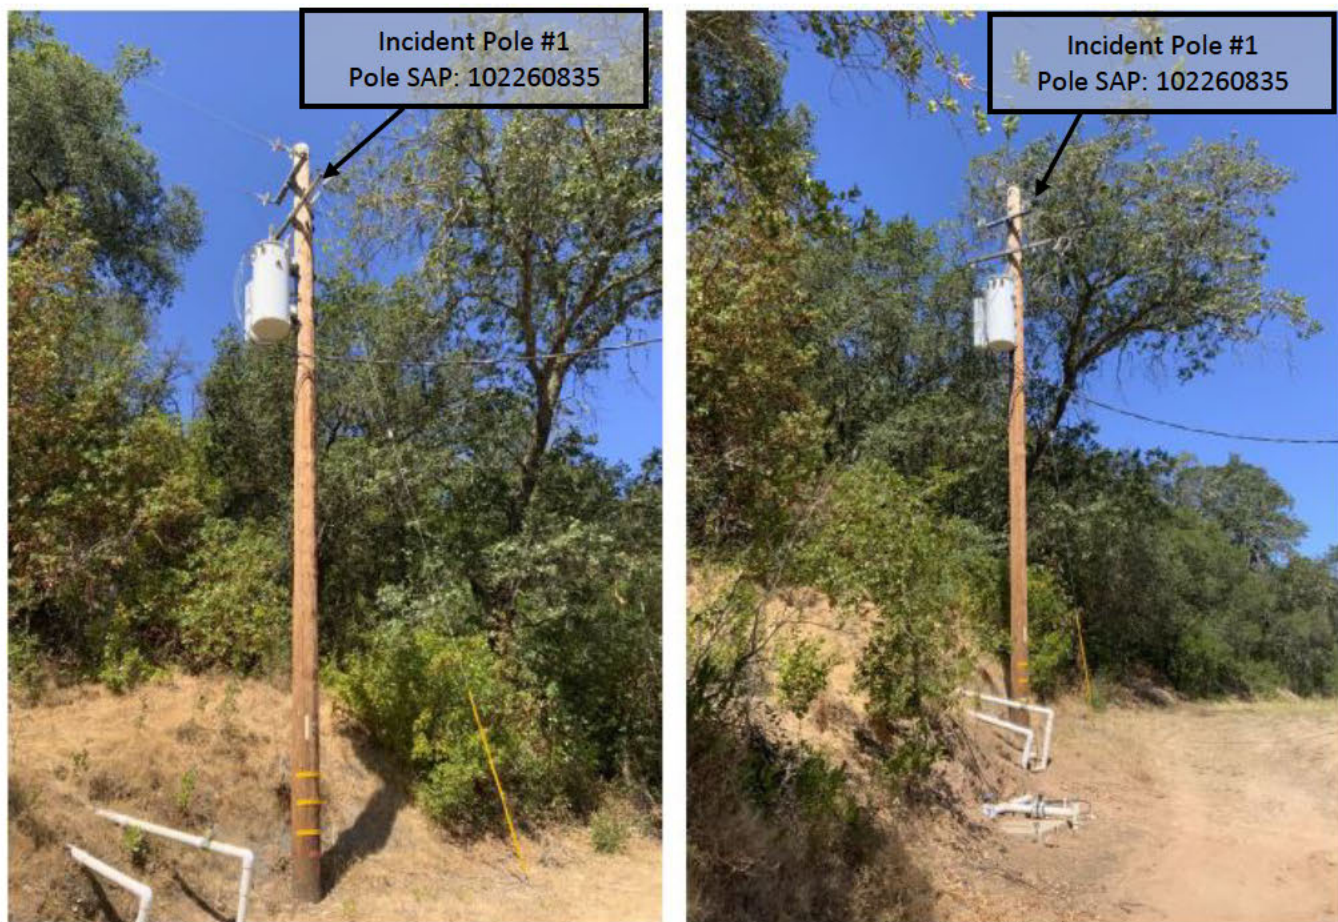
Figure 1. Inspection photos of the Incident Pole #1 (taken June 24, 2022).

<b>Source Side Structure</b>	102260835 (Incident Pole #1)	
<b>Info / Inspection</b>	<b>Most Recent Date</b>	<b>Findings</b>
Install Date:	1989	45 Foot Class-2 Wood Pole
Inspection:	June 24, 2022	Reported pole damage from woodpecker Subsequently filled through EC Notification 123915532
	June 25, 2020	-
Patrol:	-	-
Corrective History:	July 17, 2022	Filled woodpecker hole through EC Notification 123915532
Aerial Inspection Records:	-	-
VM Inspection:	-	-
EVM Inspection:	-	-
Equipment Test:	-	-
WSIP Inspection:	-	-

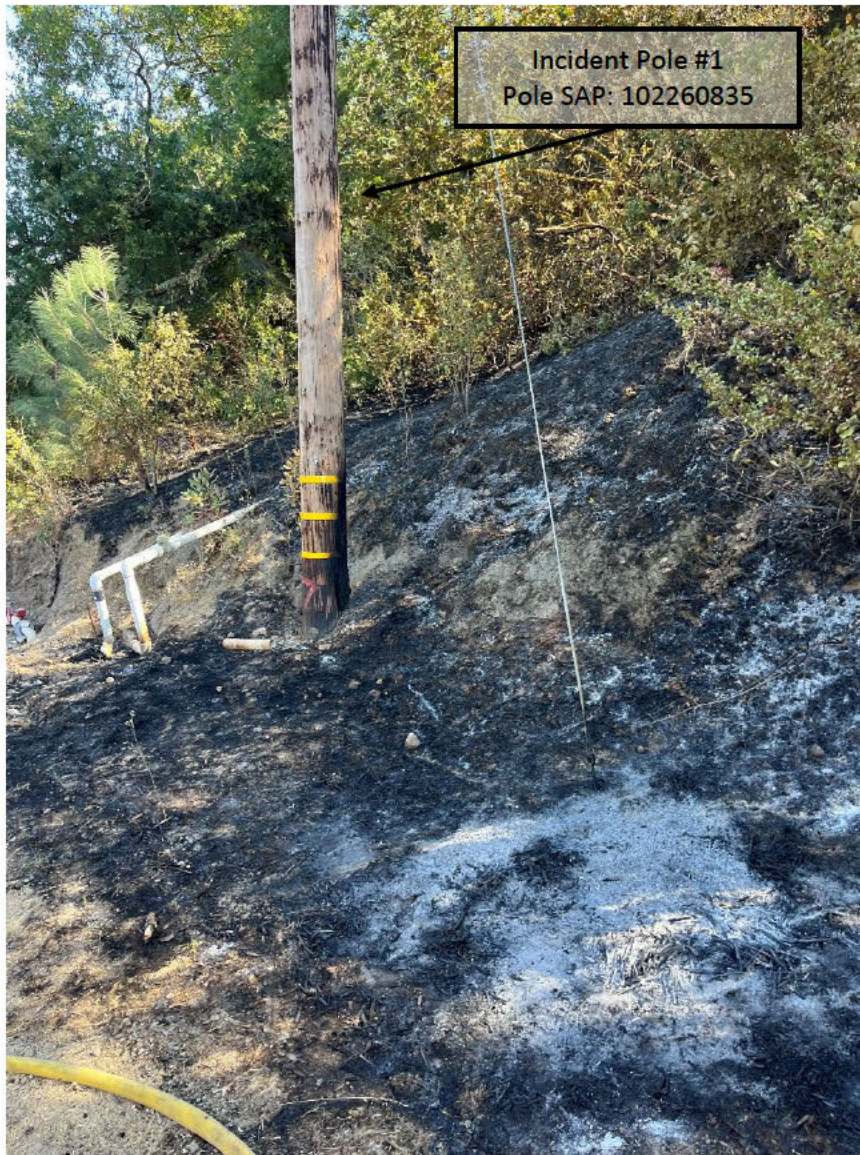
Figure 2. Incident photos of the Incident Pole #1 and some burnt area (taken July 5, 2024).

On July 5, 2024, at approximately 1134 hours, a black crow came into contact with an overhead transformer on a wooden distribution pole SAP ID 102260835 ("Incident Pole #1", Figure 1 and Figure 2), resulting in an approximately 0.25-acre vegetation fire near Conn Creek Road in the city of Rutherford ("Incident Location #1", Figure 2). Subsequently, Line Recloser (LR) 3010 on the four-wire, three-phase Silverado 2102 21kV Overhead Distribution Circuit opened on a line-to-line (A-C) fault, deenergizing 186 customers. Approximately 1.4 seconds later, LR 714 on the same circuit opened on another line-to line (A-C) fault, deenergizing additional 568 customers. At 1137 hours, PG&E dispatched a troubleshooter ("Troubleshooter #1") to LR 714 who arrived at 1144 hours and started to patrol the circuit protection zone for trouble. Meanwhile at 1203 hours, another troubleshooter in the area ("Troubleshooter #2") identified another 0.25-acre vegetation fire within proximity of a transmission with distribution underbuild pole SAP ID 40771924/102260631 ("Incident Pole #2", Transmission Structure 001/014), near the intersection of Zinfandel Lane and Silverado Trail in the city of St. Helena ("Incident Location #2", Figure 3 and Figure 4). Incident Location #1 is within non-HFTD and non-HFRA, whereas Incident Location #2 is within an HFTD Tier 2 and HFRA, both in Napa County.

It appears likely that the avian contact at Incident Location #1 initiated an ignition near the base of Incident Pole #1 (Figure 2). In addition, the Distribution Fault Anticipation ("DFA") system detected a fault induced conductor slap (FICS or roping) between phases near Incident Pole #2. As such, it is likely the fault current generated from the avian contact resulted in FICS and a phase-to-phase arc event near Incident Pole #2 leading to another ignition incident approximately a mile in the west direction. This On August 27, 2024, Wildfire Risk Management ("WRM") and Asset Health Performance Center ("AHPC") flew a drone over Incident Location #2 and observed burnt/melted conductor damage on two phases at the same approximate distance from Incident Pole #2 above

Type	Number	Description	Priority	Date Identified	Due Date
EC Notification	129176645	Replaced broken transformer primary bushing on the Incident Pole #1	A	Jul 5, 2024	Jul 5, 2024
EC Notification	129175528	Replaced insulators, crossarms, and cutout, removed overgrown vegetation near Incident Pole #1	A	Jul 5, 2024	Jul 5, 2024
EC Notification	129309574 <sup>3</sup>	Increasing the distance between different conductor lines due to future ignition hazard around vicinity of the Incident Pole #2	B	Jul 30, 2024	Aug 30, 2024

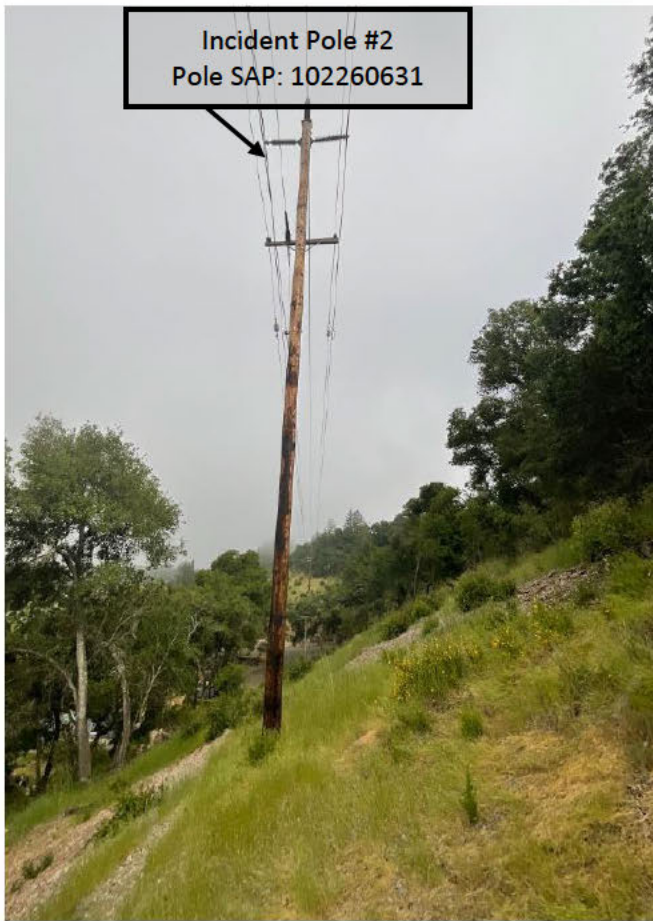
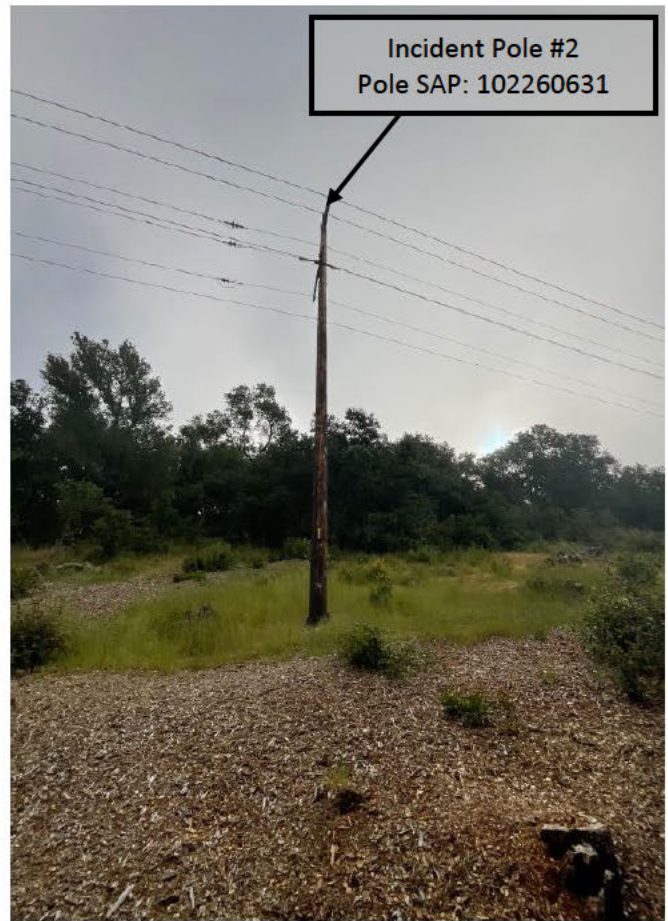
Figure 3. Inspection photos of the Incident Pole #2 (taken May 13, 2023).

<b>Source Side Structure</b>	102260631 (Incident Pole #2)	
<b>Info / Inspection</b>	<b>Most Recent Date</b>	<b>Findings</b>
Install Date:	1977	60 Foot Class-2 Wood Pole
Inspection:	May 13, 2023	-
	March 26, 2021	-
Patrol:	-	-
Corrective History:	-	-
Aerial Inspection Records:	-	-
VM Inspection:	-	-
EVM Inspection:	-	-
Equipment Test:	-	-
WSIP Inspection:	-	-

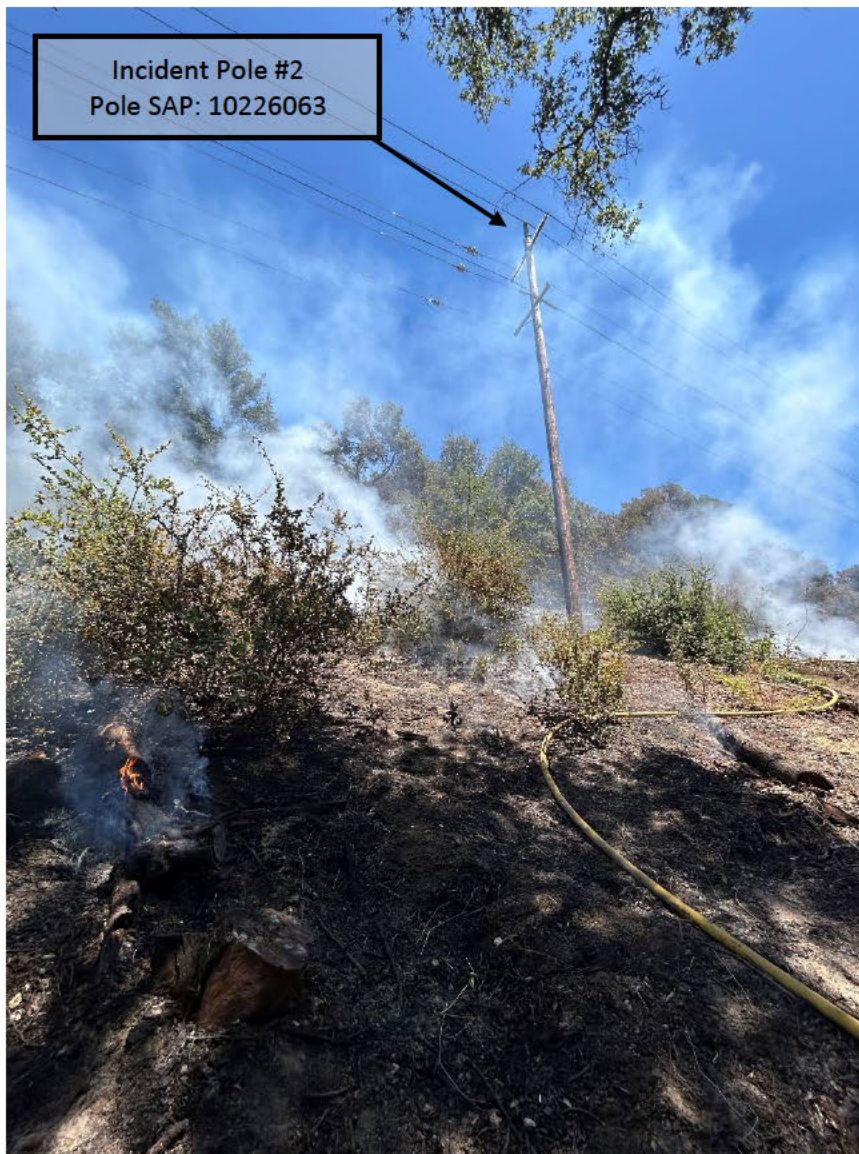
*Figure 4. Photos of the Incident Pole #2 and a section of burnt area (taken July 5, 2024).*

By 1230 hours, CAL FIRE had extinguished the pole fire and the fire at Incident Location #2. Troubleshooter #2 observed minimal damage (burn scarring) at the base of Incident Pole #2, not warranting de-energization of the Fulton-Pueblo 115kV transmission line. Troubleshooter #2 observed no other damage to PG&E structures or overhead equipment at this location. Around this time, CAL FIRE advised PG&E of another fire at Incident Location #1.<sup>1</sup> By 1333 hours, Troubleshooter #2 travelled to Incident Location #1 and found the remains of a black crow at the base Incident Pole #1 and a extinguished 0.25-acre vegetation fire (Figure 2 and Figure 5). Troubleshooter #2 also identified a broken/damaged primary insulator, cross-arm, transformer, and cutouts at Incident Pole #1 as well as adjacent overgrown vegetation. From 1333 hours to 1553 hours, troubleshooters patrolled the incident circuit and worked with Distribution Control Center ("DCC") to restore 658 customers affected by the outage. By 2236 hours, a PG&E crew completed repairs, removed the adjacent overgrown vegetation, installed protective bird guards to Incident Pole #1 and restored power to the remaining 96 affected customers. No partial voltage alarms associated with this incident have been identified.

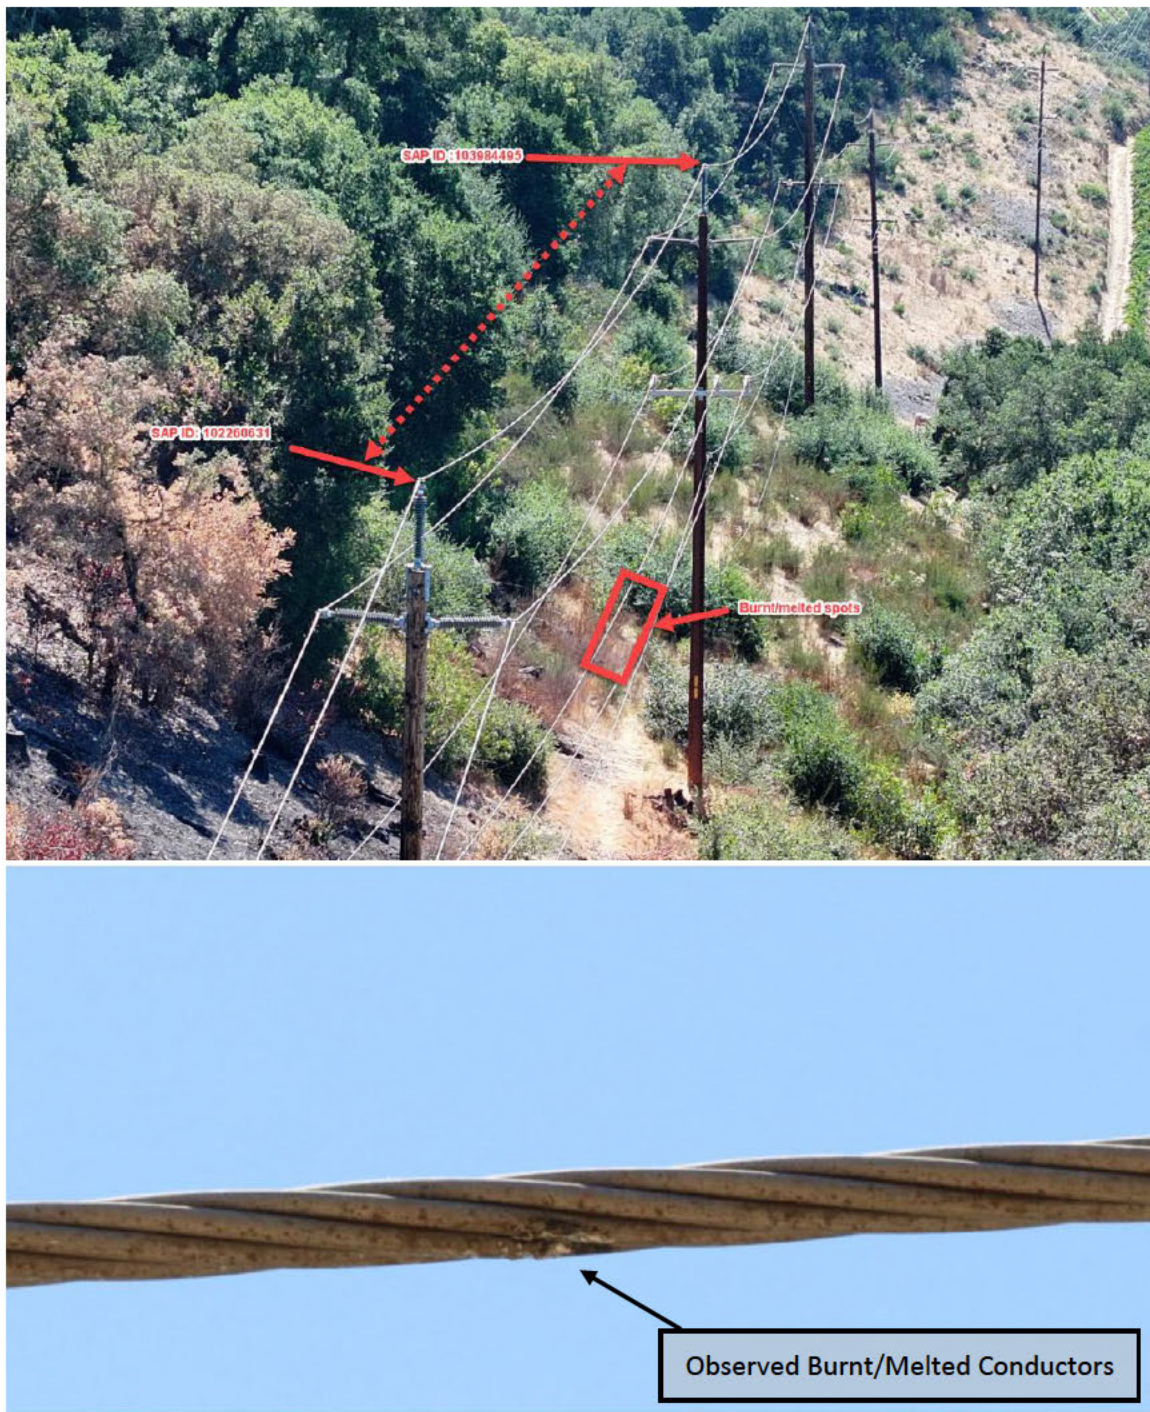
Figure 6. Site visit photos and annotations by Asset Health Performance Center (taken August 27, 2024).

a portion of the span crossing the burn scar (Figure 6). Neither AHPC or WRM observed any arc damage to the flying bells.<sup>2</sup> These observations and the meteorology data captured may suggest that the ignition at Incident Location #2 being caused by a fault induced conductor slap.
