Preliminary Ignition Investigation Report

Ignition Database Index:	20240927
Electric Incident Investigation (EII) Number:	N/A
Incident Name:	Uvas
PG&E Facility Ignition?	Yes
CPUC Reportable Ignition?	Yes
Date & Time of Incident:	July 11, 2024, at 2358 hours
Street Address:	[REDACTED]
City:	Morgan Hill
County:	Santa Clara
Latitude/Longitude:	[REDACTED]
State Responsibility Area (SRA) / Local Responsibility Area (LRA) / Federal Responsibility Area (FRA)	SRA
PG&E Division:	San Jose
High Fire Threat District (HFTD):	Tier 3
High Fire Risk Area (HFRA):	Yes
EPSS Buffer:	No
Fire Index Area (FIA):	553
Fire Potential Index (FPI) Rating: FIA	R3
Fire Potential Index (FPI) Rating: Circuit	R4
Was there a PSPS event at the time of ignition?	No
Suspected Initiating Event:	Vegetation Contact
Failure Driver:	Contact from object
Failure Sub-driver:	Contact – vegetation
Circuit:	Morgan Hill 2111
Circuit Protection Zone:	Morgan Hill 2111 XR398
Nominal Voltage:	12kV
Pole SAP Equipment ID:	100604336

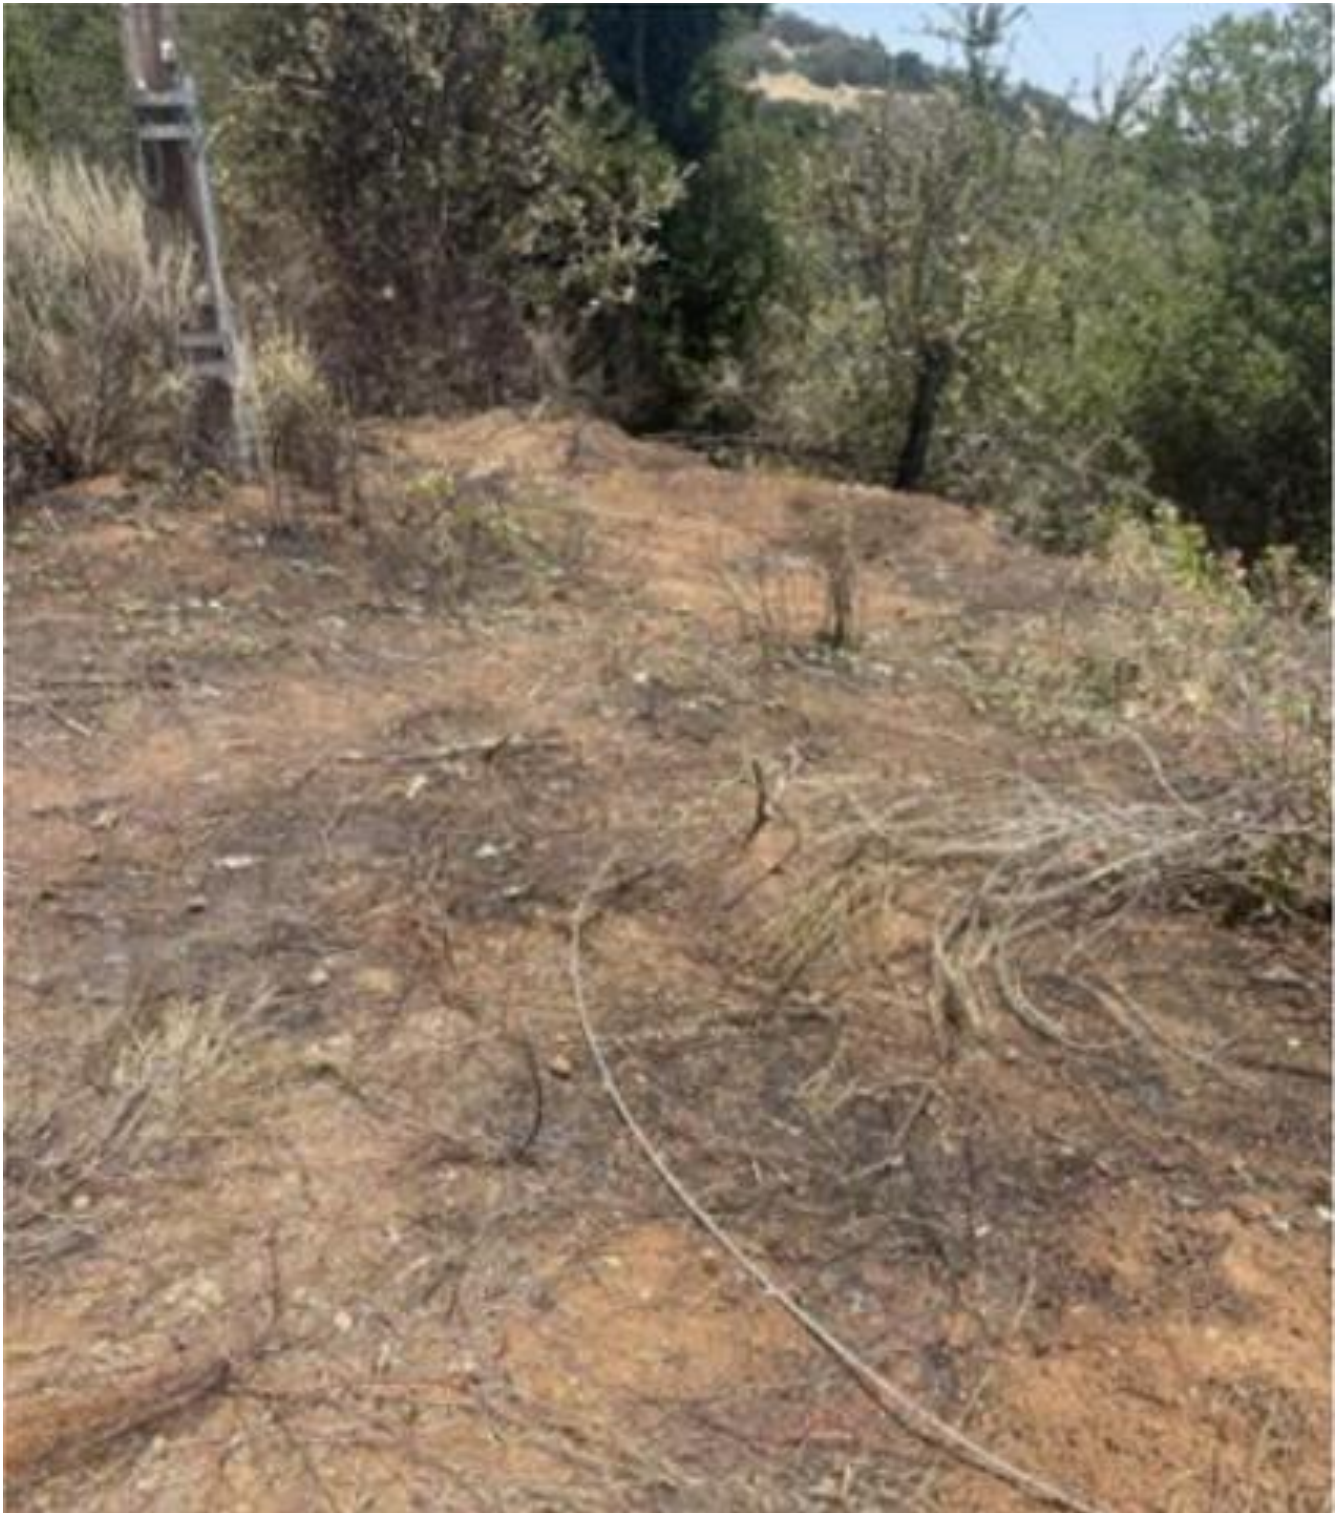
Figure 3 Photo depicts burned vegetation and broken primary conductor on ground. Photo taken by Vegetation Management.

On July 12, 2024, a priority “A” Electric Corrective Notification 129213237 was created because of this incident. A PG&E crew replaced one span of one phase of 4ACSR conductor.

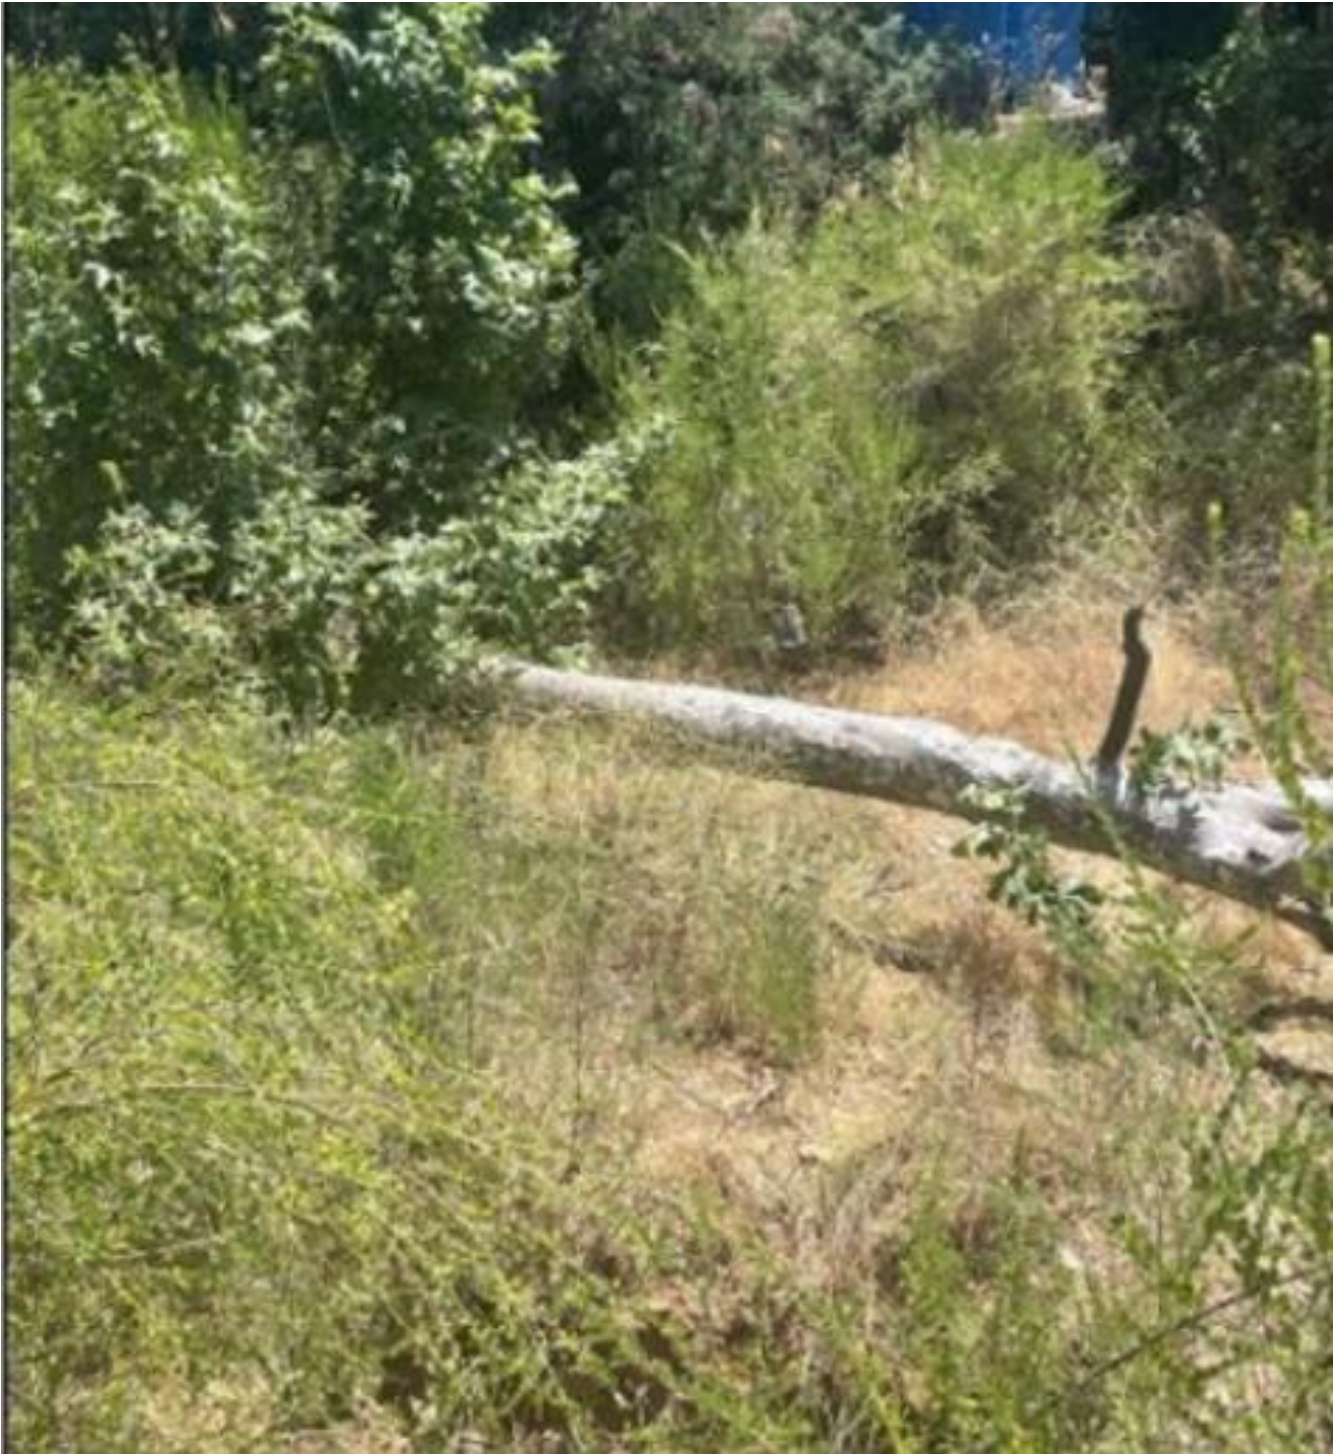
On July 11, 2024, a Vegetation Management Inspector (VMI) from PG&E's Vegetation Management (VM) program performed a VM fire investigation. The VMI identified the incident tree as a sycamore with a diameter at breast height (DBH) of 20 inches and a height of 58 feet. The tree was alive at the time of the failure and failure occurred just above the trunk flare. The VMI observed decay at the root flare that likely would not have been visible by external observation. The tree did have signs of carpenter ants and decay higher in the canopy, but it is unlikely that these signs would have been indicative of basal decay. The last VM inspection occurred on December 12, 2023, with the next planned inspection in the third quarter of 2024. During that Second Patrol inspection, the tree was prescribed for radial pruning to achieve 12 feet of clearance from the conductor on OneVM work order 0098087. The work had not been completed at the time of the incident, but it is unlikely that it would have mitigated the basal decay-related failure.

Figure 4 Photo depicts a sycamore tree with green leaves failed and laying on the ground. Photo taken by Vegetation Management.

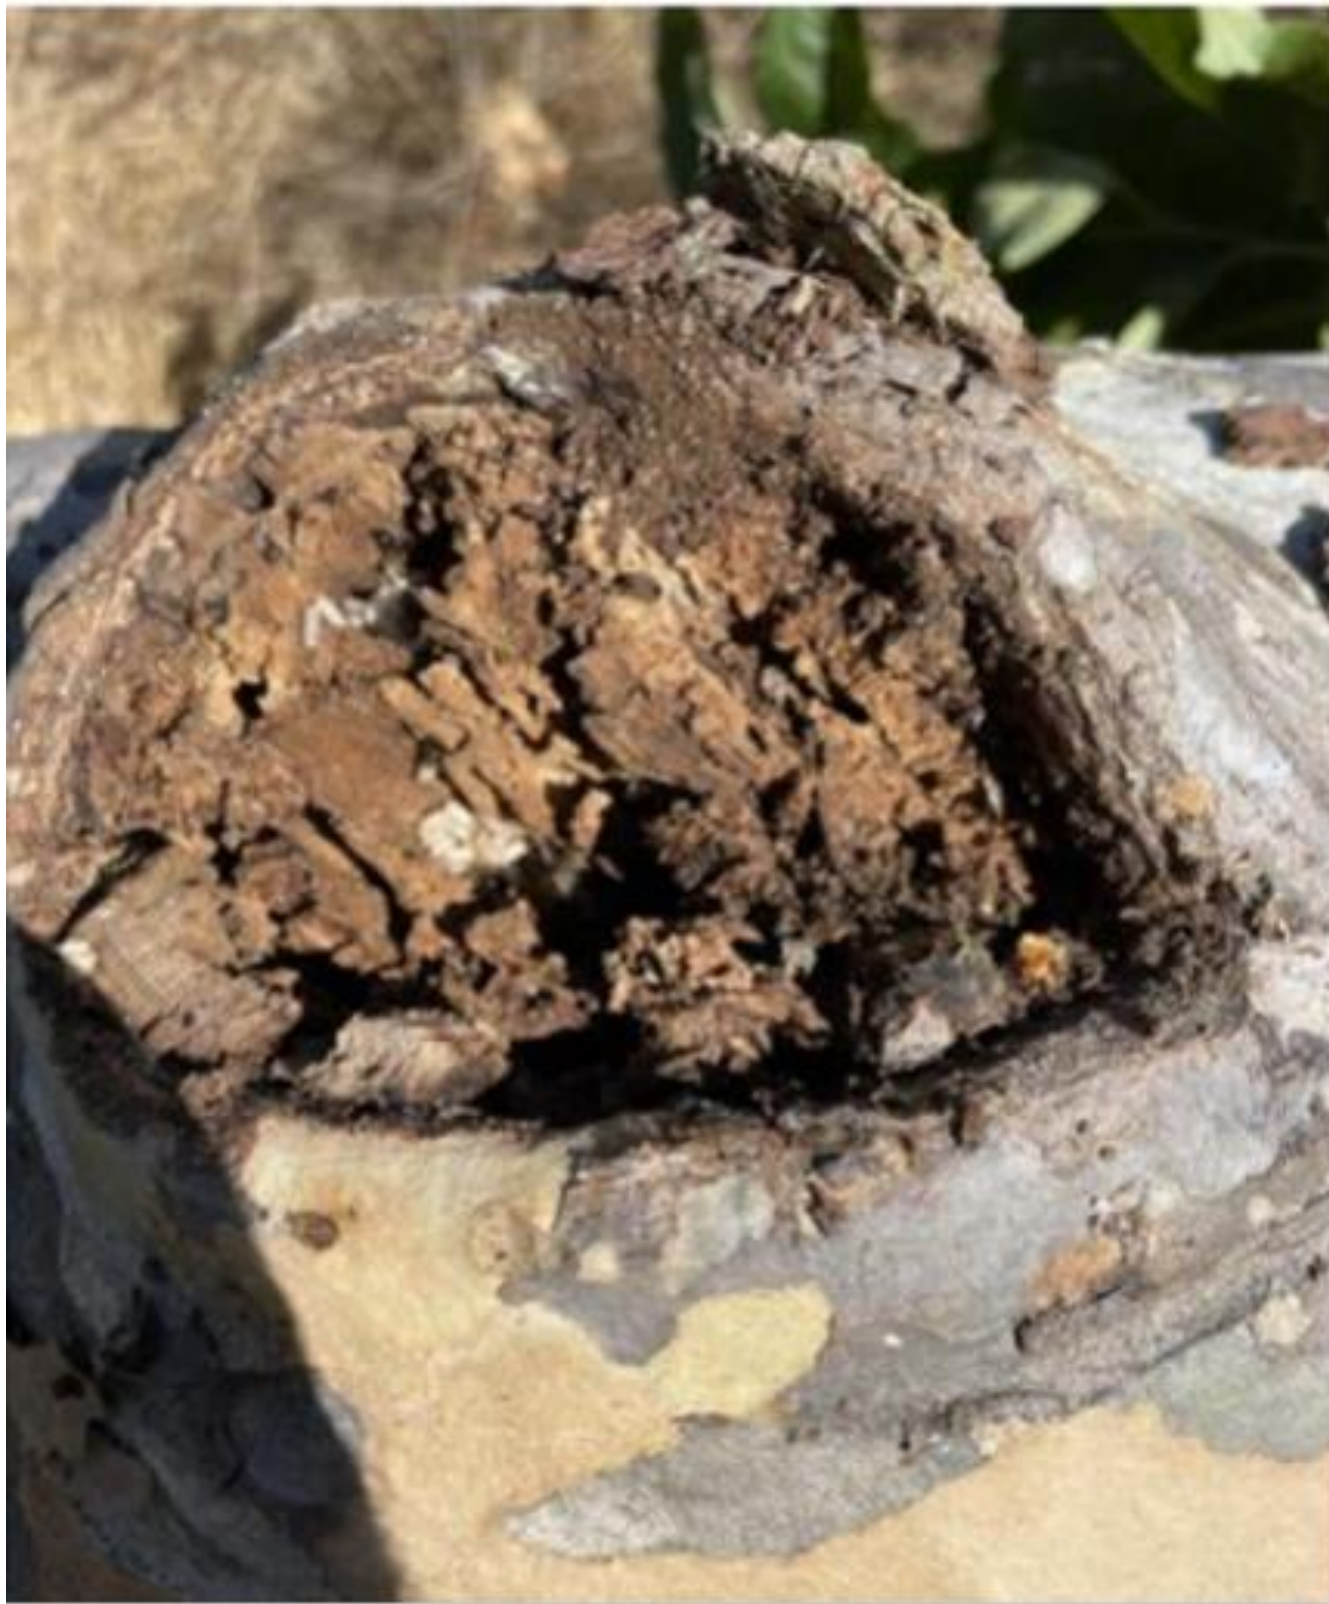
Figure 5 Photo depicts cavity with decay, carpenter ants, and eggs observed approximately 20' up the trunk from the flare. Photo taken by Vegetation Management.

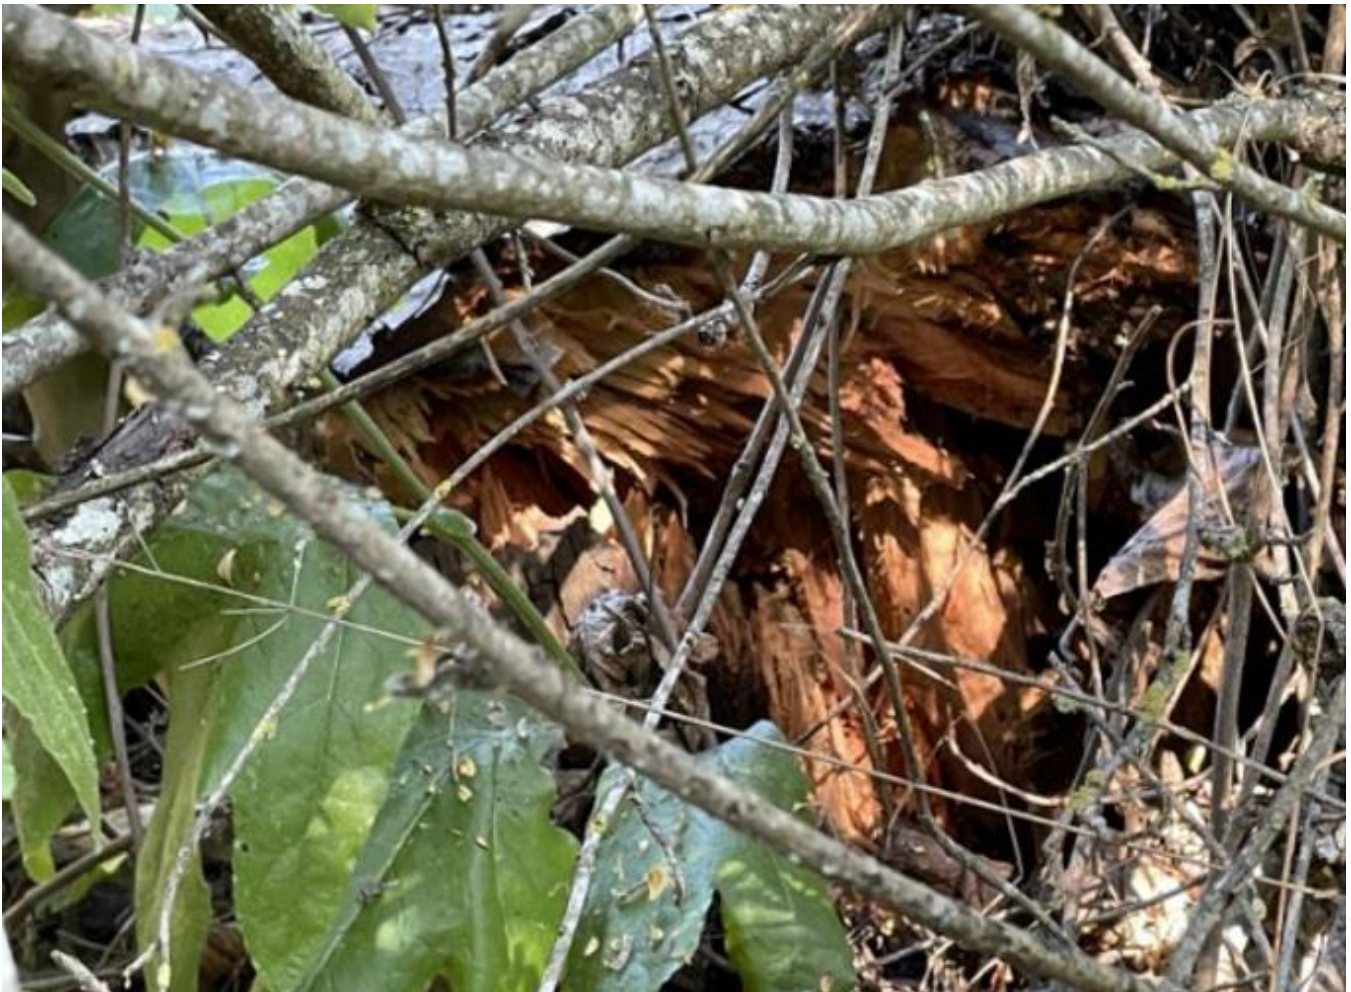
Figure 6 Photo depicts trunk failure at the base of the sycamore tree just above the trunk flare. Photo taken by Vegetation Management.

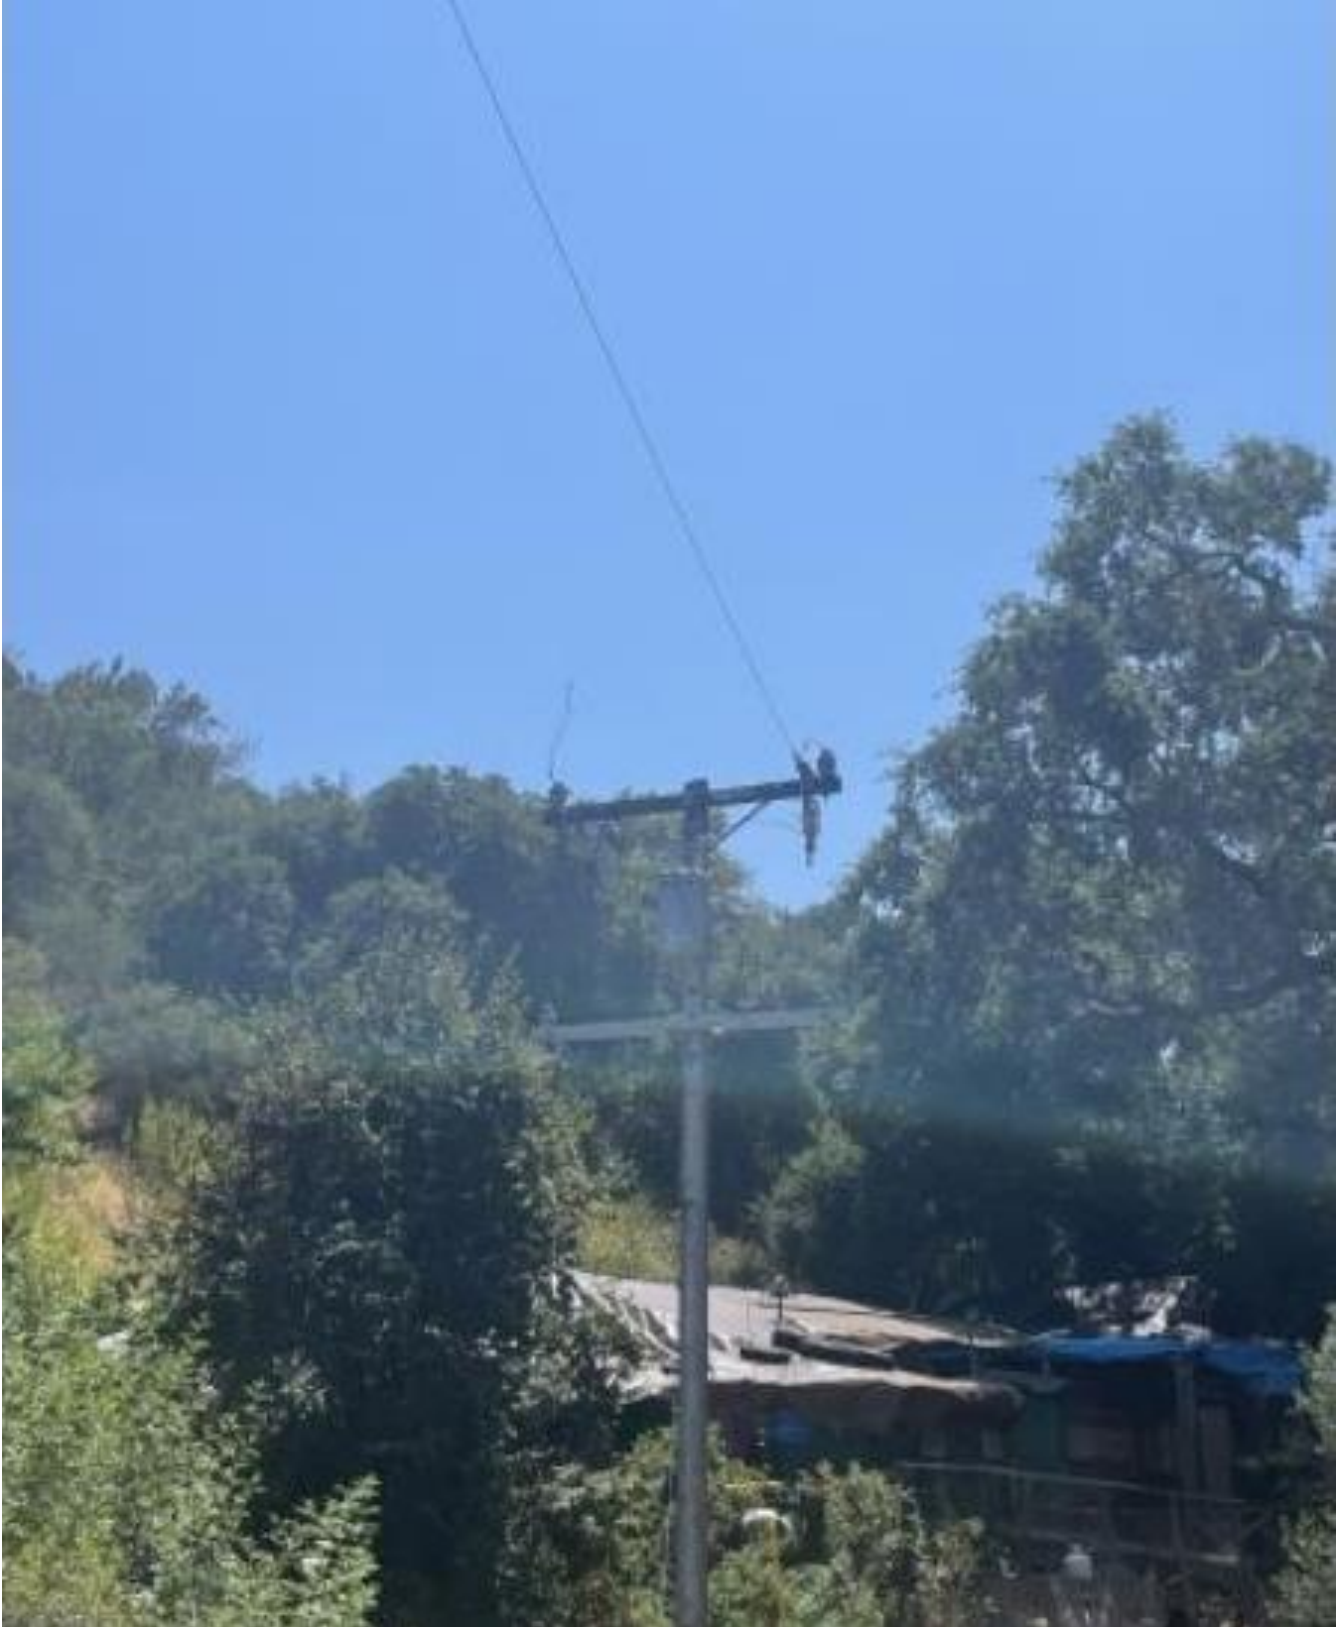
Figure 7 Photo depicts Pole (SAP ID 100604335) showing broken conductor. Photo taken by Vegetation Management.
