Preliminary Ignition Investigation Report

Ignition Database Index:	20240932
Electric Incident Investigation (EII) Number:	N/A
Incident Name:	Unconfirmed in Butte
PG&E Facility Ignition?	Yes
CPUC Reportable Ignition?	Yes
Date & Time of Incident:	July 12, 2024 at approximately 1933 hours
Street Address:	Near [REDACTED]
City:	Oroville
County:	Butte
Latitude/Longitude:	[REDACTED]
State Responsibility Area (SRA) / Local Responsibility Area (LRA) / Federal Responsibility Area (FRA)	SRA
PG&E Division:	North Valley
High Fire Threat District (HFTD):	Tier 2
High Fire Risk Area (HFRA):	Yes
EPSS Buffer:	No
Fire Index Area (FIA):	280
Fire Potential Index (FPI) Rating: FIA	R4
Fire Potential Index (FPI) Rating: Circuit	R3
Was there a PSPS event at the time of ignition?	No
Suspected Initiating Event:	Vegetation
Failure Driver:	Contact from Object
Failure Sub-driver:	Contact – Vegetation
Circuit:	Bangor 1101, 10319-1101
Circuit Protection Zone:	Bangor 1101 LR 614048
Nominal Voltage:	120V – Secondary 12kV – Primary

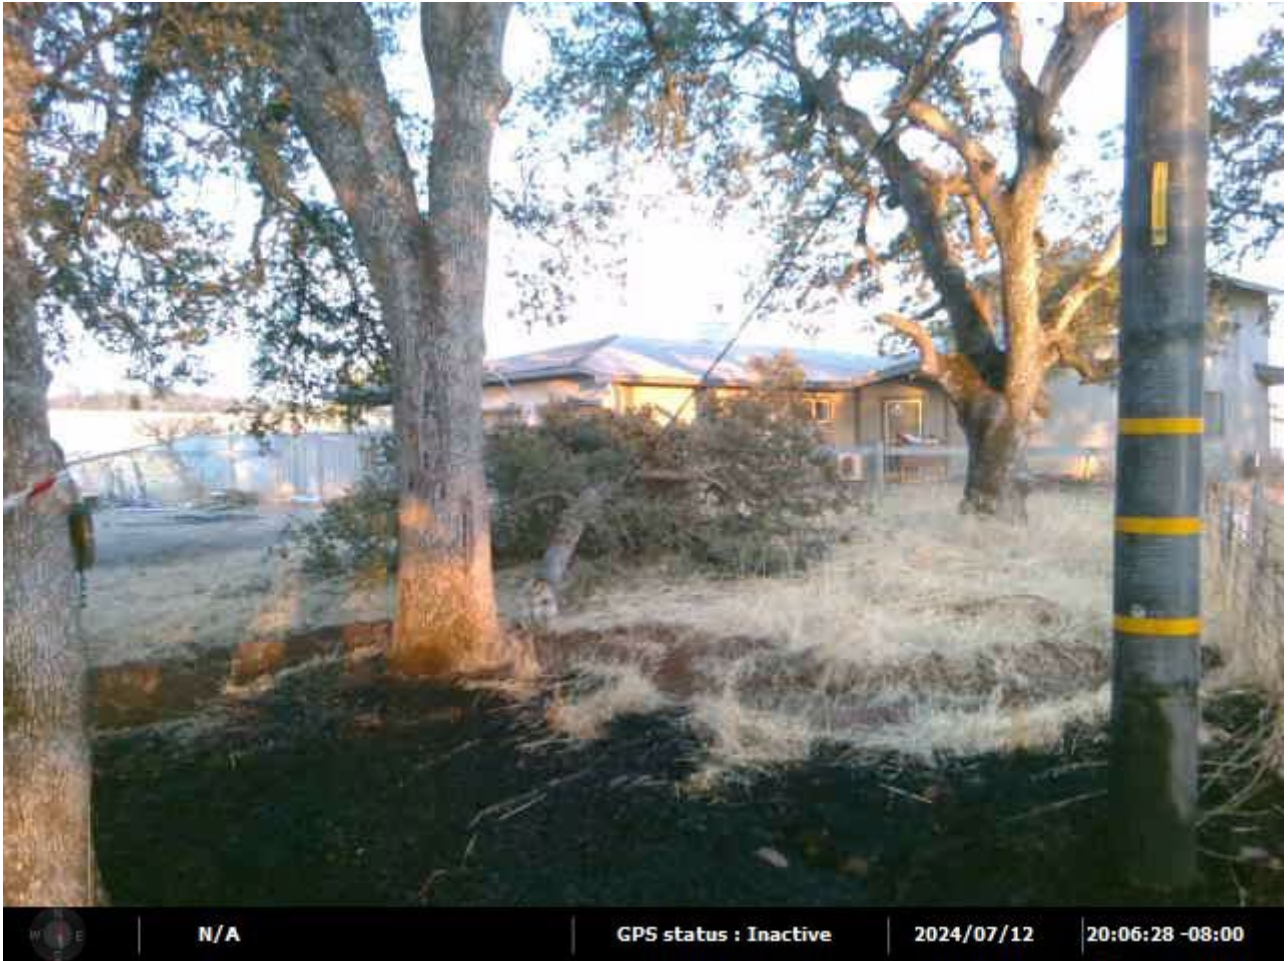
The Vegetation Management (VM) team conducted a post-incident investigation on July 12, 2024. The incident tree identified by the VM investigator is a 35-foot tall blue oak with a 23-inch diameter at breast height (DBH) located nine feet from the conductor. The blue oak experienced a partial failure of a nine-inch DBH limb that broke out and fell onto the service drop resulting in the strain, failure and arcing of the conductor. The resulting fire damage extended to a nearby fence. The VM investigator noted that the blue oak exhibited signs of decay. The blue oak is not in scope for Routine Inspection or a Tree Mortality Inspection Record as it is located near a service drop. Additionally, the blue oak is not listed within the Enhanced Vegetation Management (EVM) workplan. The closest tree identified for EVM work was located approximately 260 feet away from the Incident Location.

This event on July 12, 2024 was the result of a broken tree branch that contacted the service drop and sparked a small vegetation fire measuring less than 0.25 acre in size near the base of the pole. No outage was captured on PG&E’s Integrated Logging Information System (ILIS). However, there was an outage to a single customer that lasted 155 minutes. There were no reports of injuries, fatalities, property damages or significant media attention associated with this event.

Figure 2 – View of failed tree limb into the secondary with a portion of the burn scar shown near the Incident Pole on July 12, 2024. Photo taken by the troubleshooter.

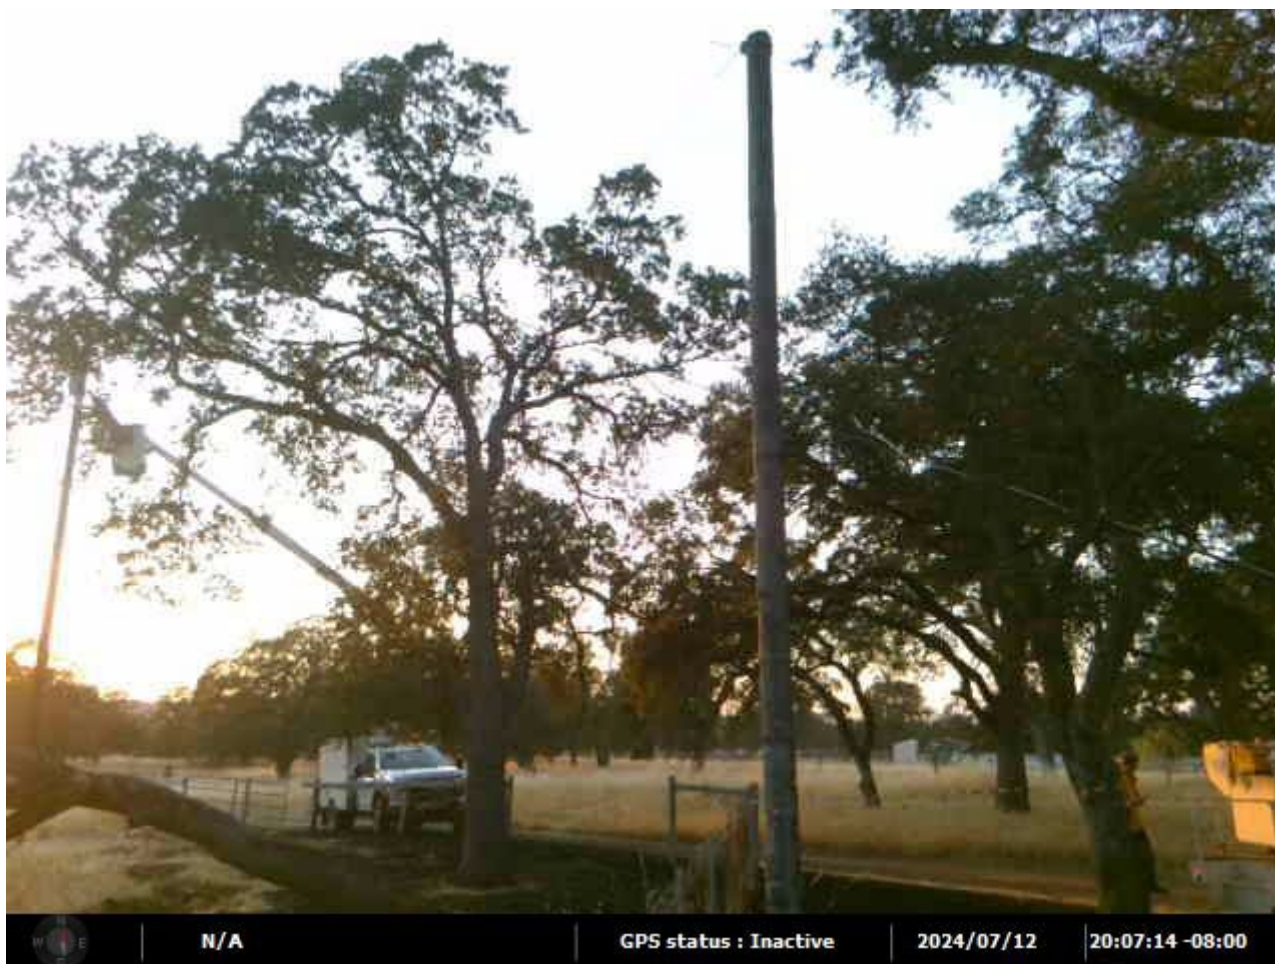
Figure 3 – View of the Incident Pole with failed tree limb also shown on the ground on July 12, 2024. Photo taken by the troubleshooter.

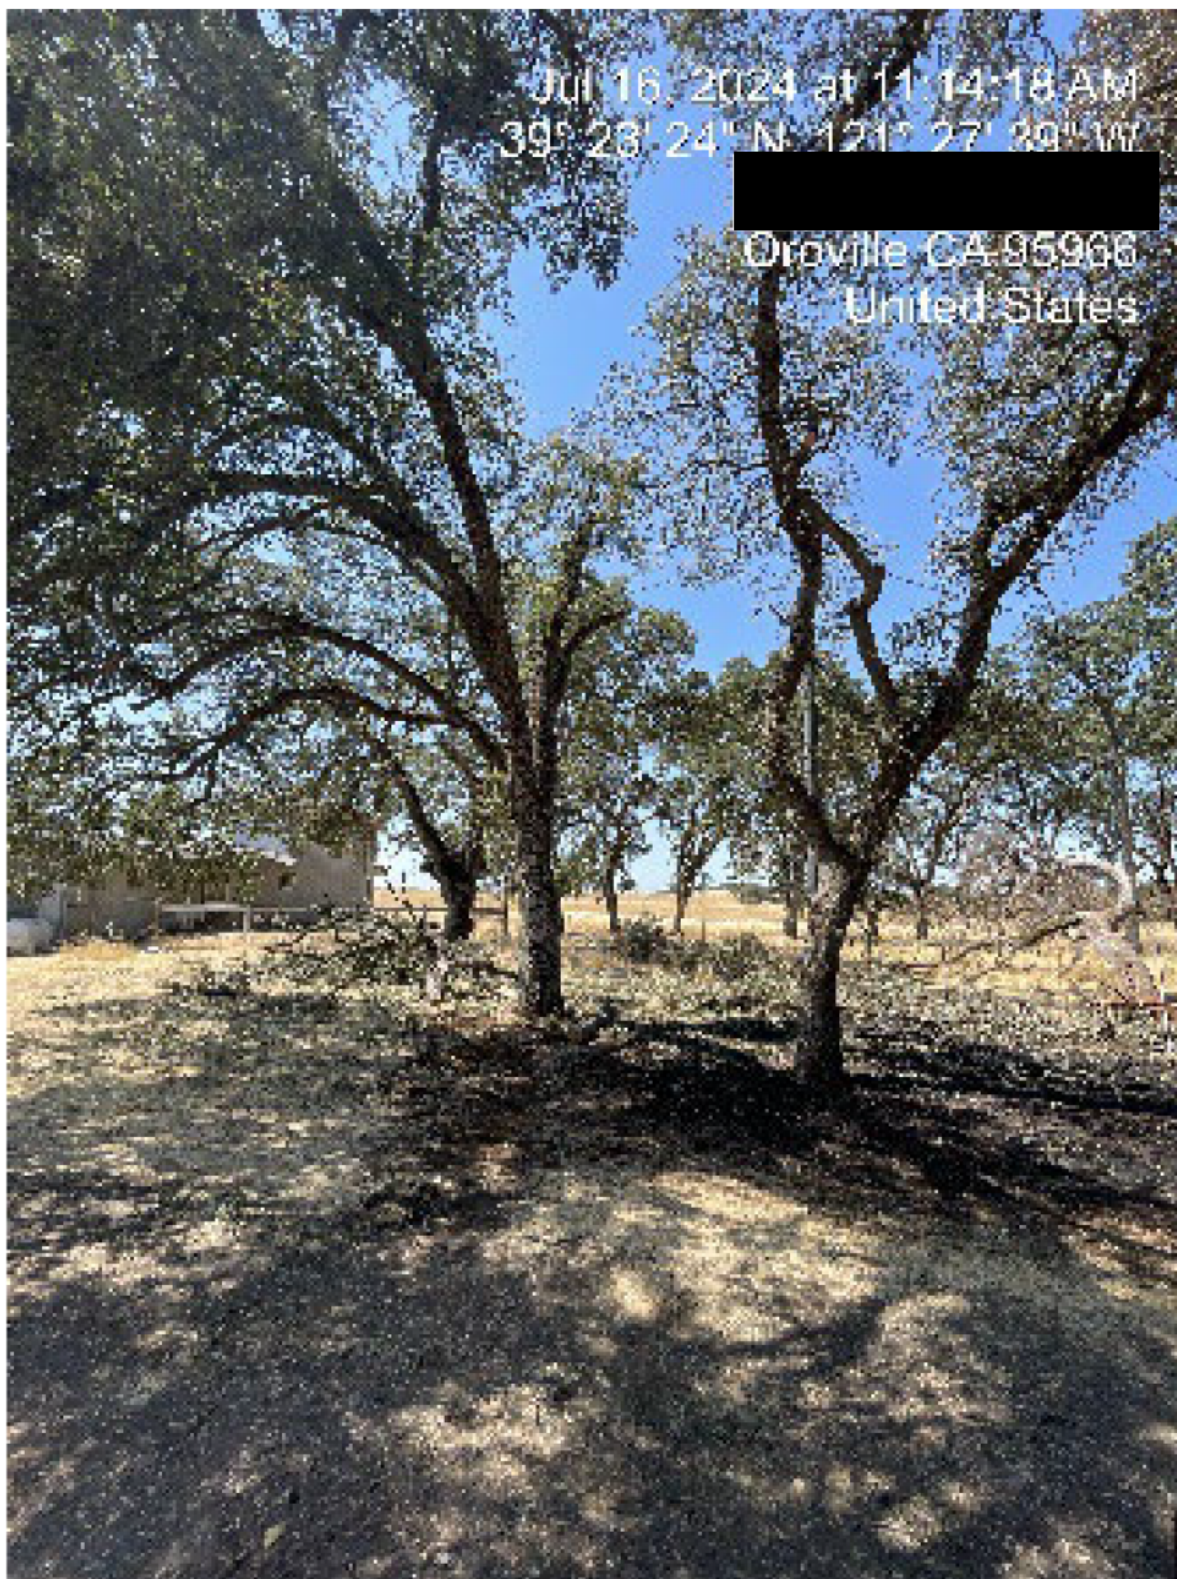
An Extent of Condition (XoC) was also completed by the VM team on July 16, 2024. The XoC included a patrol of the adjacent spans on either side of the Incident Pole for similar trees and risk conditions. One blue oak tree located near the Transformer Pole to the east of the Incident Pole was identified and prescribed for pruning (see Figure 4).

Figure 4 – An additional blue oak identified and prescribed for pruning post-incident on July 16, 2024. Photo taken by the VM team.
