Preliminary Ignition Investigation Report

Ignition Database Index:	20240994
Electric Incident Investigation (EII) Number:	N/A
Incident Name:	Slate - 21 Jul 2024
PG&E Facility Ignition?	Yes
CPUC Reportable Ignition?	Yes
Date & Time of Incident:	July 20, 2024, at approximately 2123 hours
Street Address:	[REDACTED]
City:	Orleans
County:	Humboldt
Latitude/Longitude:	[REDACTED]
State Responsibility Area (SRA) / Local Responsibility Area (LRA) / Federal Responsibility Area (FRA)	State Responsibility Area (SRA)
PG&E Division:	Humboldt
High Fire Threat District (HFTD):	Tier 2
High Fire Risk Area (HFRA):	Yes
EPSS Buffer:	No
Fire Index Area (FIA):	112
Fire Potential Index (FPI) Rating: FIA	R3
Fire Potential Index (FPI) Rating: Circuit	R3
Was there a PSPS event at the time of ignition?	No
Suspected Initiating Event:	Vegetation
Failure Driver:	Contact from object
Failure Sub-driver:	Contact – Vegetation
Circuit:	Hoopa 1110
Circuit Protection Zone:	Hoopa 11103174
Nominal Voltage:	12kV

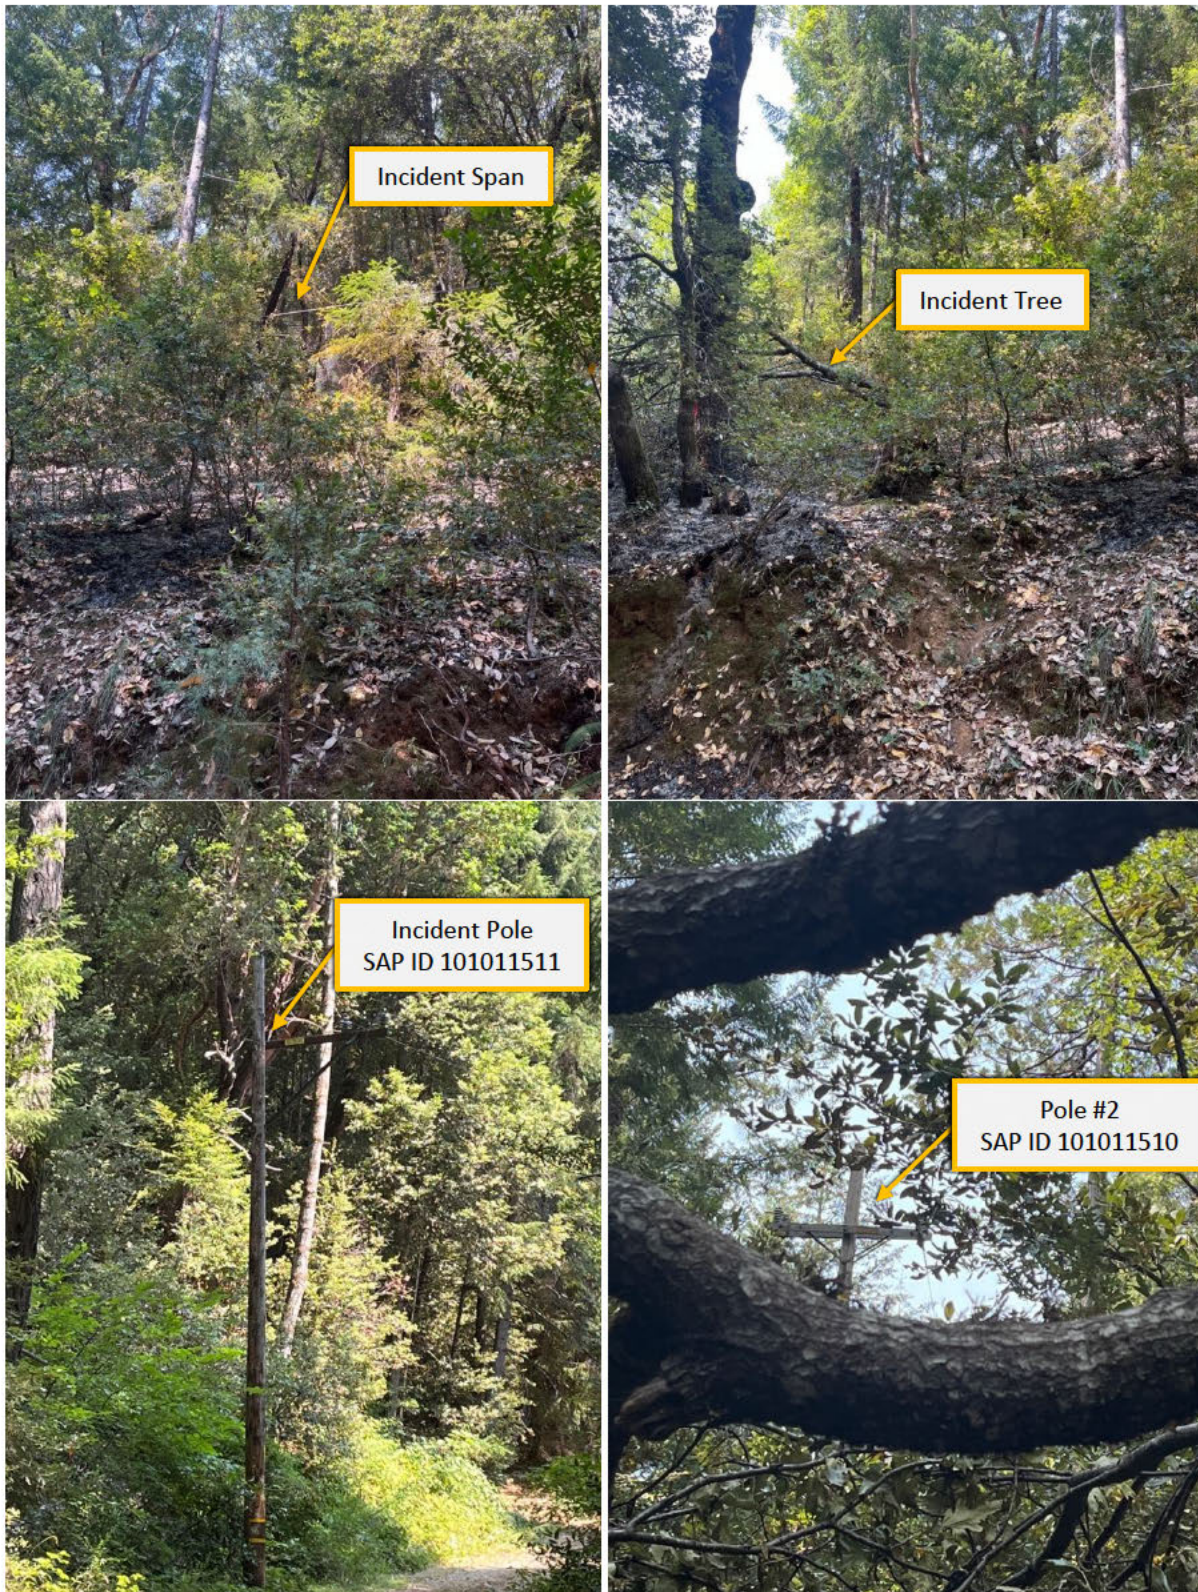
Figure 2. Incident photos of Incident Tree and poles on the Incident Span (taken July 21, 2024).

On July 20, 2024, at 2359 hours, Line Recloser (LR) 3174 on the EPSS-enabled Hoopa 1101 12kV Overhead Distribution Circuit opened on a line-to-ground fault with Sensitive Ground Fault (SGF) targets, deenergizing 487 customers. On July 21, 2024, at 0010 hours, PG&E dispatched a troubleshooter to investigate the outage. At 0135 hours, the troubleshooter arrived at LR 3174 and began patrolling the area. At 0258 hours, due to low visibility at night and a lack of fault indicators on this section of the circuit, the troubleshooter asked the Distribution Control Center (“DCC”) to temporarily suspend the patrol. At 0818 hours, the troubleshooter returned to the circuit to continue patrolling for the location of the fault. At 1142 hours, the troubleshooter reported an active fire near [REDACTED] (“Incident Location”) in Orleans, California (Figure 1), where the troubleshooter observed the U.S. Forest Service (USFS) responding to the fire.¹ The troubleshooter observed a broken conductor on the ground and a tree (“Incident Tree”) leaning on the other phase of the two phases of 2-ACSR primary overhead conductors (“Incident Span”) spanning between load-side wood pole SAP ID 101011511 (“Incident Pole”)² and source-side wood pole SAP ID 101011510 (“Pole #2”) (Figure 2, Figure 3, Figure 4). The Incident Location was within HFTD Tier 2 and HFRA.

On July 22, 2024, PG&E Vegetation Management (“VM”) patrolled the Incident Location and observed that the Incident Tree was a live black oak that was approximately 90 feet in height.³ The trunk of the tree broke approximately six feet above ground, and VM observed a large internal cavity at the location of the break (see Figure 3). VM determined that the tree was leaning toward and overhanging at least one phase of the Incident Span prior to failure. No prior work had been performed on the Incident Tree.

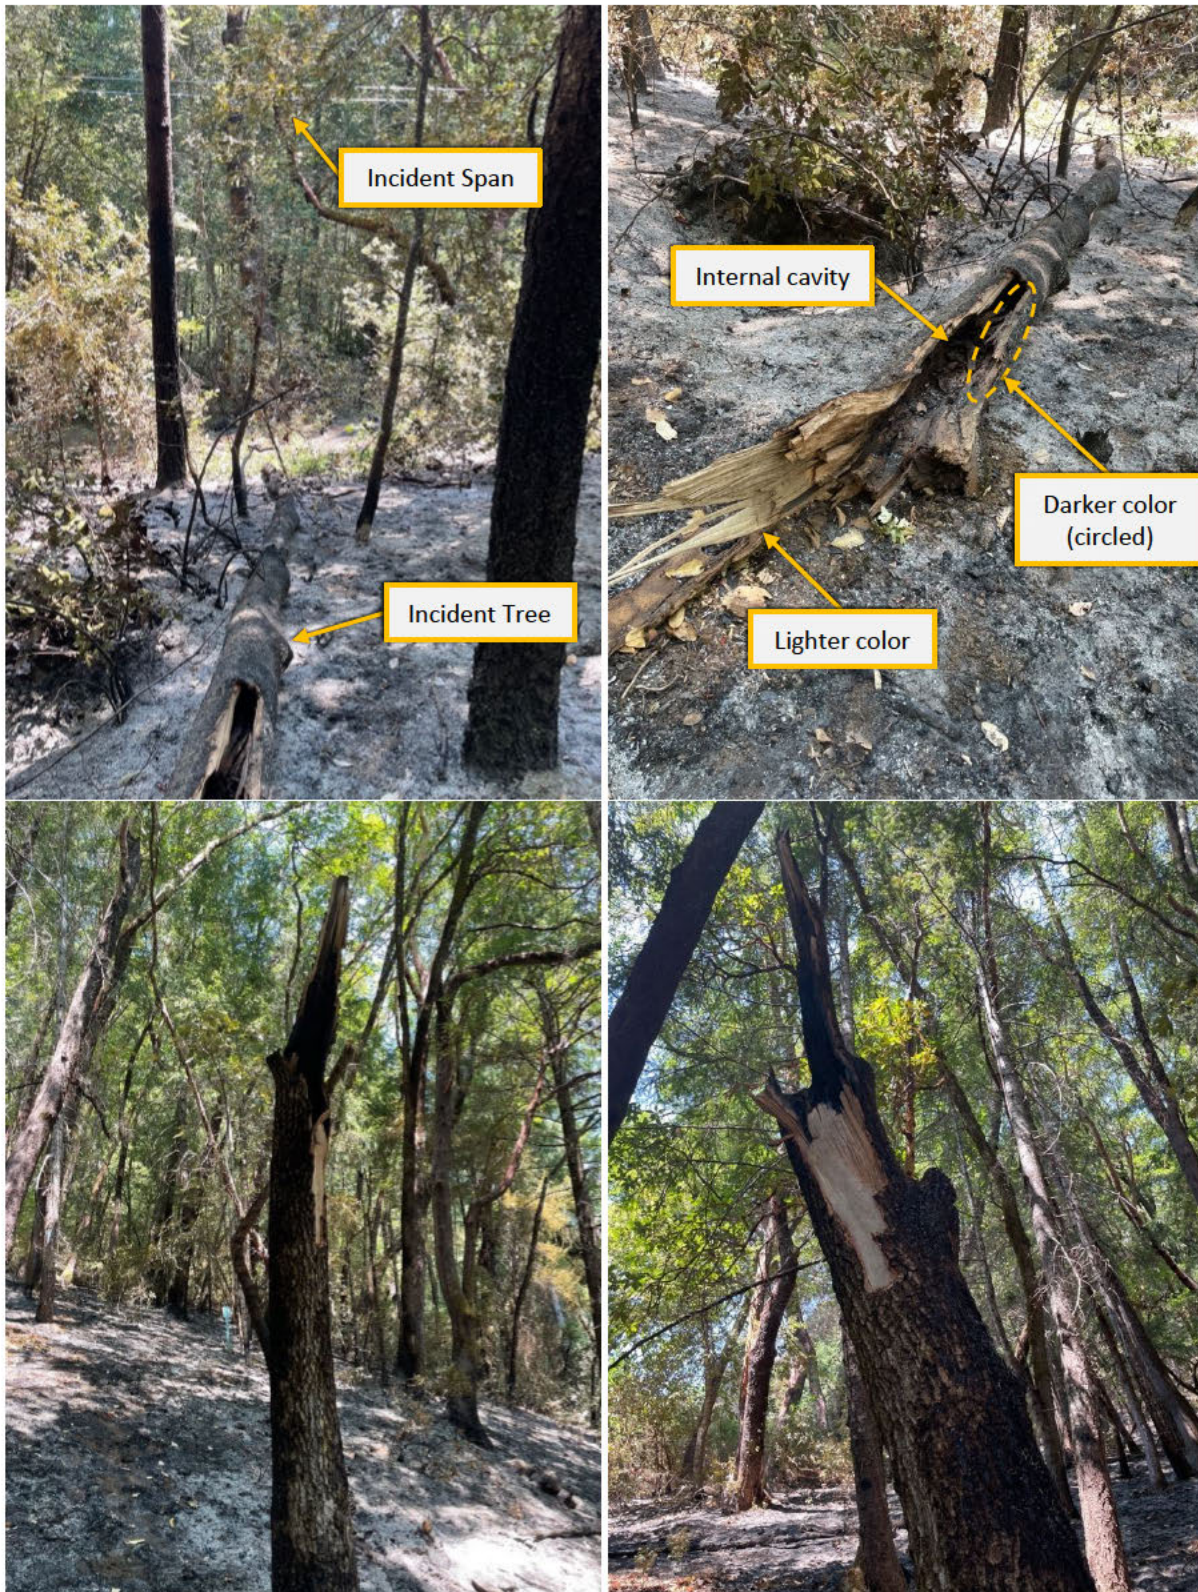
Figure 3. Photos of Incident Tree provided by Vegetation Management (taken July 22, 2024).

Based on incident photos, the post-ignition appearance of the internal cavity in the trunk of the Incident Tree suggests that decay was present within the trunk prior to the tree failure. The wood at fracture surfaces had lighter and darker-colored portions (see Figure 3), where the darker-colored portions are consistent with weathering that occurs when wood is exposed to oxygen and sunlight, suggesting that cracks in the trunk may have developed prior to the tree failure. However, the orientation of the fracture surface on the tree trunk

suggests that obvious visual defects may have been limited to the side of the tree facing away from the inspector during routine VM inspections.
