Preliminary Ignition Investigation Report

Ignition Database Index:	20241029
Electric Incident Investigation (EII) Number:	N/A
Incident Name:	Horse – 26 Jul 2024
PG&E Facility Ignition?	Yes
CPUC Reportable Ignition?	Yes
Date & Time of Incident:	July 26, 2024, at approximately 1240 hours
Street Address:	3167 Horseshoe Bend Road
City:	Somerset
County:	El Dorado
Latitude/Longitude:	38.61025, -120.714634
State Responsibility Area (SRA) / Local Responsibility Area (LRA) / Federal Responsibility Area (FRA)	State Responsibility Area (SRA)
PG&E Division:	Sierra
High Fire Threat District (HFTD):	Tier 2
High Fire Risk Area (HFRA):	Yes
EPSS Buffer:	N/A
Fire Index Area (FIA):	340
Fire Potential Index (FPI) Rating: FIA	R4
Fire Potential Index (FPI) Rating: Circuit	R5
Was there a PSPS event at the time of ignition?	No
Suspected Initiating Event:	Vegetation
Failure Driver:	Contact from object
Failure Sub-driver:	Contact – Vegetation
Circuit:	Apple Hill 2102
Circuit Protection Zone:	Apple Hill 2102186912

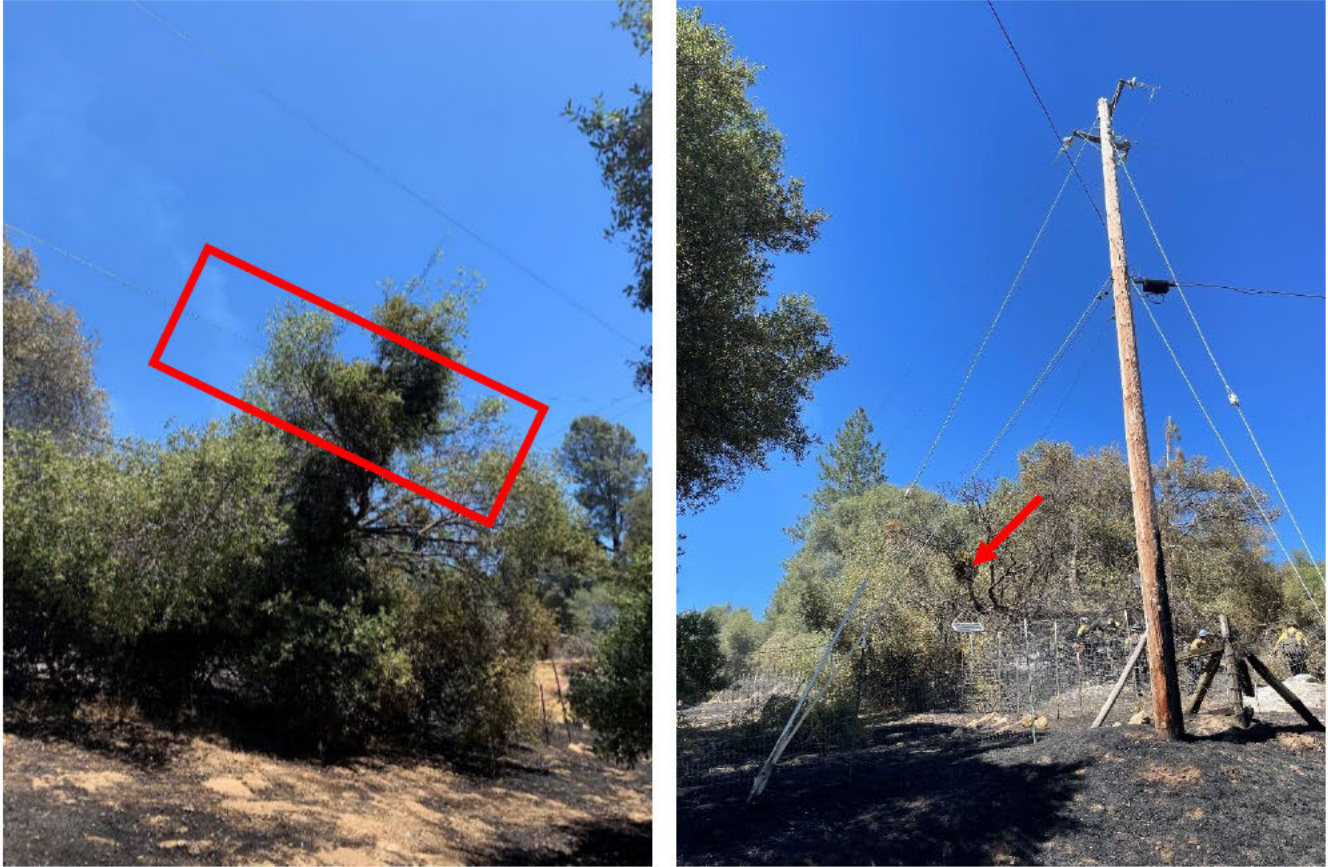
At 1402 hours, Troubleshooter #1 arrived at the Incident Span. The Incident Tree did not appear to bridge the two phases, and the restoration supervisor and two troubleshooters used a pole saw, hot stick, and rubber gloves to remove the tree from the line. By 1450 hours the PG&E restoration personnel on site had removed the Incident Tree from the line. Troubleshooter #1 did not observe any conductor damage after the tree was removed, and, as such, did not make any repairs nor issue any electric corrective (EC) notifications and informed DCC the Incident Span was safe to re-energize (see Figure 2).⁶ At 1505 hours, DCC closed SW 52195, re-energizing 685 customers.

⁶ In the right photograph of Figure 2, first responders appear to be working near the tree after it was removed.

The Apple Hill 2102 21kV circuit was EPSS-enabled at the Incident Location at the time of the incident, and PG&E's Distribution Protection Engineering team determined that contact between the tree and the east phase caused a high impedance fault condition that was not sufficient to cause upstream devices to trip.

Figure 2. Photograph taken at approximately 1340 hours depicting the Incident Tree branch in contact with the east phase (left, indicated, looking east), and photograph taken at approximately 1505 hours after the Incident Tree (right, looking north) had been removed by the troubleshooter.

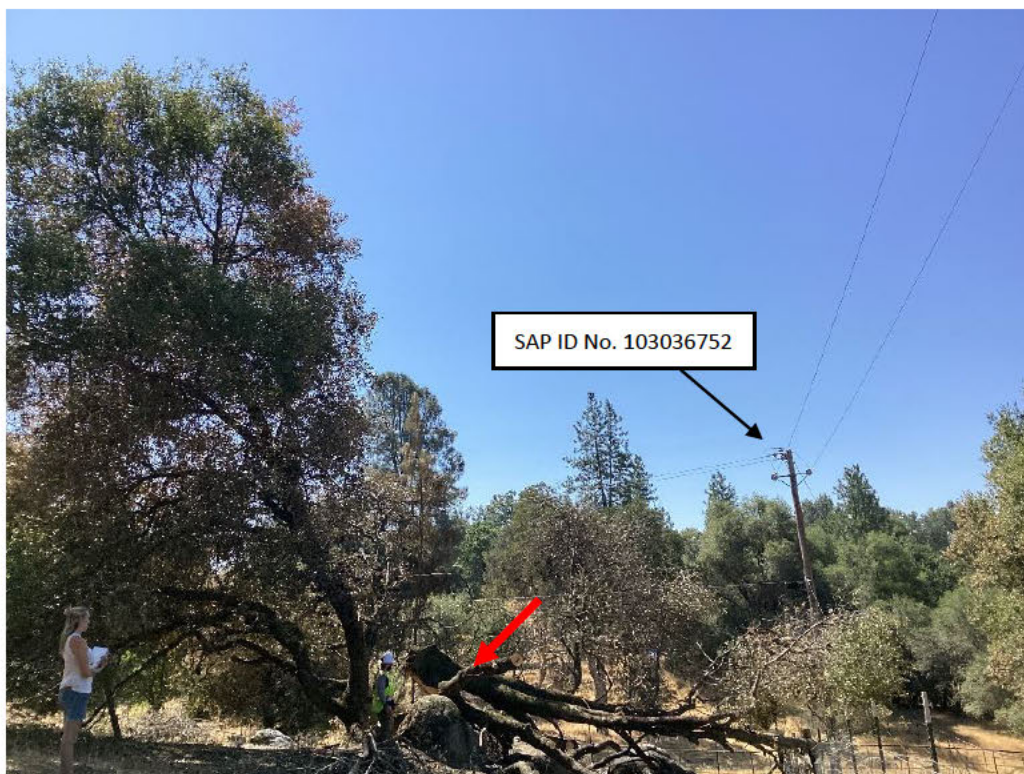
On July 30, 2024, the PG&E Vegetation Management (VM) visited the Incident Location (Figure 4), evaluated the Incident Tree, and performed an Extent of Condition assessment of trees in the general vicinity of the Incident Location. VM identified the Incident Tree as a Live Oak and determined it was last inspected on March 13, 2024

and last worked on March 9, 2021 when side pruning was performed. The tree contact location was more than ten feet from the nearest pole (SAP ID No. 103036752), and that pole was not subject to PRC 4292 pole clearing requirements.⁷ VM observed that the tree had multiple stems, and that bark inclusions observed at the break point (Figure 5) likely contributed to the observed splitting at the base of one stem. VM also reported that the Incident Tree had no external indications of damage that would have motivated prior VM inspectors to identify it for removal. The VM Extent of Conditions patrol identified five additional Live Oak trees near the Incident Span that were damaged by heat and fire exposure, four of which were identified for removal, and one of which was identified for radial pruning.

Figure 4. VM photograph of the Incident Tree (indicated, red arrow) relative to the circuit, taken on July 30, 2024, looking south.

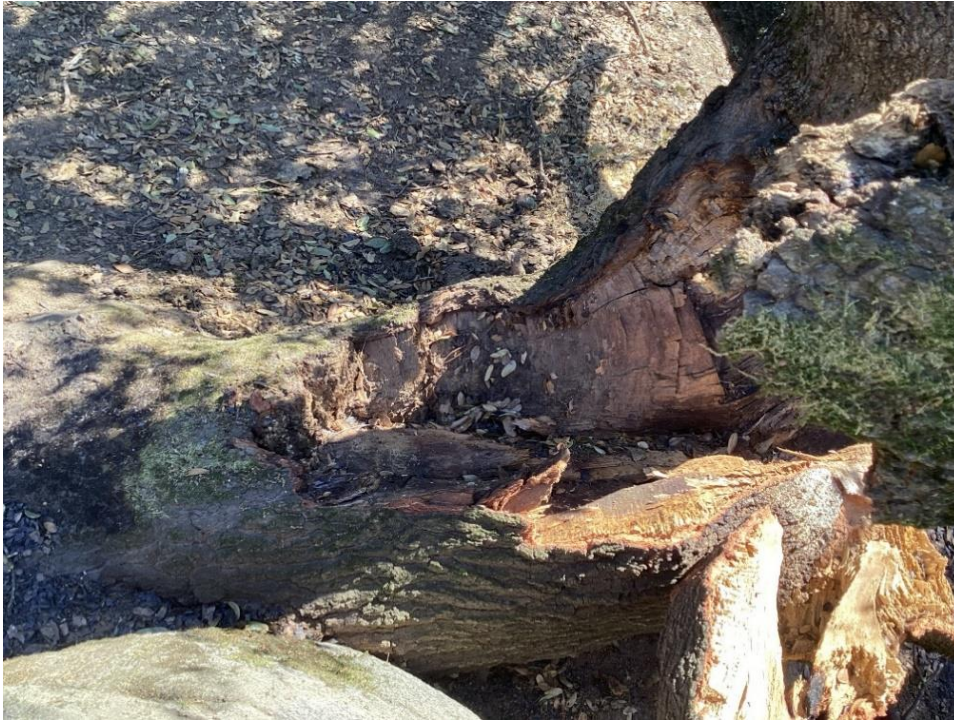
Figure 5. VM photograph of bark inclusions at the split stem.
