Preliminary Ignition Investigation Report

| Incident Name: | Hubbard – 26 Jul 2024 |
| Circuit: | Burns 2101 |

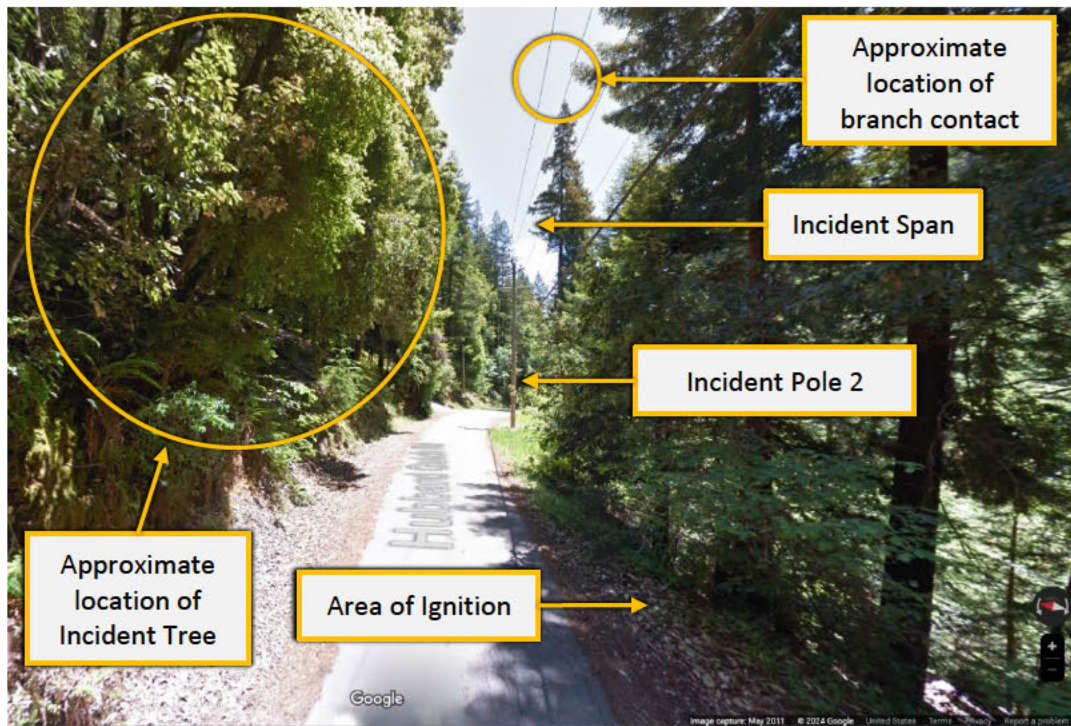
Figure 2. Publicly available image of the Incident Span, Incident Pole 2, Area of Ignition, approximate location of branch contact, and approximate location of Incident Tree before the Incident (eastbound, photo from May 2011, provided by Google Street View, accessed September 13, 2024).

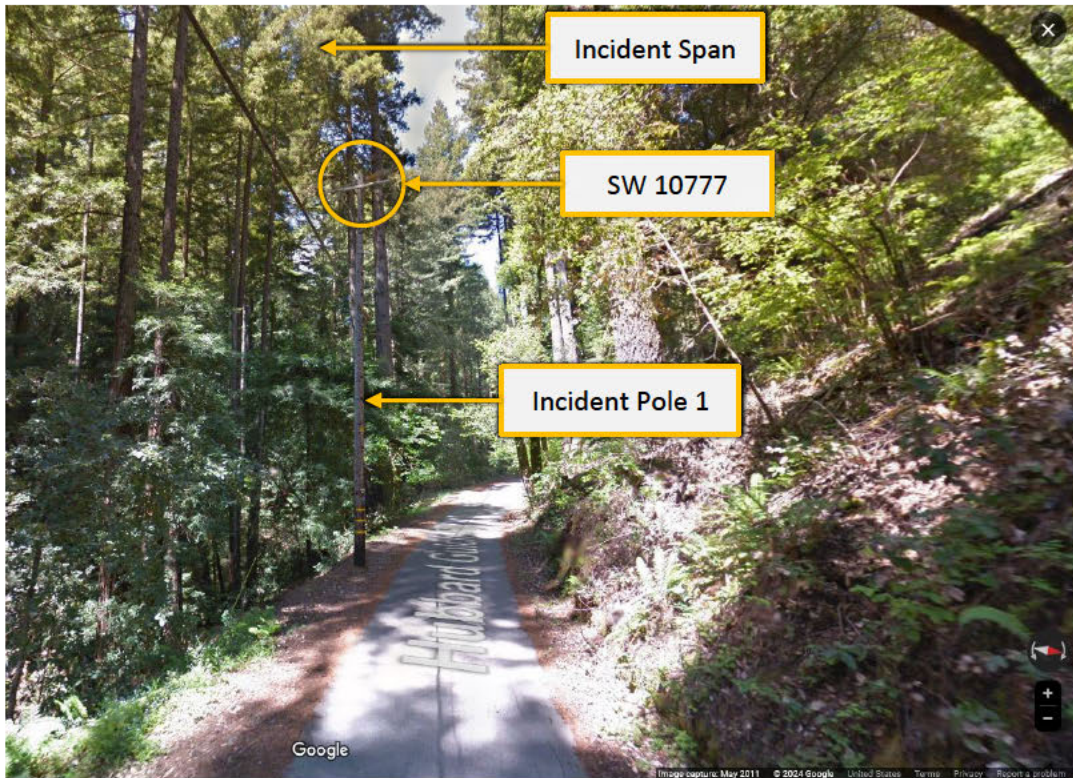
Figure 3. Publicly available image of the Incident Span, Incident Pole 1, and Switch 10777 (westbound, photo from May 2011, provided by Google Street View, accessed September 13, 2024).

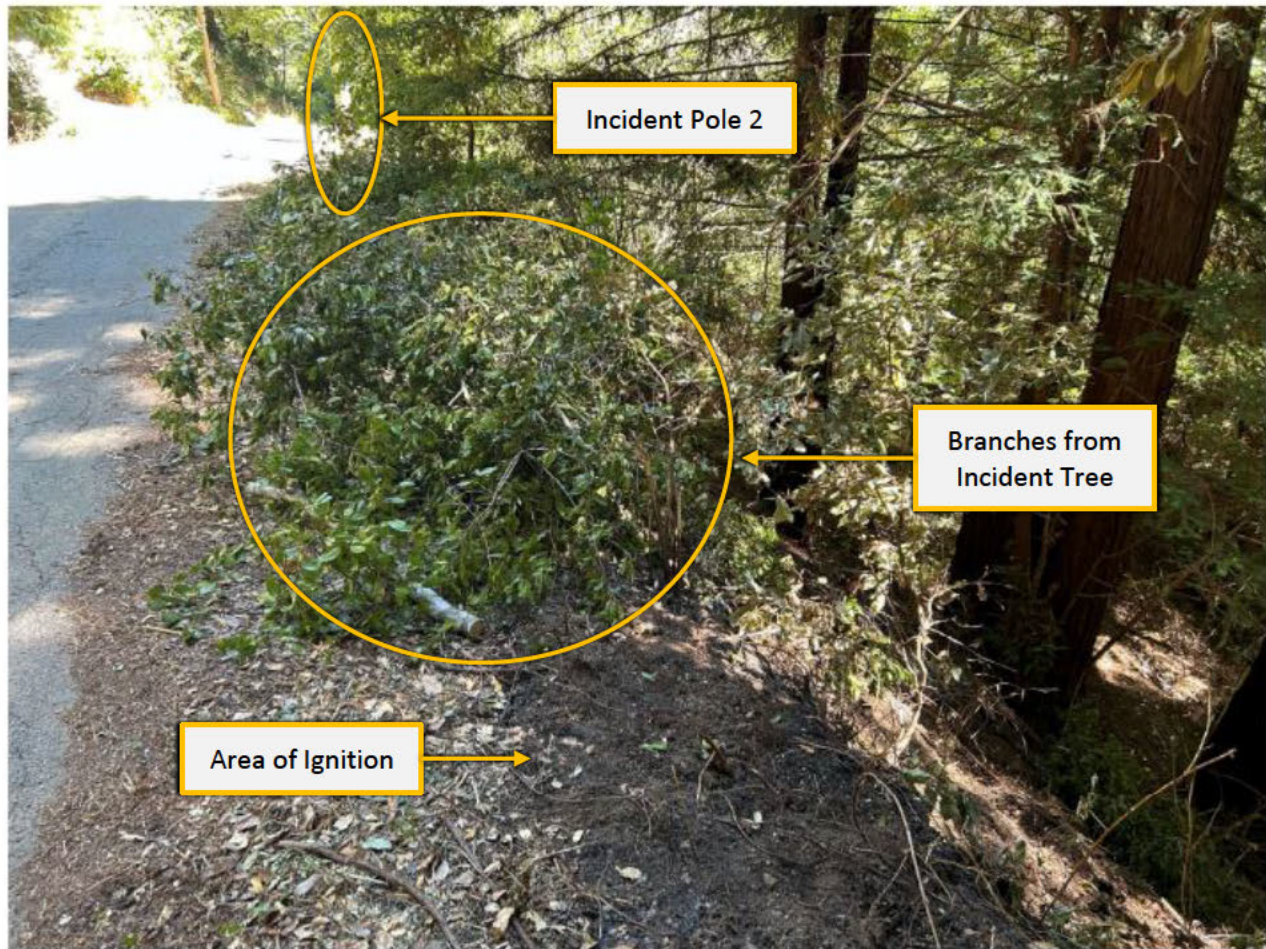
Prior to the incident, on July 15, 2024, Vegetation Management (“VM”) identified the Incident Tree as non-compliant during an annual inspection, and prescribed for complete removal with priority P2.⁴ Inspection crews noted that the Incident Tree was within the minimum distance requirement to the conductors, and posed a fall-in risk due to “unusual tree architecture.”⁵ The prescribed work was pending at the time of the Incident, and not required to be completed until August 4, 2024. A post incident review confirmed the inspection crew prioritized prescribed work in conformance with TD-7102P-01. The tree was removed by a PG&E crew on July 27, 2024. On July 29, 2024, VM patrolled the Incident Location and observed the remains of the Incident Tree but were unable to determine the failure mode (Figure 6).⁶

Figure 6. Vegetation Management Incident Report. Photo shows the edge of the area of ignition and a portion of tree canopy from the Incident Tree (eastbound, taken July 29, 2024).

One EC Notification was created in response to this incident for the removal of the Incident Tree.

| Type | Number | Description | Priority | Date Identified | Due Date |
|---|---|---|---|---|---|
| EC Notification | 129297897 | Remove tree over conductor. | A | Jul 26, 2024 | Jul 27, 2024 |
