Preliminary Ignition Investigation Report

Ignition Database Index:	20241048
Electric Incident Investigation (EII) Number:	N/A
Incident Name:	Spruce
PG&E Facility Ignition?	Yes
CPUC Reportable Ignition?	Yes
Date & Time of Incident:	July 29, 2024 at approximately 1149 hours
Street Address:	Near [REDACTED]
City:	Meadow Vista
County:	Placer
Latitude/Longitude:	[REDACTED]
State Responsibility Area (SRA) / Local Responsibility Area (LRA) / Federal Responsibility Area (FRA)	SRA
PG&E Division:	North Valley
High Fire Threat District (HFTD):	Tier 2
High Fire Risk Area (HFRA):	Yes
EPSS Buffer:	No
Fire Index Area (FIA):	340
Fire Potential Index (FPI) Rating: FIA	R5
Fire Potential Index (FPI) Rating: Circuit	R4
Was there a PSPS event at the time of ignition?	No
Suspected Initiating Event:	Contact – 3 rd Party
Failure Driver:	Contact from Object
Failure Sub-driver:	Com-Line Strike
Circuit:	Weimar 1102, 15249-1102
Circuit Protection Zone:	Weimar 1102 LR 2038
Nominal Voltage:	12kV

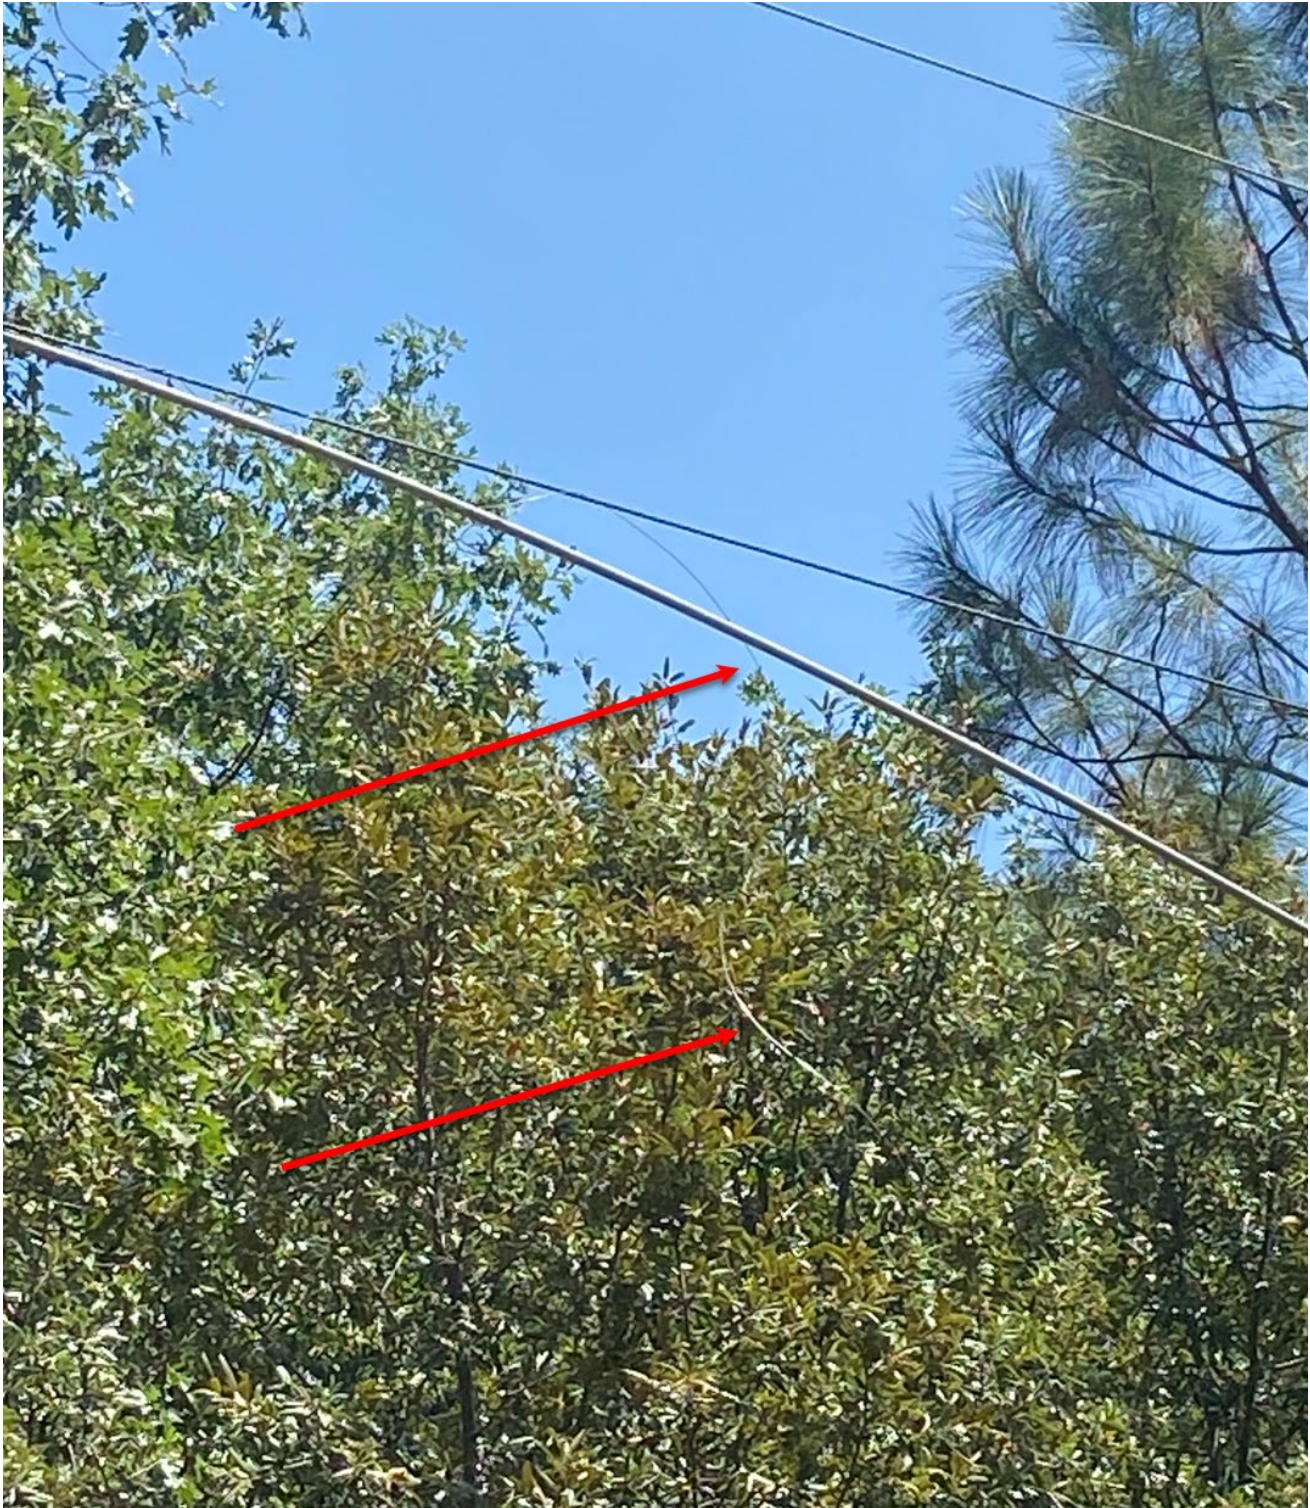
Initial analysis indicates that an unknown third-party vehicle (potentially a box delivery truck)¹ drove under the communication line near Spruce Drive, hooked and forcefully brought down the phone cables. The resulting broken tie wires from the phone cables (see Figure 2 and 3) was sent upward into the primary conductors and started an arcing event that sparked and ignited a fire on the ground below. The fire burned approximately 20 x 30-feet (see Figure 4) and was extinguished by the Colfax Fire Department prior to the arrival of the troubleshooters.

Figure 2 – View of broken tie wire on the phone cables on July 29, 2024. Photo taken by the troubleshooter.

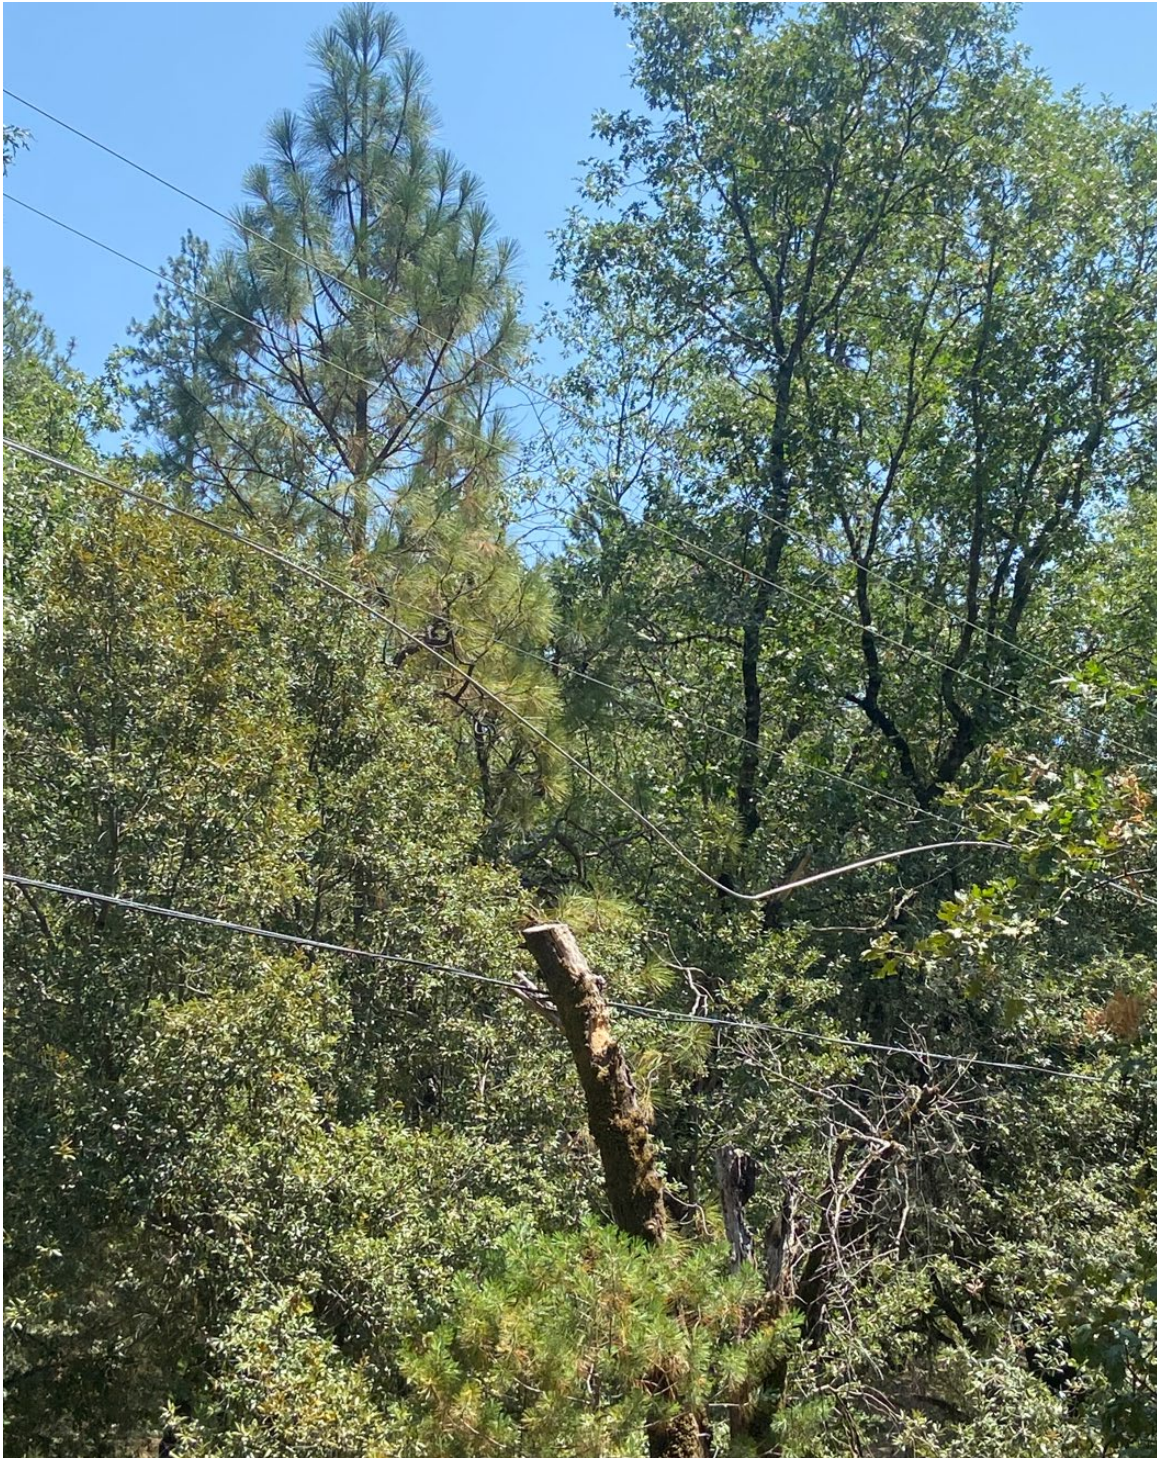
Figure 3 – Additional view of loose phone cable on July 29, 2024. Photo taken by the troubleshooter.

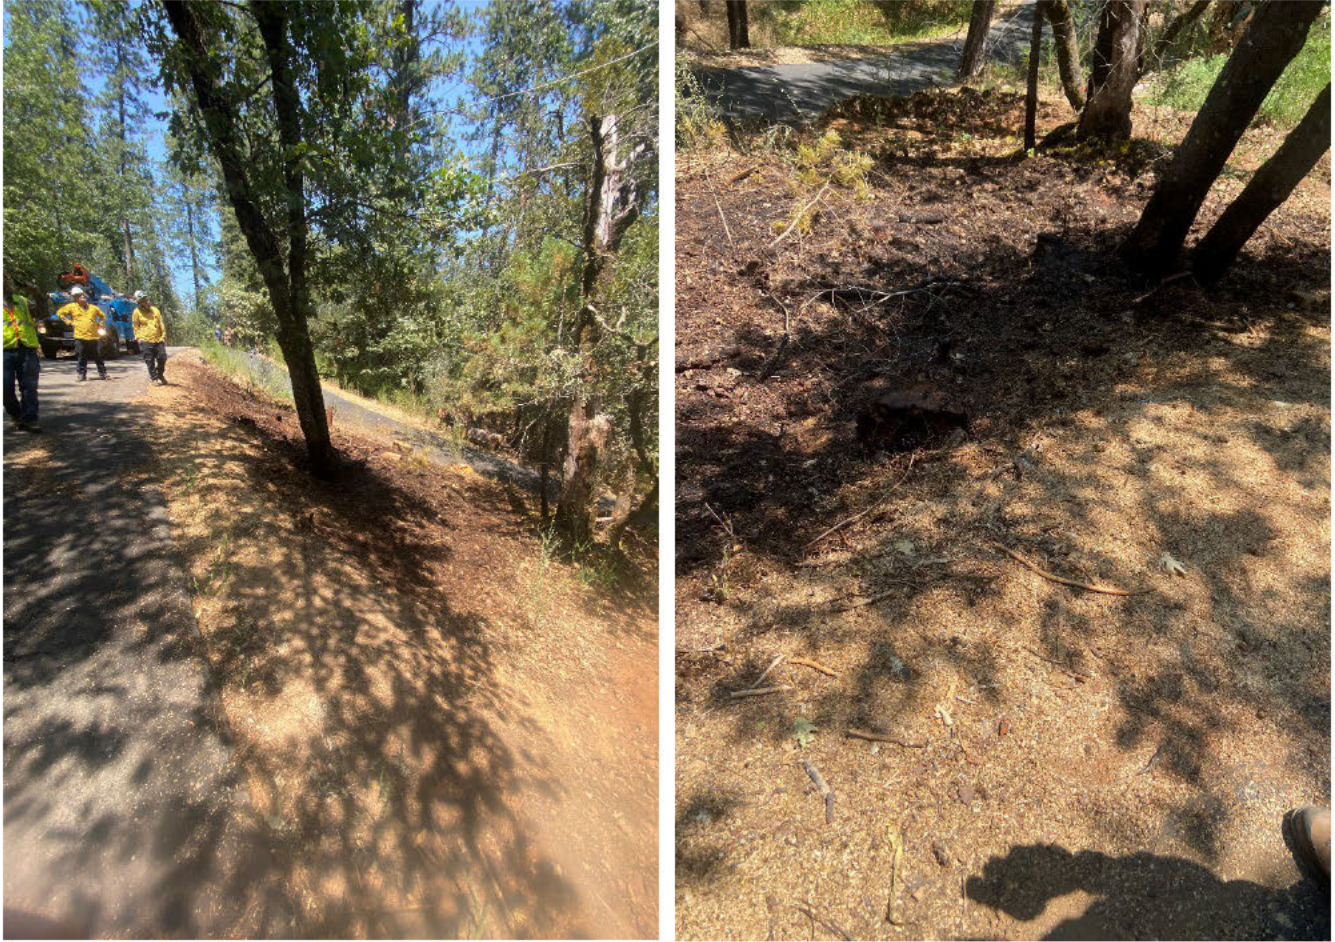
The ignition event on July 29, 2024 resulted in a small fire measuring approximately 20 x 30-feet in size and was extinguished by the Colfax Fire Department. A total of 292 customers were de-energized for a total of 114 minutes. There were no reported injuries, fatalities, property damages or significant media attention associated to this event.

Figure 4 – View of the fire footprint on July 29, 2024. Photos taken by the troubleshooter.

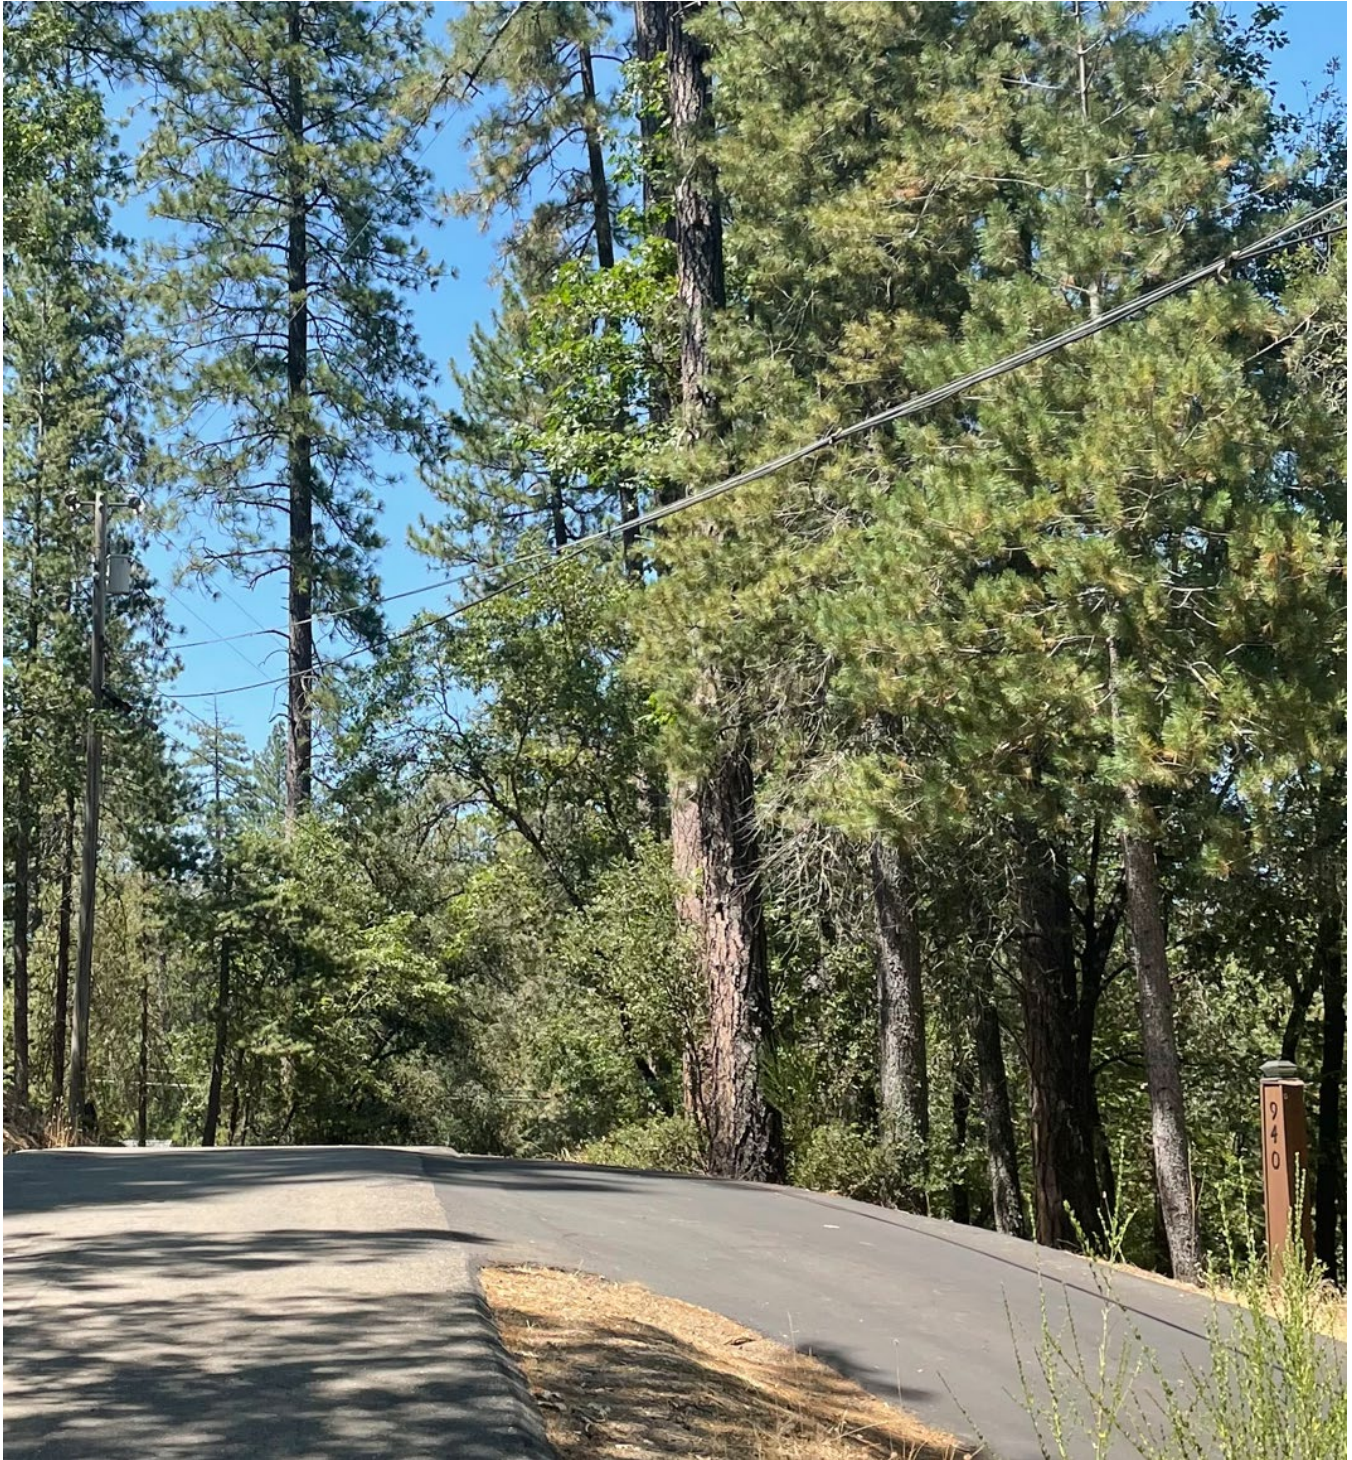
Figure 5 – Post-incident view of the incident span on July 30, 2024. Photo taken by Ignitions Investigator.

No corrective notifications were required after this ignition event. However, PG&E crew was on scene and were able to create greater clearance by re-sagging the primary conductor (see Figure 5).

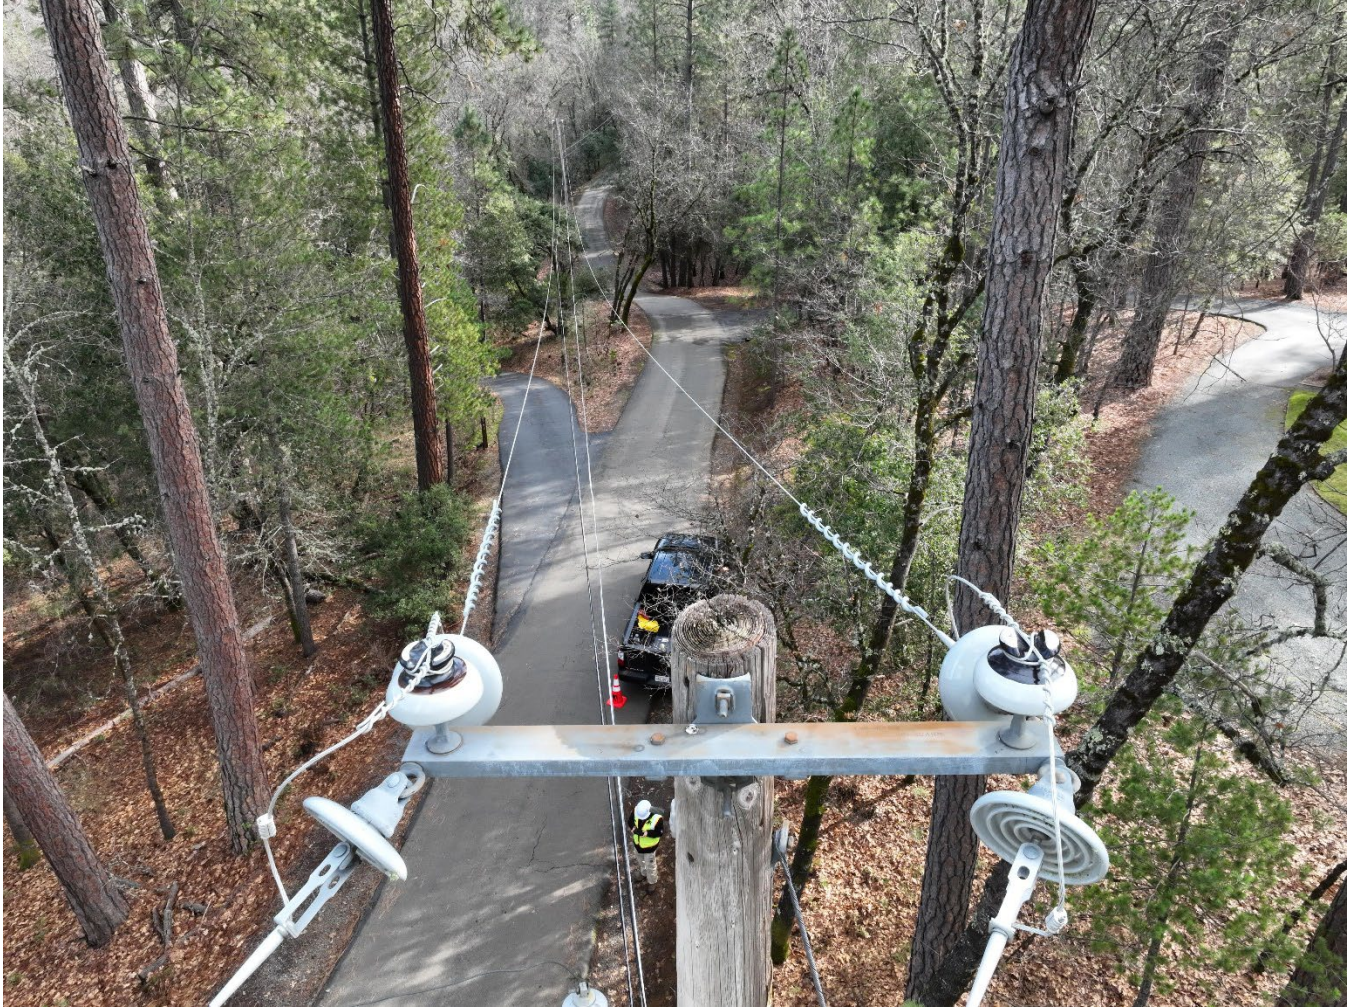
Figure 6 – Pre-incident aerial view of incident span on January 19, 2024. Photo taken from iHawk.

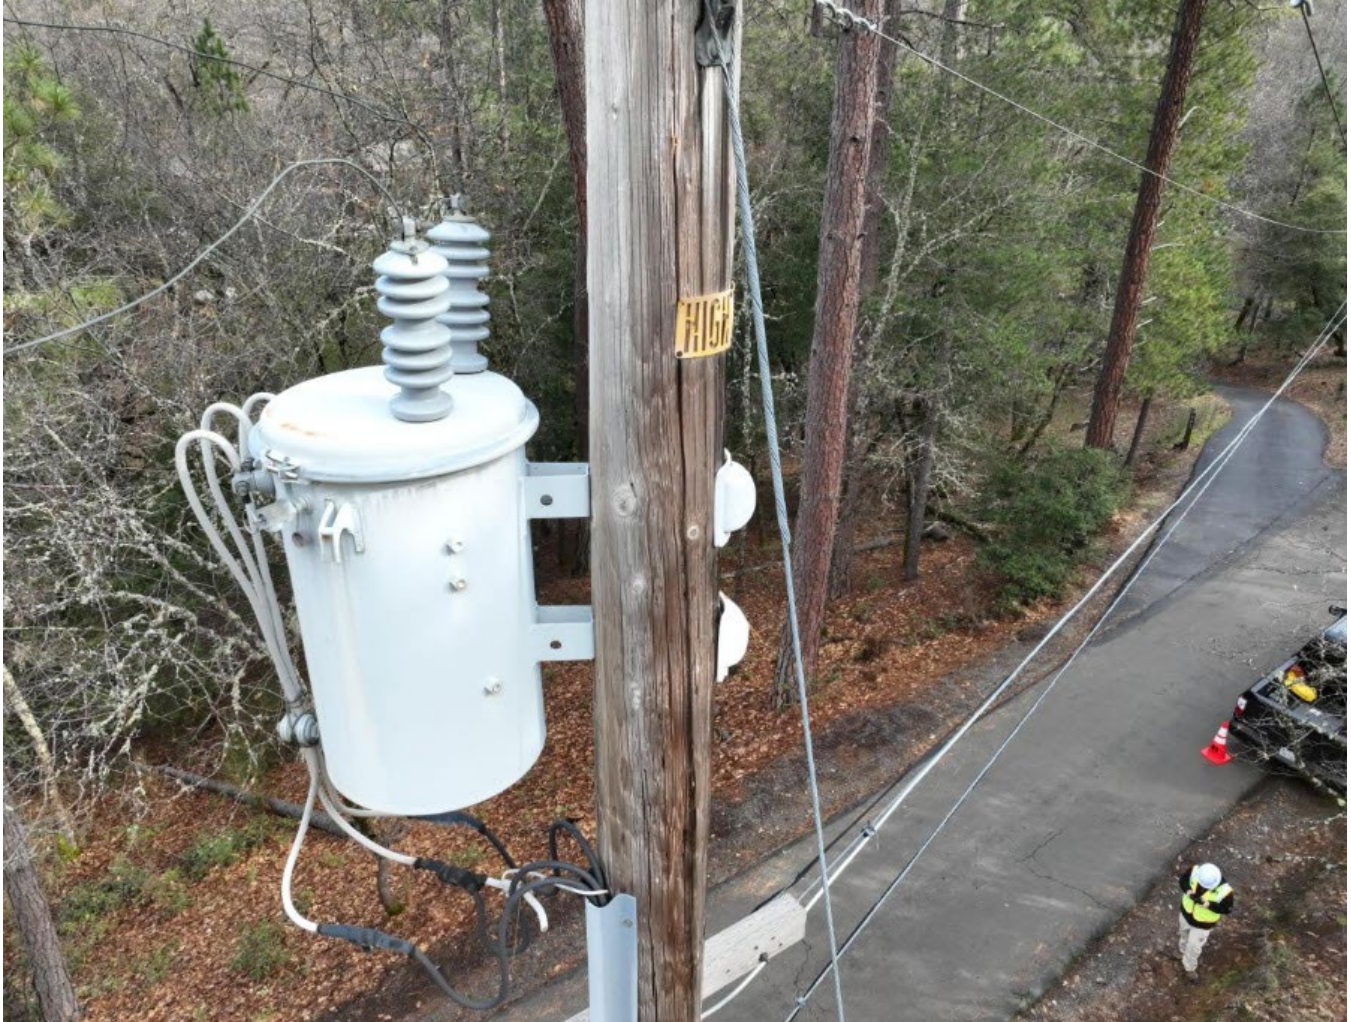
Figure 7 – Additional pre-incident view of phone cables and incident span on January 19, 2024. Photo taken from iHawk.
