## Preliminary Ignition Investigation Report

<b>Ignition Database Index:</b>	20241101
<b>Electric Incident Investigation (EII) Number:</b>	N/A
<b>Incident Name:</b>	Dalewood
<b>PG&amp;E Facility Ignition?</b>	Yes
<b>CPUC Reportable Ignition?</b>	Yes
<b>Date &amp; Time of Incident:</b>	August 7, 2024 at 1415 hours
<b>Street Address:</b>	10014 Dalewood Way
<b>City:</b>	Grass Valley
<b>County:</b>	Nevada
<b>Latitude/Longitude:</b>	39.15184, -121.06801
<b>State Responsibility Area (SRA) / Local Responsibility Area (LRA) / Federal Responsibility Area (FRA)</b>	State Responsibility Area (SRA)
<b>PG&amp;E Division:</b>	Sierra
<b>High Fire Threat District (HFTD):</b>	Tier 2
<b>High Fire Risk Area (HFRA):</b>	Yes
<b>EPSS Buffer:</b>	No
<b>Fire Index Area (FIA):</b>	330
<b>Fire Potential Index (FPI) Rating: FIA</b>	R5
<b>Fire Potential Index (FPI) Rating: Circuit</b>	R5
<b>Was there a PSPS event at the time of ignition?</b>	No
<b>Suspected Initiating Event:</b>	Vegetation

<b>Failure Driver:</b>	Contact from Object
<b>Failure Sub-driver:</b>	Contact – Vegetation
<b>Circuit:</b>	Higgins 1103
<b>Circuit Protection Zone:</b>	Higgins 1103-32120
<b>Nominal Voltage:</b>	12kV
<b>Pole SAP Equipment

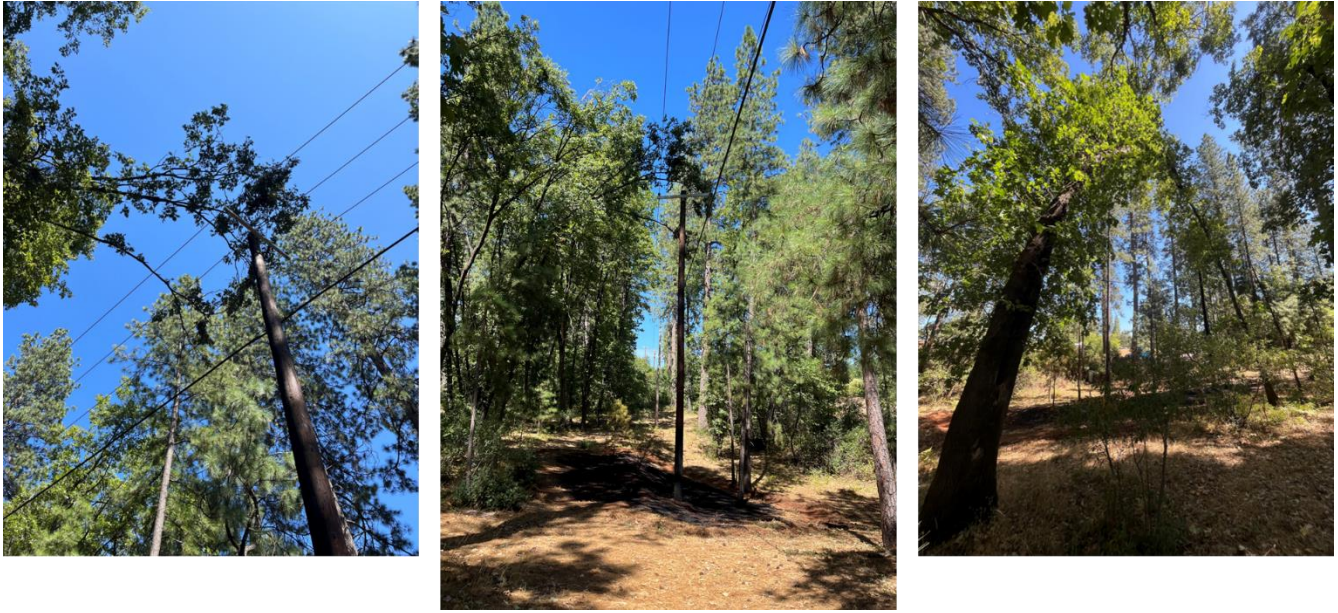
On August 7 at approximately 1410 hours, CAL FIRE reported a fire under a power line to PG&E Dispatch at 10014 Dalewood Way in Grass Valley in Nevada County ("Ignition Location"). PG&E dispatched a troubleshooter (Troubleshooter #1) to the Ignition Location at 1415 hours and a second troubleshooter (Troubleshooter #2) at 1428 hours. At 1430 hours, the Troubleshooter #2 arrived at the Ignition Location and reported a tree was on the line and a pole was on fire. Troubleshooter #2 asked the Distribution Control Center ("DCC") to open Line Recloser (LR) 32120 to de-energize the Incident Location. Between 1422 hours and 1514 hours, Troubleshooters #1 and #2 worked with DCC to isolate the Ignition Location and restore power to customers. At 1541 hours, Troubleshooter #2 cut the tree off of the line and confirmed that the pole was structurally sound and that there was no observable damage to the conductors (see Figure 2). Troubleshooters #1 and #2 then restored the circuit to normal by 1630 hours.

- 1541 hours: Troubleshooter #1 cut tree back from conductors, reported that the pole was not structurally damaged, and observed no damage to conductors.

Figure 2. Incident photos, taken August 7, 2024.

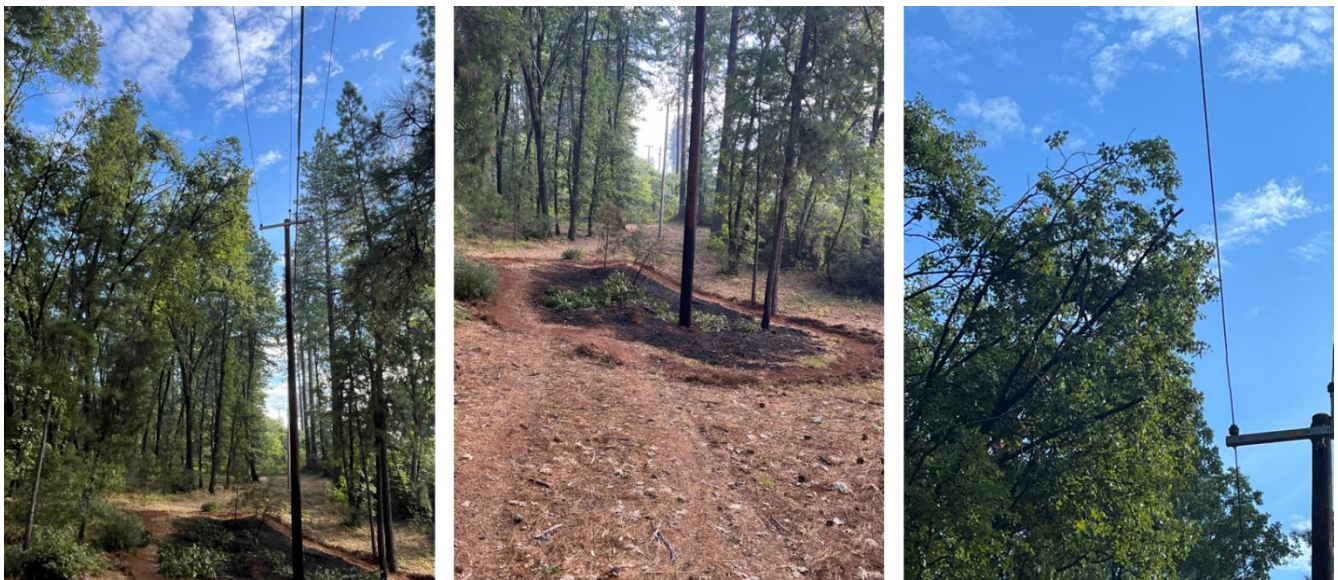
Vegetation Management ("VM") conducted a post-incident investigation and extent of condition patrol on August 8, 2024 (see Figure 3). The VM investigator concluded that the limbs of a 26-inch Diameter at Breast Height (DBH) black oak came into contact with the primary conductors, causing a small grass fire. The tree was described as in overall good health with no signs of rot or defects. Since Troubleshooter #2 had cut the tree back from the conductors at the time of restoration, the VM investigator could not determine the tree/branch-to-line clearance prior to the incident.

Figure 3. Photos from VM Post-Incident Investigation, taken August 8, 2024.

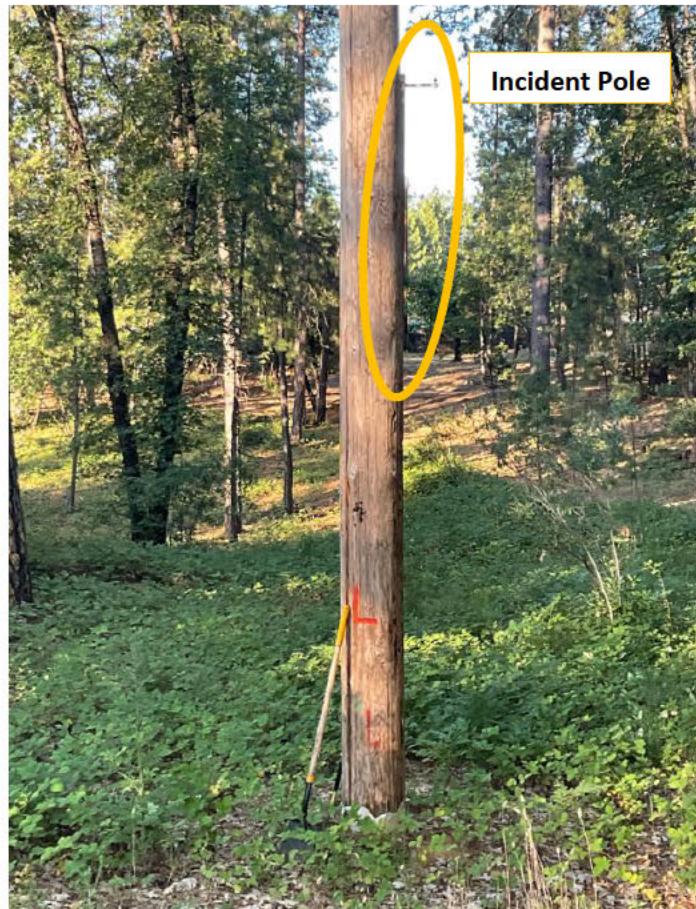
Figure 4. Photo of most recent inspection from adjacent pole (SAP ID 100067400) on July 9, 2023. Incident pole can be observed in background.

- Request for Work (RW) 129357958 was submitted and completed on August 9, 2024, to resolve the unmapped pole.
- CAP 129359337 was created to ensure the unmapped pole (SAP ID 104219586) is added to an inspection cycle and to research the reason that the pole was not mapped upon its installation in 2022.
