Preliminary Ignition Investigation Report

| Incident Name: | Camino |
| Circuit: | Monte Rio 1113, 04281-1113 |

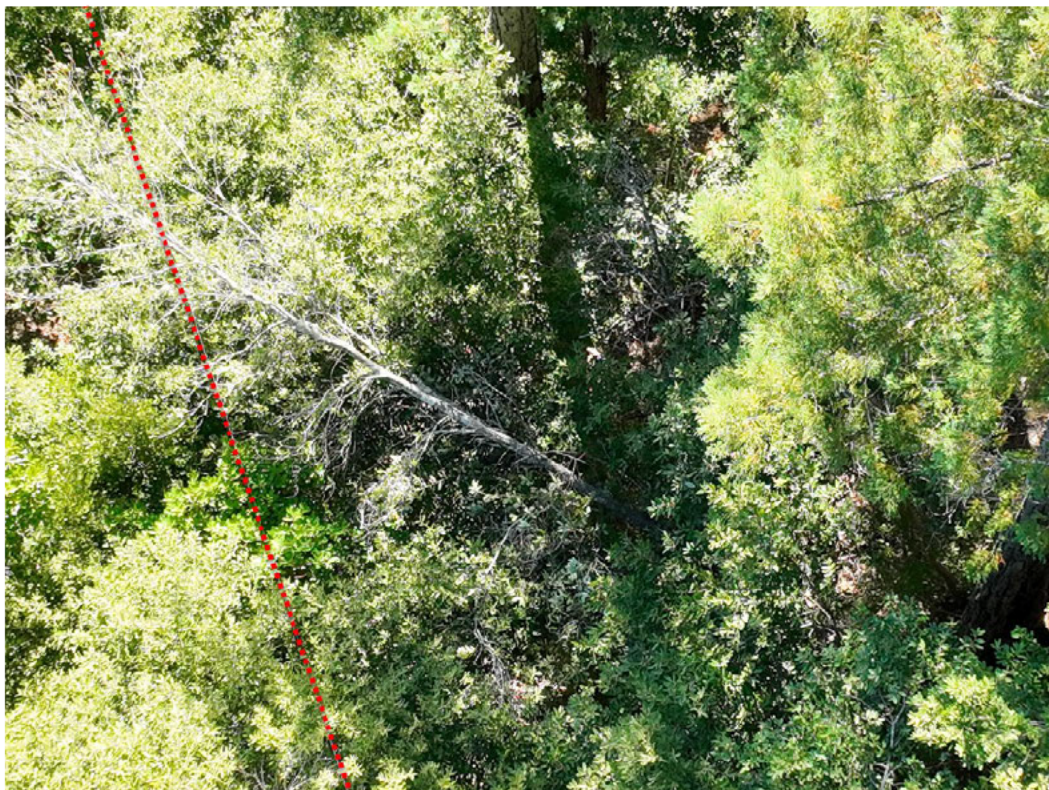
Figure 2 – Incident tree laying across primary line on August 16, 2024 taken via drone. Photo taken by the troubleshooter.

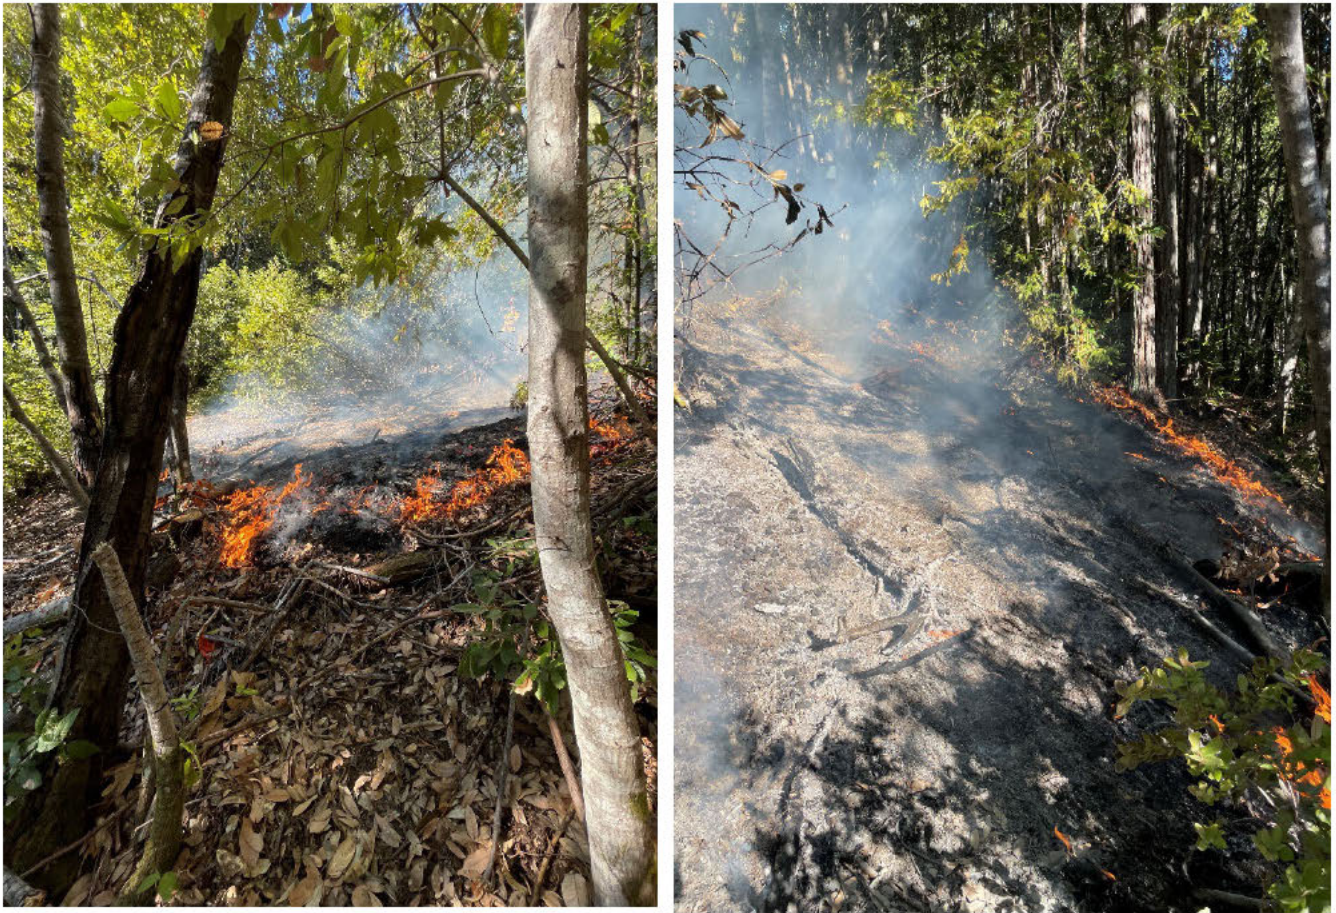
Figure 3 – Actively burning fire at Incident Location on August 16, 2024. Photos taken by the troubleshooter.

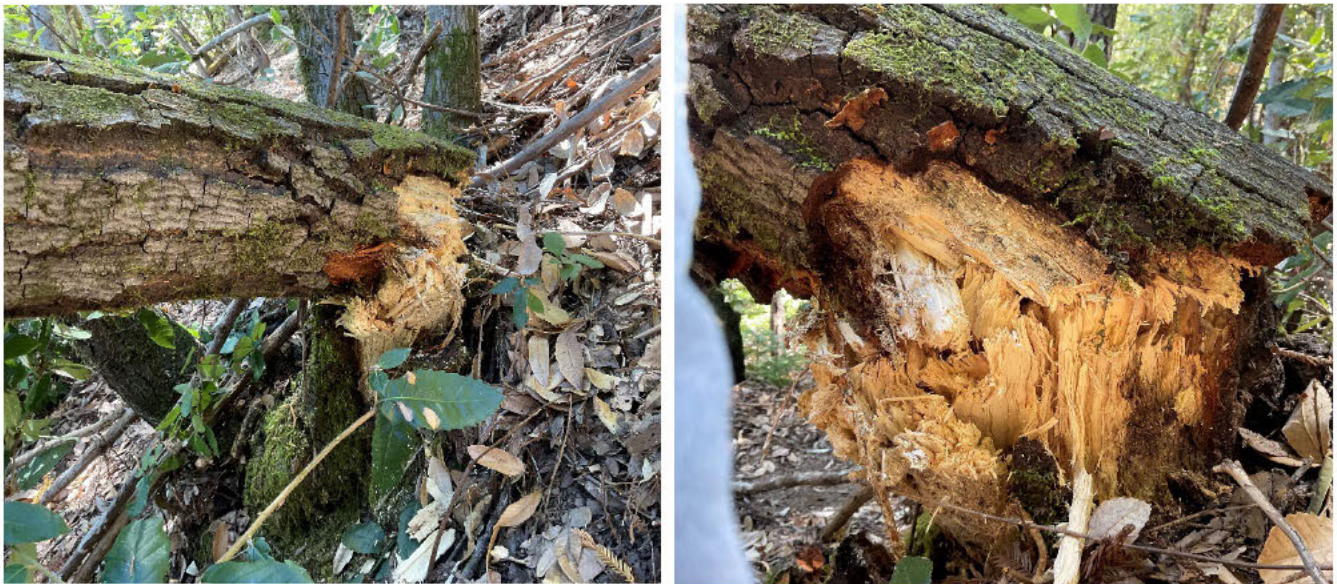
The Vegetation Management (VM) team conducted a post-incident investigation on August 16, 2024. The incident tree identified by the VM investigator is a 50-foot-tall tan oak with a nine-inch diameter at breast height (DBH) located approximately 40-feet from the conductor. The tan oak broke at the base of the tree and fell towards the primary conductors (see Figure 4) that resulted in a 50 x 30-foot fire. The VM investigator noted that the tree appeared alive but with slight thinning of the foliage. Further observation showed that the base of the tree exhibited significant decay at the failure point (see Figure 5) but there was no visible evidence of external decaying. The VM investigator also indicated that tiny fruiting body of hypoxylon¹ fungi was observed on the tree (see Figure 6) but was hidden and covered by moss.

Figure 5 – Base of incident tree with internal visible decay at the failure point on August 16, 2024. Photos taken by the VM team.

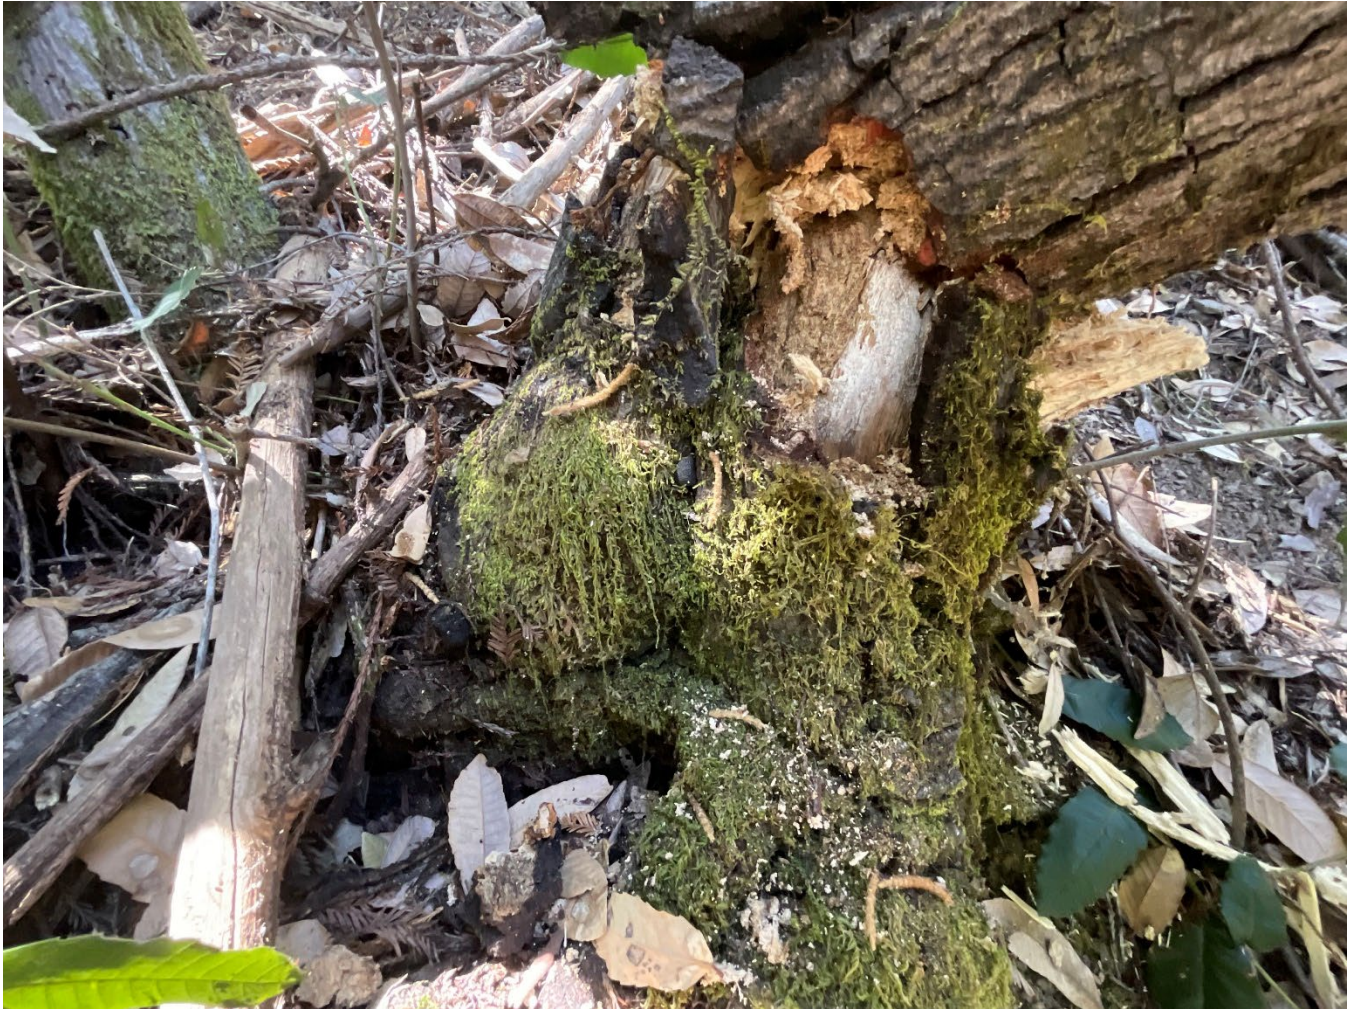
Figure 6 – Additional view of the base of the tree with other signs of decay that may have been covered by moss on August 16, 2024. Photo taken by the VM team.

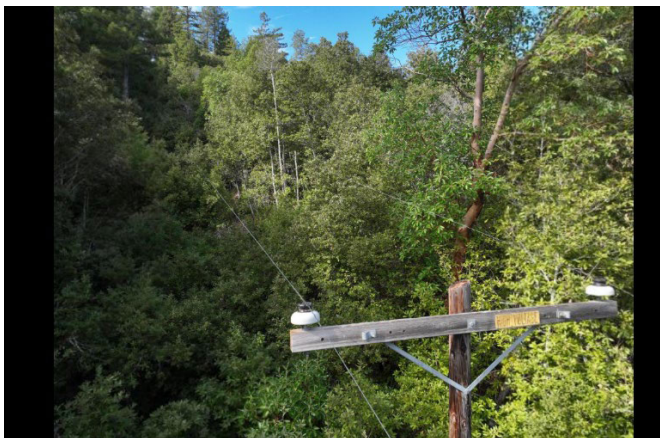
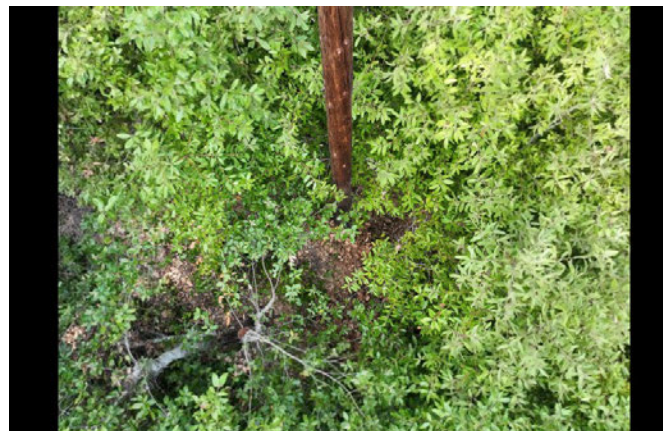
| Inspection: | July 26, 2022 | GO165 Inspection identified vegetation overgrowth. Noted pole wrapped at ground-line. Referred to pre-existing EC tag (#116756536). See “Pending Work” section above for details. |
| | November 4, 2023 | Aerial photos of Incident Pole in iHawk (see Figure 7). |

Figure 7 – Aerial view of Incident Pole (left) with surrounding vegetation at the base of the pole shown (right) on November 4, 2023. Photo taken by iHawk.
