Preliminary Ignition Investigation Report

Ignition Database Index:	20241158
Electric Incident Investigation (EII) Number:	N/A
Incident Name:	N/A
PG&E Facility Ignition?	Yes
CPUC Reportable Ignition?	Yes
Date & Time of Incident:	August 16, 2024, 1824 hours
Street Address:	[REDACTED]
City:	San Anselmo
County:	Marin
Latitude/Longitude:	[REDACTED]
State Responsibility Area (SRA) / Local Responsibility Area (LRA) / Federal Responsibility Area (FRA)	Local Responsibility Area
PG&E Division:	North Bay
High Fire Threat District (HFTD):	Tier 3
High Fire Risk Area (HFRA):	Yes
EPSS Buffer:	No
Fire Index Area (FIA):	190
Fire Potential Index (FPI) Rating: FIA	R4
Fire Potential Index (FPI) Rating: Circuit	R4
Was there a PSPS event at the time of ignition?	No
Suspected Initiating Event:	Equipment – PG&E
Failure Driver:	All types of equipment/facility failure
Failure Sub-driver:	Utility work/Improper construction
Circuit:	SAN RAFAEL 1108
Circuit Protection Zone:	SAN RAFAEL 1108322

Nominal Voltage:	750V – Secondary (Incident Location) 12kV – Primary
Pole SAP Equipment ID:	104121953
Subject to PRC 4292 Veg Pole Clearance:	No
PG&E Equipment associated with ignition:	Service Drop Conductor
EPSS enabl

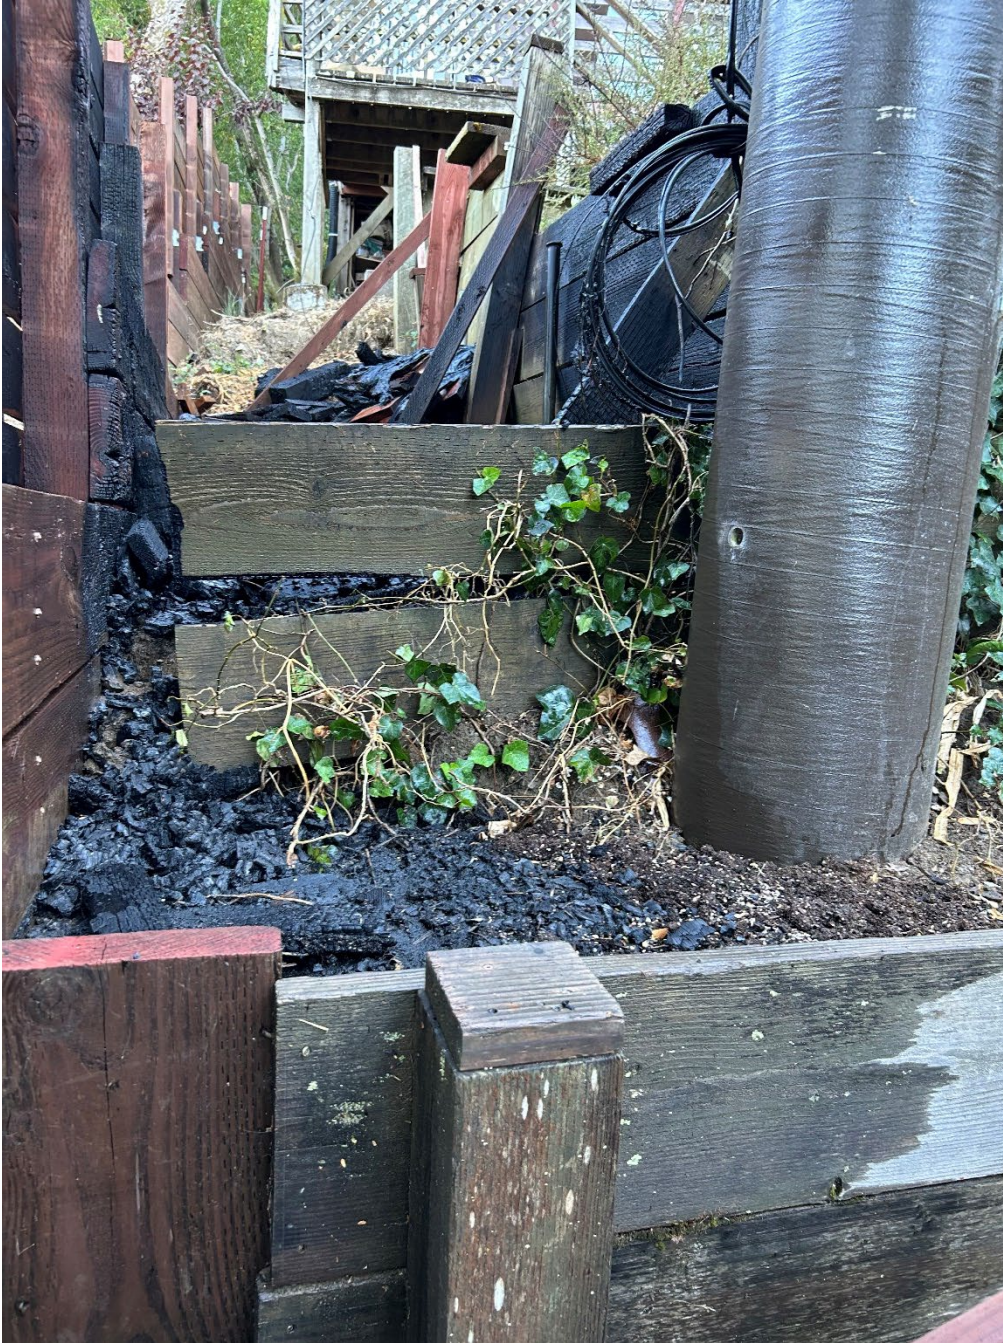
The ignition was isolated at the base of a intumescent wrapped wood pole, leaving a burn scar approximately one to three meters in size.

Figure 2 Burn scar at the base of pole. Photo taken by troubleshooter on August 16, 2024

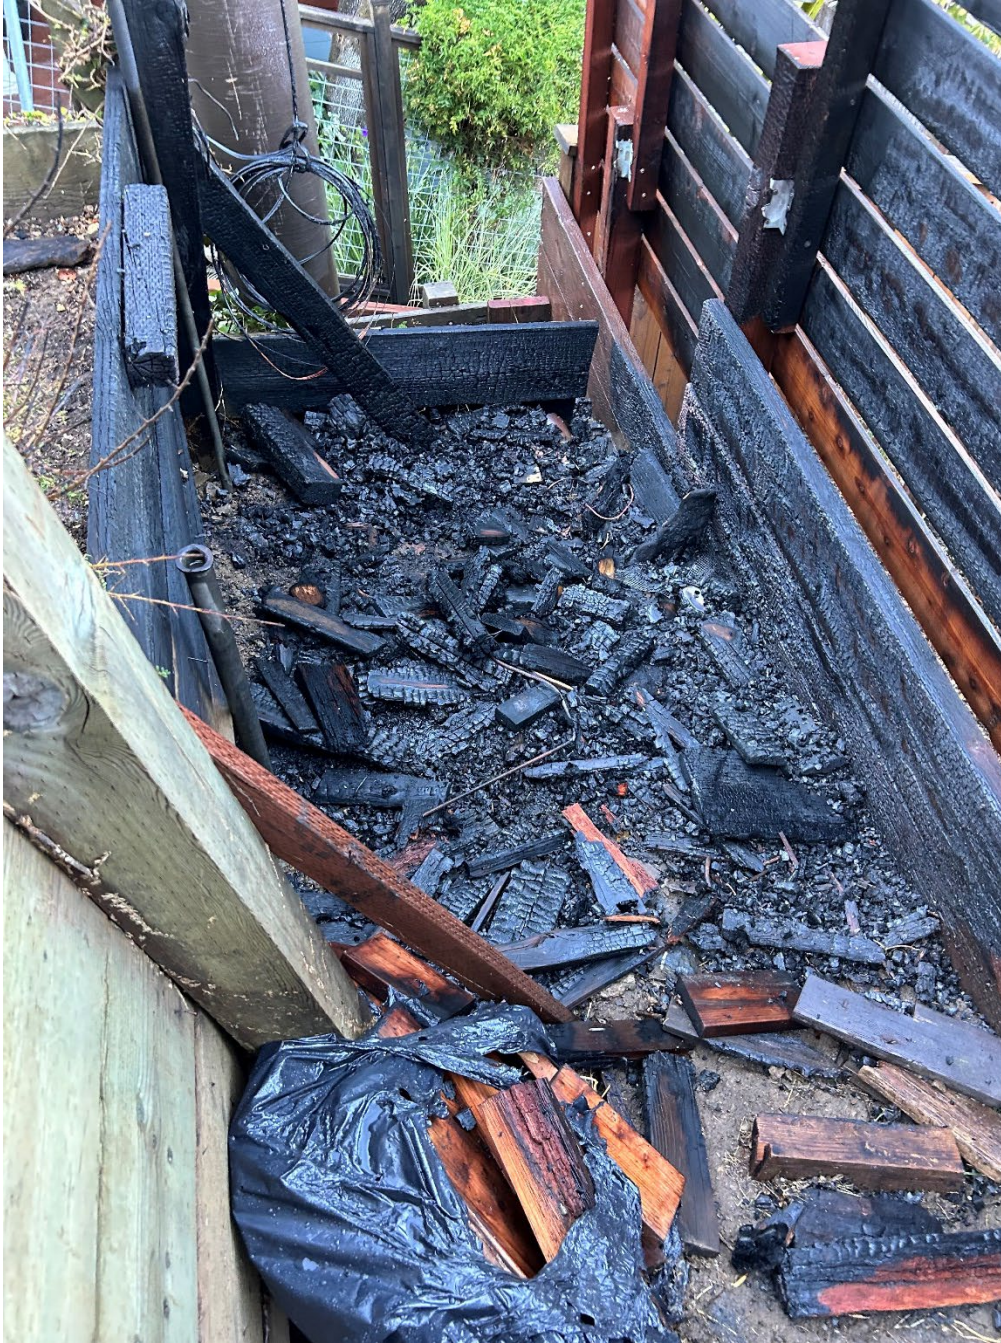
Figure 3 Property damage near the Incident Pole. Photo taken by troubleshooter on August 16, 2024.

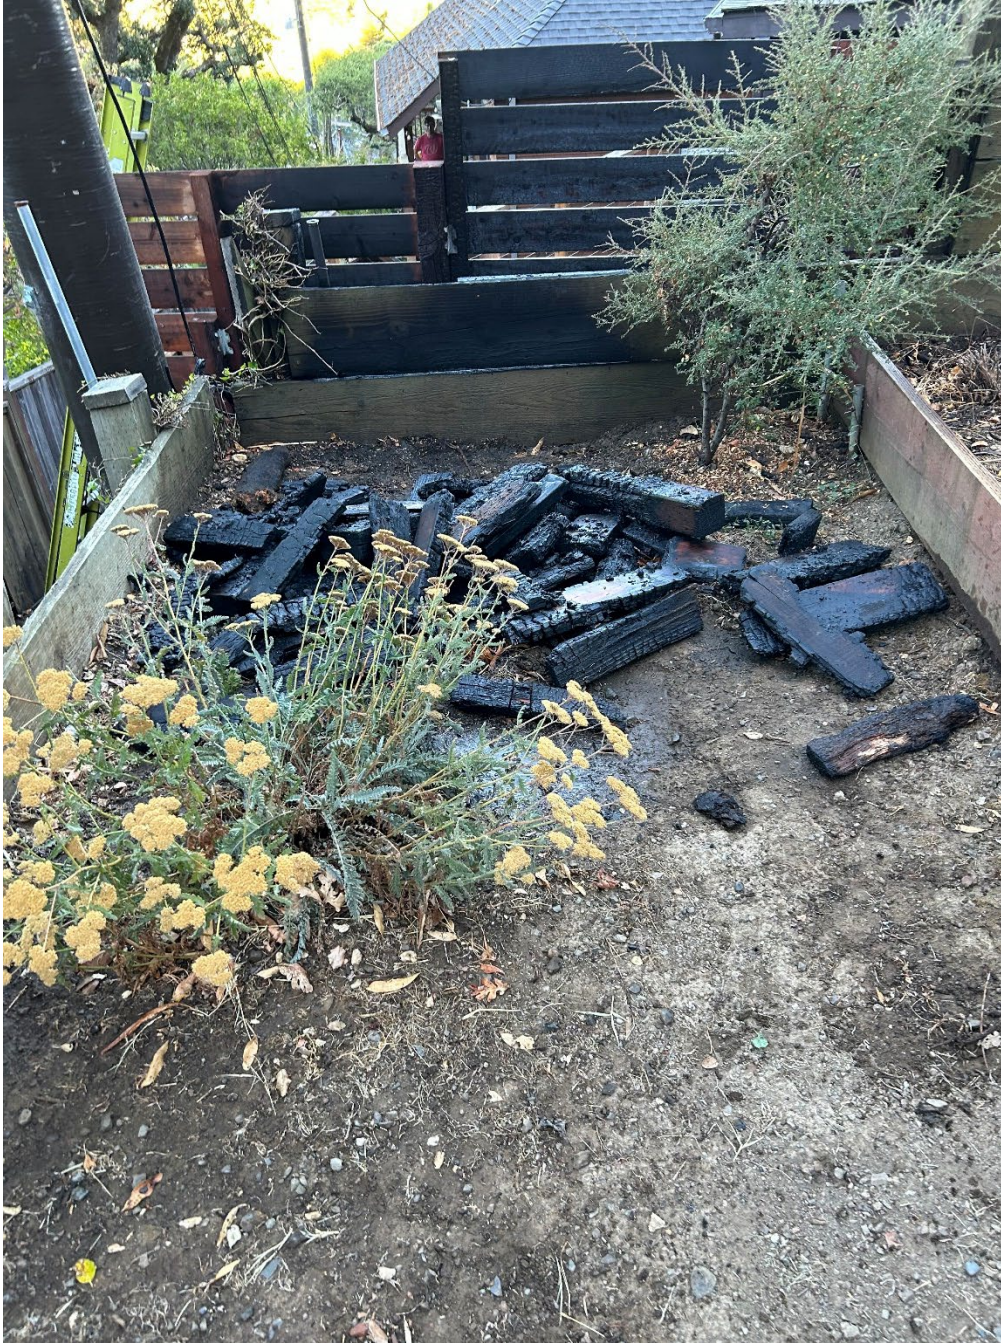
Figure 3 Property damage near the incident pole. Photo taken by troubleshooter on August 16, 2024

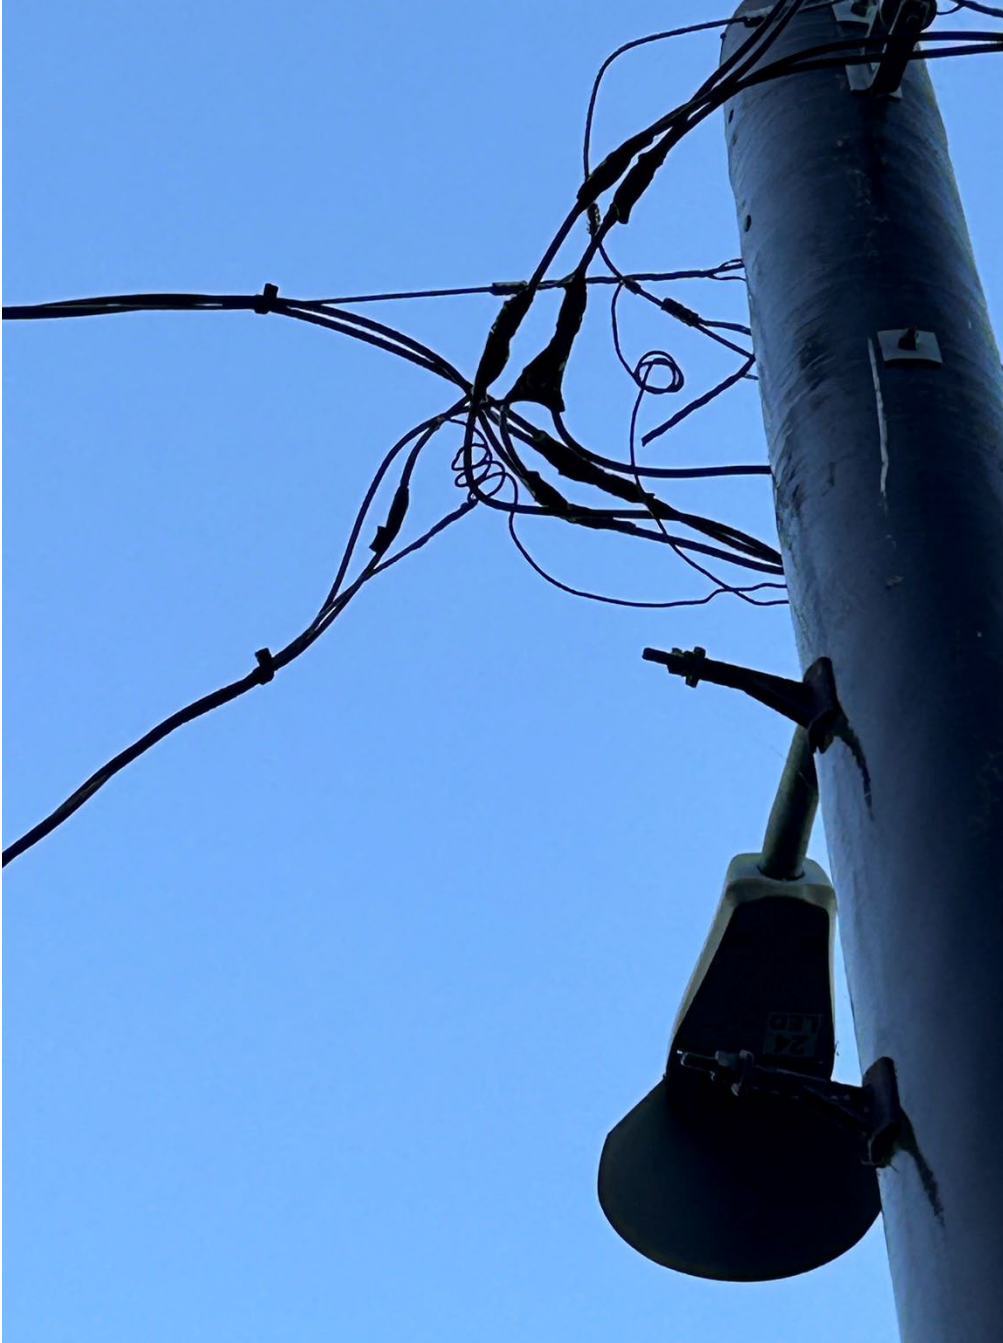
Upon arrival at 1840 hours, the responding troubleshooter observed multiple fire engines at the incident location clearing the vegetation fire. In addition, the troubleshooter observed the service neutral to the customer residence was broken due to a shorting to the hot leg at wood pole SAP ID 104121953. The troubleshooter assessed that the cause of the short circuit was due to the construction of the connectors being too close to the neutral, creating tension over time under the insulated secondary wire. The shorting hot leg created sparks, igniting the vegetation fire in the vicinity of the pole. The ensuing fire was between one and three meters in size, burning a pile of wood and a wooden fence near the pole. The estimated damages to the property were estimated as less than \$10,000 by the Fire Department. On August 17, 2024 at 0817 hours, PG&E dispatched a repair crew to make repairs to replace the secondary conductor, EC Notification 129400622.

The incident and failure were reviewed by an Asset Failure Analysis (AFA) engineer. AFA concluded that due to a lack of air gap between the impacted hot leg/conductor and neutral messenger, the two components rubbed

Figure 5 Damaged neutral and hot leg. Photo taken by troubleshooter on August 16, 2024

The responding troubleshooter created Corrective Notification EC 129400622 to replace the service neutral conductor and hot leg. Replacement of the conductor was completed on August 17, 2024.

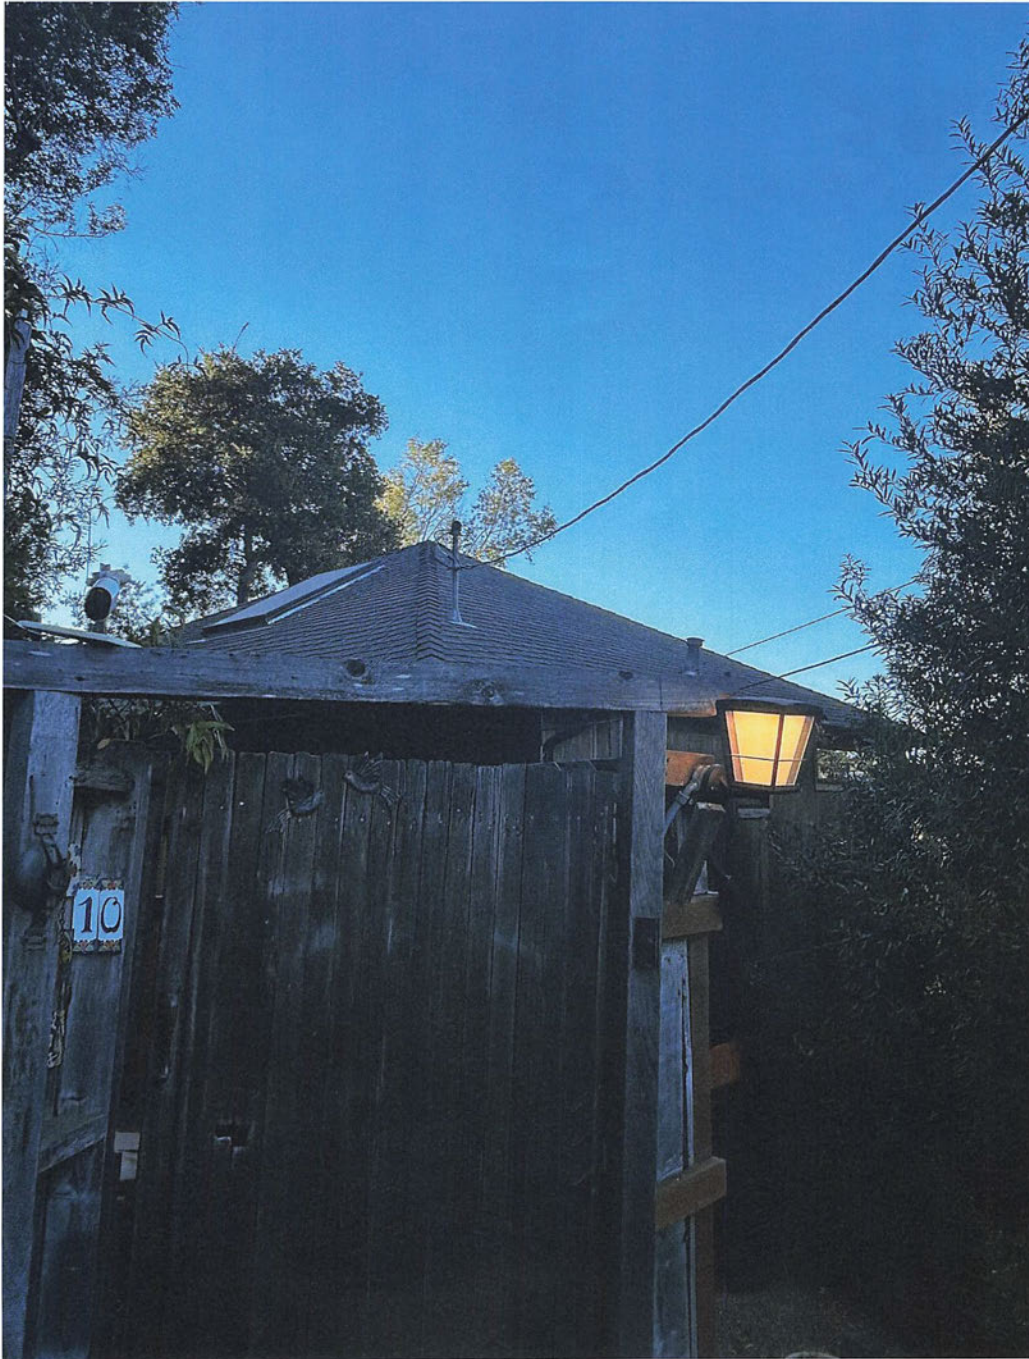
Figure 6 Service conductor from the residence. Photo taken by troubleshooter on August 16, 2024
