## Preliminary Ignition Investigation Report

Ignition Database Index:	20241219
Electric Incident Investigation (EII) Number:	N/A
Incident Name:	Tilton
PG&E Facility Ignition?	Yes
CPUC Reportable Ignition?	Yes
Date & Time of Incident:	August 25, 2024 at approximately 1617 hours
Street Address:	Near [REDACTED]
City:	Sebastopol
County:	Sonoma
Latitude/Longitude:	[REDACTED]
State Responsibility Area (SRA) / Local Responsibility Area (LRA) / Federal Responsibility Area (FRA)	SRA
PG&E Division:	Sonoma
High Fire Threat District (HFTD):	Tier 2
High Fire Risk Area (HFRA):	Yes
EPSS Buffer:	No
Fire Index Area (FIA):	180
Fire Potential Index (FPI) Rating: FIA	R3
Fire Potential Index (FPI) Rating: Circuit	R4
Was there a PSPS event at the time of ignition?	No
Suspected Initiating Event:	Vegetation
Failure Driver:	Contact from Object
Failure Sub-driver:	Contact – Vegetation
Circuit:	Molino 1101, 04257-1101
Circuit Protection Zone:	Molino 1101 LR 5042
Nominal Voltage:	12kV

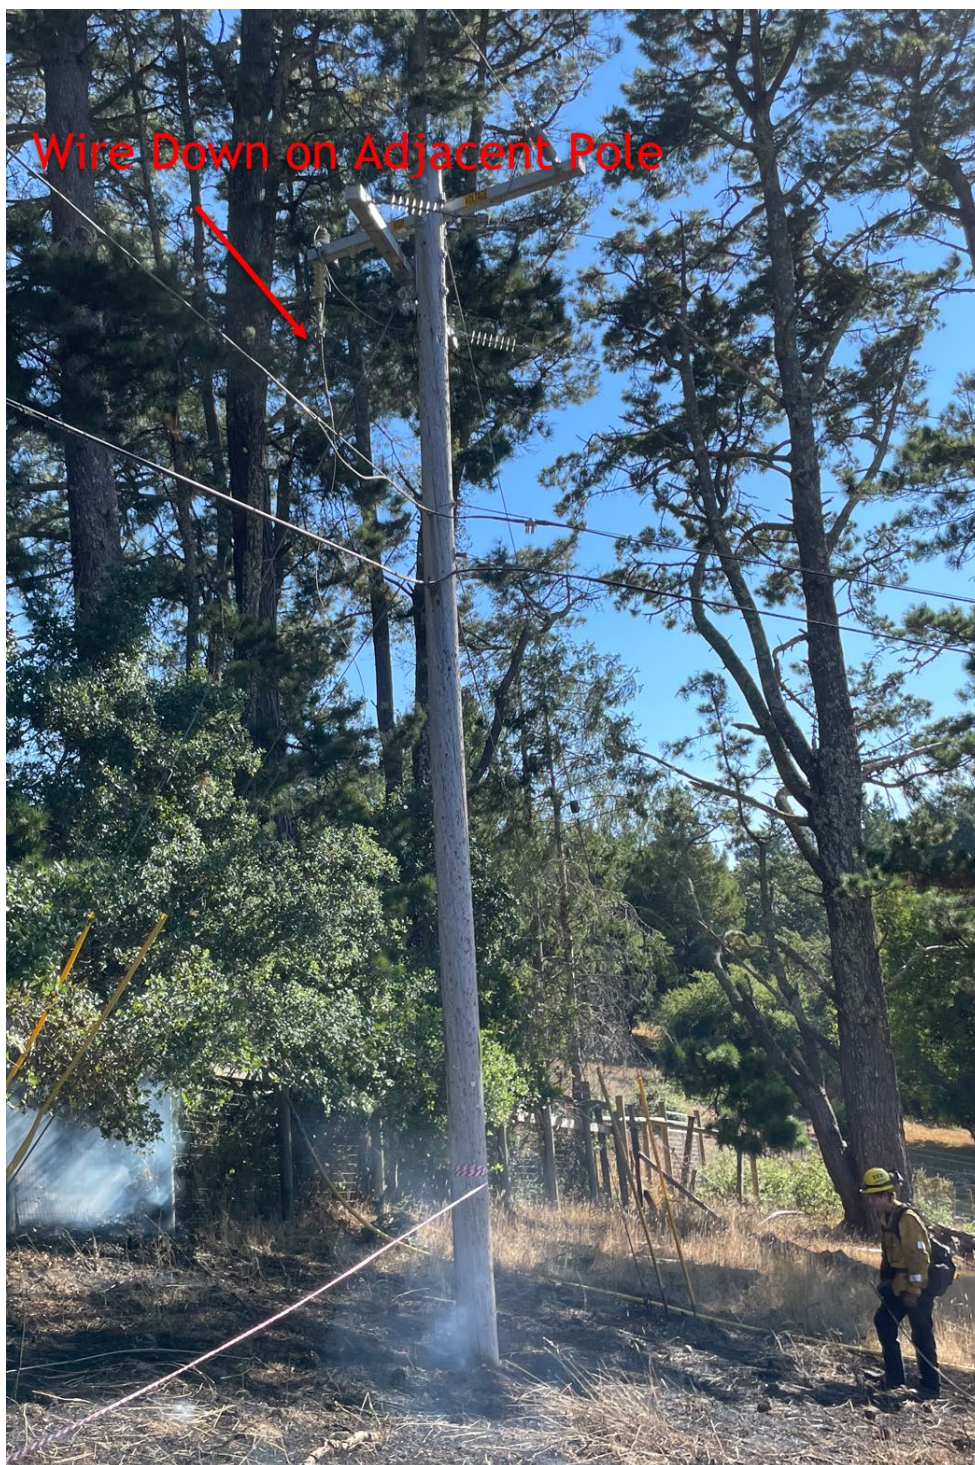
- 1659 Hours: Troubleshooter #2 arrives onsite.
- 1710 Hours: Troubleshooter #2 opens Fuse 18129 to make safe, found closed, nine customer de-energized. Reports to DO that tree limb took down one span, one wire located two spans load side of Fuse 18129.

Figure 2 – Wire down on adjacent pole SAP ID 102009312 on August 25, 2024. Photo taken by the troubleshooter.

A priority "A" EC tag (#129433545) was created to replace the flashed transformer, the cutout and the damaged crossarm. One phase of 200-feet 4 ACSR was also replaced.

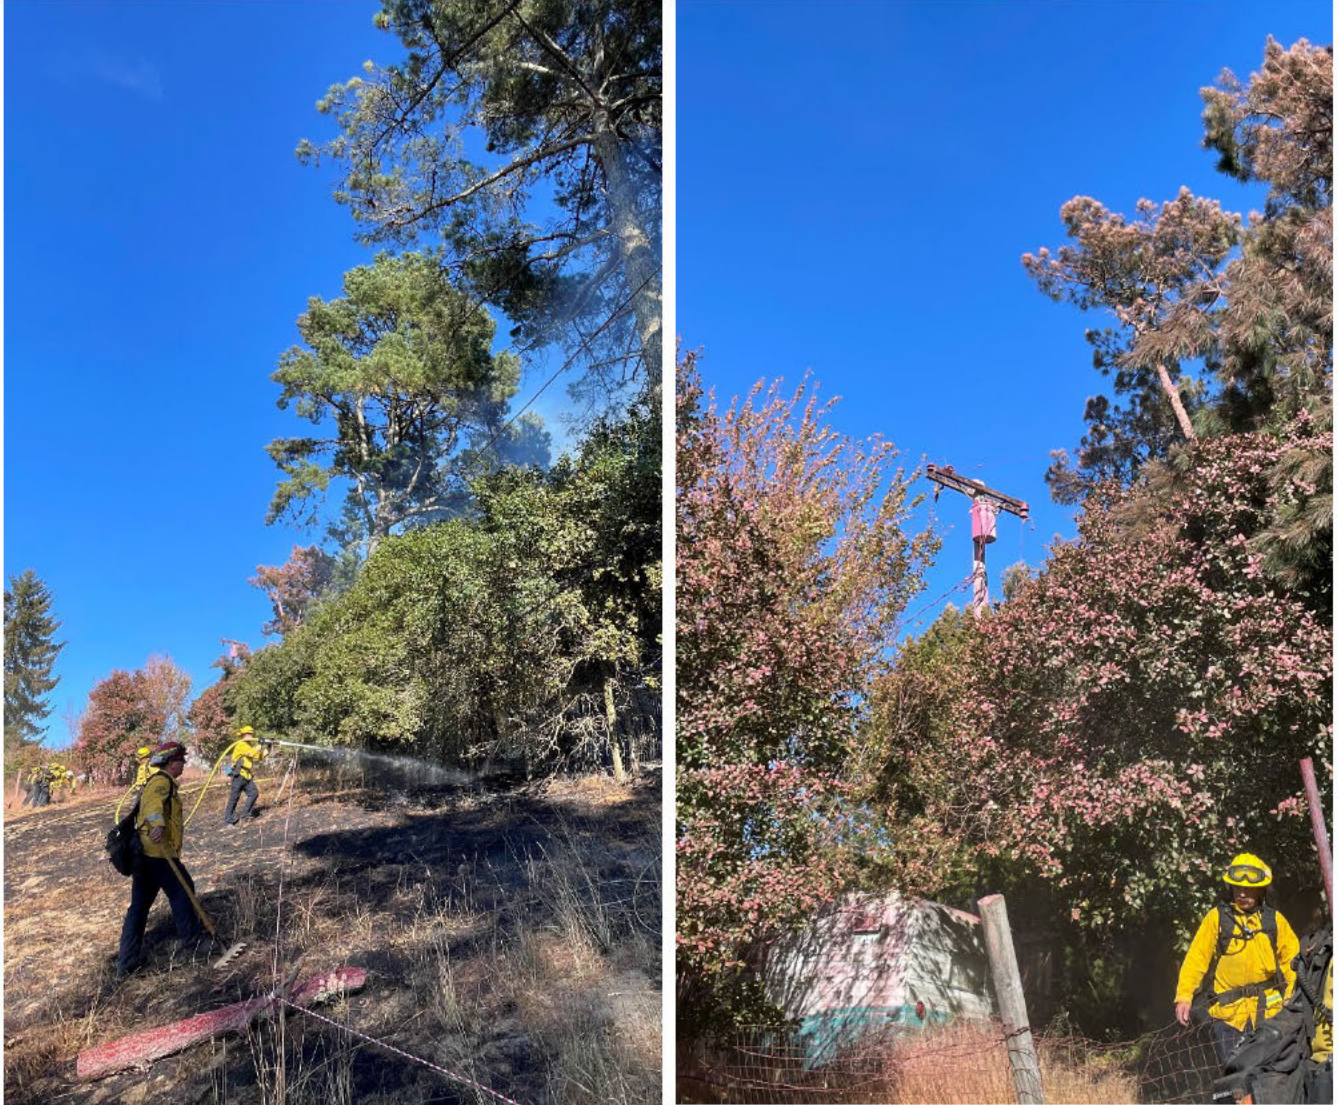
On August 25, 2024 at approximately 1617 hours, PG&E troubleshooters (three in total) were dispatched in response to a SmartMeter™ auto-generated tag for an outage that occurred near Tilton Road and Falstaff Road in the City of Sebastopol. At 1633 hours, PG&E received a customer call on its emergency line with reports of an electrical wire down and vegetation fire.<sup>1</sup> The troubleshooters arrived onsite to the two-phase primary overhead segment of the Molino 1101 12kV distribution circuit (see Figure 1) and observed a downed conductor, however, Fuse 18129 was found closed. To make the scene safe, the troubleshooters opened Fuse 18129 and continued their patrol of the area. At approximately 1710 hours, the troubleshooters identified and confirmed with the Distribution Operator (DO) that a broken tree limb made contact and took down one span of one phase (see Figure 2) midspan between pole SAP ID 101990411 and 102009312, two spans load side of Fuse 18129. The wire down resulted in a burn measuring between three meters and 0.25 acres in size and was extinguished by CAL FIRE (see Figure 3).

Figure 3 – View of Incident Location/Span with CAL FIRE on scene on August 25, 2024. Fire retardant covers pole SAP ID 101990411. Photos taken by the troubleshooter.

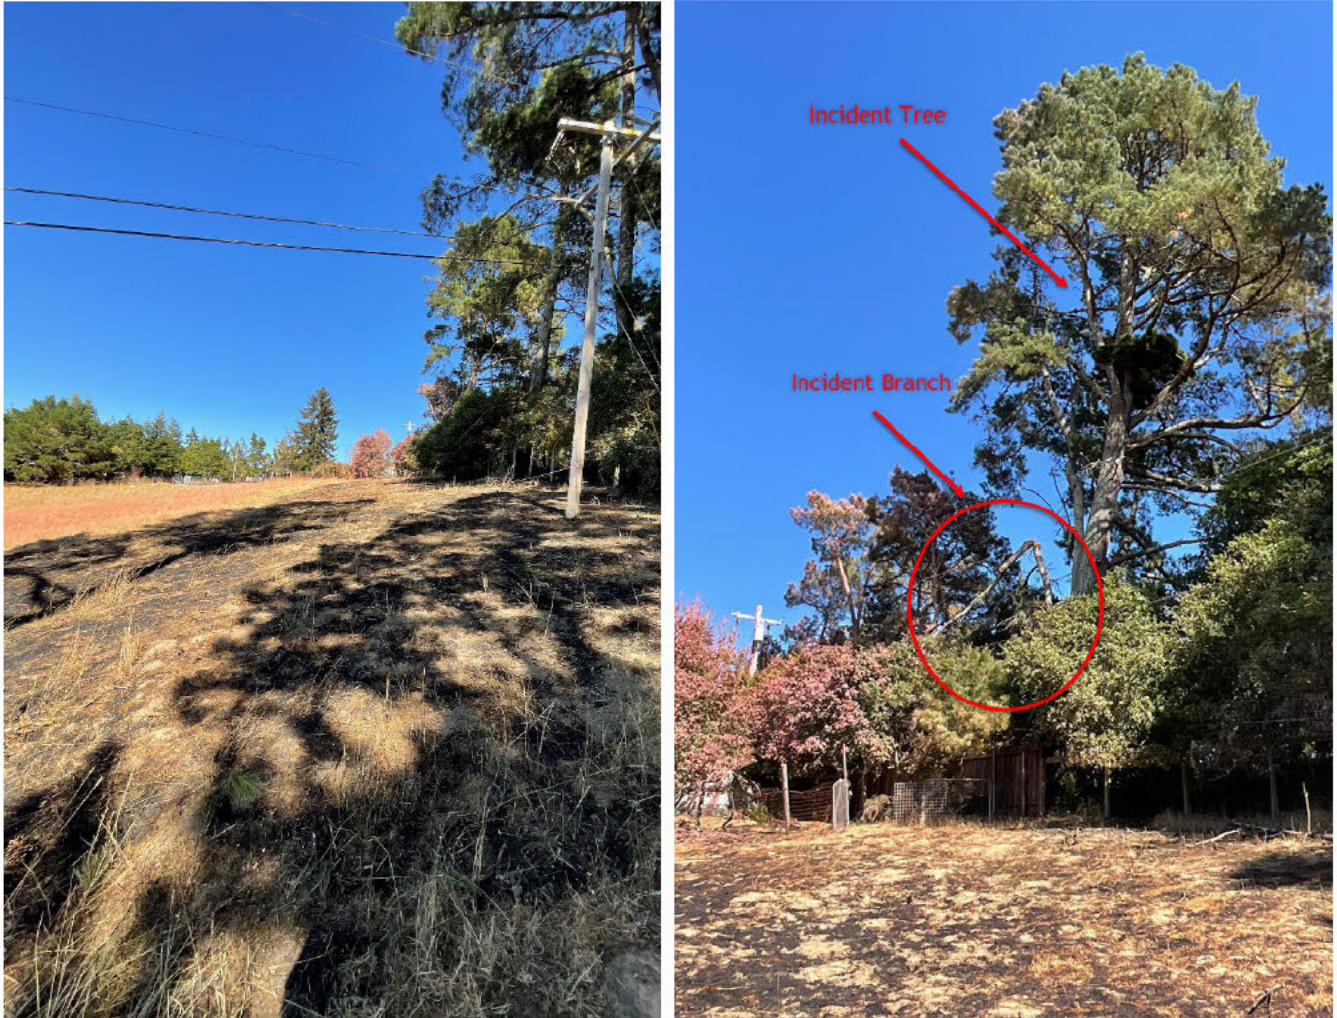
The Vegetation Management (VM) team conducted a post-incident investigation on August 25, 2024. The incident branch identified by the VM investigator belongs to a 110-foot tall Monterey pine with a diameter at breast height (DBH) of 45-inches located 15-feet from the conductors. The branch is approximately 45-foot long (with most of the foliage weight out towards the end) and broke about 30-feet above ground but was found still partially attached to the tree (see Figure 4 and 5). No visible signs of decay or defects were observed on the incident branch (see Figure 6). However, the pine tree did show both old and recent signs of broken branches on the tree. The VM investigator also noted a fire size of approximately 0.6 acres between two different properties.

Figure 4 – Additional view of Incident Location/Span with incident tree/branch near pole SAP ID 101990411 on August 25, 2024. Photos taken by the VM team.

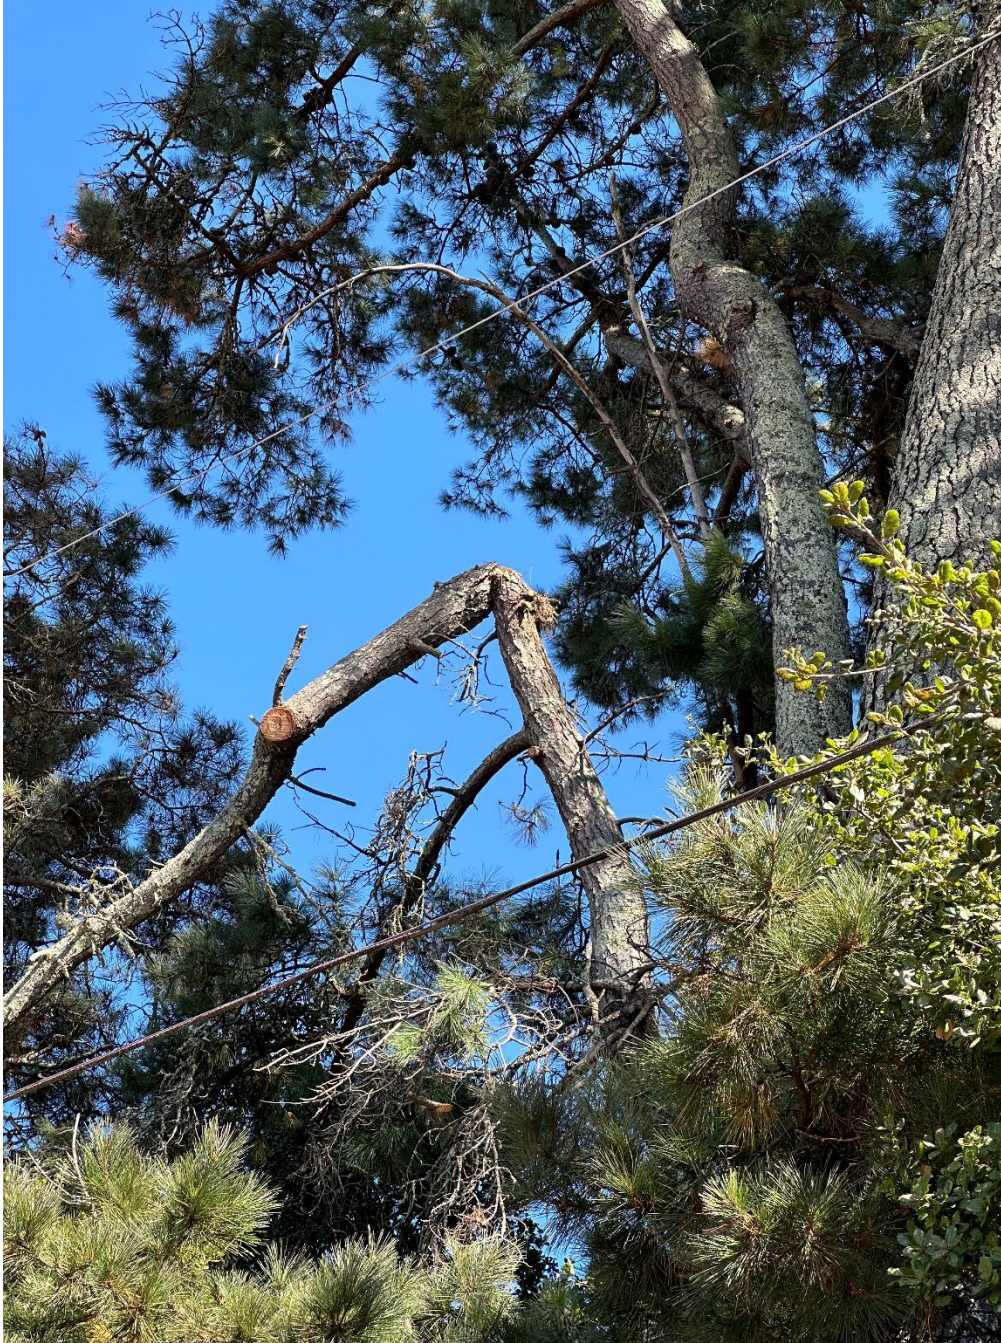
*Figure 5 – Close view of incident branch on August 25, 2024. Photo taken by the VM team.*

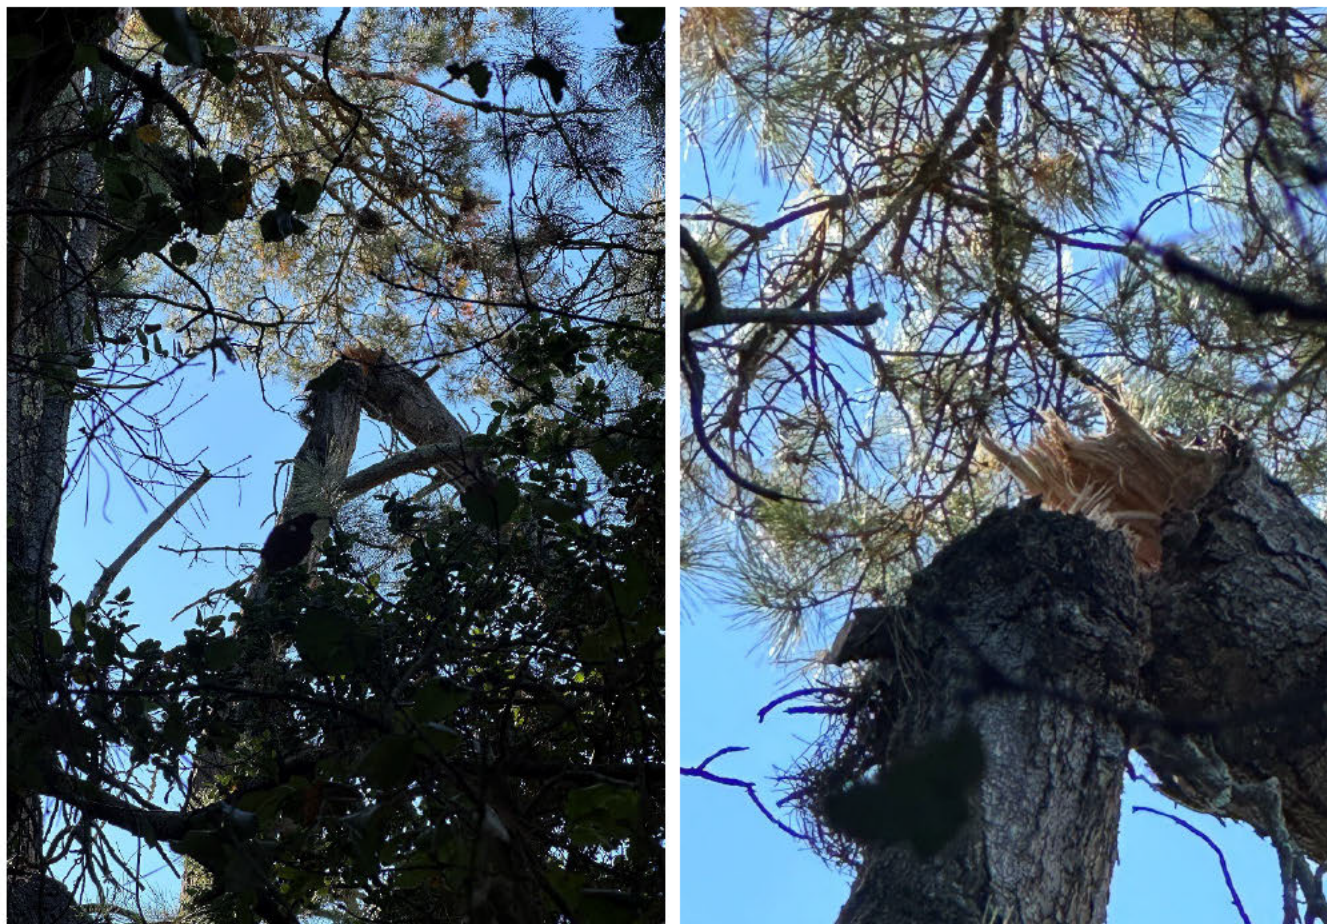
*Figure 6 – Alternate angle of incident branch on August 25, 2024. Photos taken by the VM team.*
