Preliminary Ignition Investigation Report

Ignition Database Index:	20241351
Electric Incident Investigation (EII) Number:	N/A
Incident Name:	N/A
PG&E Facility Ignition?	Yes
CPUC Reportable Ignition?	Yes
Date & Time of Incident:	September 16, 2024, at 1629 hours
Street Address:	[REDACTED]
City:	Novato
County:	Marin
Latitude/Longitude:	[REDACTED]
State Responsibility Area (SRA) / Local Responsibility Area (LRA) / Federal Responsibility Area (FRA)	LRA
PG&E Division:	North Bay
High Fire Threat District (HFTD):	Tier 3
High Fire Risk Area (HFRA):	Yes
EPSS Buffer:	No
Fire Index Area (FIA):	190
Fire Potential Index (FPI) Rating: FIA	R2
Fire Potential Index (FPI) Rating: Circuit	R1
Was there a PSPS event at the time of ignition?	No
Suspected Initiating Event:	Equipment – PG&E
Failure Driver:	All types of equipment/ facility failure
Failure Sub-driver:	Splice/Clamp/Connector
Circuit:	Ignacio 1101
Circuit Protection Zone:	Ignacio 1101LR1300
Nominal Voltage:	12kV
Pole SAP Equipment ID:	102235782

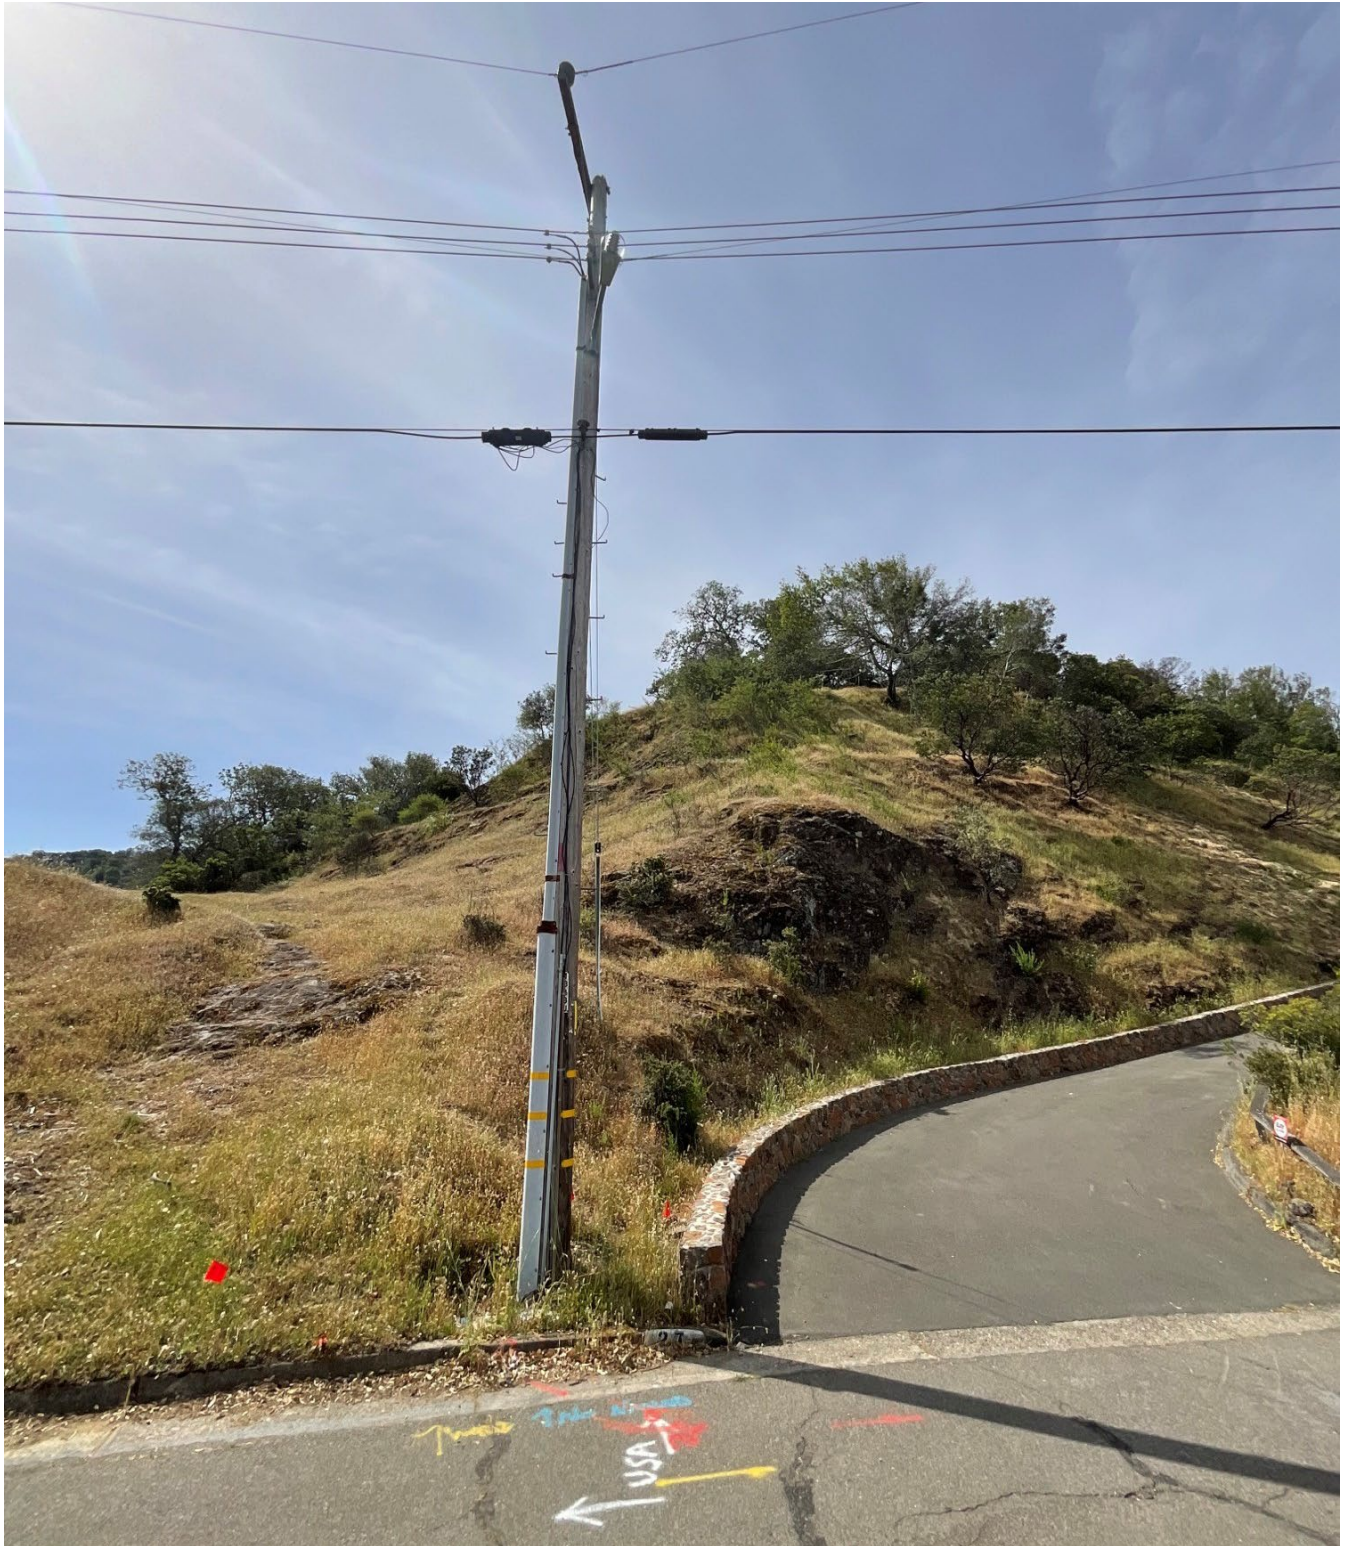
Source Side Structure		
Info / Inspection	Most Recent Date	Findings
Install Date:	1968	
Inspection:	April 30, 2022	No abnormal conditions identified
Patrol:	August 21, 2019	Pending receipt
Corrective History:	April 23, 2019	EC Notification 117083615 identified pole with SAP ID 102235782 as needing replaced due to rotten pole top.

Notes in long text challenge the condition of the pole and a 2022 GO165 inspection did not note any compelling damage to the pole. The EC Notification is currently open.
EVM Inspection:		(Note: document if “not previously in EVM Scope”)
Pole Intrusive Test:	December 7, 2021	No abnormalities identified

Photo showing Incident Location and incident pole. Photo is from an inspection prior to the incident.

Type	Number	Description	Priority	Date Identified	Due Date
EC Notification	117083615	Pole replacement	E	4/23/2019	10/20/2019
COE Notification	N/A				
LC Notification	N/A				
Veg Work Order	N/A

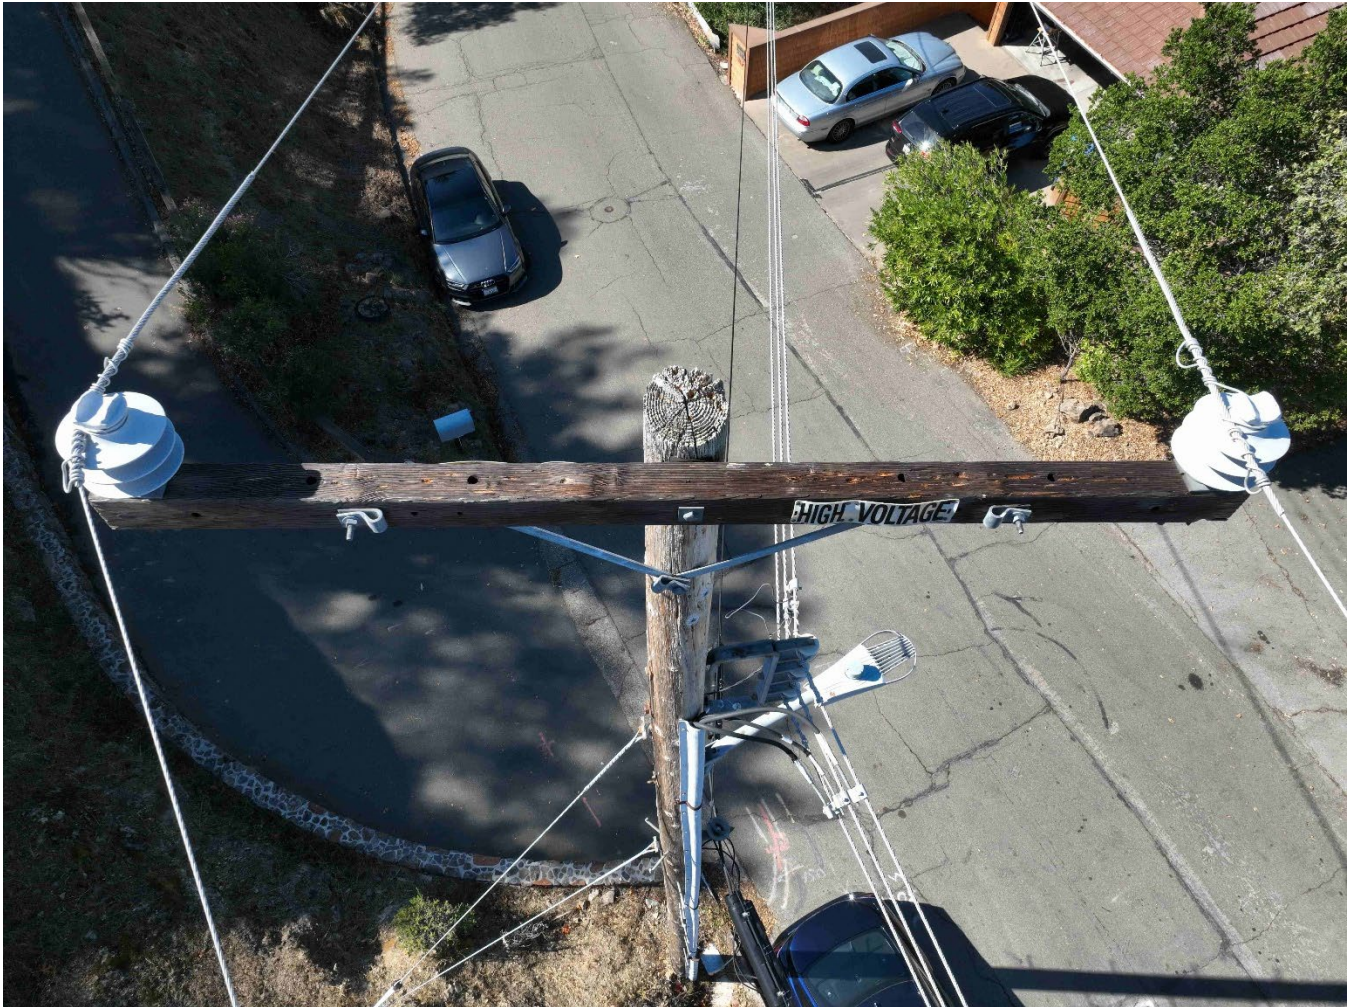
FD. inspected pole, found 1 bolt connectors from riser pin terminals to rack secondary NG, arcing occurred when touched. replaced all 1 bolts with press connections. customer stated his electrician noticed high voltage (255) at meter. tag created to install RVM next day. voltage at time is 252
HAWC Summary:	N/A
Injuries / Fatalities / Property Damage / Media Attention:	0/0/0
Weather Conditions:	On September 16, 2024, at 0910 hours near the Incident Location: Temperature: 57.9°F Relative Humidity: 77% Wind Speed: 1.8 MPH Wind Gust: 3.2 MPH from the east-northeast
Red Flag Warning (RFW) / High Wind Warning (HWW):	No RFW/No HWW
911 Standby Relief Time:	N/A
OIS #:	2569944
ILIS #:	N/A
FAS #:	T006502243
TOTL #:	N/A
Assigned Attorney:	N/A
Ignition Investigator & Phone:

Photo of the top of the Incident Pole. Photo taken by responding troubleshooter

On September 16, 2024, at 1629 hours, a PG&E troubleshooter was dispatched to the Incident Location after the resident contacted PG&E. The troubleshooter arrived at the Incident Location at 1732 hours where resident explained that earlier in the day, they had witnessed sparks from the top of the pole that ignited a small grass fire. The troubleshooter inspected the incident pole and observed a no-good bolted connector from the riser pin terminals to the rack secondary that was arcing when touched. The troubleshooter replaced all three bolted connectors with press connectors as part of Field Order T006502234.

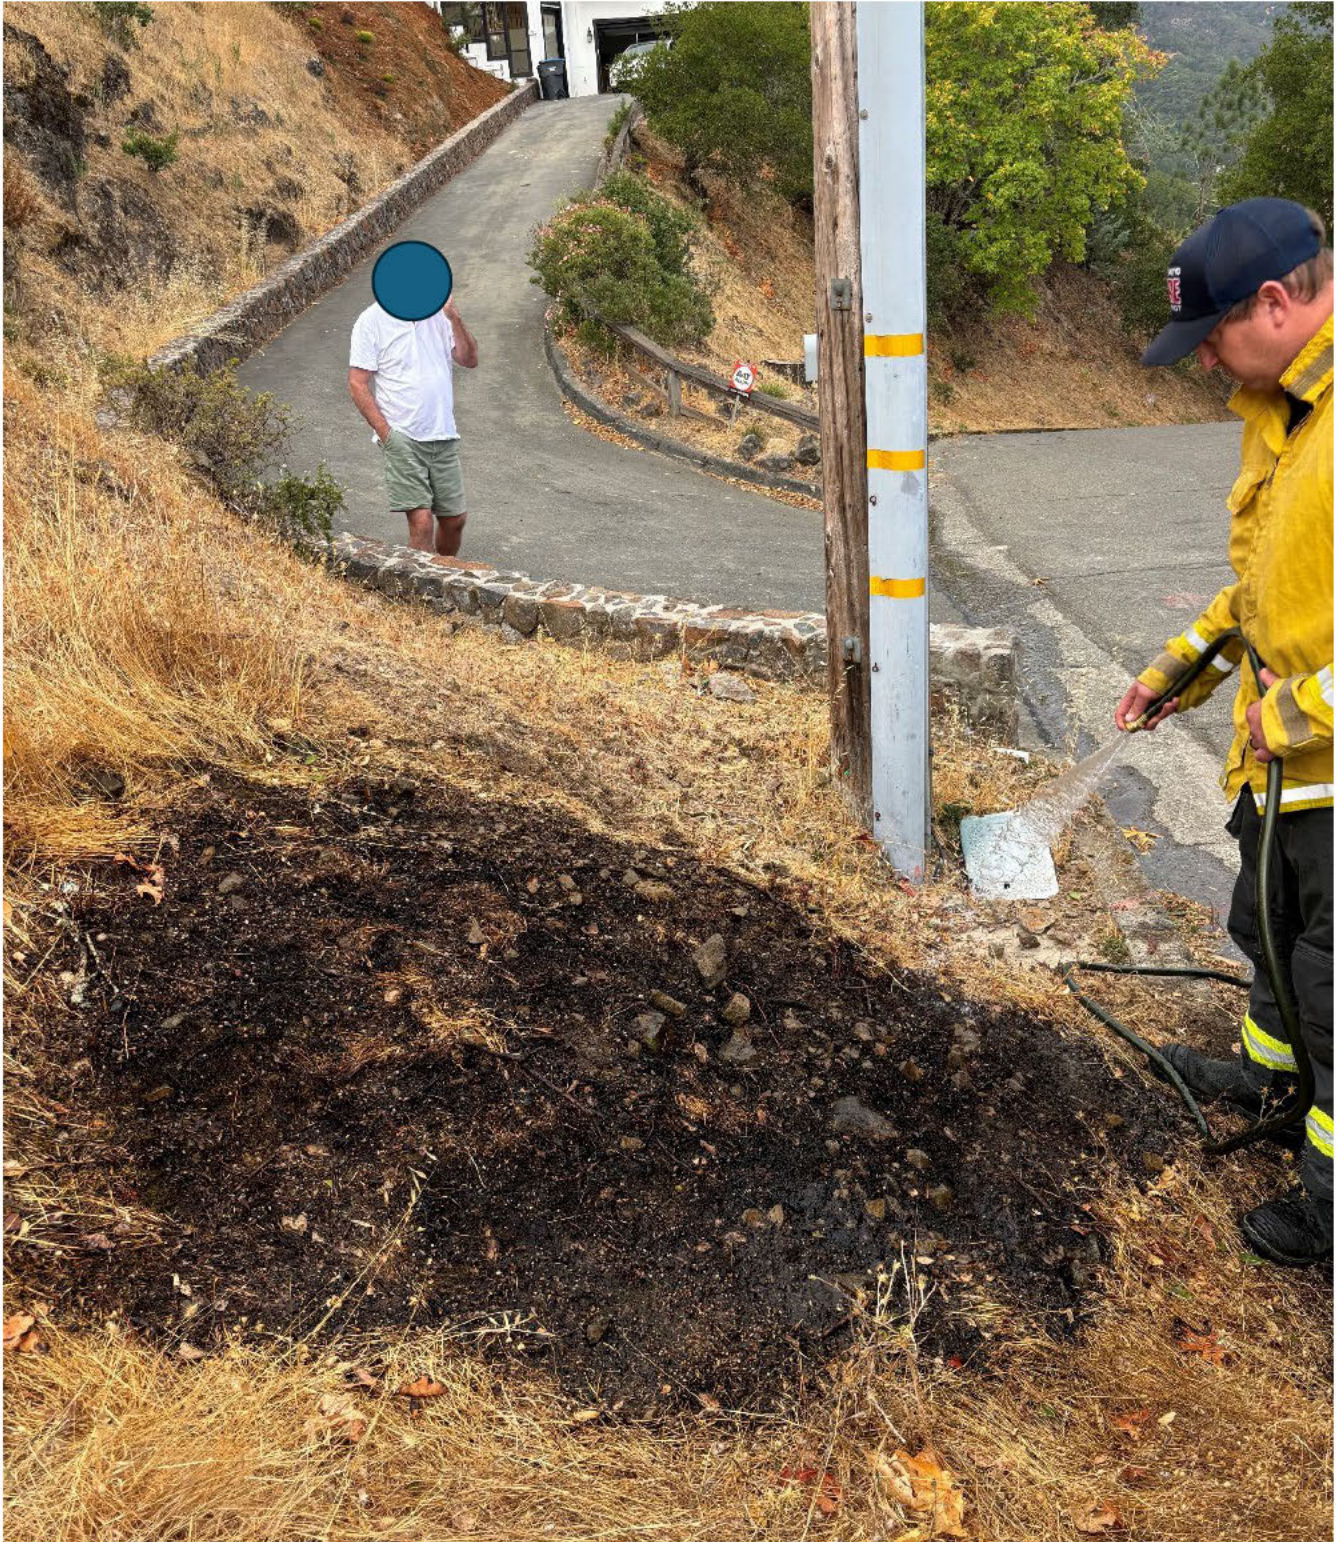
On the morning of September 16, 2024, a resident at the Incident Location observed sparking from the top of the pole with SAP ID 102235782 that ignited a small grass fire. The resident suppressed the fire but contacted the Novato Fire Protection District (NFPD) at 0906 hours as a safety precaution after the fire was extinguished. NFPD was dispatched at 0907 hours and arrived at the Incident Location at 0915 hours and confirmed the fire was extinguished. NFPD cleared the scene at 0920 hours.

Photo of NFPD on site. Fire was initially suppressed by resident who contacted NFPD as a safety precaution.

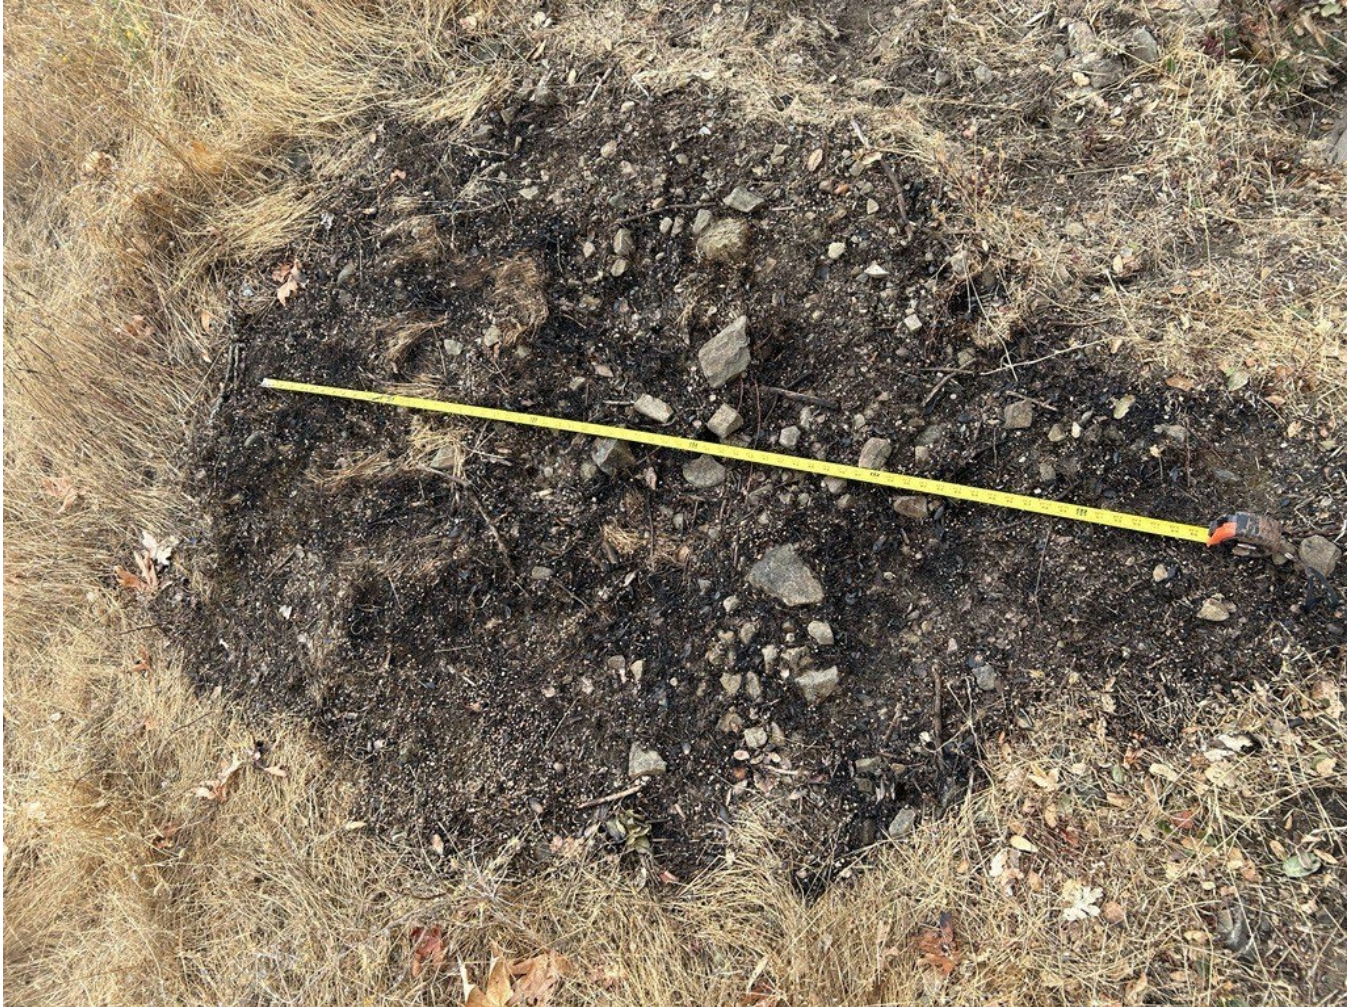
The ignition resulted in a small grass fire spreading to a size of approximately three feet by 5.5 feet. There were no sustained outages associated with the ignition. No injuries, property damage or significant media coverage was identified with this incident.

Photo showing measurement of fire footprint. Photo taken by responding troubleshooter.

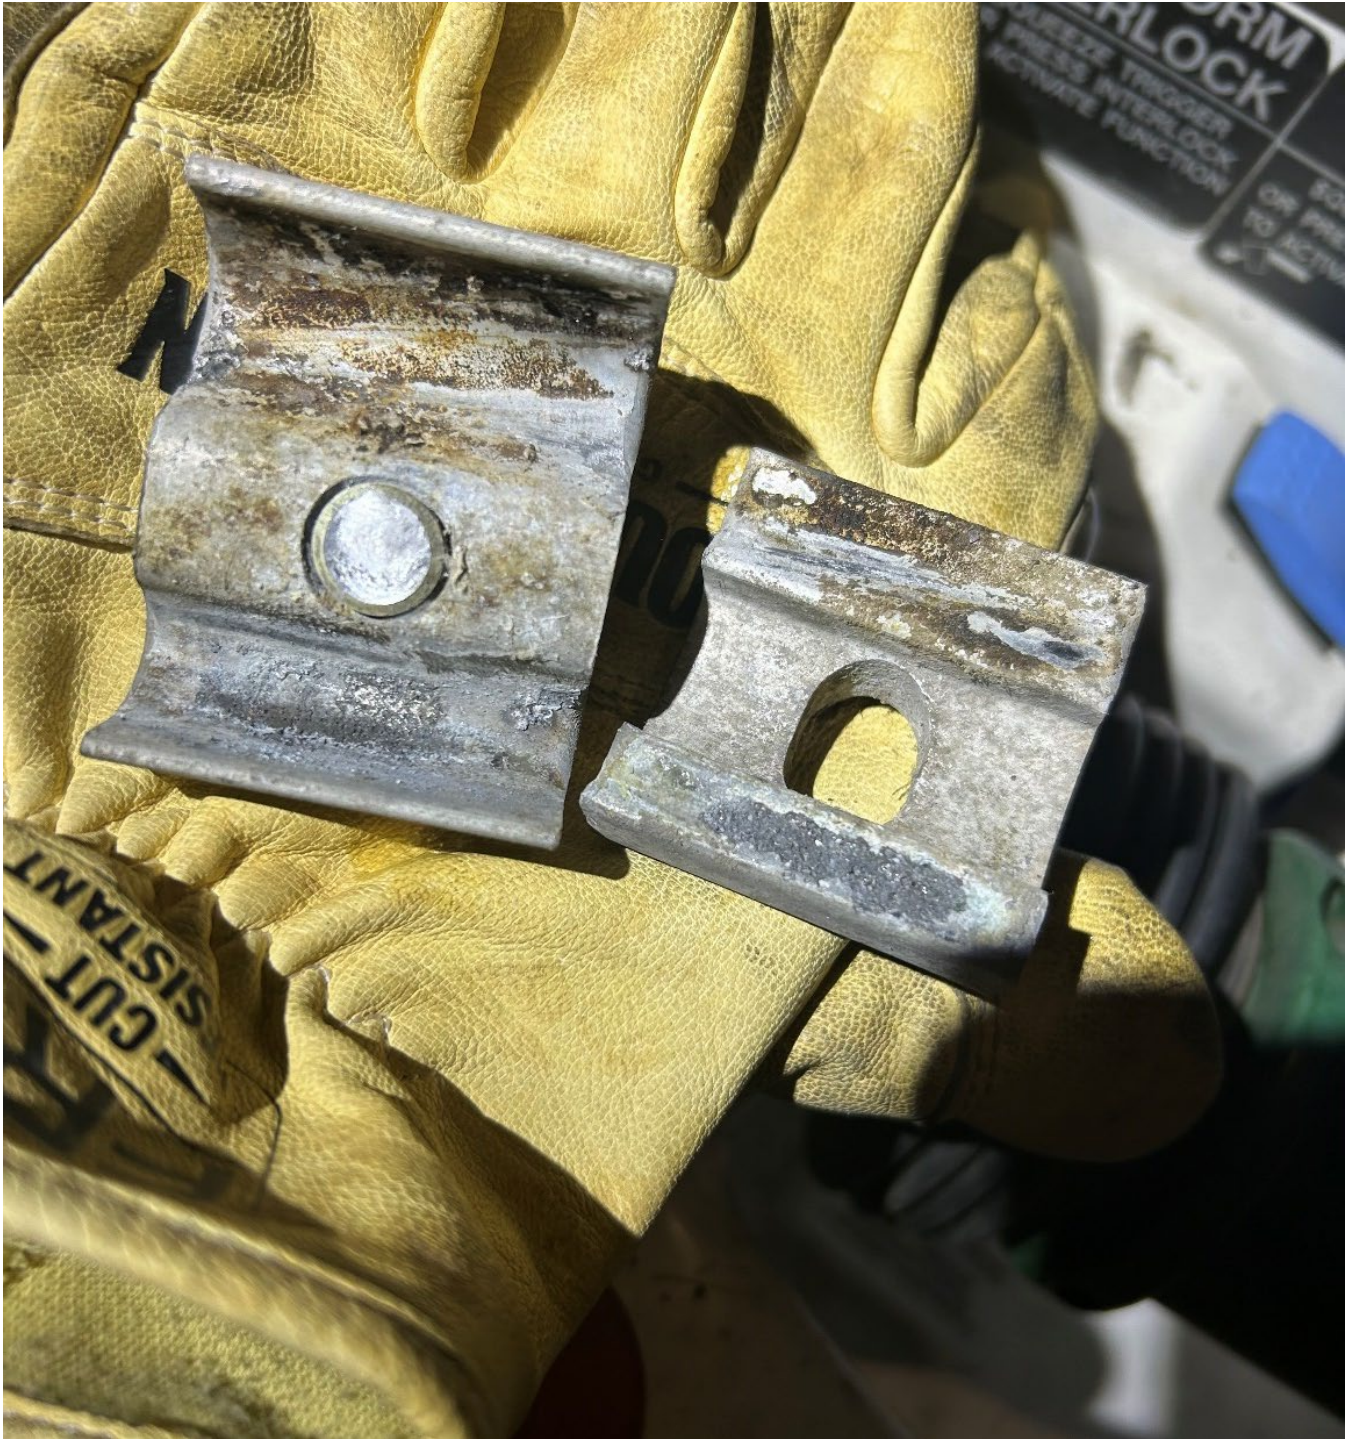
The no-good bolt connector was collected for analysis by PG&E's Applied Technology Services (ATS) team. The ATS team conducted a visual examination to document the failed bolted connector. The ATS team observed internal arc damage, external arc marking due to contact with secondary conductor, and tool marks and gouging on the bolt. It was also observed that the bolt had sheared into two pieces and showed signs of over-tightening. The PG&E troubleshooter who replaced the bolted connectors explained that the bolt sheared as he was making the repairs.

PG&E's Asset Failure Analysis (AFA) team performed an Extent of Condition (XOC) on the failed connector. The XOC identified the failed connector as a parallel groove (PG) bolted connector. PG bolted connectors are known "bad actors" and [Document 028852](#), Connectors for Aluminum Conductors on Distribution Linesⁱ, calls for the replacement of PG bolt connectors in the field when performing work on a structure with these connectors present. The AFA also points out that a prior inspection did not identify the PG connector in HFTD. As required in document 028852, the responding troubleshooter did replace all present PG bolted connectors on the structure.

Photo of failed bolt connector at the Incident Location. Photo provided by responding troubleshooter.

On September 16, 2024, Field Order T006502234 was created and a PG&E troubleshooter replaced three bolt connectors with three press connectors.
