Preliminary Ignition Investigation Report

| Incident Name: | Lindburg |
| Suspected Initiating Event: | Vegetation |
| Circuit: | Diamond Springs 1103 |

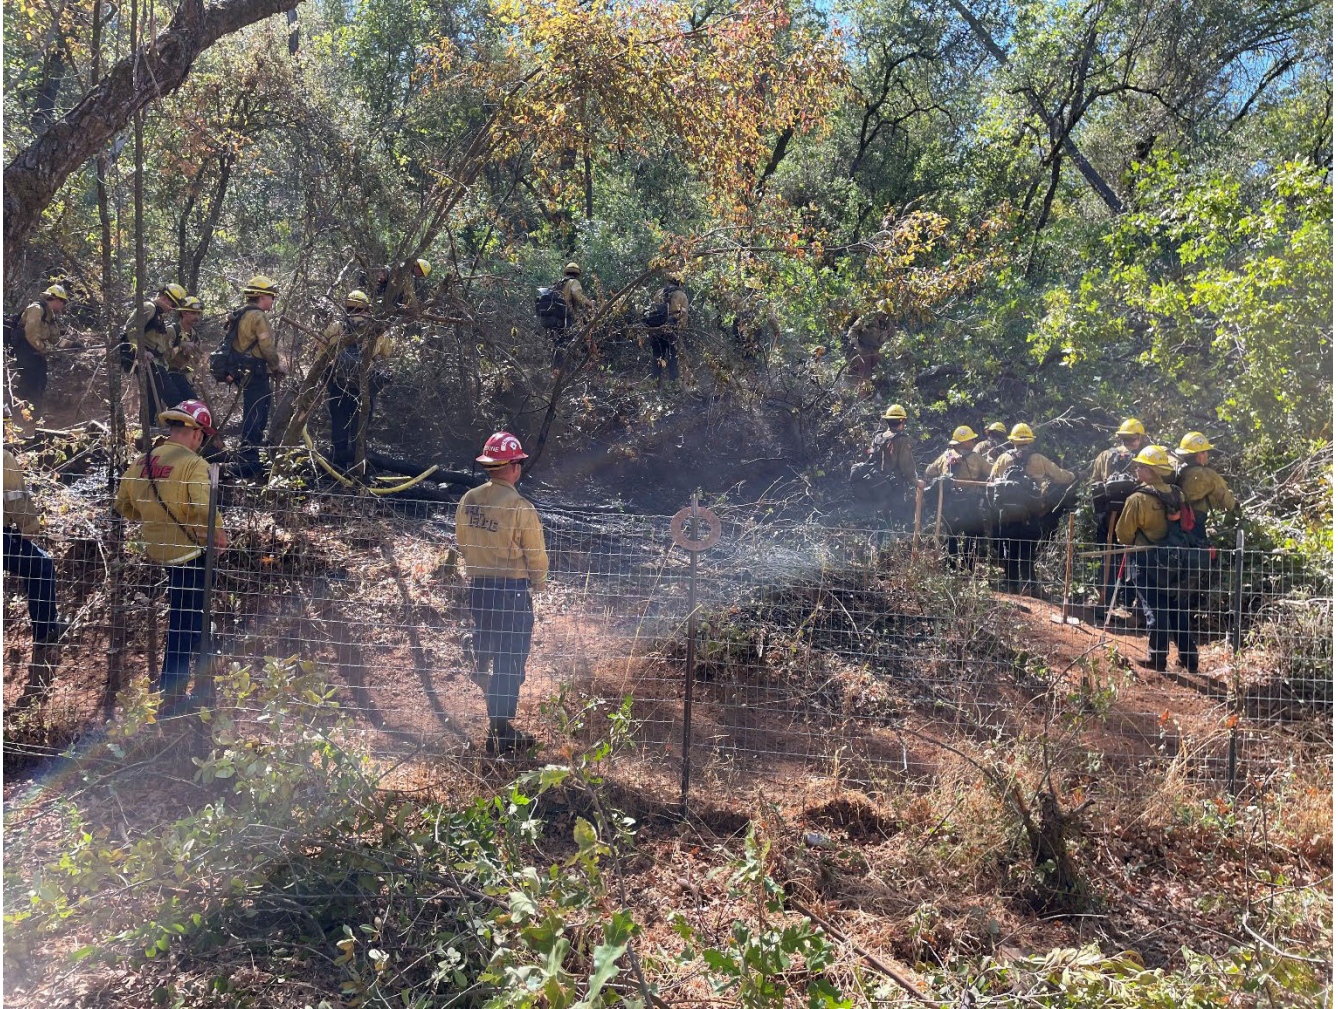
Figure 2 – CAL FIRE personnel engaged in suppression/mop up efforts. Photo taken by troubleshooter on September 30, 2024.

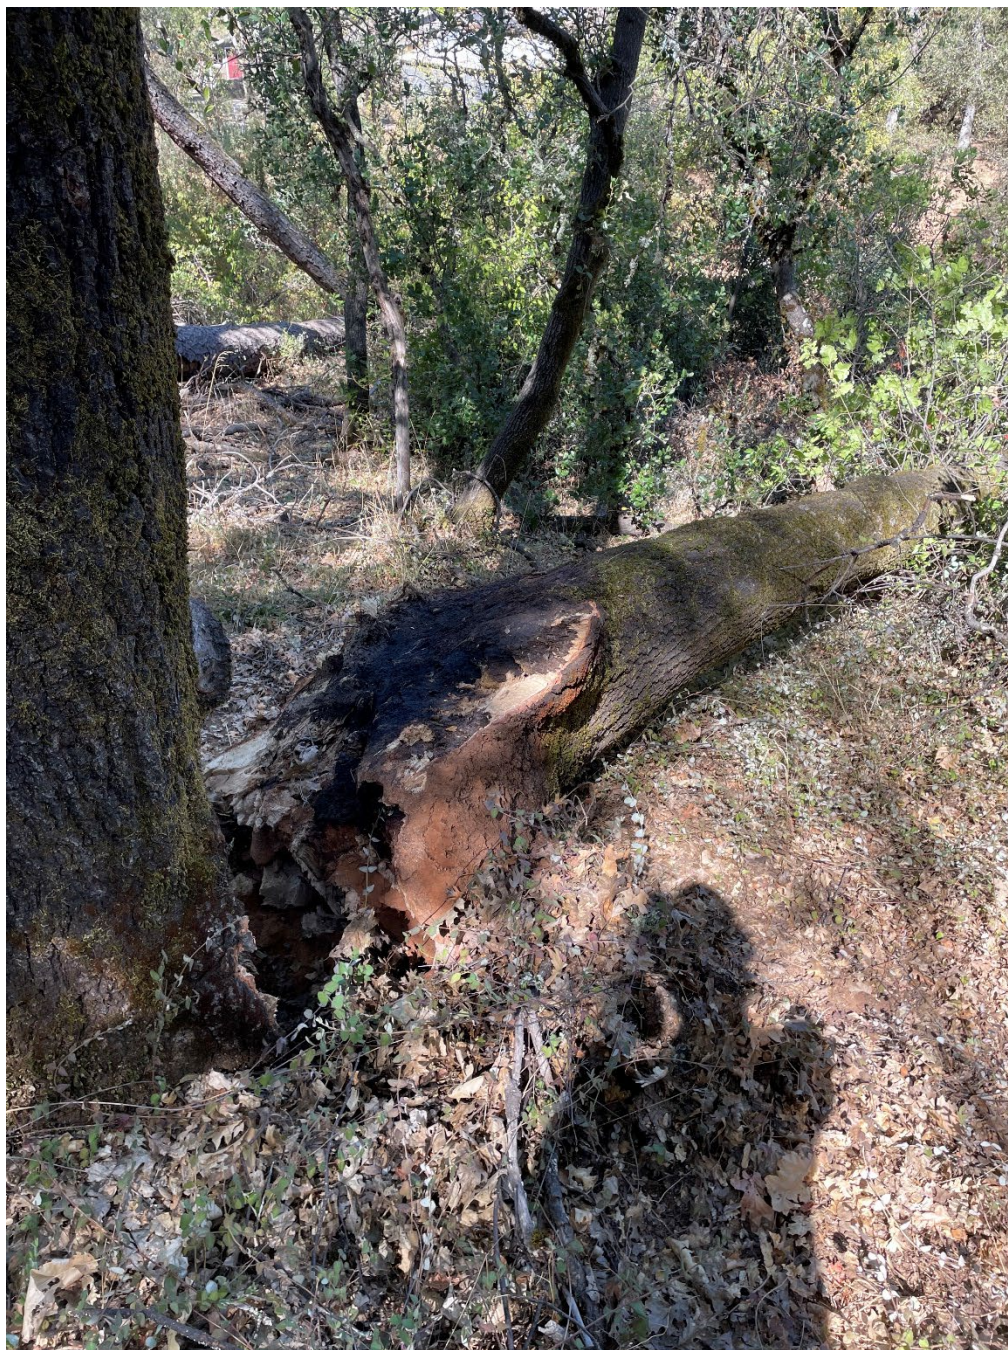
The Vegetation Management (VM) team conducted a post-incident investigation on October 3, 2024. A 75-foot black oak with a diameter at breast height (DBH) of 40 inches experienced a partial failure of its low codominant attachment (see Figure 5, 6 and 7). The incident low attachment that broke is on a slope approximately 50-feet from the conductor and fully exposed to winds in the area. The VM investigator noted the presence of decay deep inside the trunk where the break occurred. However, the decay would not have been externally visible during an inspection. Half of the tree was still standing and green but was removed under RX-03540445 on October 30, 2024. The resulting fire from the broken tree into the line, left a burn area measuring approximately 50 x 20-foot in size east of the incident tree (see Figure 8).

Figure 3 – Point of failure on incident tree (black oak). Photo taken by troubleshooter on September 30, 2024.

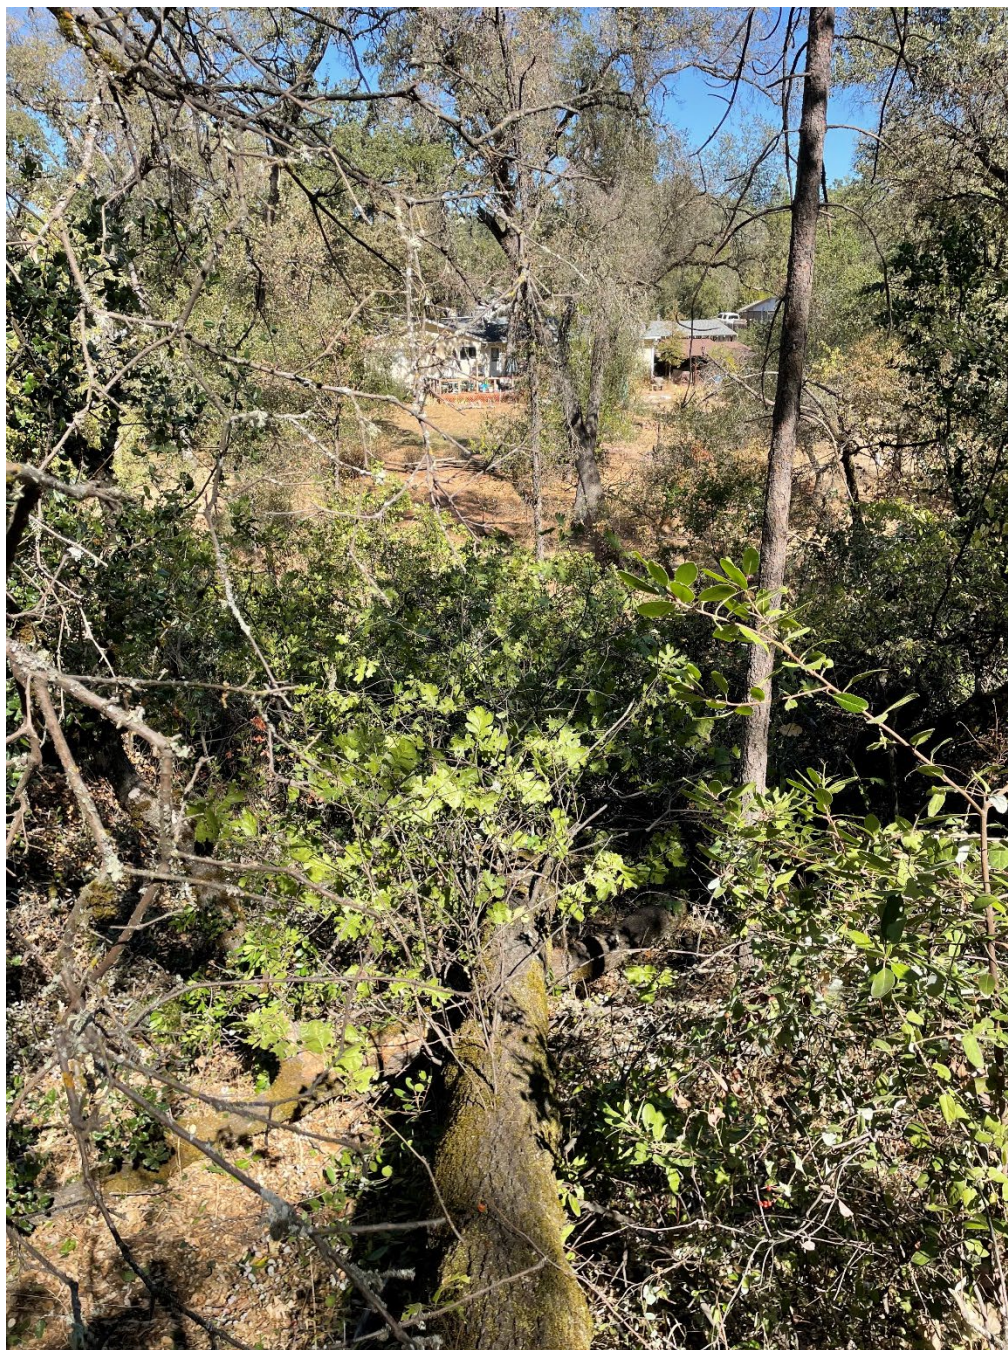
Figure 4 – Failed incident tree (upper portion). Photo taken by troubleshooter on September 30, 2024.

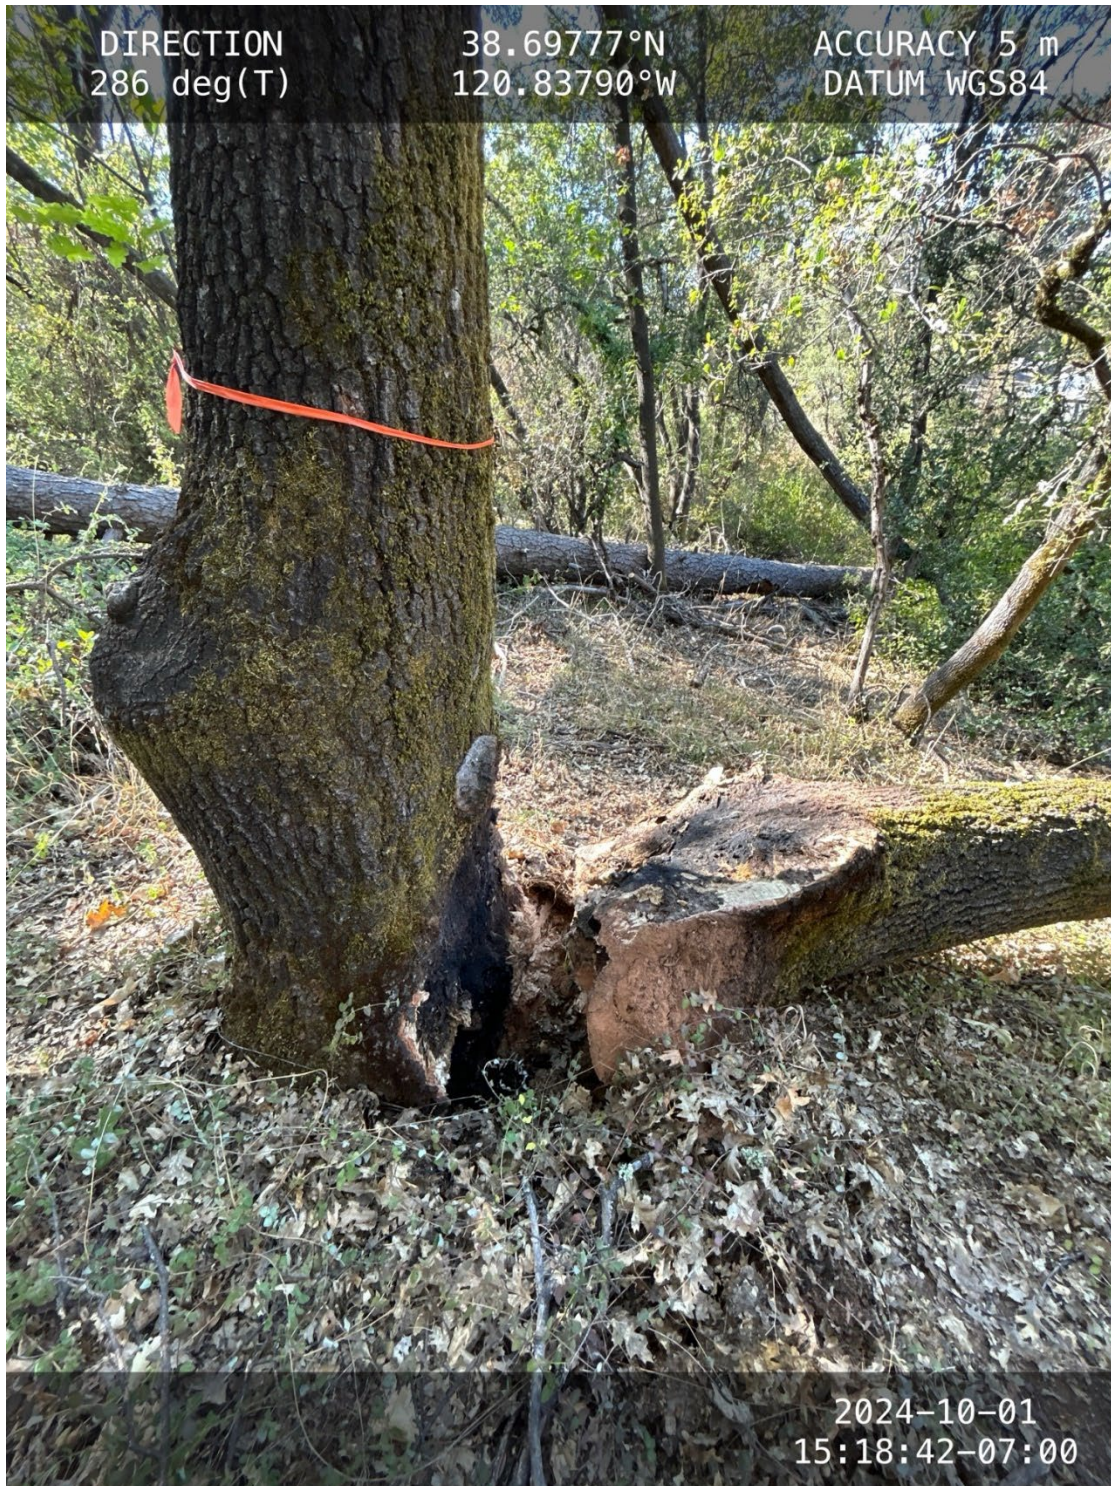
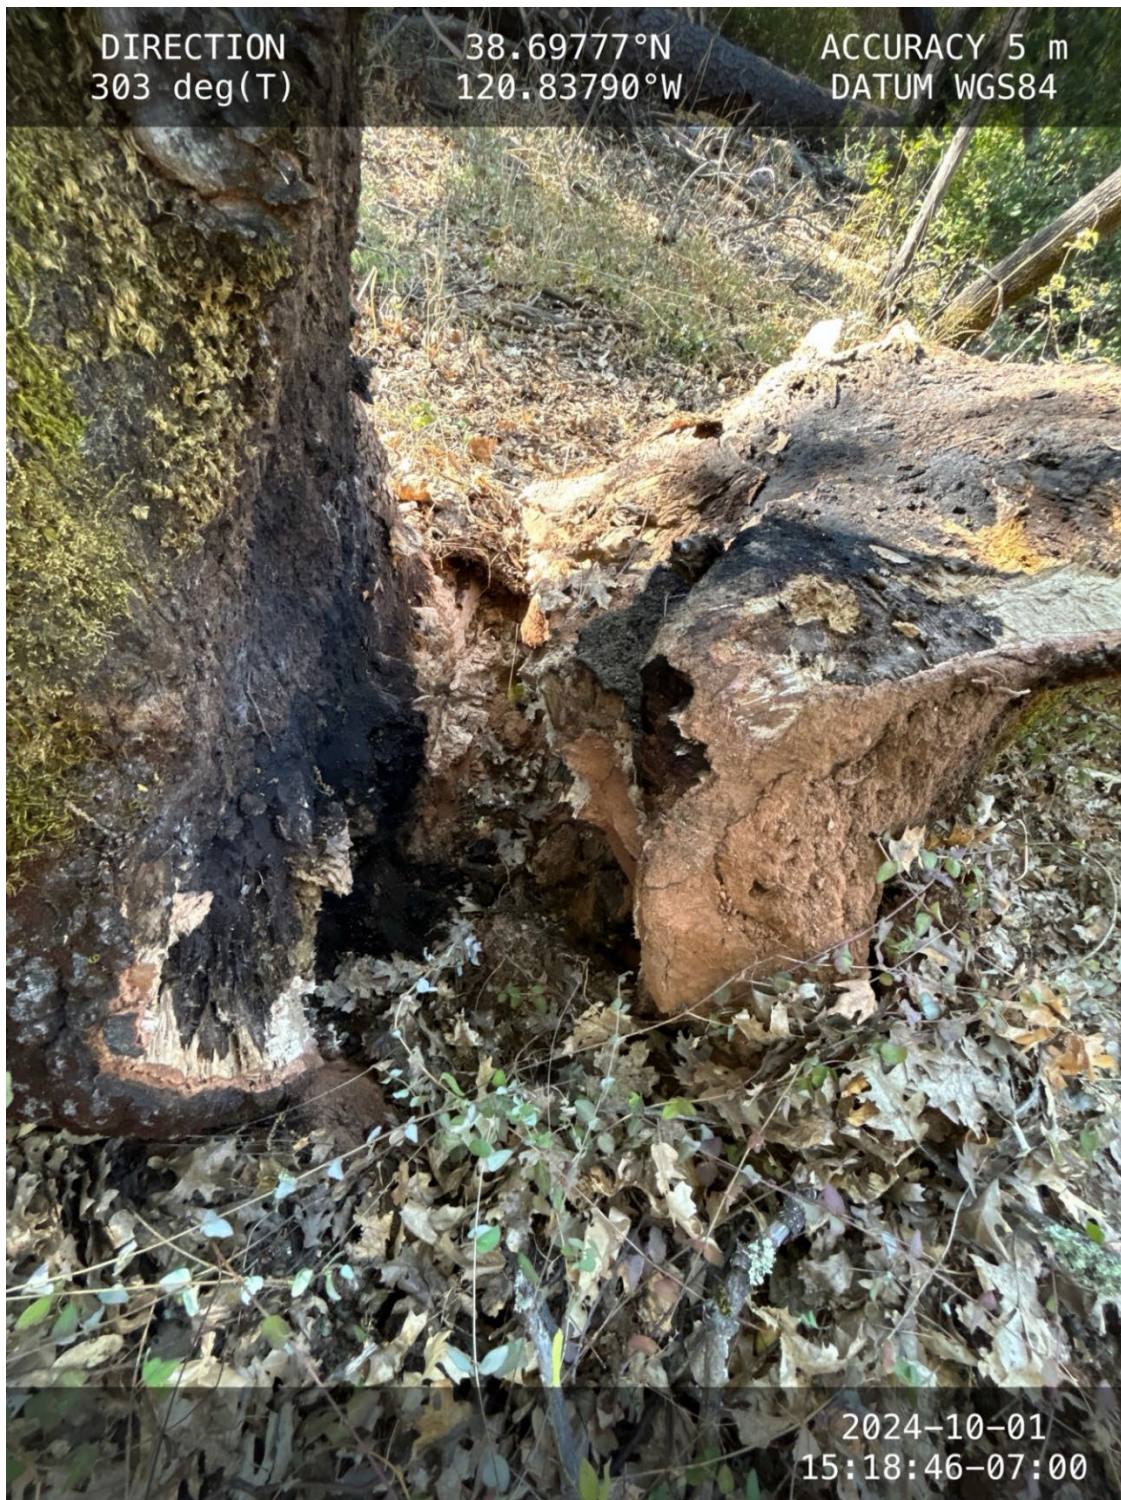
Figure 5 – Incident tree. Photo taken by VM investigator on October 1, 2024.

Figure 6 – Incident tree. Photo taken by VM investigator on October 1, 2024.

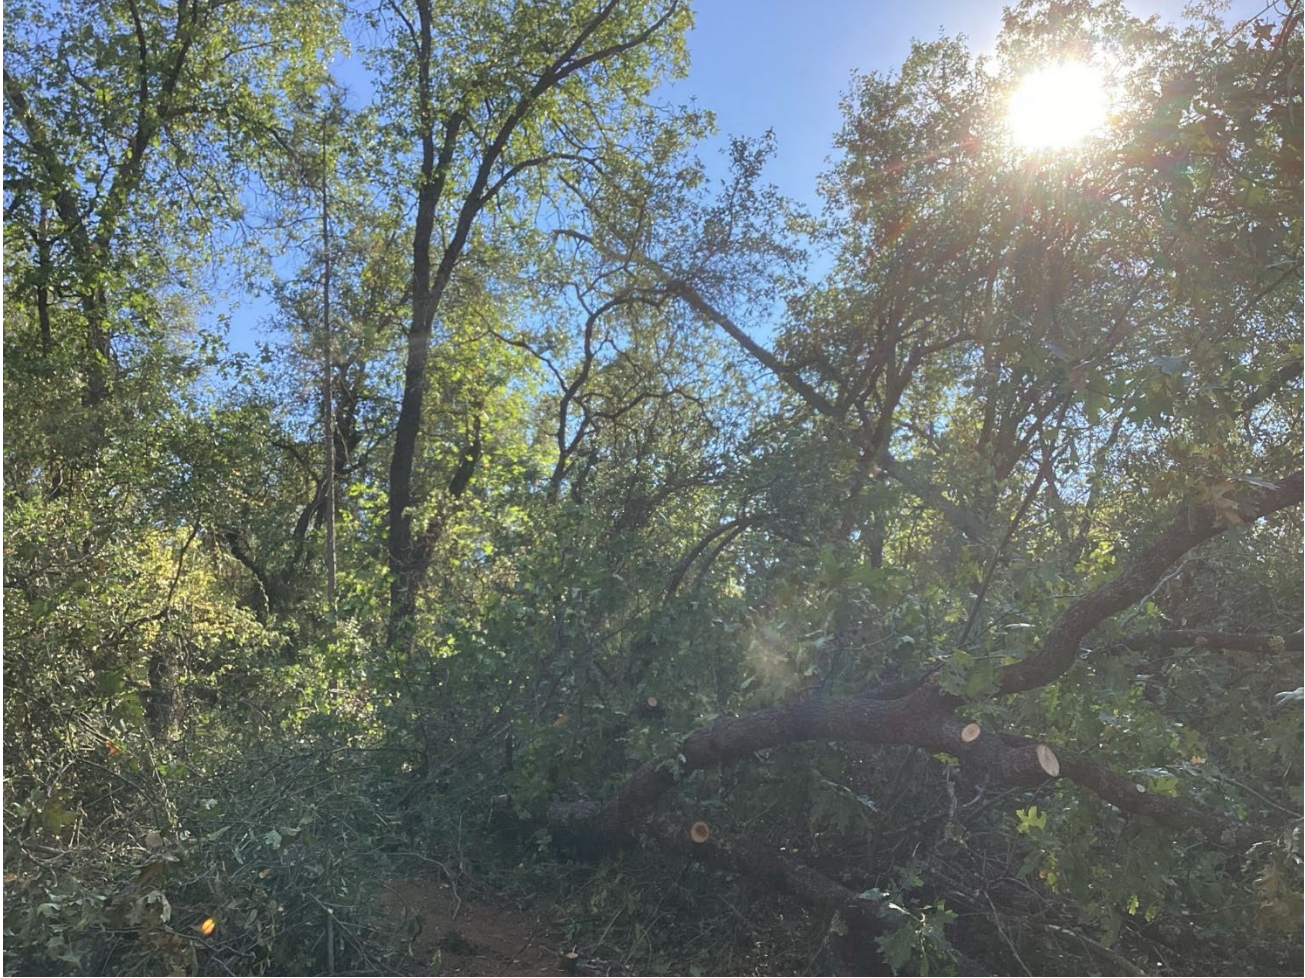
Figure 7 – Top of failed incident tree. Photo taken by VM investigator on October 1, 2024.

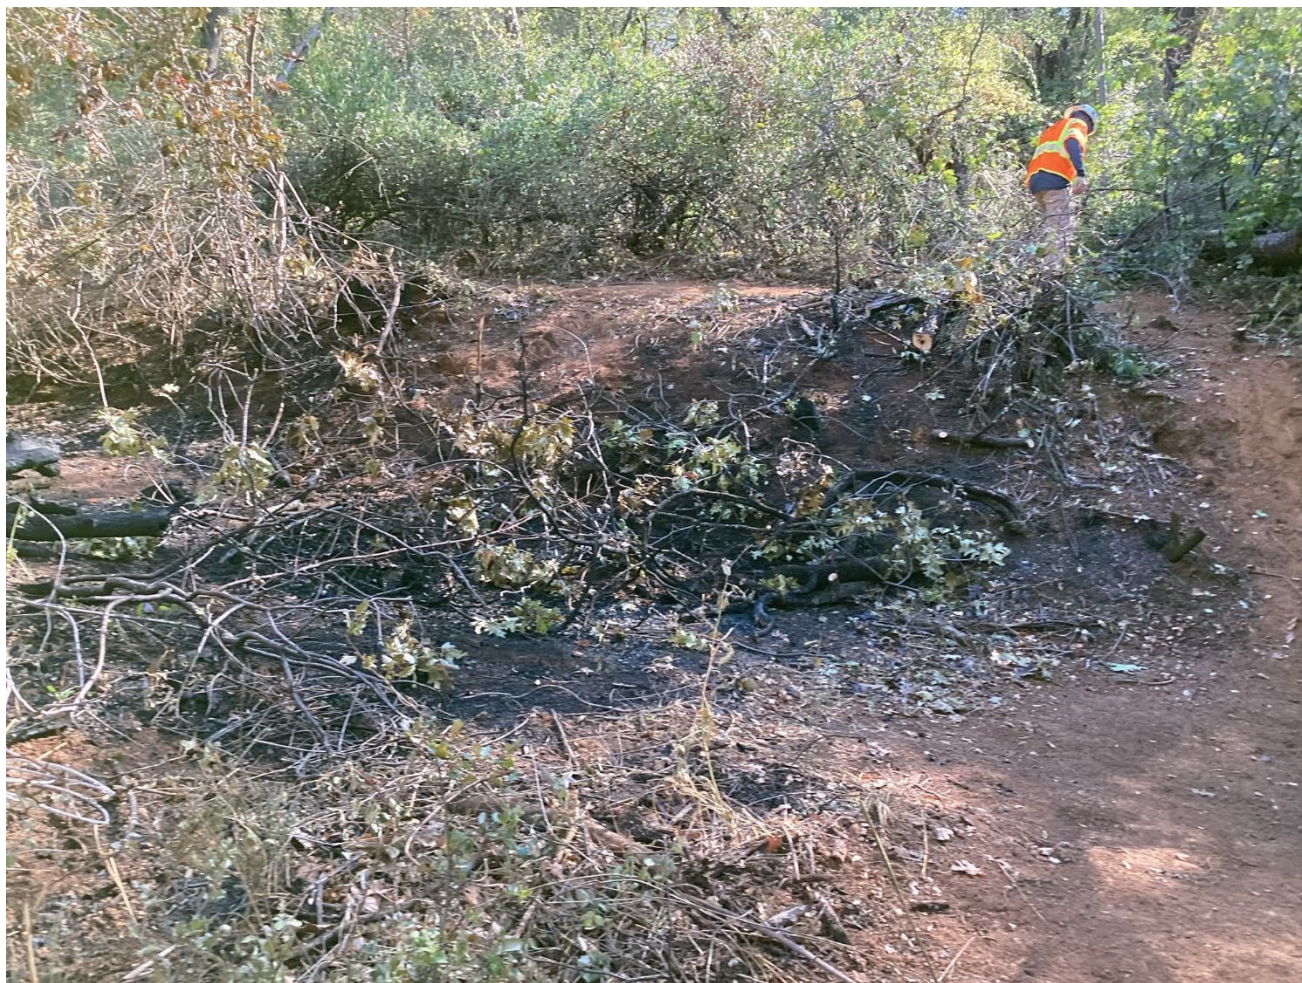
The ignition was isolated to the incident tree and vegetation on the ground, resulting in a burn scar approximately 50 x 20-foot in size. There were no reports of injuries, fatalities, or property damage. There were two customers impacted by the outage for a total of 464 combined customer minutes.

Figure 8 – Burned vegetation/brush at Incident Location. Photo taken by VM investigator on October 1, 2024.
