Preliminary Ignition Investigation Report

Ignition Database Index:	20241422
Electric Incident Investigation (EII) Number:	N/A
Incident Name:	Barr
PG&E Facility Ignition?	Yes
CPUC Reportable Ignition?	Yes
Date & Time of Incident:	October 2, 2024 at 1552 hours
Street Address:	[REDACTED]
City:	Grass Valley
County:	Nevada
Latitude/Longitude:	[REDACTED]
State Responsibility Area (SRA) / Local Responsibility Area (LRA) / Federal Responsibility Area (FRA)	State Responsibility Area (SRA)
PG&E Division:	Sierra
High Fire Threat District (HFTD):	Tier 3
High Fire Risk Area (HFRA):	Yes
EPSS Buffer:	No
Fire Index Area (FIA):	330
Fire Potential Index (FPI) Rating: FIA	R5
Fire Potential Index (FPI) Rating: Circuit	R5
Was there a PSPS event at the time of ignition?	No
Suspected Initiating Event:	Vegetation
Failure Driver:	Contact from Object
Failure Sub-driver:	Contact – Vegetation
Circuit:	Brunswick 1106
Circuit Protection Zone:	Brunswick 11062416
Nominal Voltage:	120V

Executive Summary

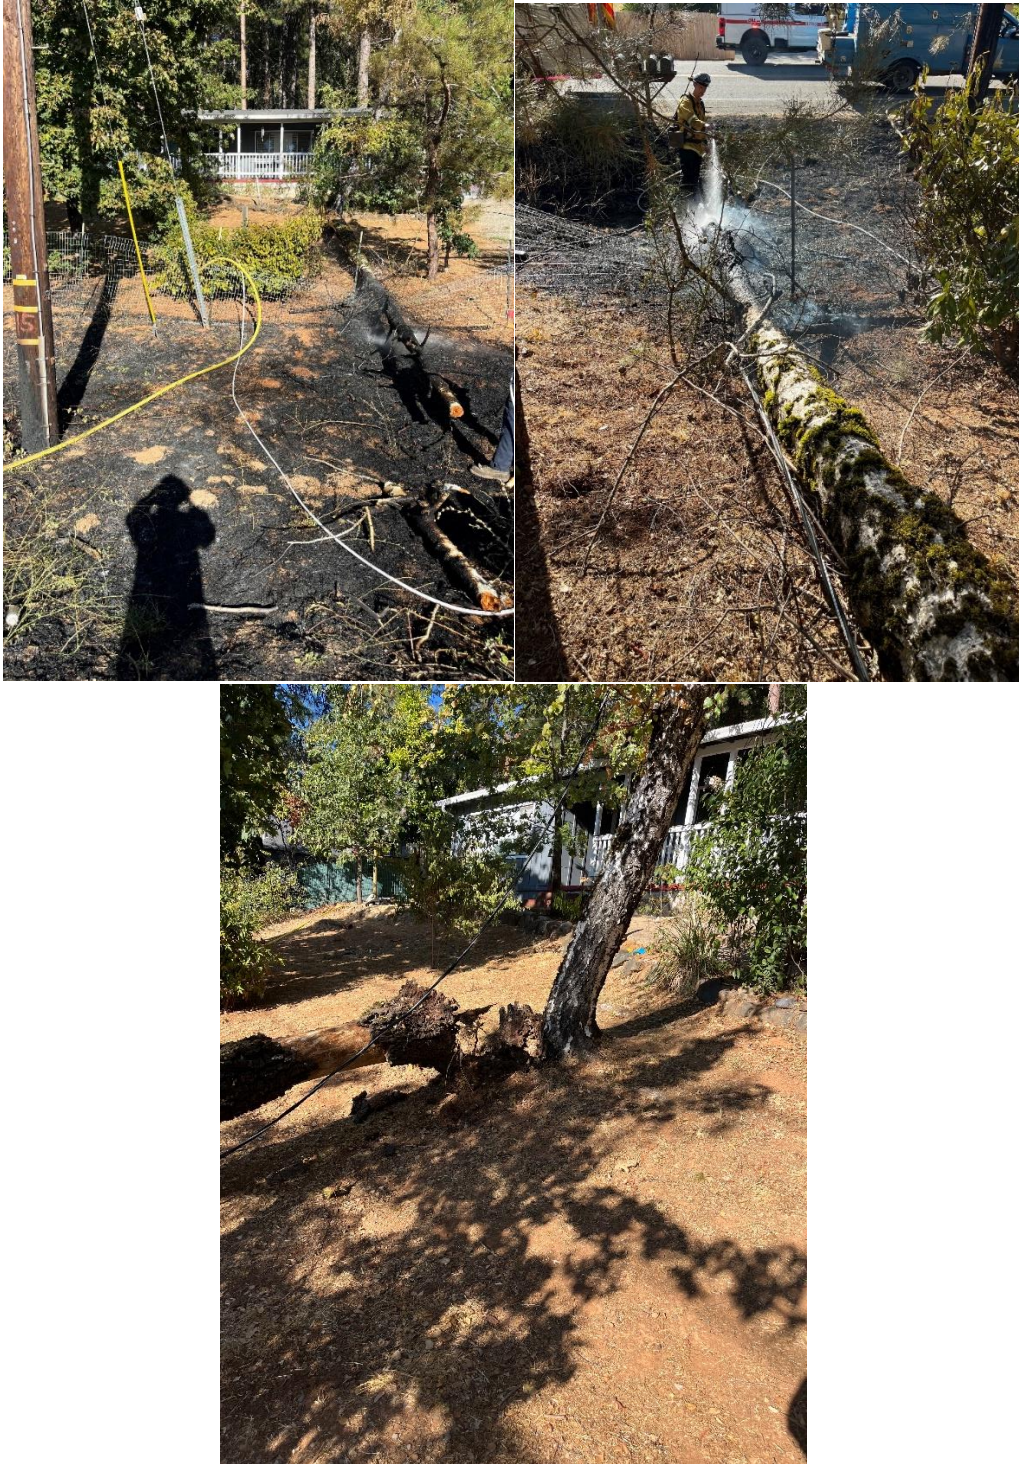
Upon arrival at the Incident Location at approximately 1615 hours, the troubleshooter reported that a tree fell on the service conductor, causing damage to the service and secondary mainline and starting a fire (see Figure 2 and Figure 3). CAL FIRE and the SIPT crew extinguished the fire. The troubleshooter created a Priority A Electric Corrective (EC) notification 129621745 to replace the transformer, crossarm, cutout, secondary and service conductors, and fuse on pole SAP ID 100067377 and a PG&E crew completed repairs October 3, 2024.

Figure 2. Incident photos showing Incident Tree and parts of burn area (taken October 2, 2024).

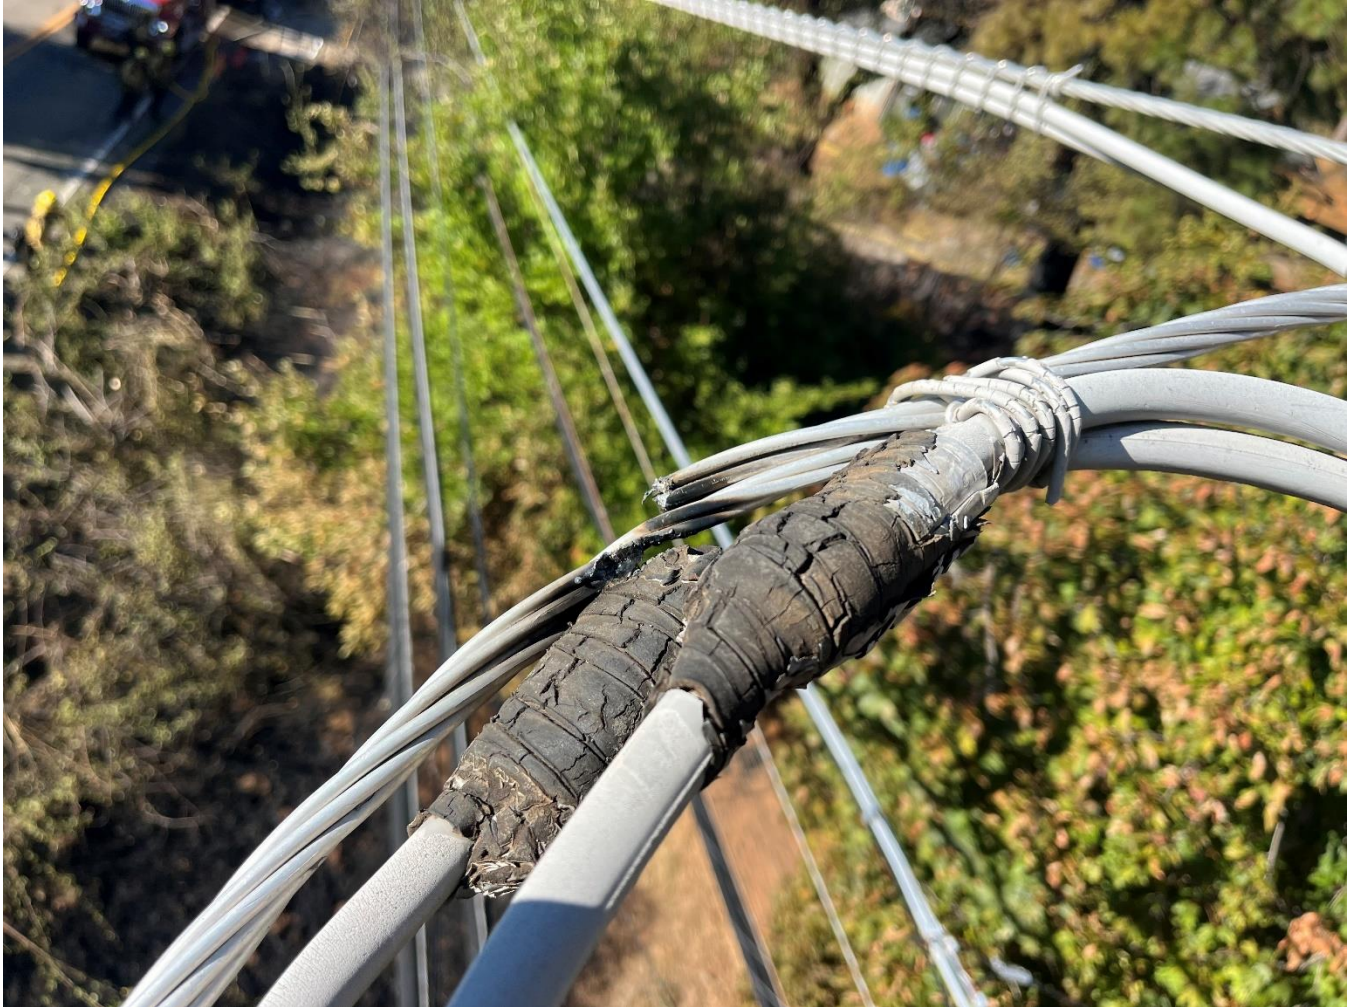
Figure 3. Incident photo showing damaged grey AWAC conductor and service conductor.

Priority A corrective notification #129621745 was created to replace the transformer, crossarm, cutout, fuse, and secondary and service conductors on pole SAP ID 100067377. This work was completed on October 3, 2024.

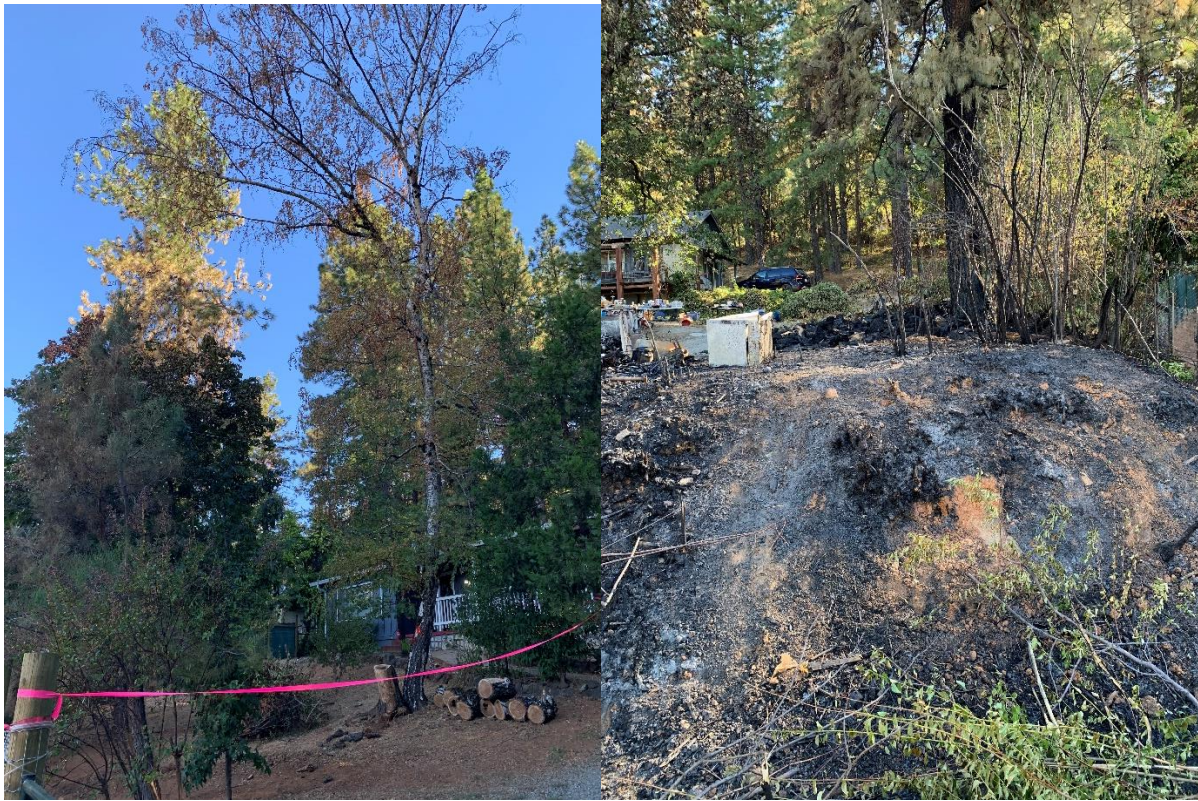
On October 4, 2024, Vegetation Management (“VM”) conducted a fire investigation and Extent of Condition patrol at the Incident Location. VM identified a burn area that was approximately 150 feet by 25 to 60 feet surrounding two poles in front of the Incident Location. They observed a two-stemmed birch tree (*Betula sp.*) that was approximately 24 feet west of the edge of the burned area with a recently failed stem (“Incident Tree”). The Incident Tree experienced failure at the root collar of one dead, line-facing stem measuring approximately 14 inches in diameter at breast height (see Figure 4). The stem had extensive basal decay and partial erosion externally visible at the base of the dead stem as well as internal heartwood decay extending four to five inches up the center of the failed stem that would not have been visible externally. The dead stem was prescribed for removal with routine priority during the most recent VM routine maintenance patrol on July 15, 2024, but was not appropriately marked “dead/dying” and the work was not completed at the time of the incident. Trees marked “dead/dying” should be worked within six months, so this did not impact the timeline of the ignition. Two priority 2 trees were prescribed for removal on the Extent of Condition patrol, including the remaining stem of the Incident Tree and a fire-damaged black oak (*Quercus kelloggii*).

Figure 4. Vegetation Management Investigation photos. Left photo shows remaining stem of Incident Tree and right photo shows burn area (taken October 4, 2024).
