Preliminary Ignition Investigation Report

Ignition Database Index:	20241461
Electric Incident Investigation (EII) Number:	NR241008A
Incident Name:	Piney
PG&E Facility Ignition?	Yes
CPUC Reportable Ignition?	Yes
Date & Time of Incident:	October 8, 2024 @ 1500 hours
Street Address:	38675 E Carmel Valley Rd
City:	Carmel Valley
County:	Monterey County
Latitude/Longitude:	36.38296321457728, -121.57254642709965
State Responsibility Area (SRA) / Local Responsibility Area (LRA) / Federal Responsibility Area (FRA)	State Responsibility Area (SRA)
PG&E Division:	Central Coast
High Fire Threat District (HFTD):	Tier 2
High Fire Risk Area (HFRA):	Yes
EPSS Buffer:	No
Fire Index Area (FIA):	550
Fire Potential Index (FPI) Rating: FIA	R4
Fire Potential Index (FPI) Rating: Circuit	R4
Was there a PSPS event at the time of ignition?	No
Suspected Initiating Event:	Vegetation
Failure Driver:	Contact from object
Failure Sub-driver:	Contact – Vegetation
Circuit:	LAURELES 1111

Executive Summary

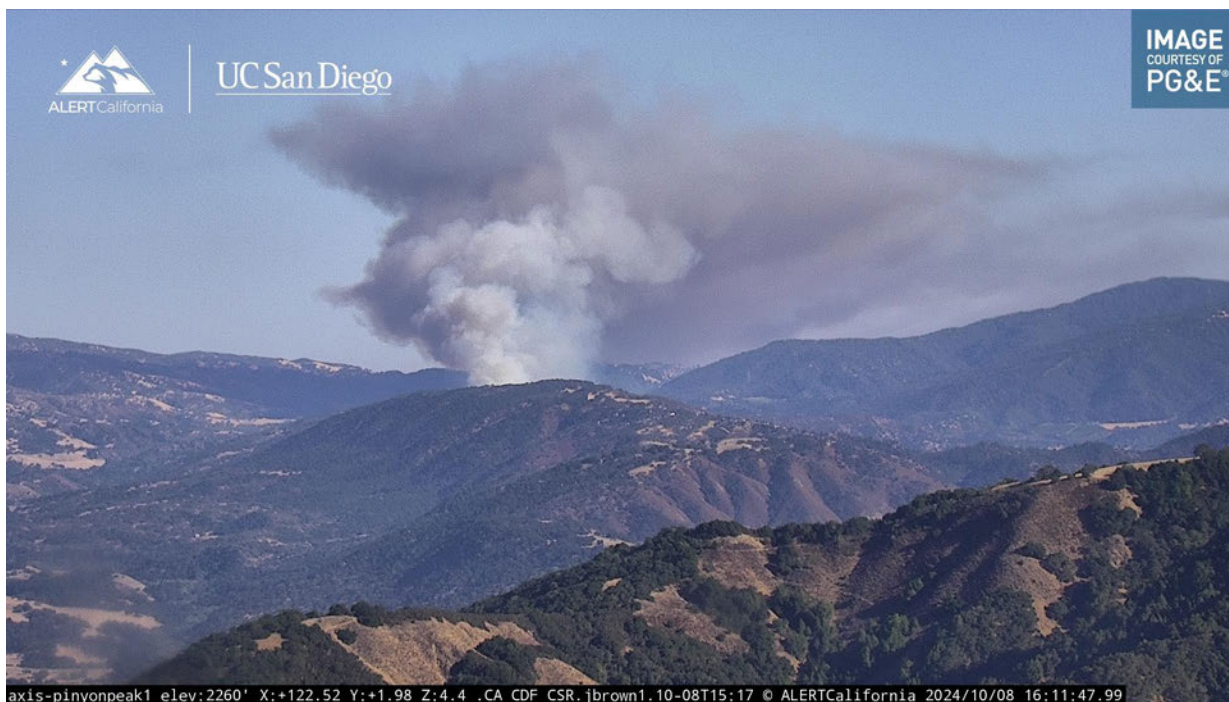
Figure 3: Smoke view from wildfire camera on October 8, 2024

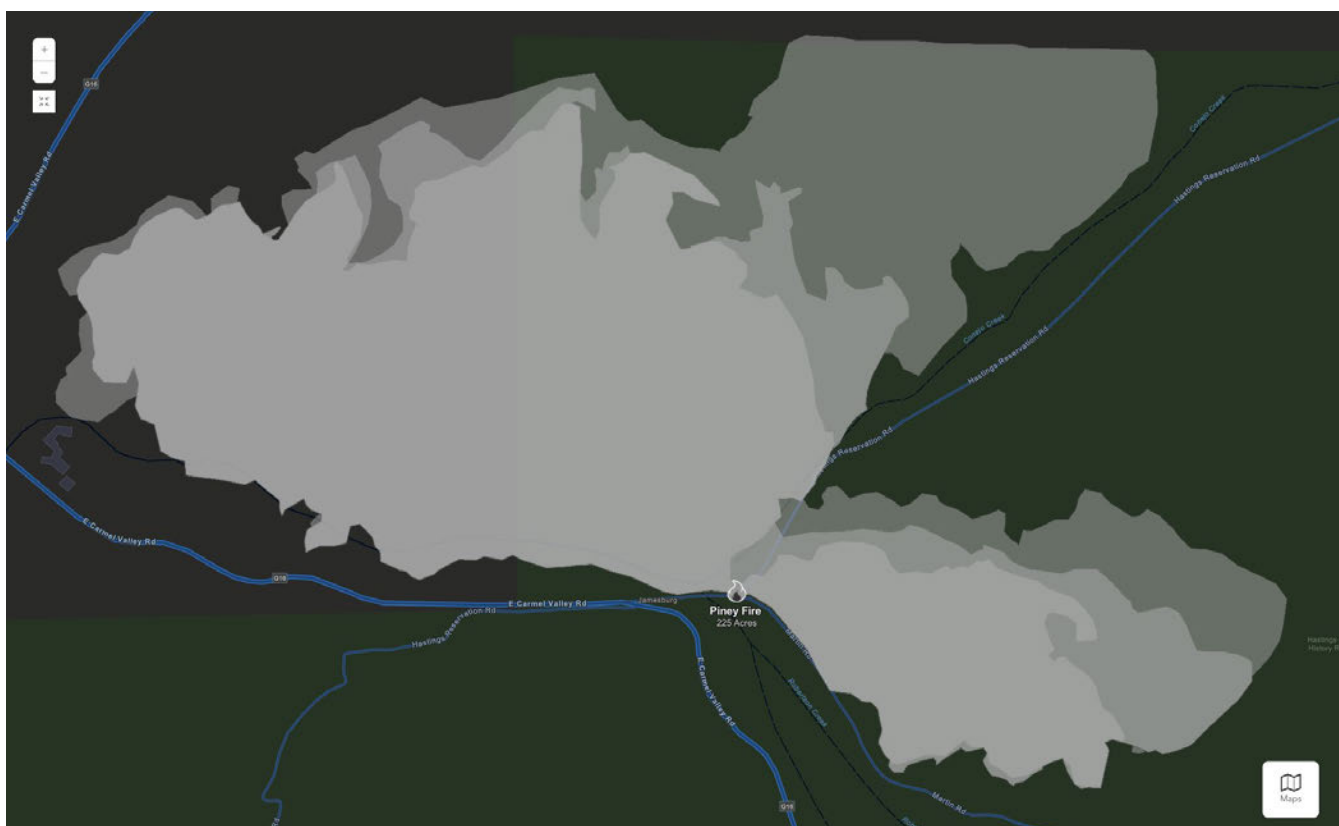
Figure 4: Fire burn area per CAL FIRE website

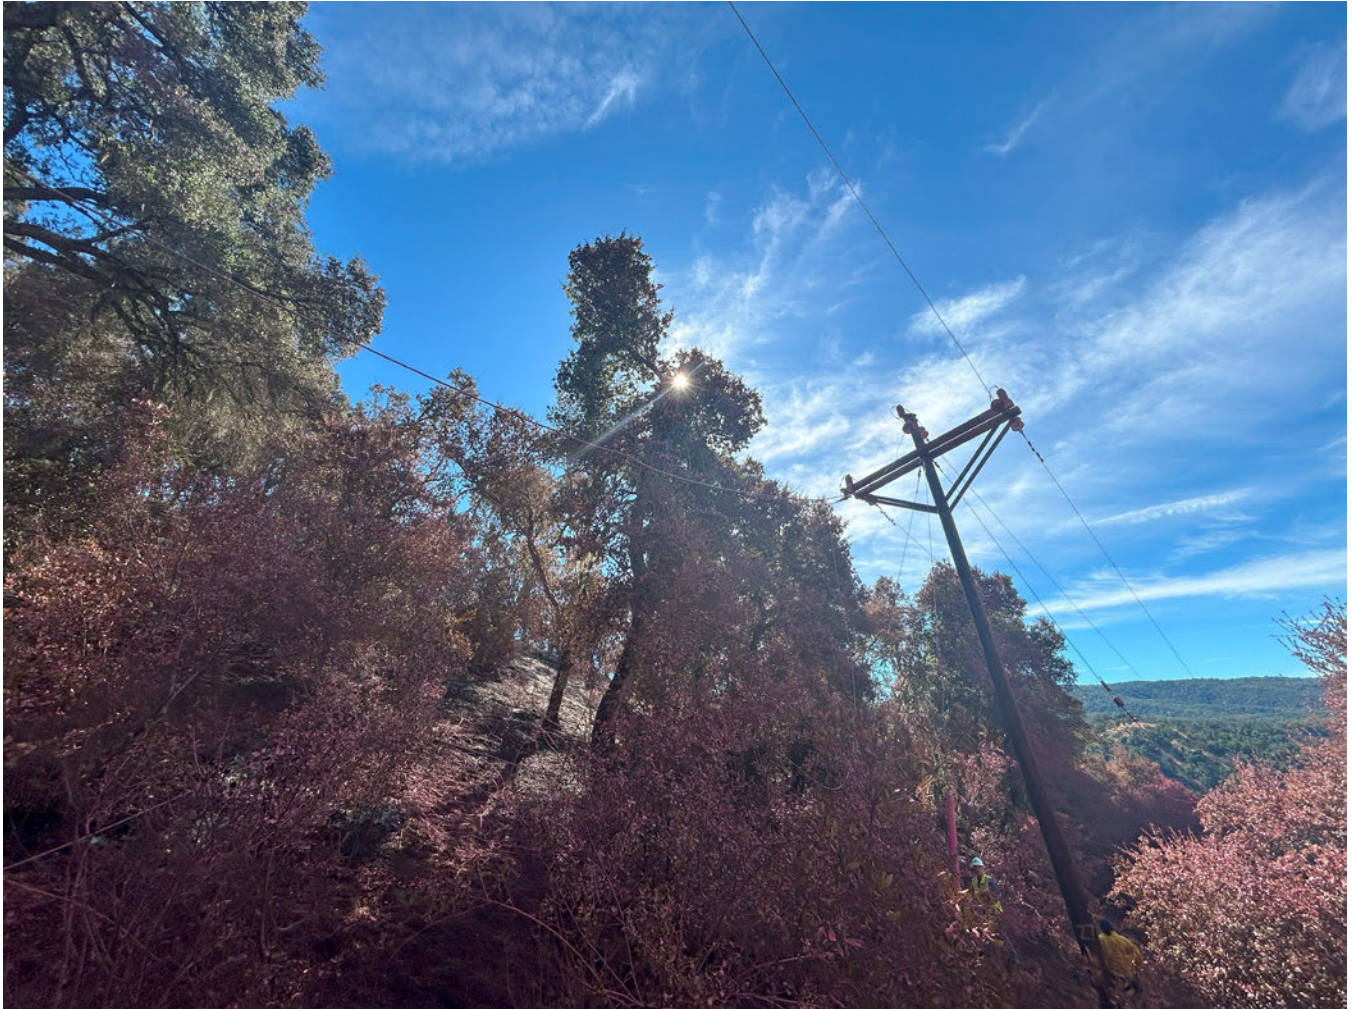
The closest pole to the Incident Tree was Pole #1. Pole #2 was the pole to the east and up the hill from the ignition location. Pole #2 was completely burned and appeared to have been cut by CAL FIRE at its base. The pole was sawed at the base and was found leaning into a nearby tree.

Figure 5: Pole #1 (SAPID 101702581) closest to the ignition site; photo taken by ignitions investigator October 9, 2024

- EC tag 129662057: at SAPID 101702581 Pole #1 — Replace three spans of conductor
- EC tag 129662056: at SAPID 101702582 Pole #2 — Replace burnt pole and reconductor
- EC tag 129669307: at SAPID 103946432 Pole #3 — Replace one span of conductor

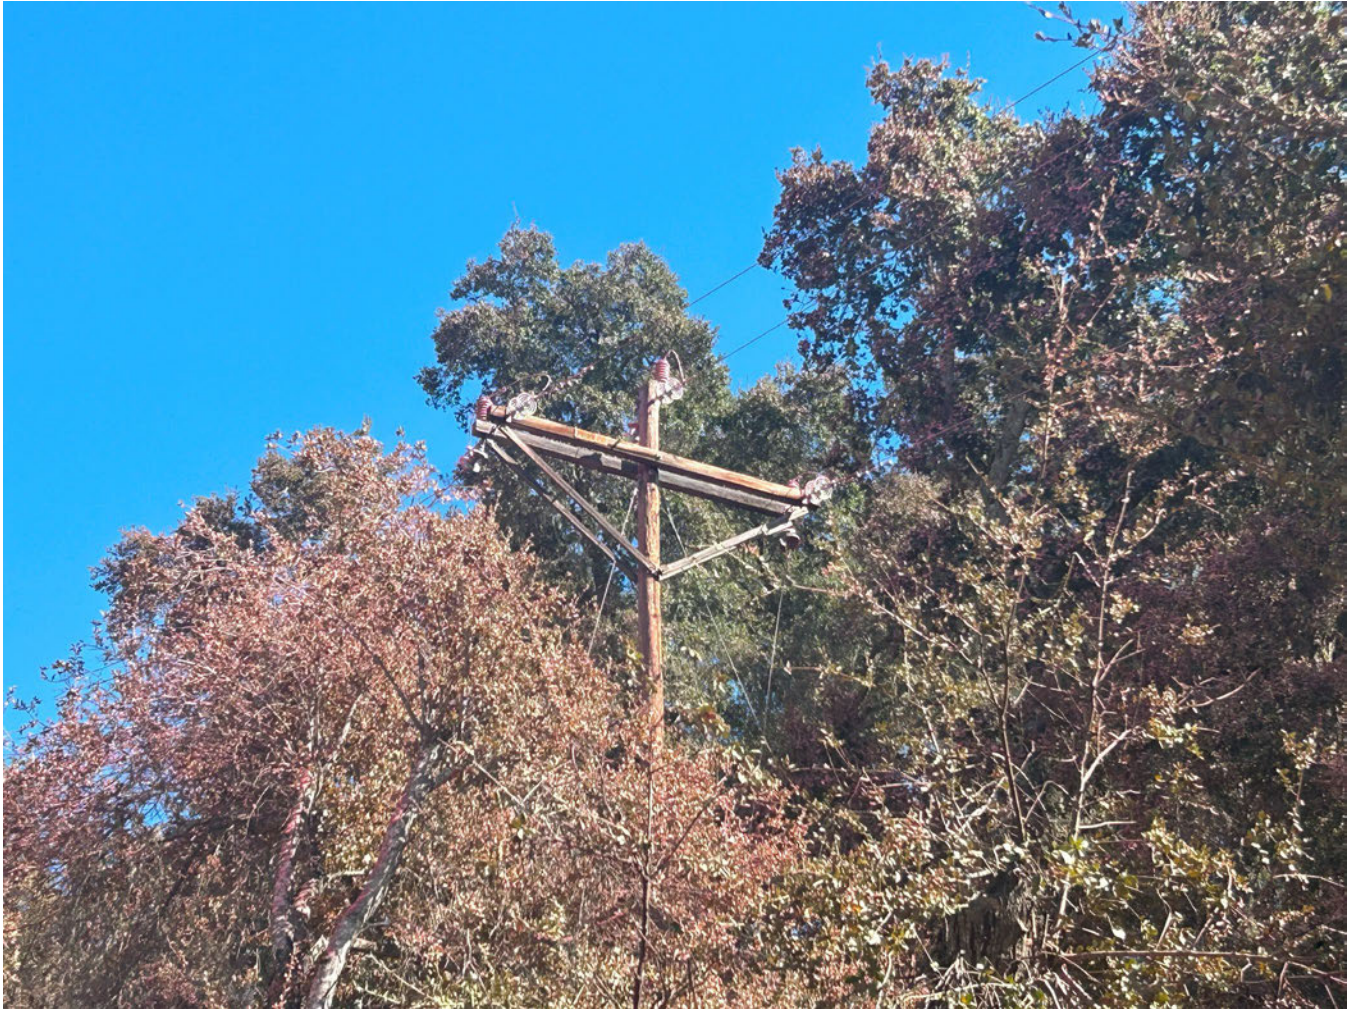
Figure 6: Pole #1 (SAPID 101702581) closest to the ignition site; photo taken by ignitions investigator October 9, 2024

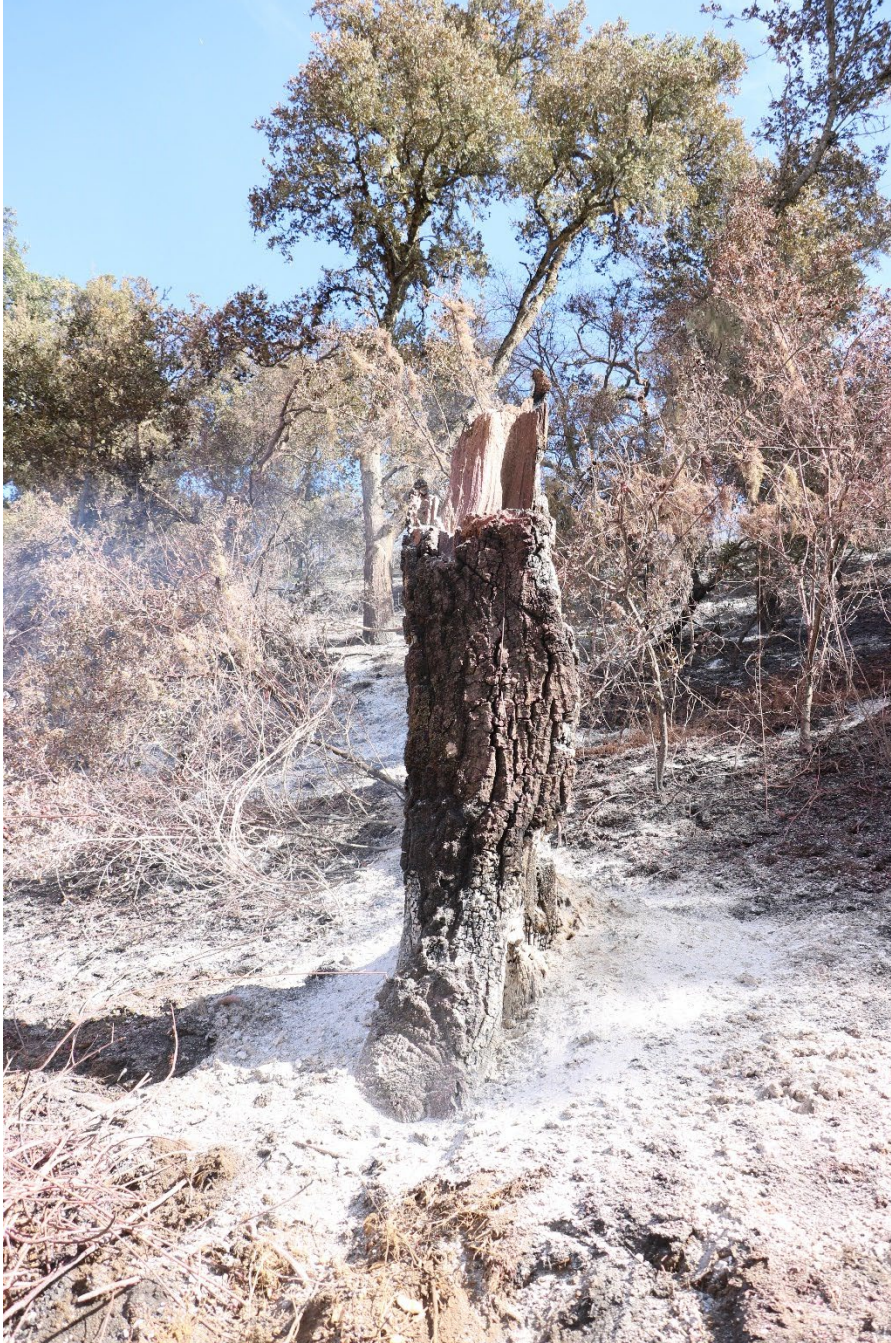
The trunk of the fallen tree was still on fire and smoldering at the time of inspection. The tree appeared to be externally green and healthy at the time of the ignition based on observations of its color and condition by PG&E investigators. After reviewing photographs provided by CAL FIRE investigators, PG&E investigators were able to determine the Incident Tree likely had a codominant top with two main stems emerging partway up its trunk. This was not evident based on the visual investigation completed on October 9, 2024 by PG&E investigators. At that time, the remains of the Incident Tree had no evidence of defects or decay.

Figure 7: Failed tree stump: photo taken by ignitions investigator October 9, 2024

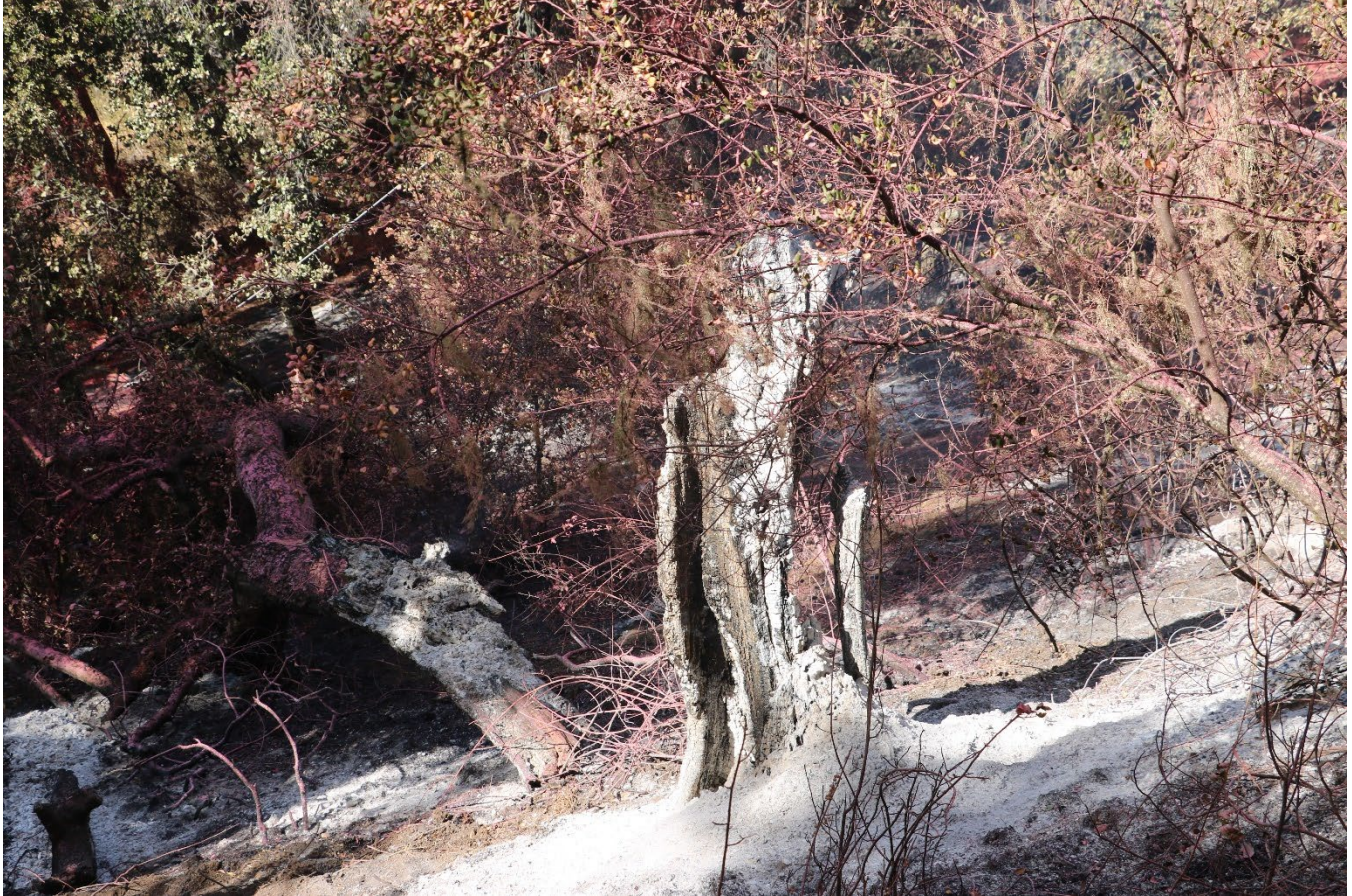
The incident site was released to PG&E investigators on October 9, 2024, at approximately 1430 hours. PG&E observed that the Incident Tree was a coast live oak (*Quercus agrifolia*) tree that had fallen across all three phases of conductor at what was determined to be the ignition site. The Incident Tree was approximately 65-foot tall with a diameter at breast height (DBH) of 26 inches. The tree broke seven feet above the base and fell in the north-northeast direction, downhill toward the conductors. The base of the tree was approximately 25 feet from the closest conductor.

Figure 8: Failed tree and stump: photo taken by ignitions investigator October 9, 2024

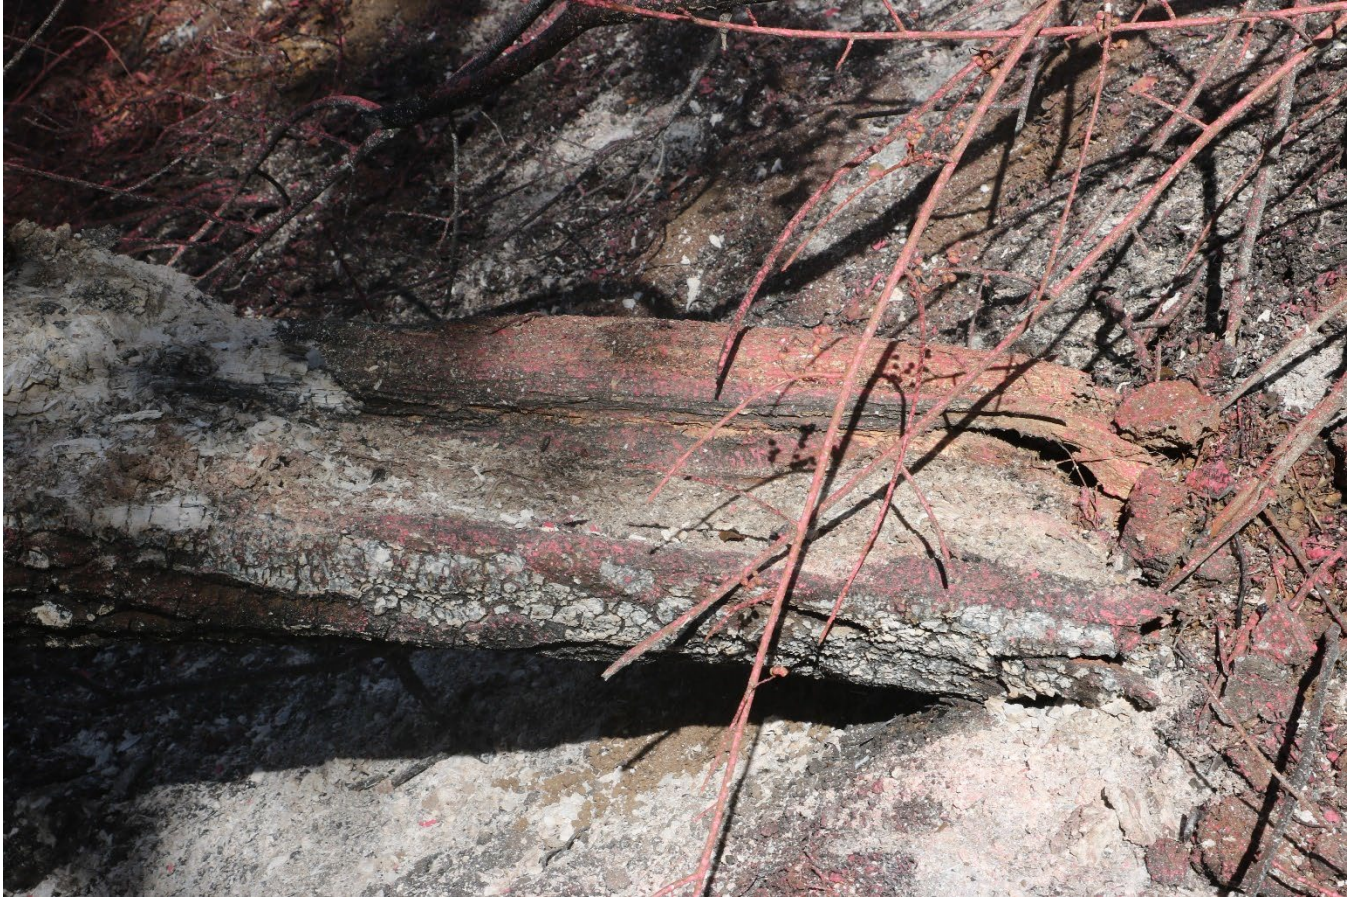
Figure 9: Bottom of the top half of failed tree: photo taken by ignitions investigator October 9, 2024

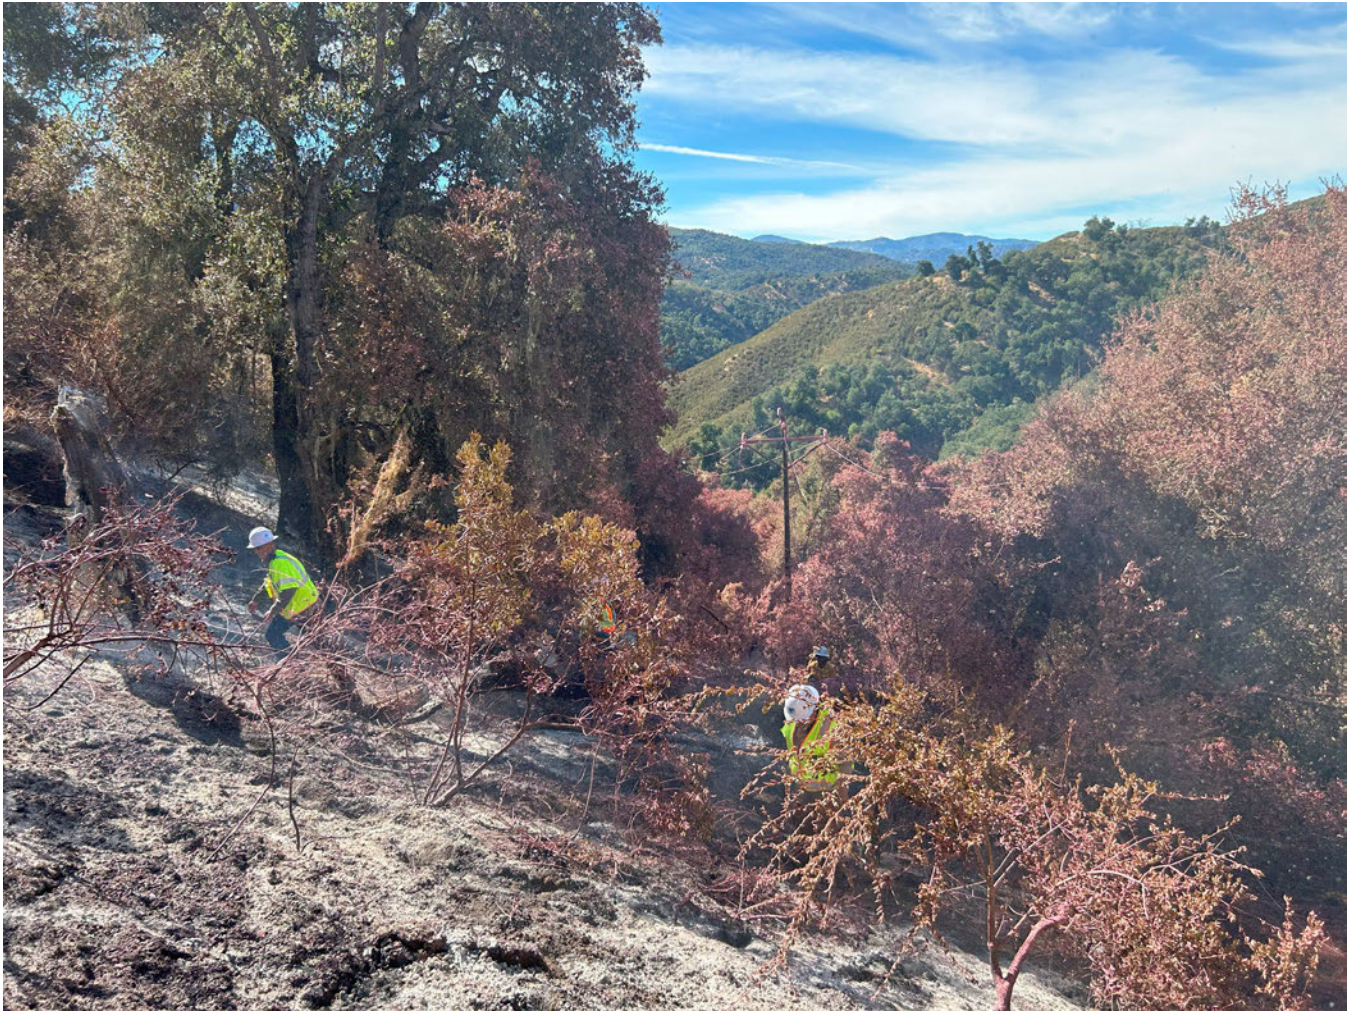
Figure 10: Failed tree in relation to overhead lines: photo taken by ignitions investigator October 9, 2024

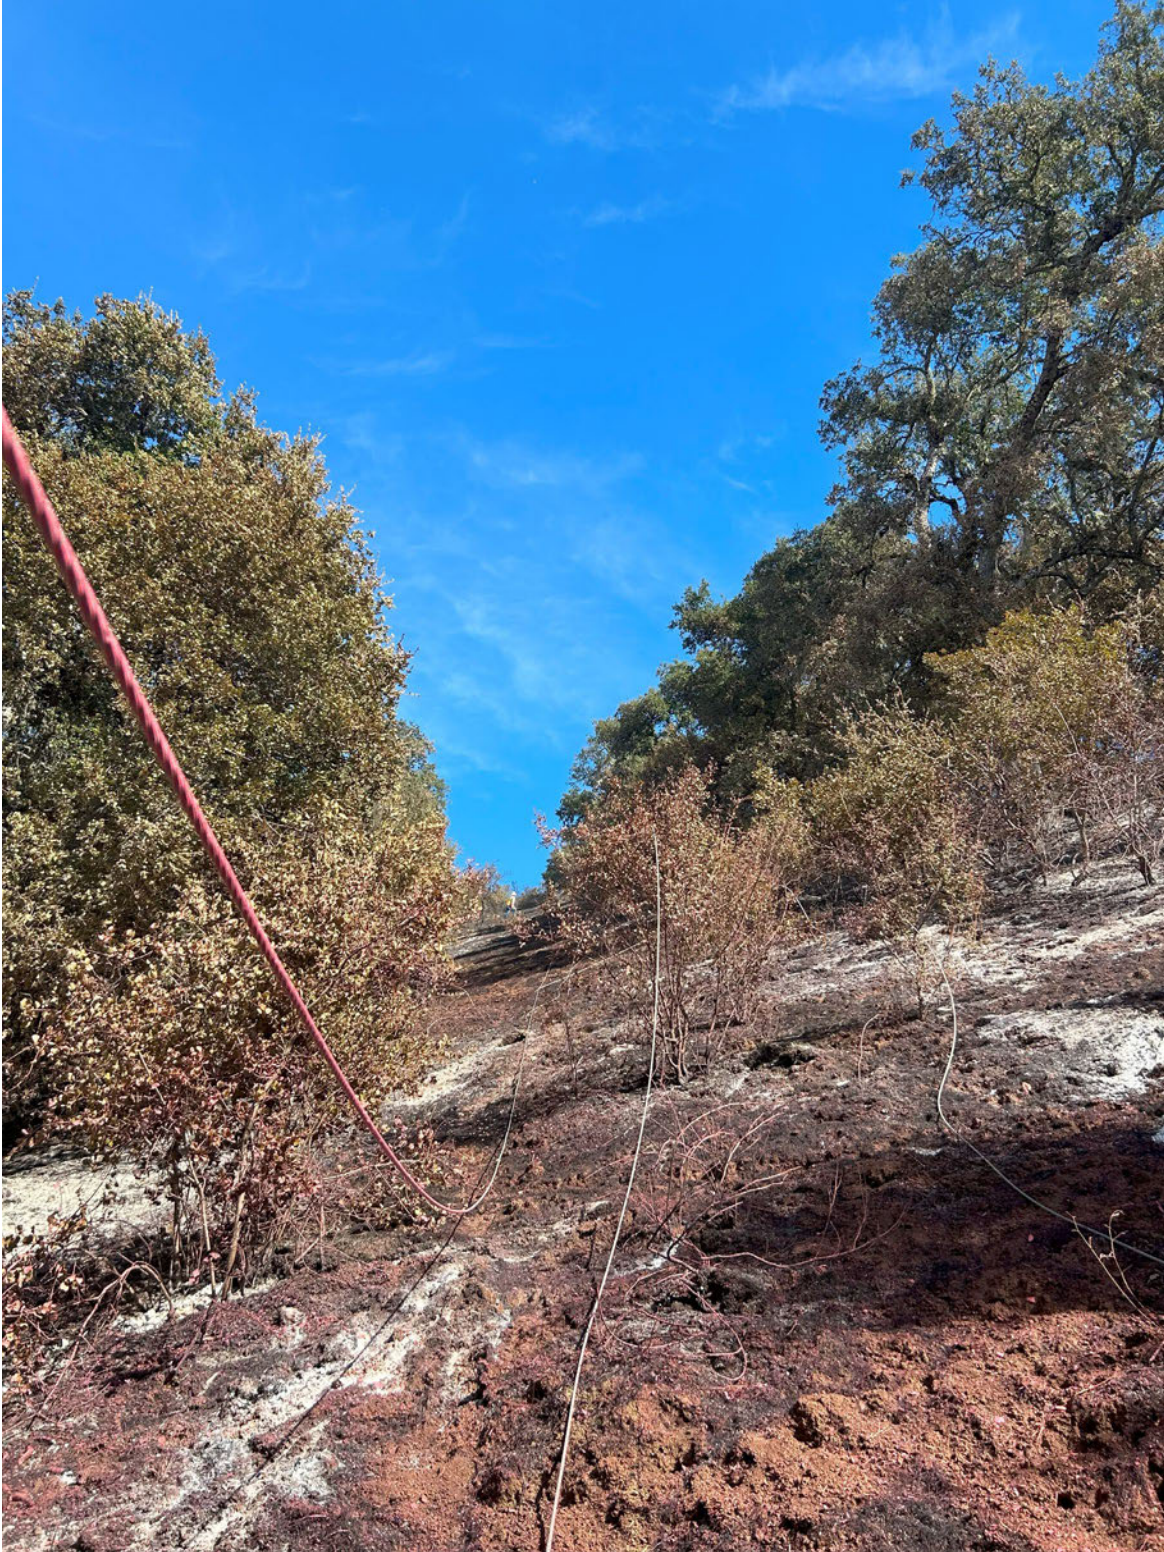
All three phases of the entire span between Pole #1 and Pole #2 were inspected by the VM and the ignitions investigation team on site on October 9, 2024. The conductor was found intertwined with the Incident Tree at the ignition site and was broken in multiple locations to the east of the ignition site. None of the broken sections of conductor were broken at connectors or splices.

Figure 11: Conductor laying on ground heading looking uphill; photo taken by ignitions investigator October 9, 2024

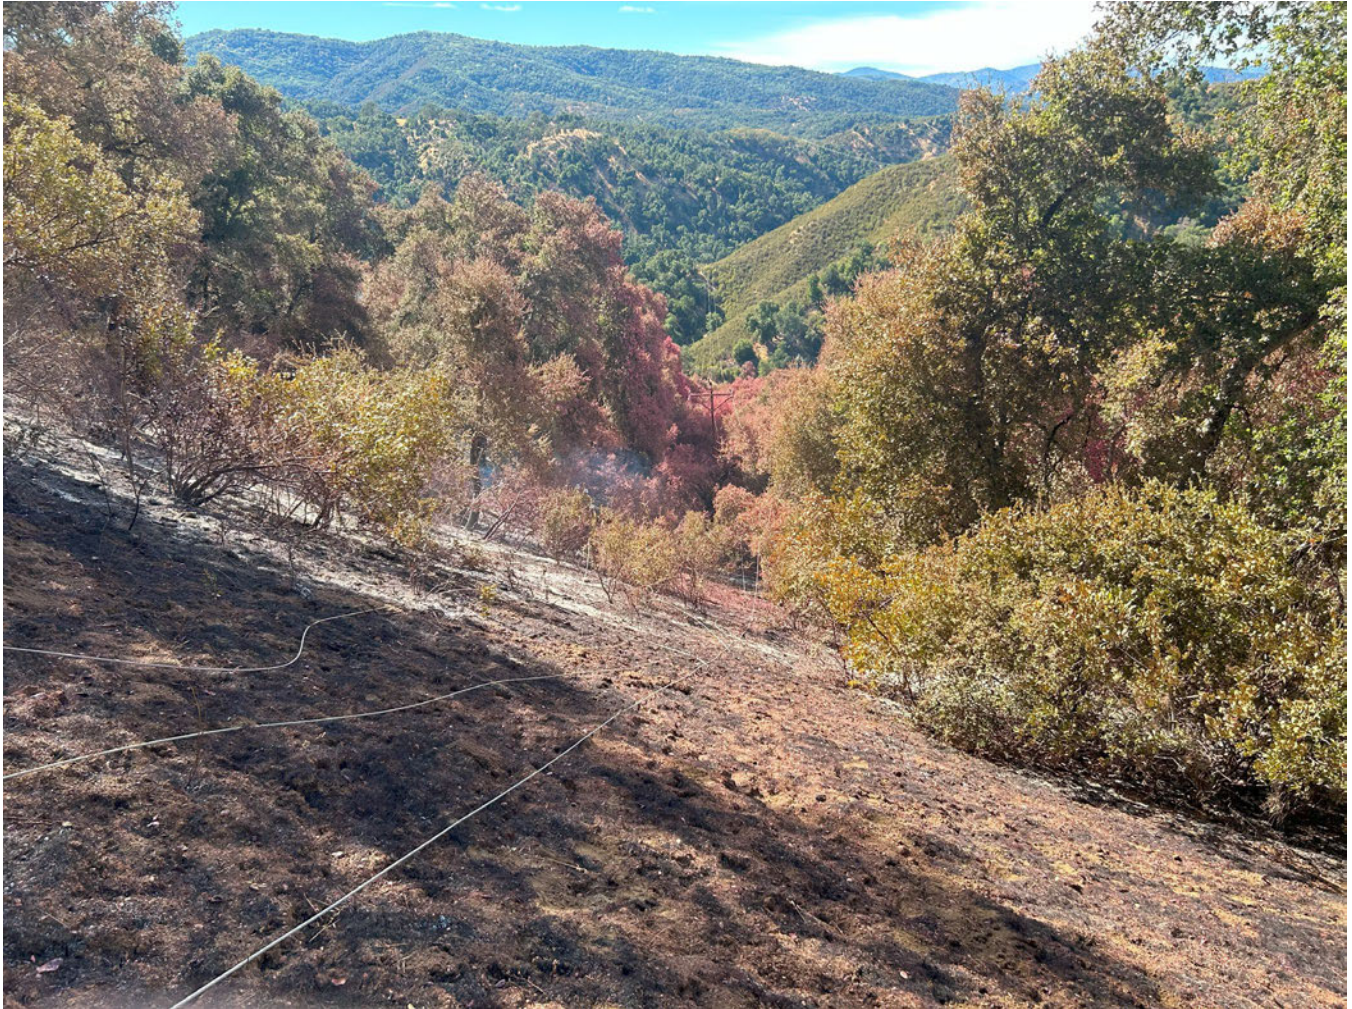
Figure 12: Conductor laying on ground looking downhill; photo taken by ignitions investigator October 9, 2024

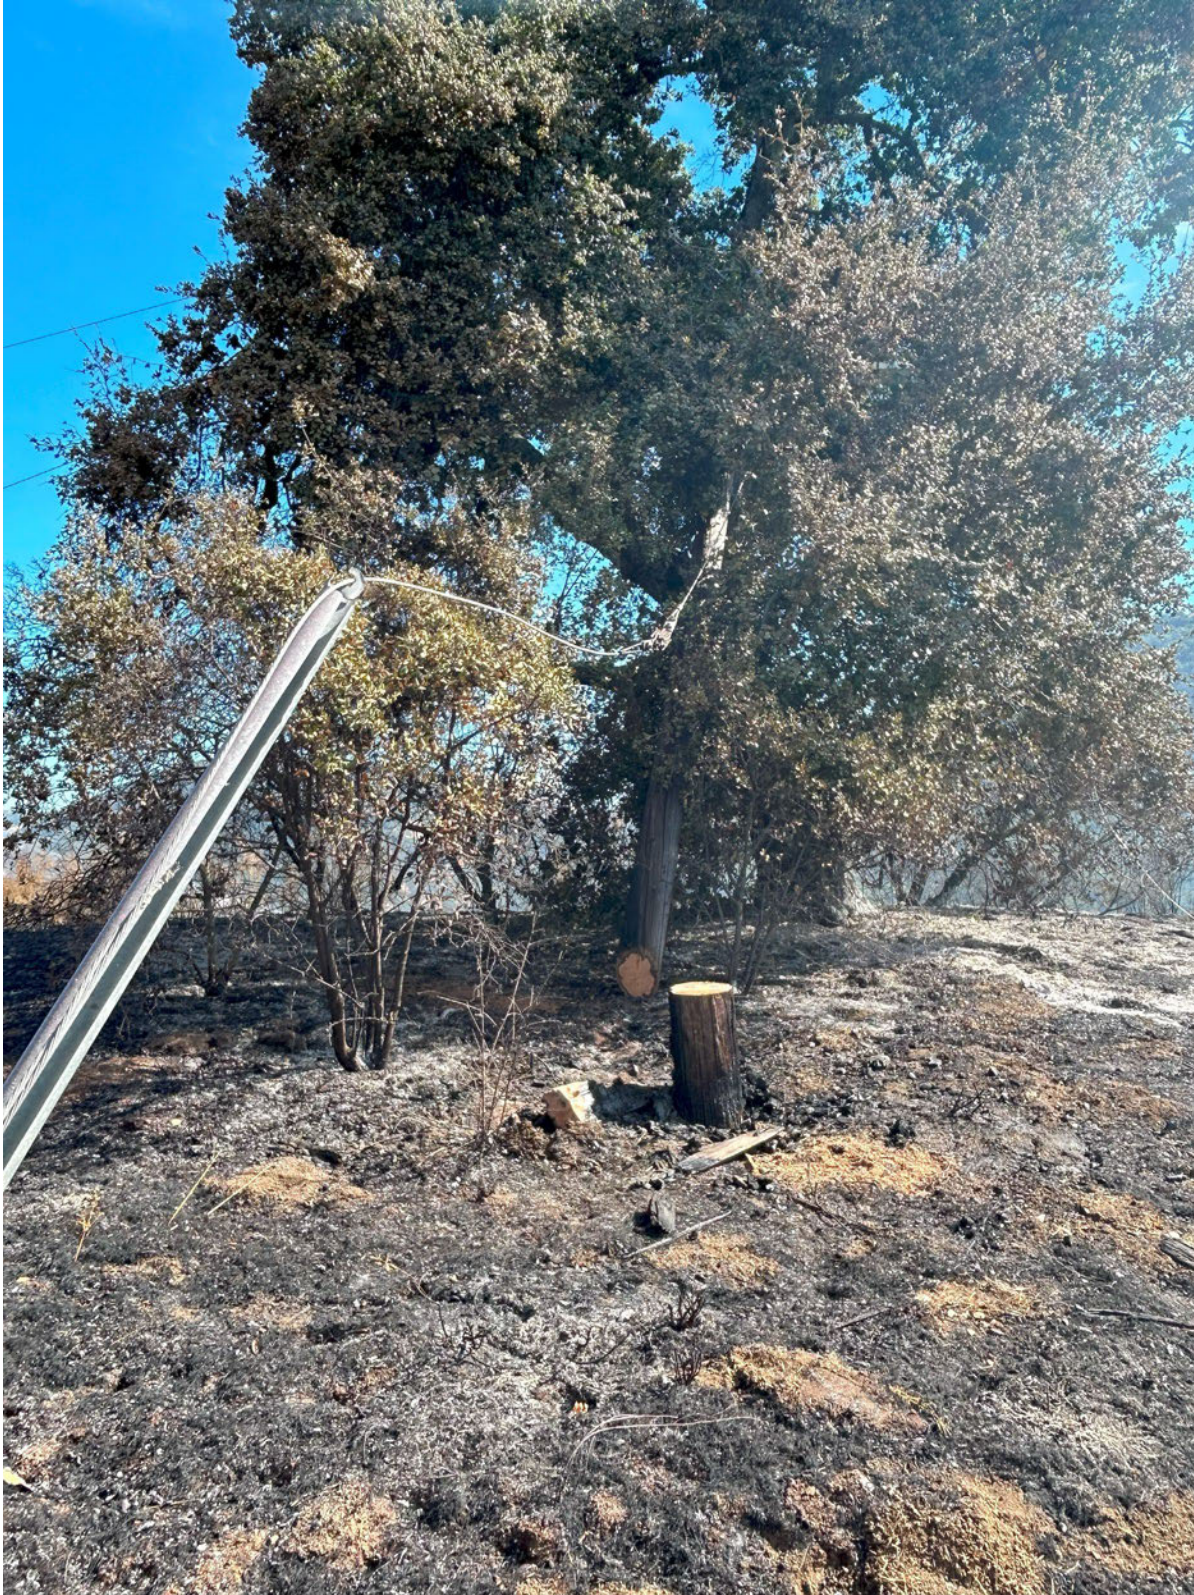
Figure 13: Burned/broken Pole #2 (SAPID 101702582) at top of hill; photo taken by ignitions investigator October 9, 2024

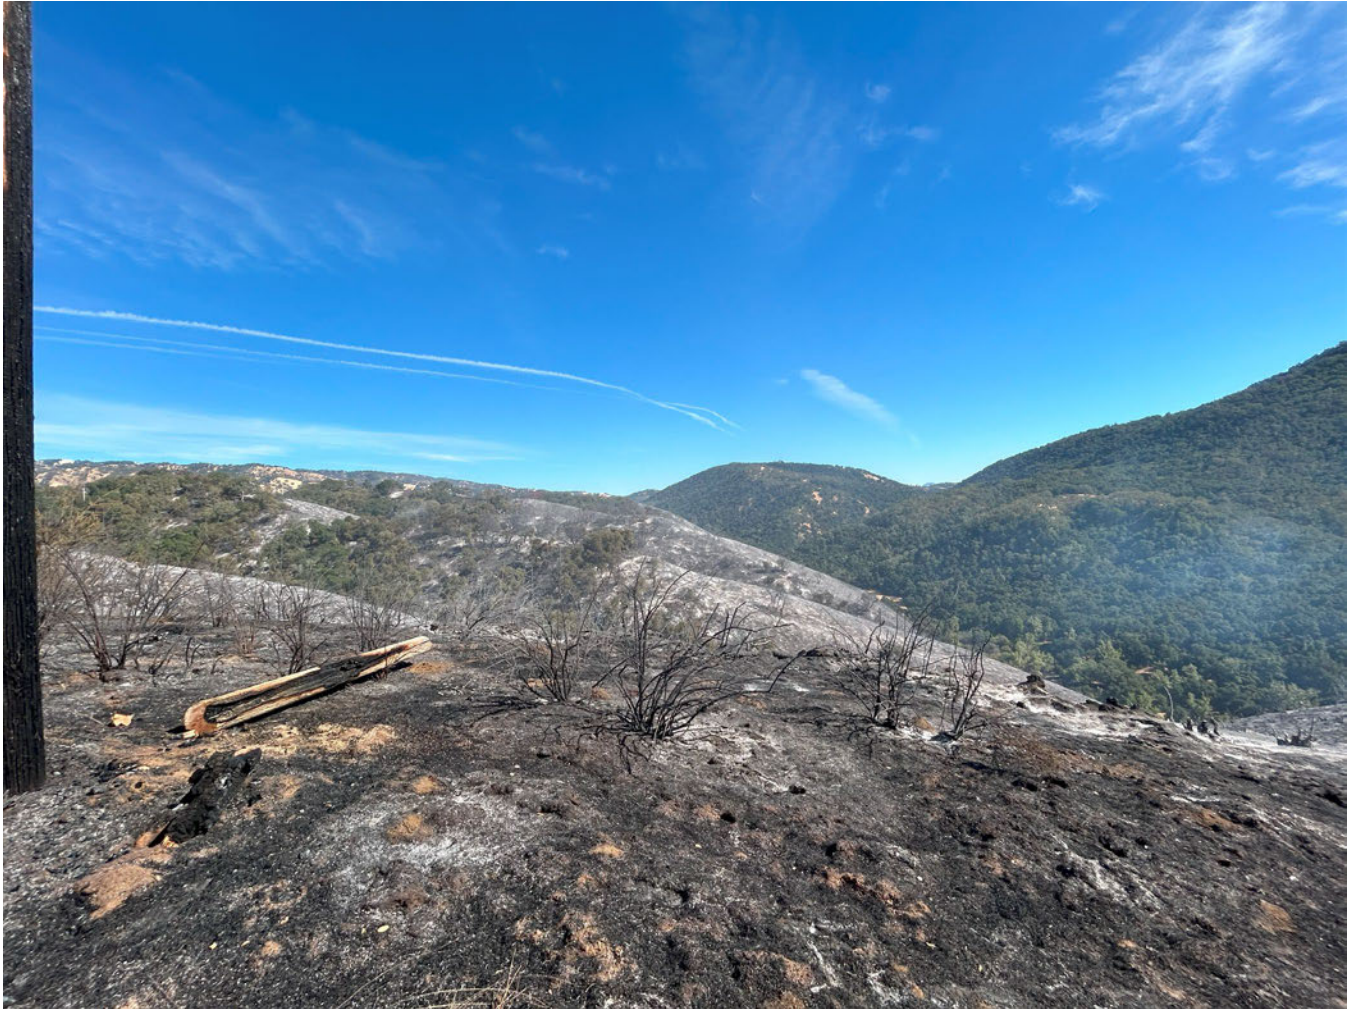
Figure 14: Fire burn area; photo taken by ignitions investigator October 9, 2024
