Preliminary Ignition Investigation Report

Ignition Database Index:	20241487
Electric Incident Investigation (EII) Number:	N/A
Incident Name:	Ridge
PG&E Facility Ignition?	Yes
CPUC Reportable Ignition?	Yes
Date & Time of Incident:	October 14, 2024 at approximately 0954 hours
Street Address:	4619 Tulle Lane
City:	Shingle Springs
County:	El Dorado
Latitude/Longitude:	38.659627, -120.910922
State Responsibility Area (SRA) / Local Responsibility Area (LRA) / Federal Responsibility Area (FRA)	State Responsibility Area (SRA)
PG&E Division:	Sierra
High Fire Threat District (HFTD):	Tier 3
High Fire Risk Area (HFRA):	Yes
EPSS Buffer:	No
Fire Index Area (FIA):	305
Fire Potential Index (FPI) Rating: FIA	R3
Fire Potential Index (FPI) Rating: Circuit	R3
Was there a PSPS event at the time of ignition?	No
Suspected Initiating Event:	Equipment – PG&E
Failure Driver:	Equipment Failure
Failure Sub-driver:	Capacitor Bank Failure
Circuit:	Shingle Springs 2110
Circuit Protection Zone:	Shingle Springs 21107742 ¹

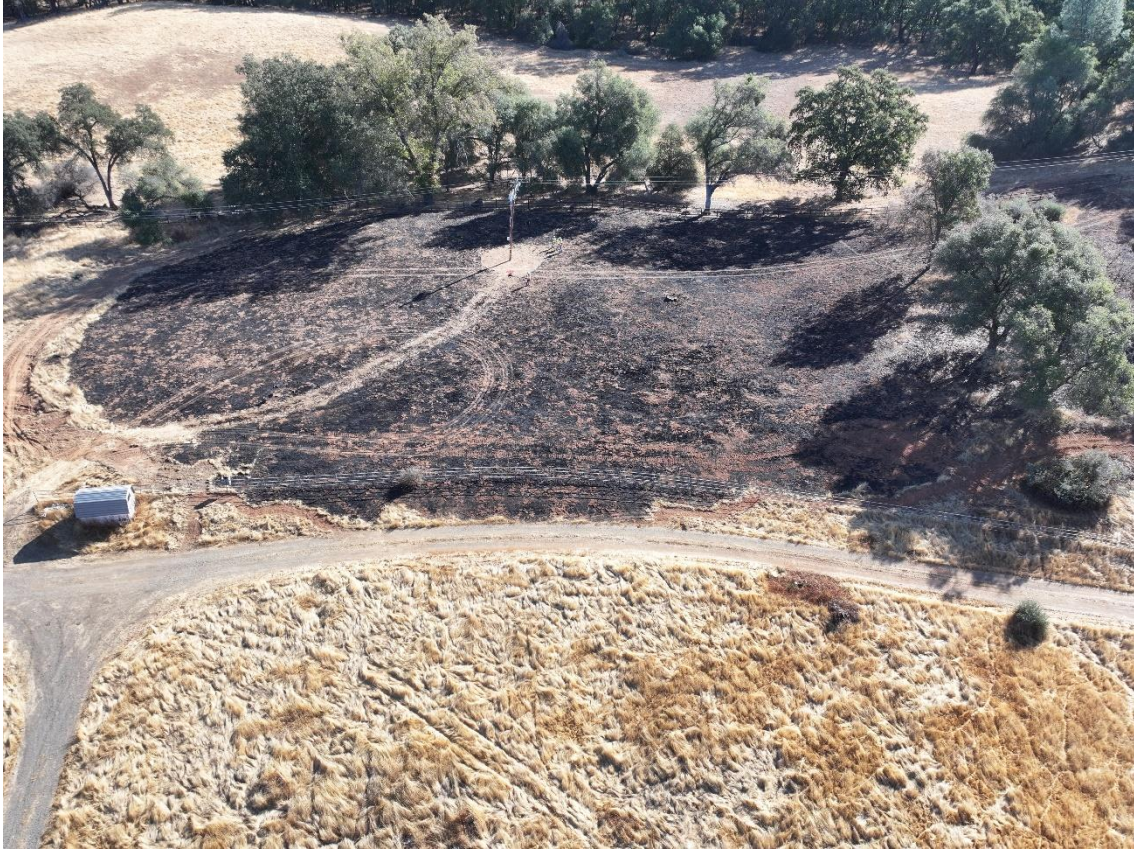
The ignition burned a dry grassy area surrounding C2044 approximately 2 acres in size and caused an outage to 721 customers for approximately 84 minutes. There were no injuries, fatalities, property damage, or media attention identified for this incident.

Figure 2. Fire footprint surrounding pole SAP ID 101380976 with capacitor bank C2044 (taken October 14, 2024).

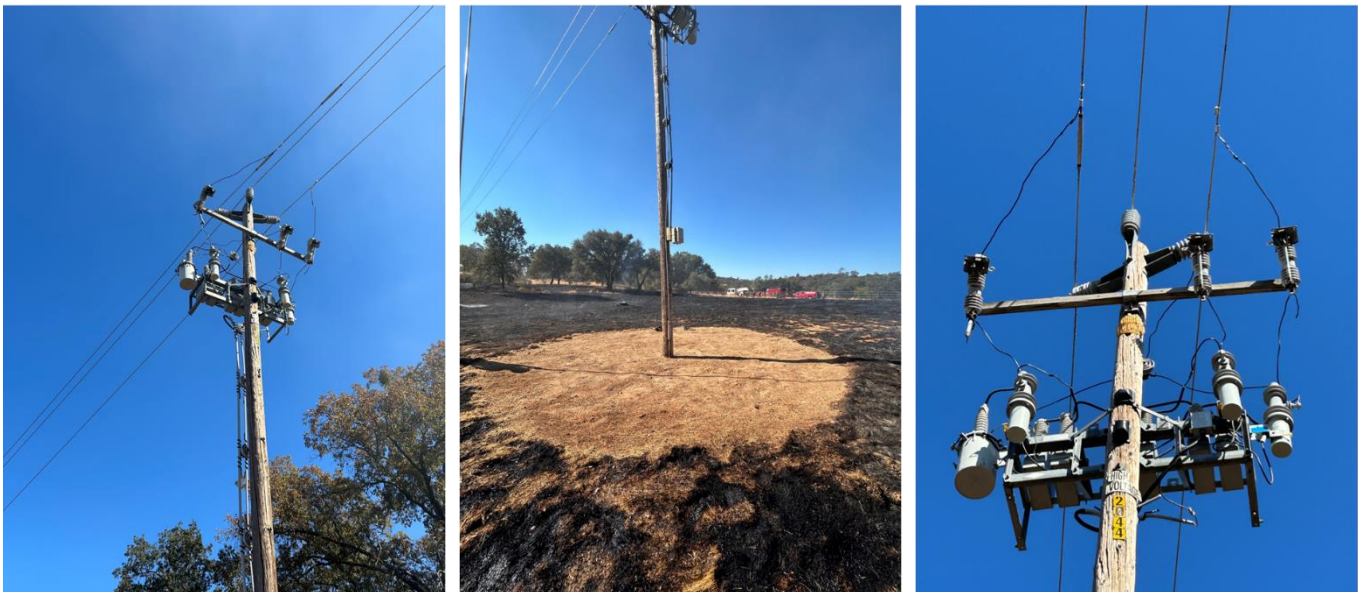
Figure 3. Incident photos showing pole SAP ID 101380976 (left), burned area outside of base of pole (center), and capacitor bank C2044 (right) (taken October 14, 2024).

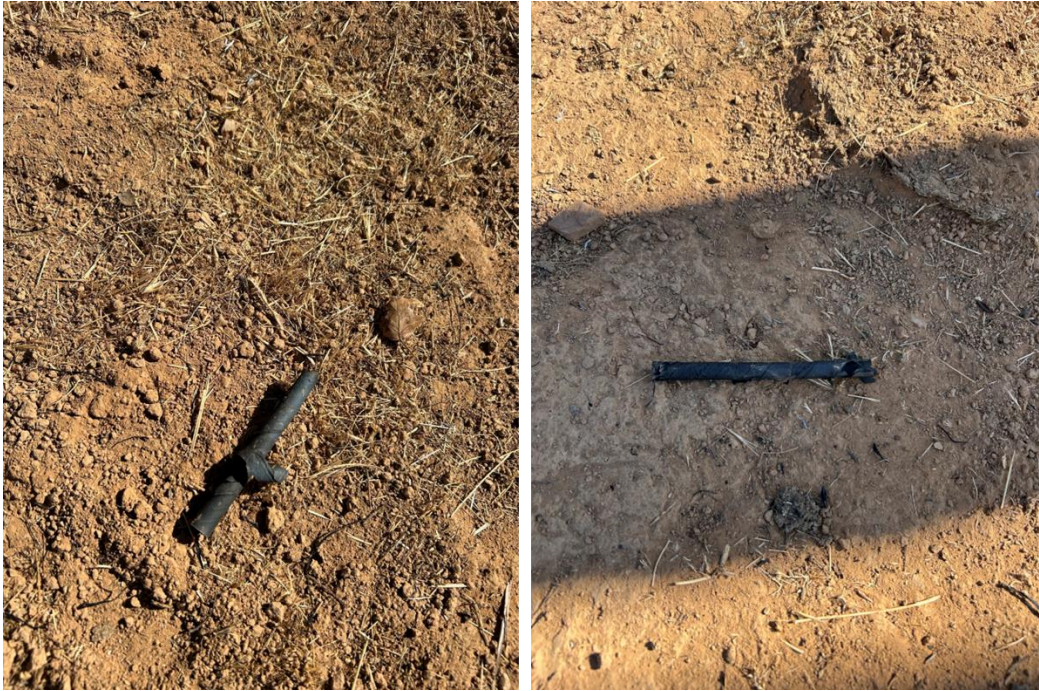
Pole Clearing Program	<p>Expected Performance: Decrease ignition potential and fire spread from operation of non-exempt universal fuses.</p> <p>Observed Performance: Barrier did not perform as expected</p>	A2B2C2D5 – Non-exempt equipment caused ignition outside of cleared radius	Fuses operated and expelled flammable paper material, igniting dry grass outside of 10-ft cleared area.

Figure 4. Incident photos showing two burned paper elements of fuse link (taken October 14, 2024).

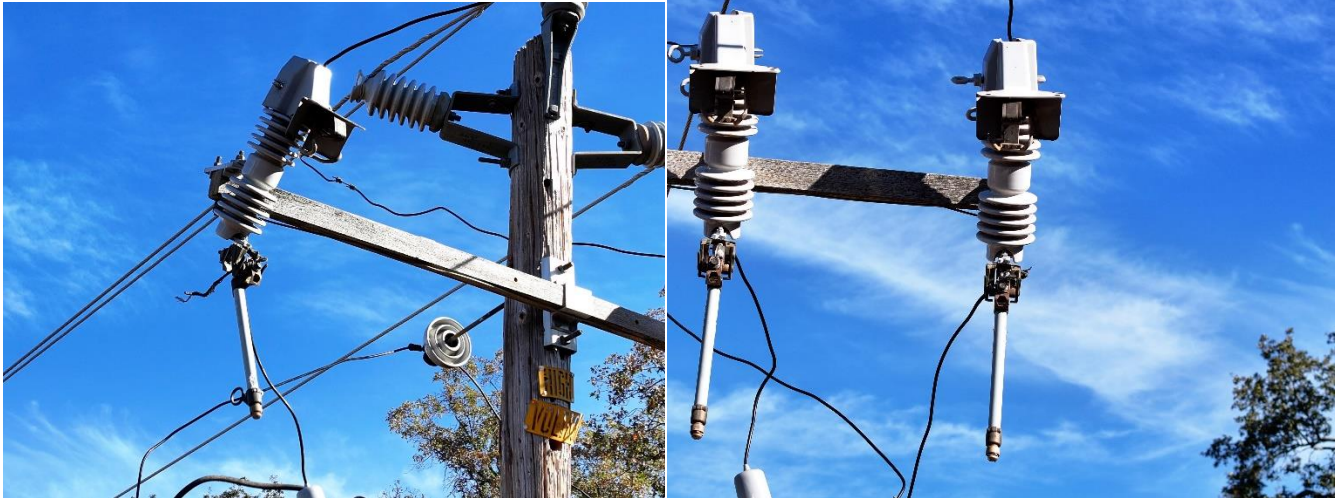
Upon arrival, Troubleshooter #1 reported that two of three Universal Fuses on capacitor bank C2044 were blown. CAL FIRE was on scene mopping up the extinguished fire when the troubleshooters arrived. At 1047 hours, the Distribution Operator (“DO”) gave Troubleshooter #1 the go ahead to place C2044 offline when the troubleshooters could gain access. The troubleshooters noted that the two outside phase fuses were blown and that the fuses expelled paper material when they blew. One of the pieces of paper material fell outside of the cleared area around the base of the pole, igniting the dry grass and leading to an approximately two-acre fire (see Figure 3, Figure 4, Figure 5, and Figure 6). At 1116 hours, Troubleshooter #1 reported that C2044 was placed offline and that the troubleshooters patrolled back to LR 7742 and found no other trouble. The troubleshooters created Priority F Critical Operating Equipment (COE) notification 129684037 to repair the capacitor bank.

Figure 6. Post-incident photos showing blown fuses on capacitor bank C2044 (taken October 22, 2024).

On October 24, 2024, a local Maintenance and Construction Supervisor created Priority X Electric Corrective (EC) Notification 129725347 to replace the broken capacitor bank, cutouts, and lightning arrester. On October 25, a PG&E crew replaced C2044 and, subsequently, sent the failed capacitor bank, fuse cutouts, and two fuses to Applied Technology Solutions (“ATS”) for analysis. ATS determined that the capacitor bank’s failure mode appeared to be an internal short in one of the six capacitor units. One of the phase C units measured zero capacitance and was confirmed to be a dead short. Radiography of the capacitor unit was not conclusive in providing a root cause of the failure. ATS determined that the fault from the capacitor bank failure was momentary but caused two fuses to operate and expel flammable material into the surrounding grass, igniting the fire. Based on discussion with an engineer from a fuse testing lab, expulsion of fuse link material outside of 10 feet from a pole is typical normal behavior for a fuse operation. ATS report 006.6-24.71 describes the laboratory analysis of the failed capacitor unit.
