Preliminary Ignition Investigation Report

Ignition Database Index:	20241539
Electric Incident Investigation (EII) Number:	N/A
Incident Name:	N/A
PG&E Facility Ignition?	Yes
CPUC Reportable Ignition?	Yes
Date & Time of Incident:	October 23, 2024 at approximately 1532 hours
Street Address:	Near intersection of Meadow Way and San Geronimo Valley Drive
City:	San Geronimo
County:	Marin
Latitude/Longitude:	38.012561, -122.662975
State Responsibility Area (SRA) / Local Responsibility Area (LRA) / Federal Responsibility Area (FRA)	SRA
PG&E Division:	North Bay
High Fire Threat District (HFTD):	Tier 3
High Fire Risk Area (HFRA):	Yes
EPSS Buffer:	No
Fire Index Area (FIA):	190
Fire Potential Index (FPI) Rating: FIA	R3
Fire Potential Index (FPI) Rating: Circuit	R3
Was there a PSPS event at the time of ignition?	No
Suspected Initiating Event:	Vegetation
Failure Driver:	Contact from Object
Failure Sub-driver:	Contact – Vegetation
Circuit:	Woodacre 1101, 04302-1101
Circuit Protection Zone:	Woodacre CB 1101/2

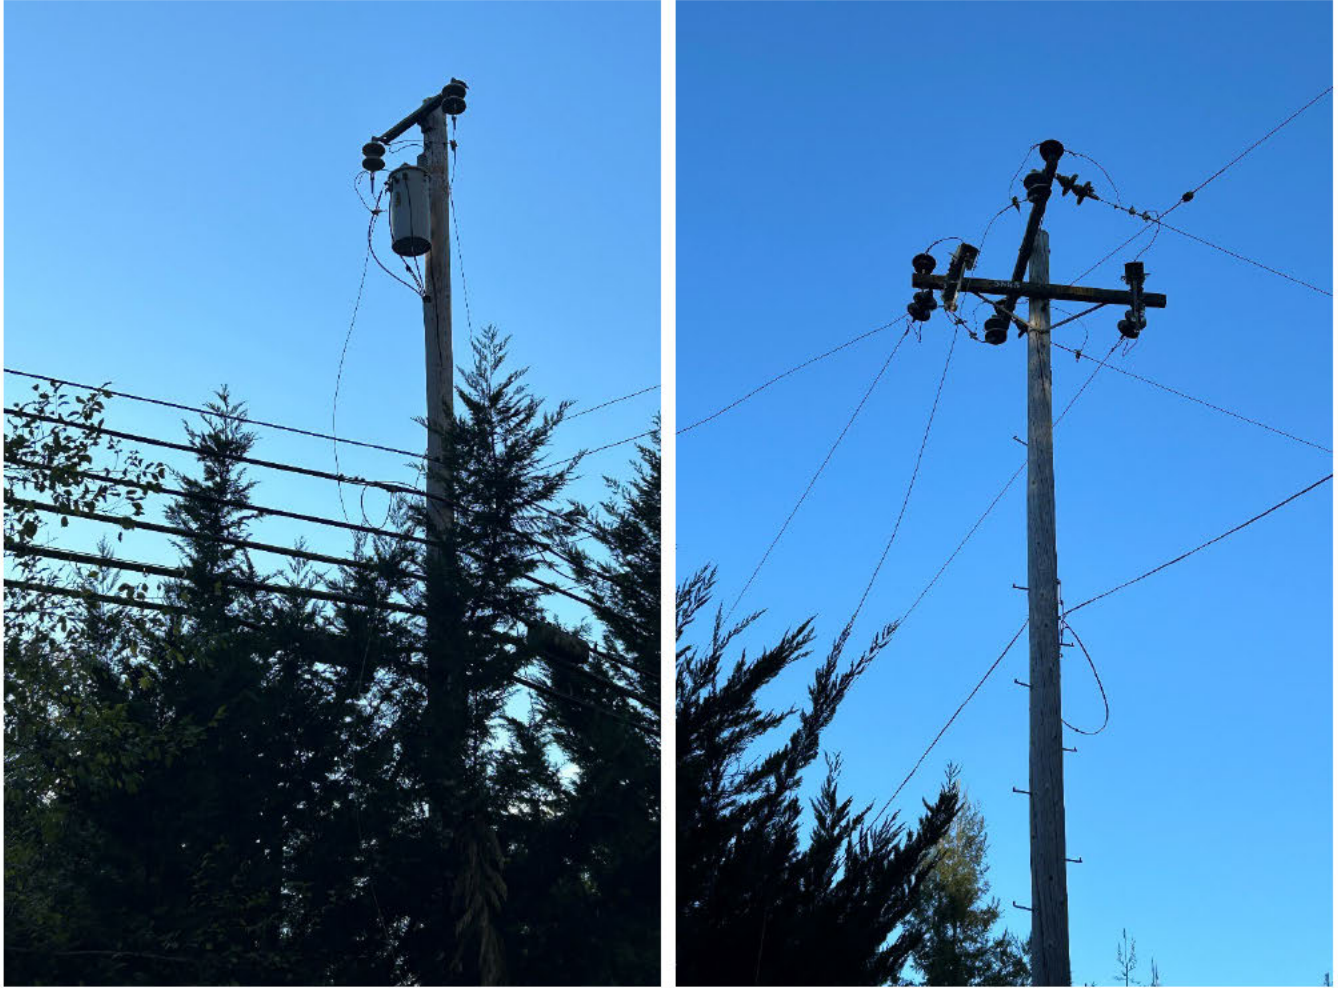
Figure 2 – View of Pole SAP ID 102257882 (left) and 102257887 (right) on October 23, 2024. Photos taken by troubleshooter.

As a result of this ignition event, two priority “A” Electric Corrective (EC) tags were created in association to OIS (#2602418). EC tag (#129723072) was created to replace the two broken phases of 4 ACSR from the tree into lines.

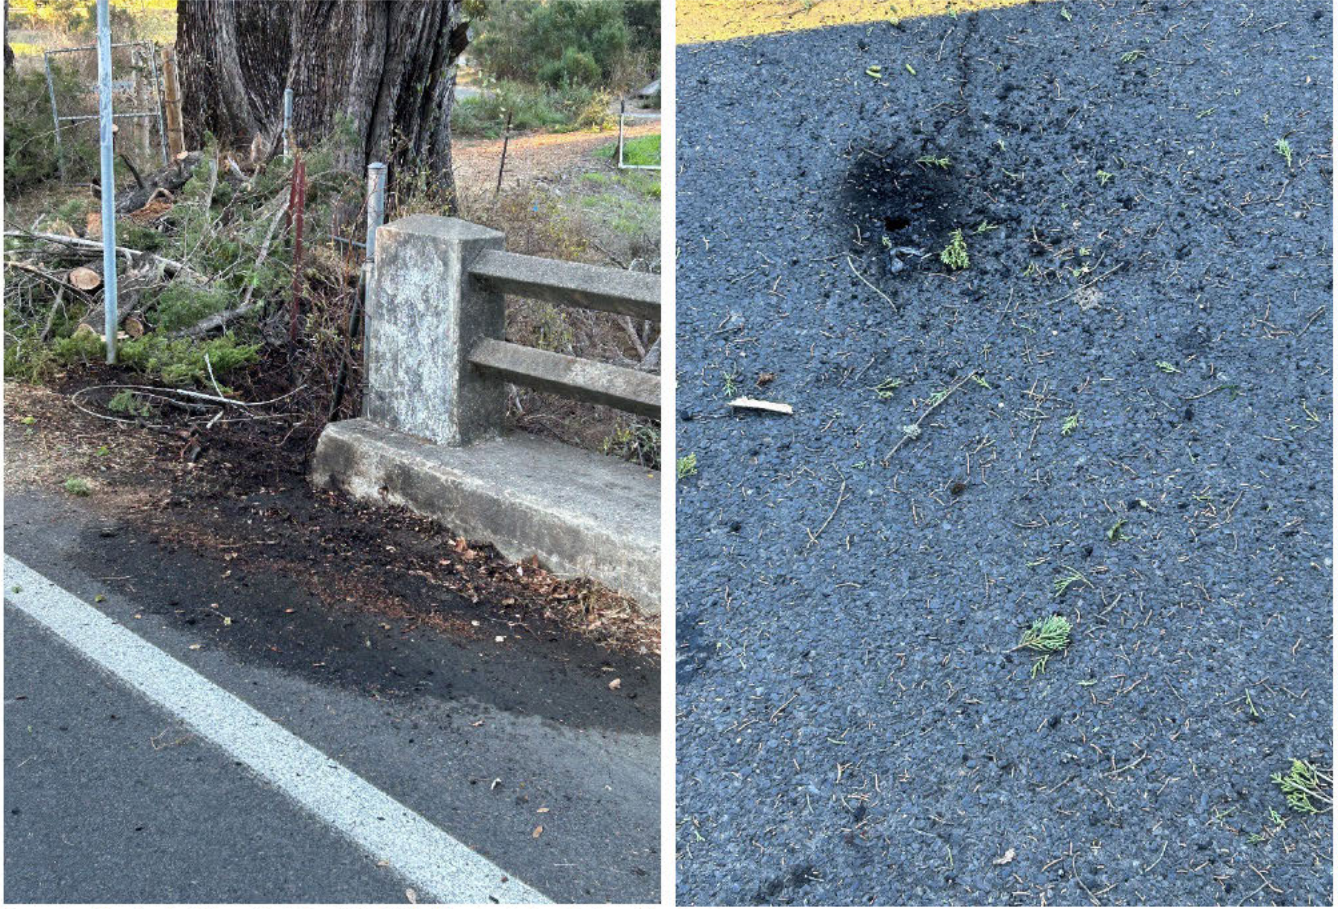
The ignition event on October 23, 2024 resulted in a fire measuring 3 x 10-foot in size. The resulting outage during PG&E's patrol and repair work lasted a total of 580 minutes affecting a total of 1130 customers. There were no reported injuries, fatalities, property damages or significant media attention associated to this vegetation-caused wire down event.

Figure 3 – Fire footprint on October 23, 2024, Photos taken by troubleshooter.

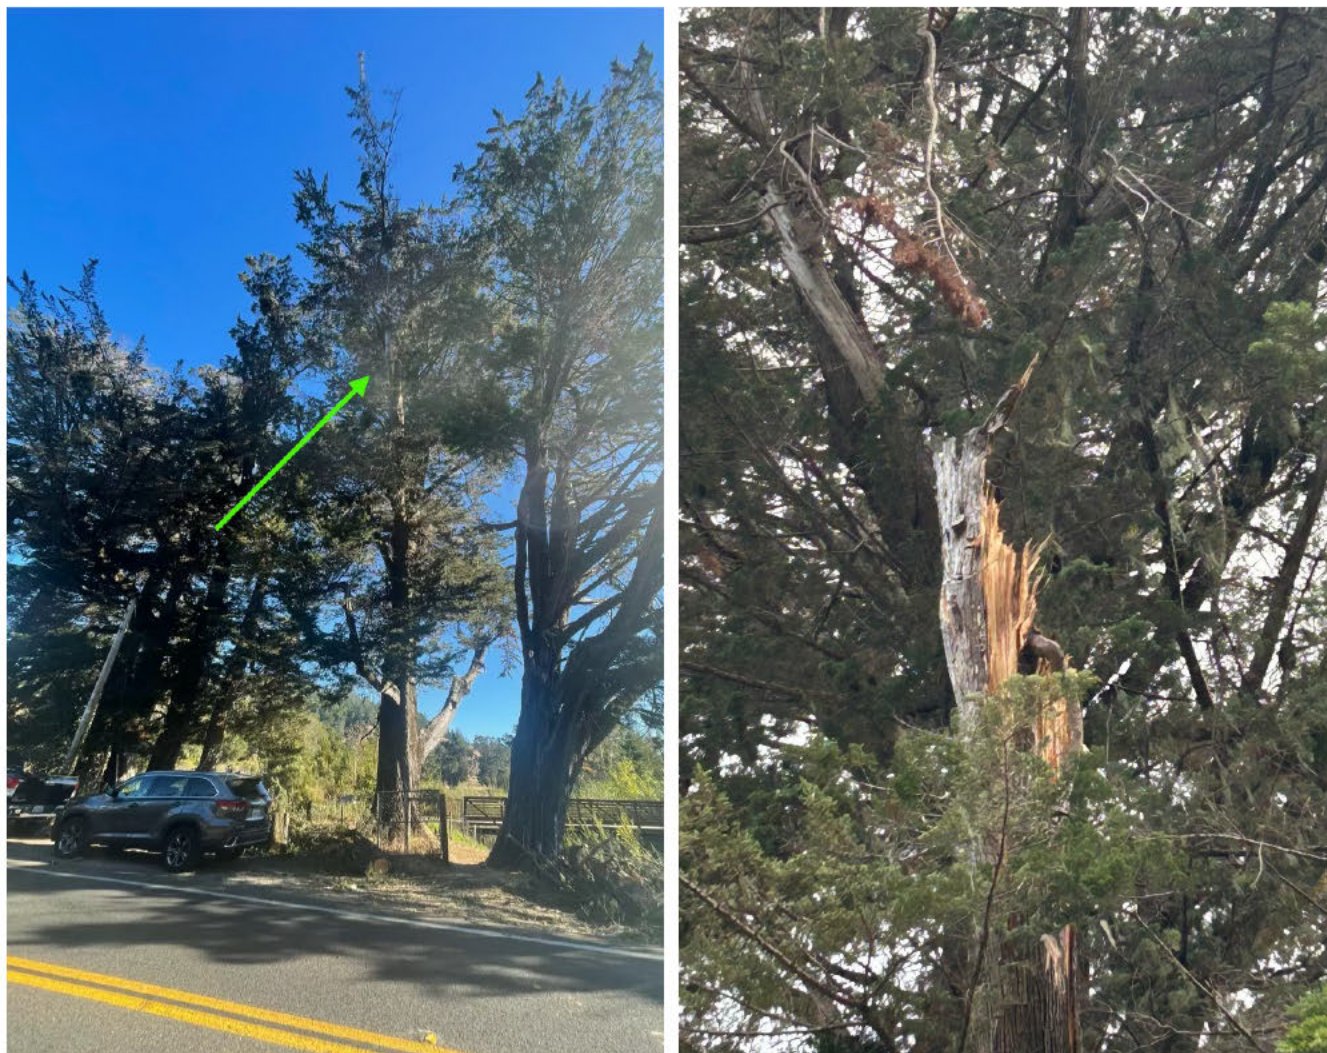
The Vegetation Management (VM) team conducted a post-incident investigation on October 24, 2024. A large 12-inch diameter branch/limb from a Monterey Cypress broke and fell into and through the primary lines (see Figure 4) starting a 3 x 10-foot vegetation fire 30-feet from the base of the tree. The 70-foot tall Monterey Cypress with a diameter at breast height (DBH) of 63-inches located 35-feet from the conductors exhibited evidence of recent branch breaks. Although the incident branch was live, green and showed no signs of foliage discoloration, there were visible damage and severe decay from termites.

Figure 4 – Incident tree (left) and fracture point (right) on October 24, 2024. Photos taken by the VM team.

The incident Monterey Cypress has an existing prescription in OneVM² under work request #00188765 (RX-02805546). The tree is listed for a major dismantle to remove all dead branches that can potentially cross phase(s). However, the tree work had not been completed prior to the incident date (due date of November 11, 2024). The prescription has since been updated to remove the entire tree.
