Preliminary Ignition Investigation Report

Ignition Database Index:	20241550
Electric Incident Investigation (EII) Number:	N/A
Incident Name:	Hawk
PG&E Facility Ignition?	Yes
CPUC Reportable Ignition?	Yes
Date & Time of Incident:	October 25, 2024 at approximately 1444 hours
Street Address:	Near Chicken Hawk Road and Michigan Bluff Road
City:	Foresthill
County:	Placer
Latitude/Longitude:	39.046612, -120.741229
State Responsibility Area (SRA) / Local Responsibility Area (LRA) / Federal Responsibility Area (FRA)	SRA
PG&E Division:	Sierra
High Fire Threat District (HFTD):	Tier 3
High Fire Risk Area (HFRA):	Yes
EPSS Buffer:	No
Fire Index Area (FIA):	330
Fire Potential Index (FPI) Rating: FIA	R3
Fire Potential Index (FPI) Rating: Circuit	R3
Was there a PSPS event at the time of ignition?	No
Suspected Initiating Event:	Contact – 3 rd Party
Failure Driver:	Contact from Object
Failure Sub-driver:	Contact – Vegetation
Circuit:	Foresthill 1101, 15218-1101
Circuit Protection Zone:	Foresthill 1101 LR 37238

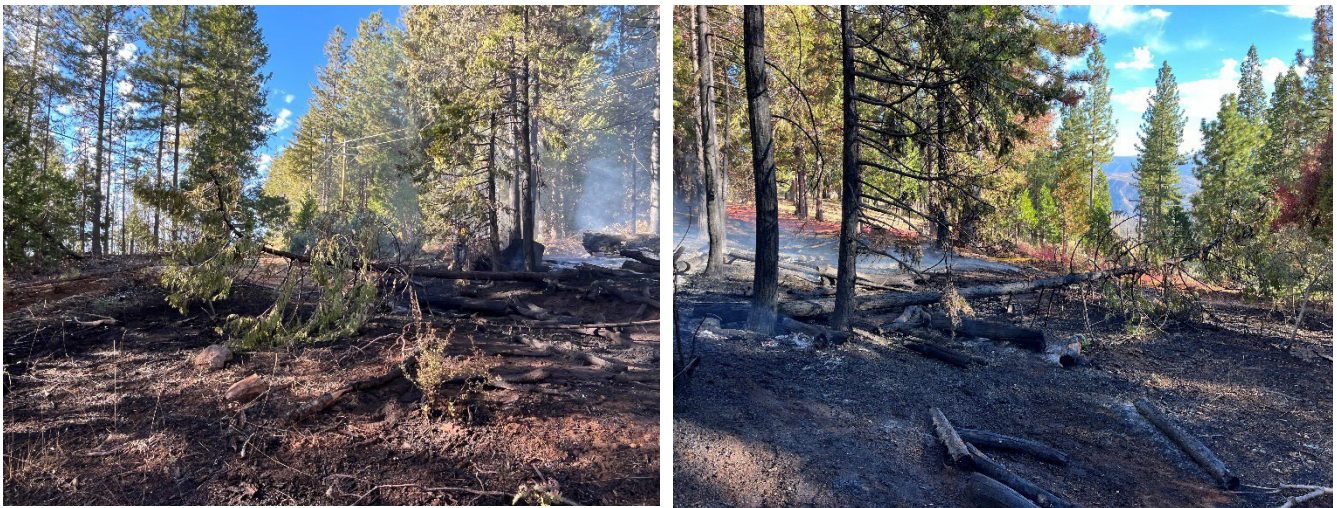
Nominal Voltage:	12kV
Pole SAP Equipment ID:	103847387
Subject to PRC 4292 Veg Pole Clearance:	No
PG&E Equipment associated with ignition:	2 Aluminum Conductor Steel Reinforced (ACSR)
EPSS enabled at time of ignition?	Yes
Fault Type:	Force Out
Wire Down (Primary)?	No
Lead Agency/Agency Having Jurisdiction:	CAL FIRE
Fire Size:	100 x 100-foot
FAS Field Remarks:	Arrived on scene and fire lead said lines were hot and tree on phase. Called DO and killed the line at LR 37238. Tree was fresh cut and landed on hot phase per fire inspector. Fire was 100ft x 100ft

Figure 2 – View of incident tree facing northwest towards Pole SAP ID 103847387 (left) and facing southeast towards Pole SAP ID 100076338 (right) on October 25, 2024. Photos taken by the troubleshooter.

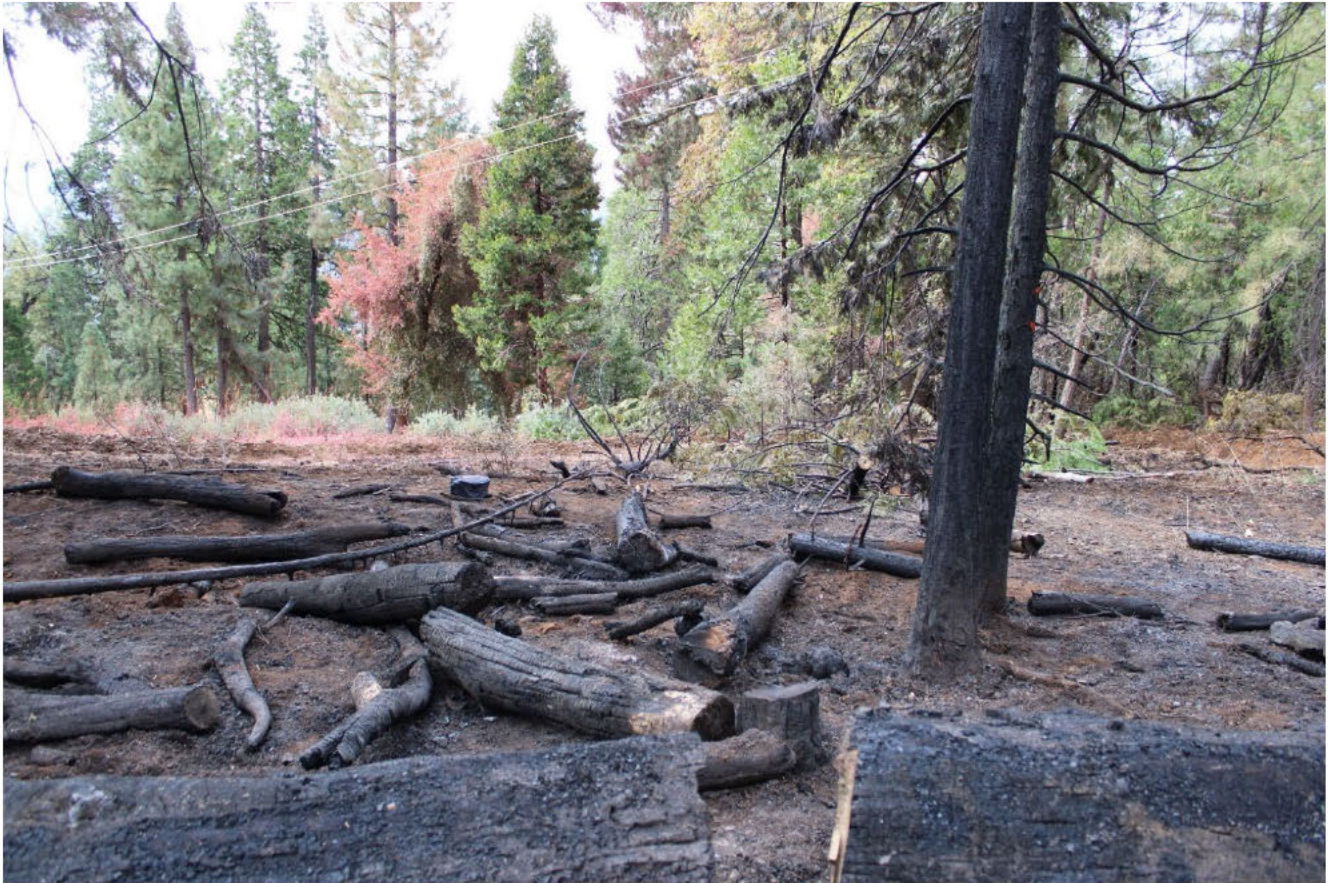
Figure 3 – Incident Location facing towards conductor on October 30, 2024. Photo taken by Ignitions Investigator.

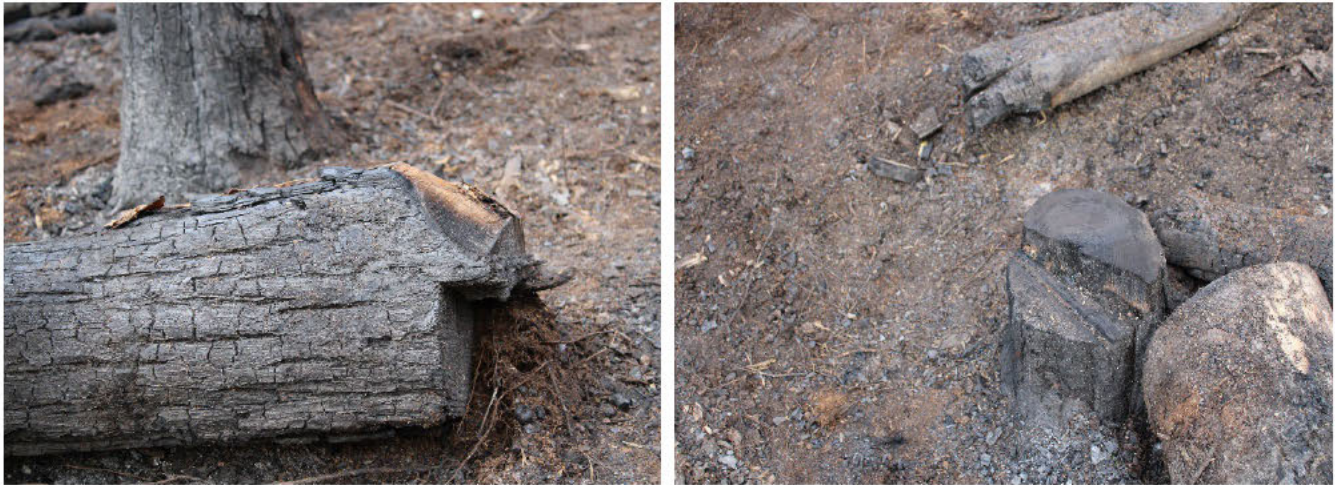
PG&E's Public Safety Specialist team advised the Vegetation Management (VM) team that the two individuals were issued citations by CAL FIRE. Although, the VM team did not investigate the history or the health of the

Figure 4 – Incident tree shown with steep angled cuts on the failed top end (left) and the stump (right) on October 30, 2024. Photos taken by Ignitions Investigator.

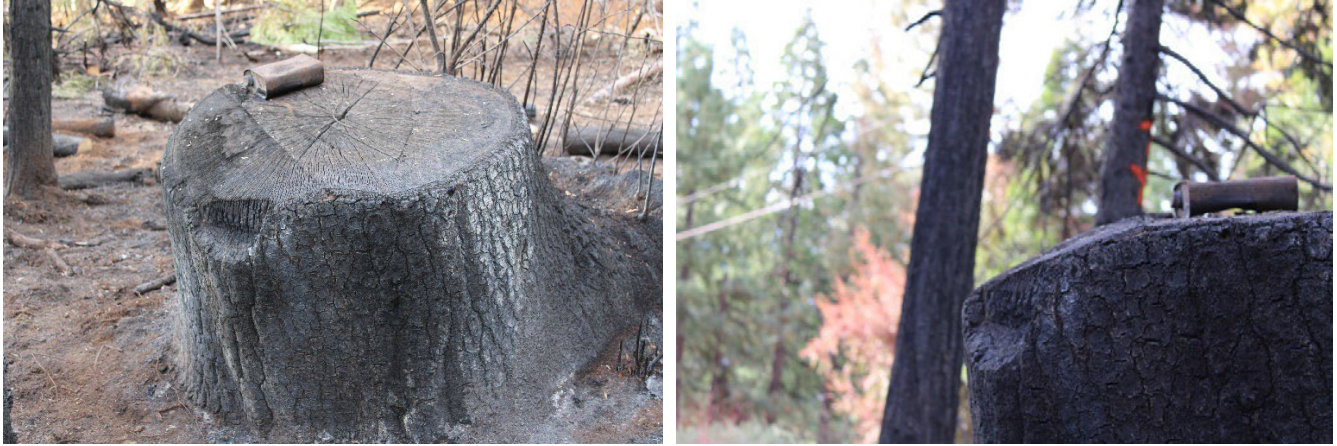
Figure 5 – Stump of nearby black oak with steep angled cuts on October 30, 2024. Photos taken by Ignitions Investigator.

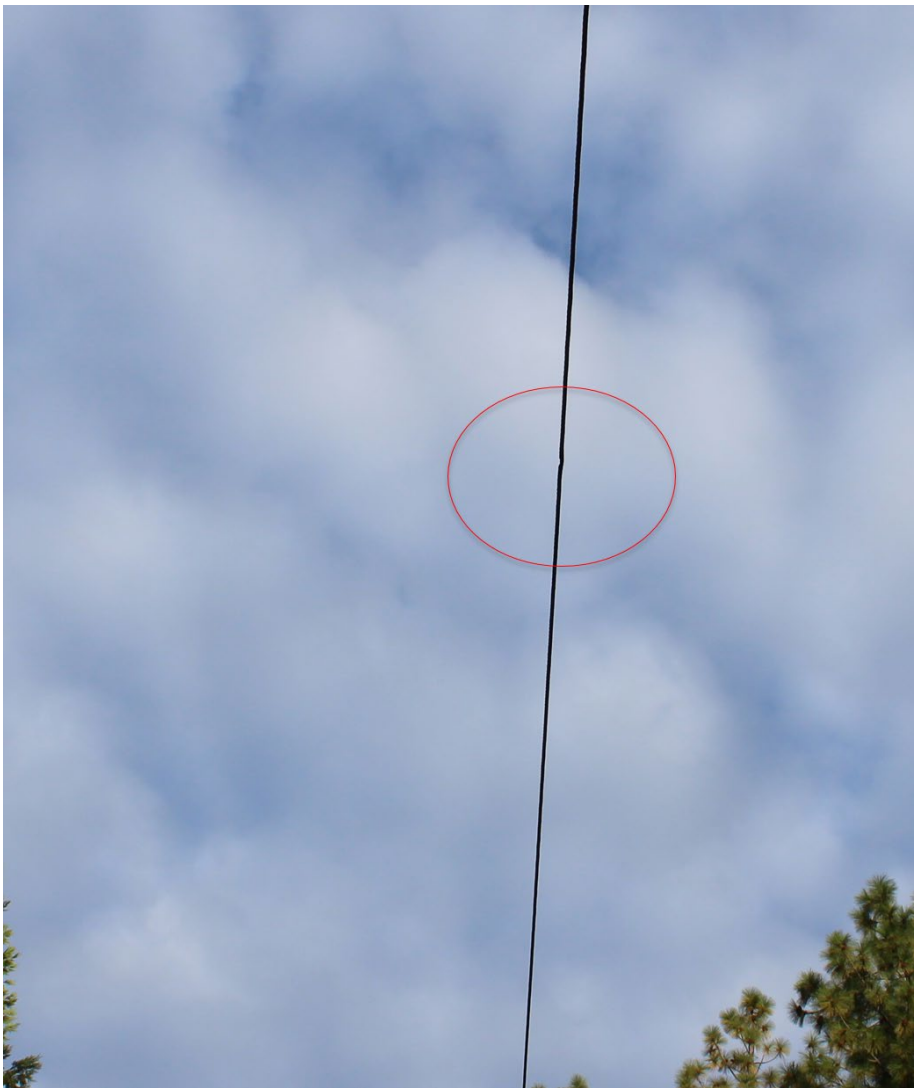
An Ignitions Investigator conducted a follow up site visit on October 30, 2024. The Incident Location was found with a litter of tree debris piled on the ground from multiple tree sources that had been cut. The Ignitions Investigator was able to locate an incense cedar (*Calocedrus decurrens*, Incident Tree) that was cut and had fallen towards the direction of PG&E's conductors. In viewing the stump of the Incident Tree in conjunction with the base of the cut of the fallen section, the Ignitions Investigator observed steep angled cuts that did not extend into the center or within the majority of the Incident Tree's diameter (see Figure 3 and 4). Within a few feet from the Incident Tree, there was a large black oak (*Quercus kelloggii*) that was also cut down. Both the stump and base of the fallen section of the black oak showed evidence of cuts that were not extended into the center or within the majority of the tree diameter (see Figure 5). The Ignitions Investigator was uncertain if the Incident Tree was cut and accidentally felled towards the conductors as a singular event or if the Incident Tree's contact with the powerlines was from a chain of events that involved cutting and felling the black oak initially via a *domino effect*. However, it does appear that the technique involved in wedging/cutting the trees did not align with proper felling practices. This likely resulted in the tree falling in an unintended direction. In viewing the Incident Span, the Ignitions Investigator noted visible damage to the conductor (see Figure 6) (See Potential Next Steps / Associated CAP Items section).

There were no corrective notifications created as a result of this ignition event. However, during a site visit on October 30, 2024, an Ignitions Investigator identified visible damage on the conductor where the tree had made contact (See Potential Next Steps / Associated CAP Items section).

Figure 6 – Damage to the conductor on October 30, 2024. Photo taken by Ignitions Investigator.

- CAP [129894216](#): Created to have Maintenance and Construction review incident span for potential repairs.
