Preliminary Ignition Investigation Report

Ignition Database Index:	20241646
Electric Incident Investigation (EII) Number:	N/A
Incident Name:	Spring
PG&E Facility Ignition?	Yes
CPUC Reportable Ignition?	Yes
Date & Time of Incident:	November 11, 2024
Street Address:	33211 Paraiso Springs Road
City:	Soledad
County:	Monterey
Latitude/Longitude:	36.33681, -121.35690
State Responsibility Area (SRA) / Local Responsibility Area (LRA) / Federal Responsibility Area (FRA)	State Responsibility Area (SRA)
PG&E Division:	Central Coast
High Fire Threat District (HFTD):	Tier 2
High Fire Risk Area (HFRA):	Yes
EPSS Buffer:	No
Fire Index Area (FIA):	570
Fire Potential Index (FPI) Rating: FIA	R1
Fire Potential Index (FPI) Rating: Circuit	R1
Was there a PSPS event at the time of ignition?	No
Suspected Initiating Event:	Equipment – PG&E
Failure Driver:	Equipment Failure
Failure Sub-driver:	Conductor failure-all
Circuit:	Los Coches 1101
Circuit Protection Zone:	Los Coches 1101625902

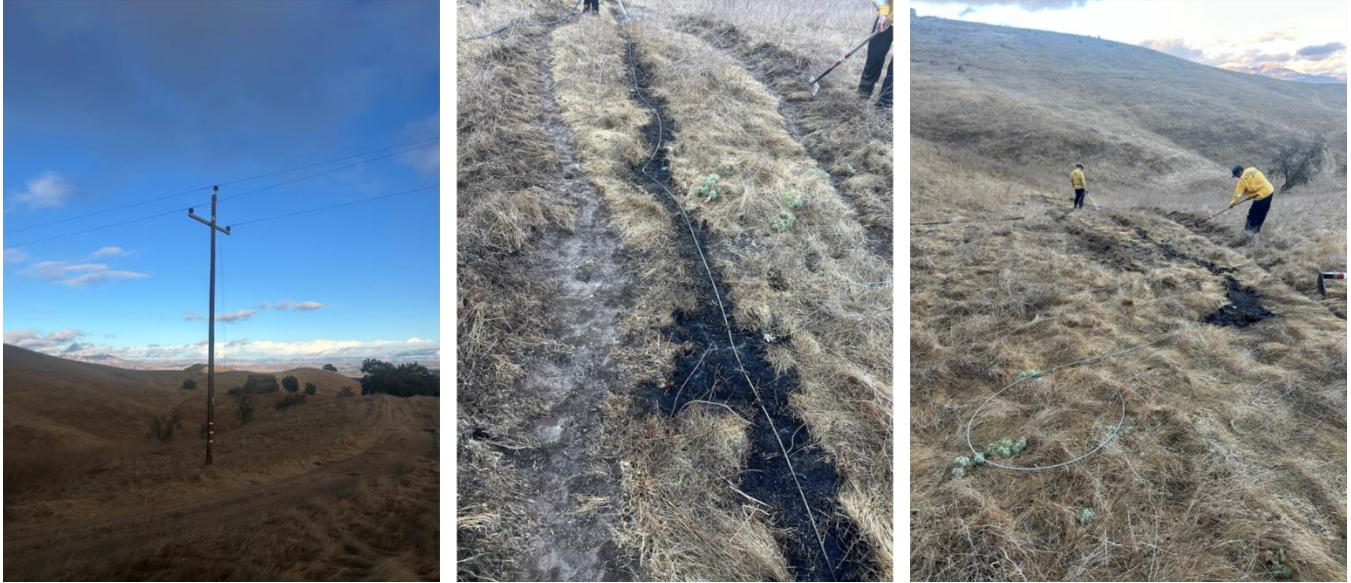
Upon arrival at the Incident Location at approximately 1541 hours, the troubleshooter observed one span of downed 4-ACSR on the ground and still energized between pole SAP IDs 101757232 and 101766759. The troubleshooter reported that there were burn marks in the wet grass surrounding the downed conductor with a burned area between one and three meters (Figure 3). CAL FIRE was on the scene mopping up the burned area. The troubleshooter created Priority A Electric Corrective Notification 129801455 to repair the broken conductor and asked the Distribution Control Center ("DCC") to open Line Recloser (LR) 625902 to de-energize the downed conductor. DCC opened LR 625902 at 1551 hours and the troubleshooter opened jumpers three spans to the source side of pole SAP ID 101766759 to isolate the trouble.

The ignition burned an area under the downed conductor between one and three meters in size and caused an outage to one customer for approximately 780 minutes and 17 customers for approximately 69 minutes. There were no injuries, fatalities, property damage, or media attention identified for this incident.

Figure 3. Incident photos showing pole SAP ID 101757232 with broken conductor (left) and burn area (center and right) (taken November 11, 2024).

A PG&E crew completed repairs to the conductor and closed the open jumpers on November 12, 2024 at approximately 0405 hours.

The troubleshooter created Priority A Electric Corrective Notification 129801455 to repair the broken conductor. This work was completed the morning of November 12, 2024.
