Preliminary Ignition Investigation Report

Ignition Database Index:	20241773
Electric Incident Investigation (EII) Number:	N/A
Incident Name:	N/A
PG&E Facility Ignition?	Yes
CPUC Reportable Ignition?	Yes
Date & Time of Incident:	December 3, 2024 at approximately 1519 hours
Street Address:	Near 37084 Road 425C
City:	Coarsegold
County:	Madera
Latitude/Longitude:	37.287362, -119.655203
State Responsibility Area (SRA) / Local Responsibility Area (LRA) / Federal Responsibility Area (FRA)	SRA
PG&E Division:	Yosemite
High Fire Threat District (HFTD):	Tier 2
High Fire Risk Area (HFRA):	Yes
EPSS Buffer:	No
Fire Index Area (FIA):	424
Fire Potential Index (FPI) Rating: FIA	R1
Fire Potential Index (FPI) Rating: Circuit	R1
Was there a PSPS event at the time of ignition?	No
Suspected Initiating Event:	Vegetation
Failure Driver:	Contact from Object
Failure Sub-driver:	Contact – Vegetation
Circuit:	Coarsegold 2104, 25443-2104
Circuit Protection Zone:	Coarsegold 2104 LR 10160

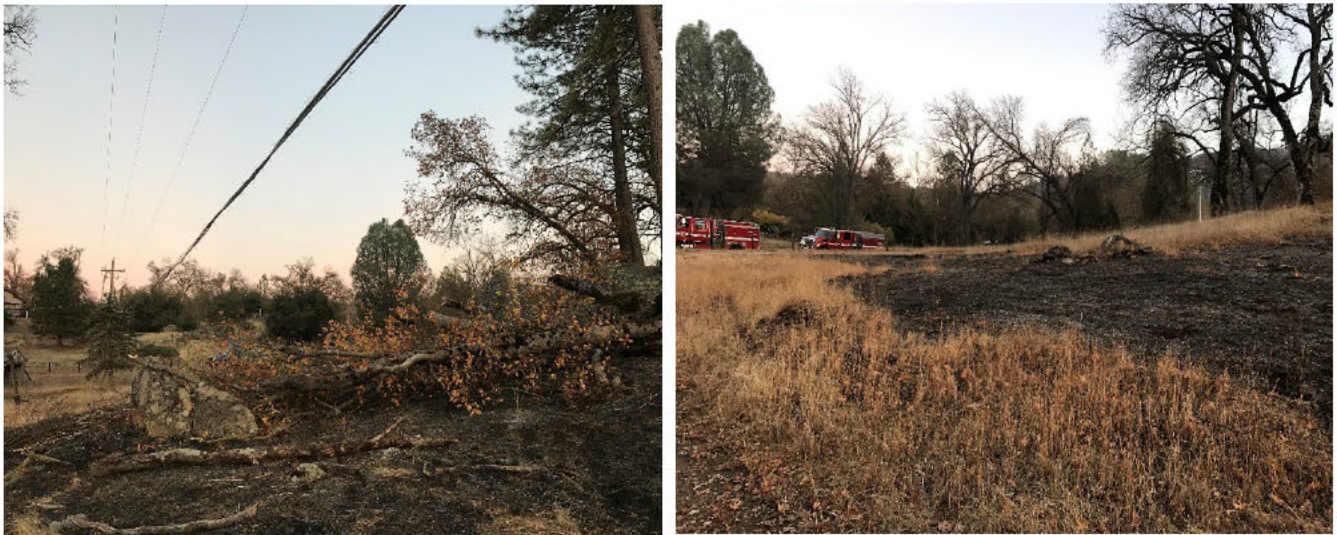
On December 3, 2024 at approximately 1519 hours, SmartMeter™ alarms detected a momentary outage to the Coarsegold 2104 12kV distribution circuit when Line Recloser (LR) 10110 temporarily opened and closed within one minute. PG&E received a 911 call for a fire with possible damages to powerlines. The official Integrated Reporting of Wildfire Information (IRWIN) time for this fire is logged at 1558 hours. Shortly after, a troubleshooter was dispatched at 1626 hours to the Incident Location near Road 425C and Highway 41 in the community of Coarsegold in Madera County situated within a Tier 2 High Fire Threat District (HFTD) and High Fire Risk Area (HFRA) (see Figure 1 and 2). CAL FIRE was already on scene and actively extinguishing a 0.33-acre fire with a five-gallon bladder bag. The troubleshooter arrived at the Incident Location between Pole SAP ID 101026374 (Pole #1, source side) and 103387968 (Pole #2, load side) and confirmed that a tree was down in the middle of the fire between the spans but did not observe a wire down on the ground. However, the troubleshooter noticed a floating conductor, while another conductor had detached from its insulator and was resting on a charred crossarm (see Figure 3 and 4). Based on CAL FIRE's investigation and the observations of the troubleshooter, it is suspected this ignition event was caused by the large tree falling into the primary conductor, catching fire as it rested on the line and eventually falling and igniting the ground below³.

Figure 3 – View of downed incident tree (left) and fire footprint (right) on December 3, 2024. Photos taken by troubleshooter.

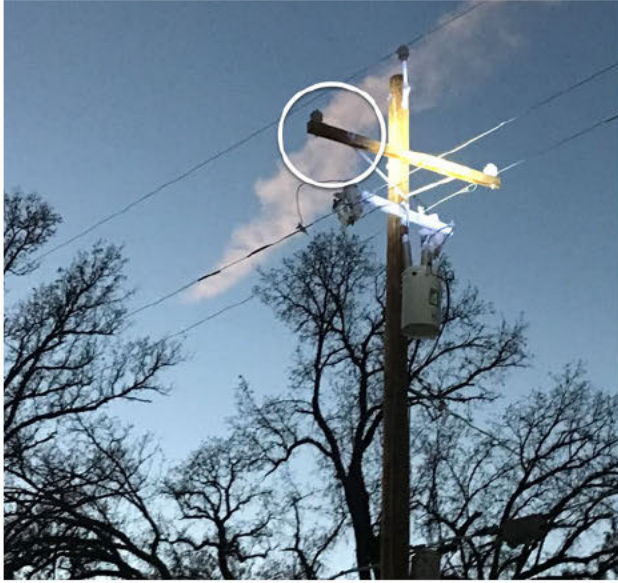
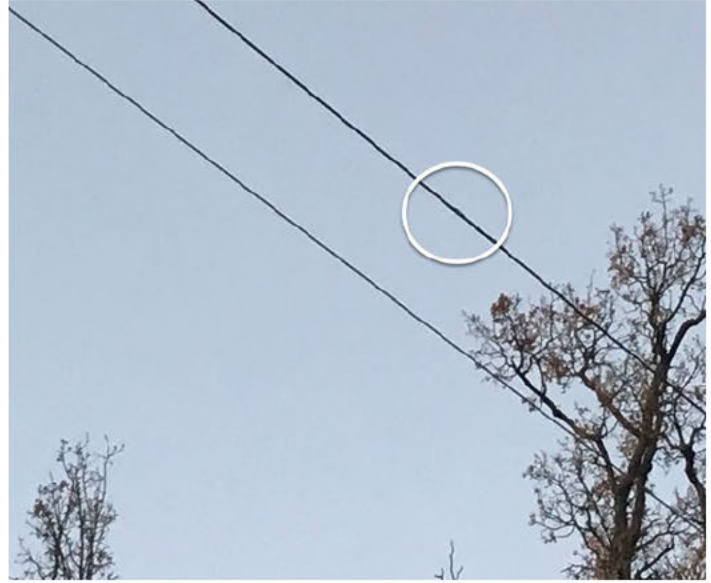
FAS Field Remarks¹:	Tree fell on primary, caused 0.33 acre vegetation fire, one floater, one on crossarm, and bird caged wire.
HAWC Summary²:	N/A
Injuries / Fatalities / Property Damage / Media Attention:	No Injuries/Fatalities/Property Damage/Media Attention
Weather Conditions:	At 1630 hours near the Incident Location: Temperature: 58.5°F Relative Humidity: 63% Wind Speed: Calm
Red Flag Warning (RFW) / High Wind Warning (HWW):	RFW – No HWW – No
911 Standby Relief Time:	20 minutes
OIS #:	2643201 2643145
ILIS #:	24-0142244
FAS #:	T006572217
TOTL #:	N/A
Assigned Attorney:	N/A
Ignition Investigator & Phone:

Figure 4 – View of charred crossarm on Pole #2 (left) and damaged/bird caged conductor (right) on December 3, 2024. Photos taken by troubleshooter.

As a result of this ignition event, a priority "A" Electric Corrective (EC) tag (#129890835) was created to repair the damaged/bird caged conductor. Repairs were completed by a PG&E crew on December 3, 2024.

As a result of this event, a priority “A” EC tag (#129890835) was created/associated to Pole #2 to repair the damaged bird caged conductor.

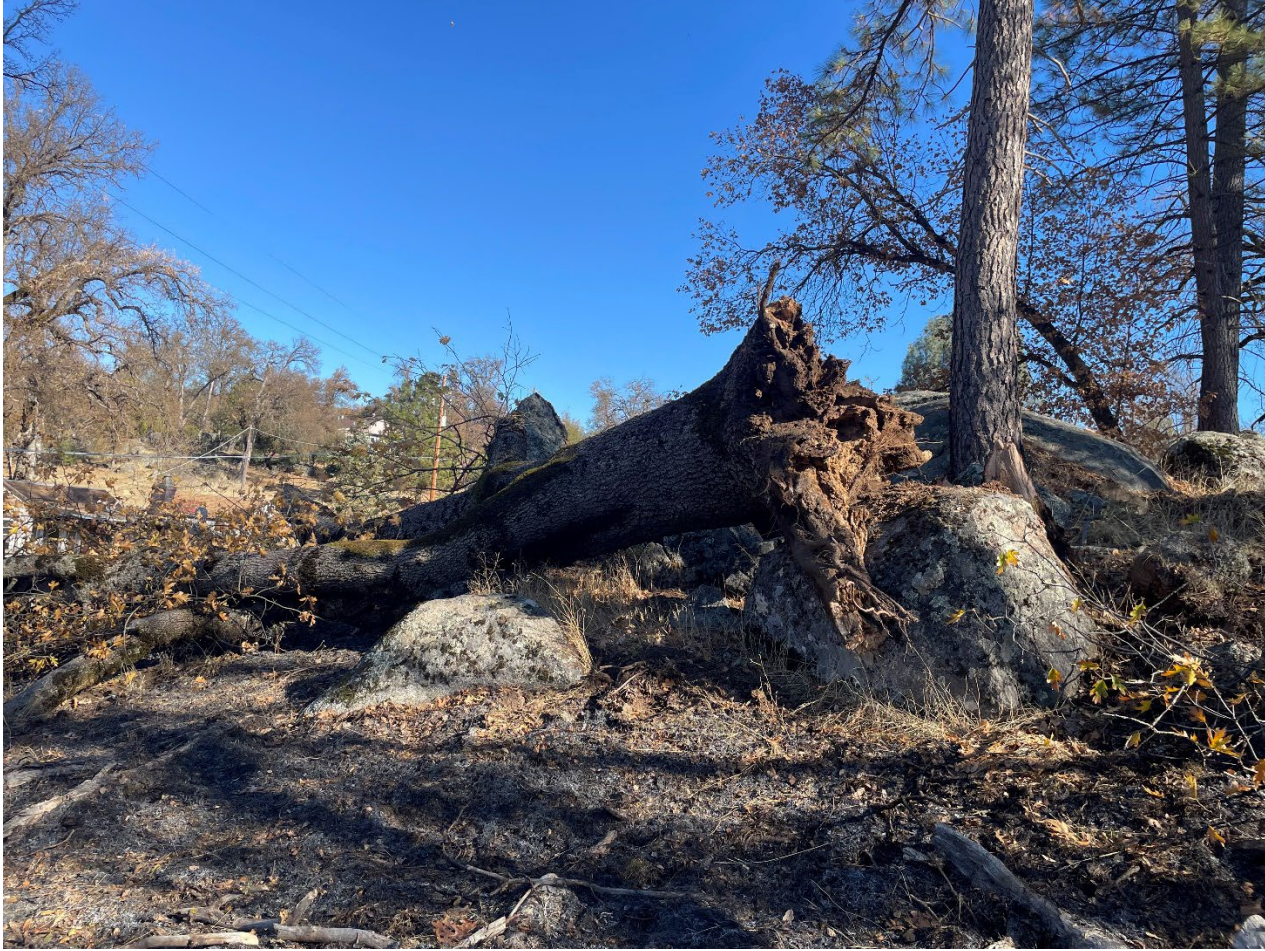
The Vegetation Management (VM) team conducted a post-incident investigation on December 3, 2024. A black oak (*Quercus kelloggii*) measuring 52-feet tall with a diameter at breast height (DBH) of 35-inches uprooted towards the live 12kV line located 40-feet away (see Figure 5). Although one branch was identified as dead, the canopy was otherwise green and healthy. Two small partially healed wounds were identified at the base of the tree, however, the bark was intact and healthy. The wound wood indicated compartmentalization⁴ with no evidence of significant rot inside the tree at the wound location. The trunk of the tree at the base had about 95% holding wood. It was determined that the incident tree likely failed due to poor root attachment caused by decay and large rocks present around its base. Other than the previously described characteristics, the tree appeared alive and did not show signs of external rot, decay, or disease (see Figure 6). The VM team has the fire around the tree listed as approximately 50 x 225-foot in size.

Figure 5 – View of incident tree on December 3, 2024. Photo taken by the VM team.

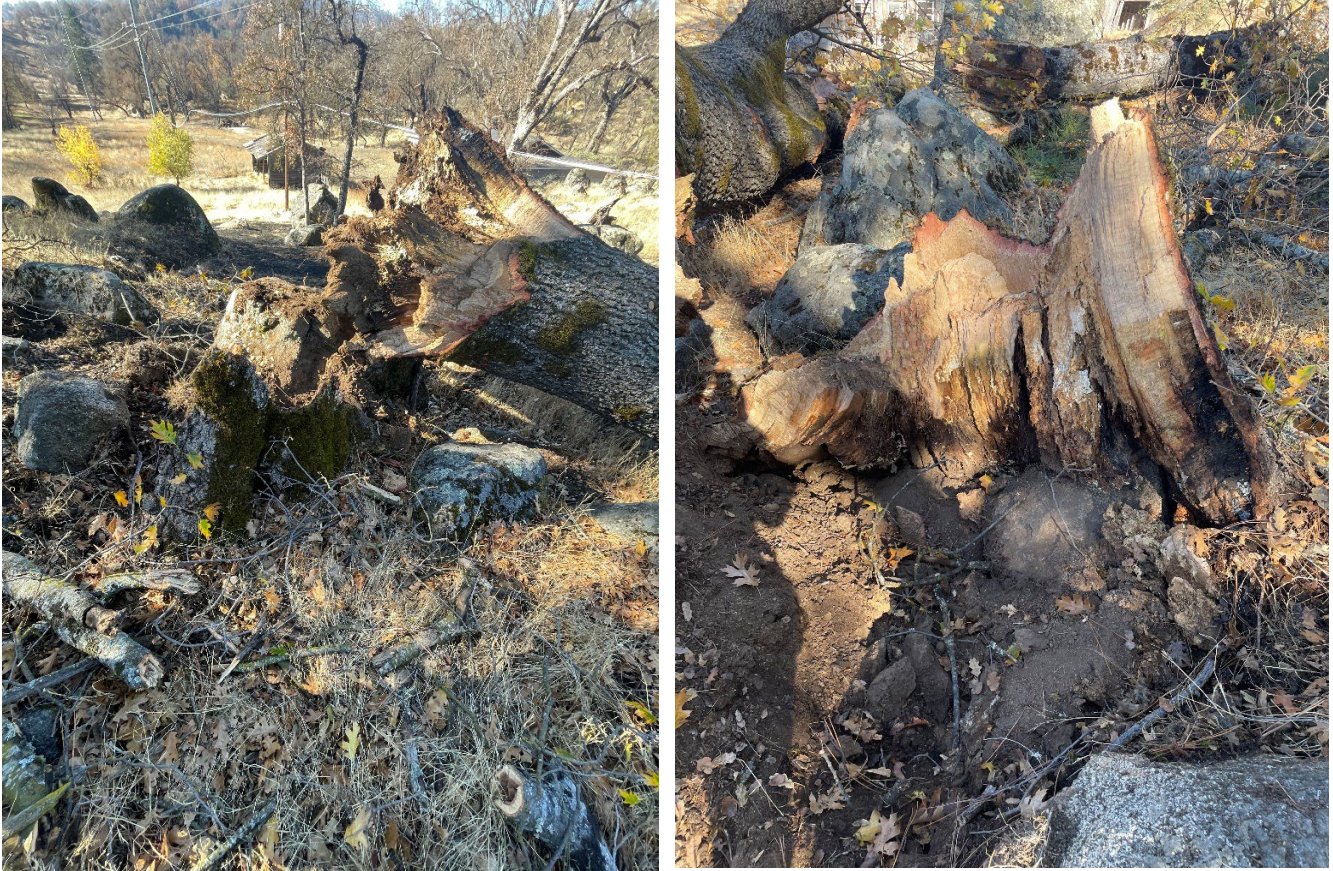
Figure 6 – View of failure/uprooted point of incident tree on December 3, 2024. Photos taken by the VM team.

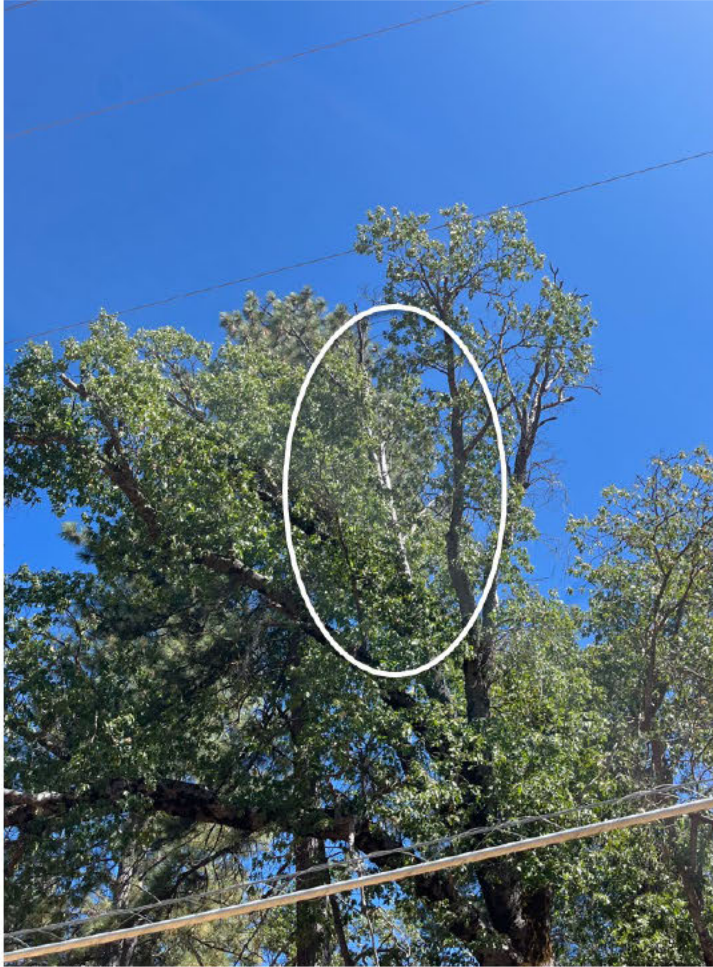
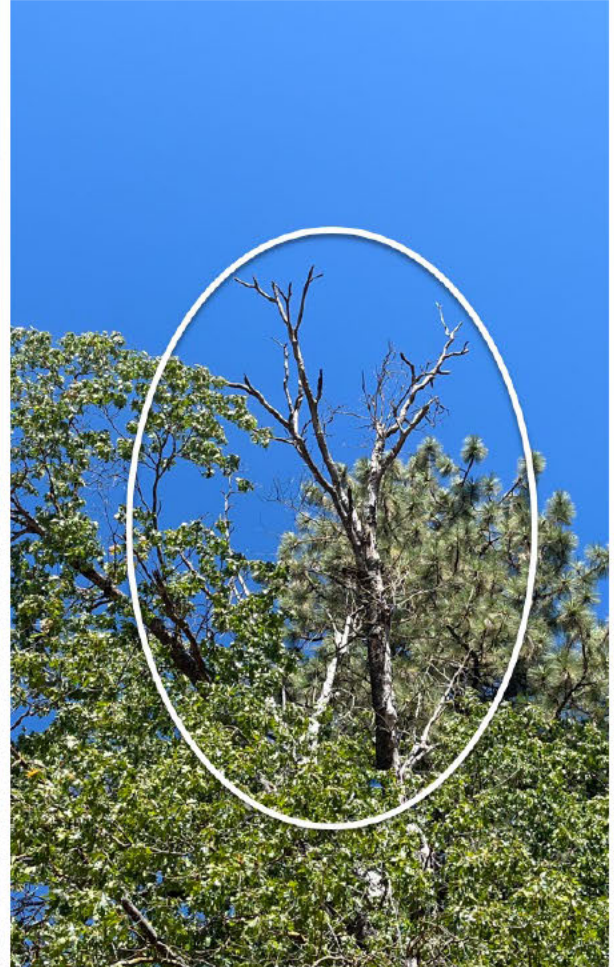
The incident black oak is listed on a Routine Inspection Record. The tree was last inspected on August 21, 2024 with a next inspection date scheduled for February 2025. During the course of a Level 1 inspection on August 21, 2024, the inspector identified two dead spars on the top of the tree that may fall into or make contact with the powerlines (see Figure 7). The observed conditions triggered a Level 2 inspection that required a closer look at the tree⁵. Due to the detailed Level 2 inspection, the inspector identified a hole located on the back side base of the tree (see Figure 8) that would not have been noticeable if the inspector was standing below the powerline.

Figure 7 – View of dead spars on treetop on August 21, 2024. Photo taken by VM Inspector.

Prescription RX-02958666 was created to have the tree top cleared so that if the tree failed, no branches would make contact with the conductors. Although the tree was prescribed to be cleared prior to the ignition event, work was constrained because the tree was on tribal land. Work constraint case number 00414984 was created on September 4, 2024 but was in 'New' status at the time of the ignition.

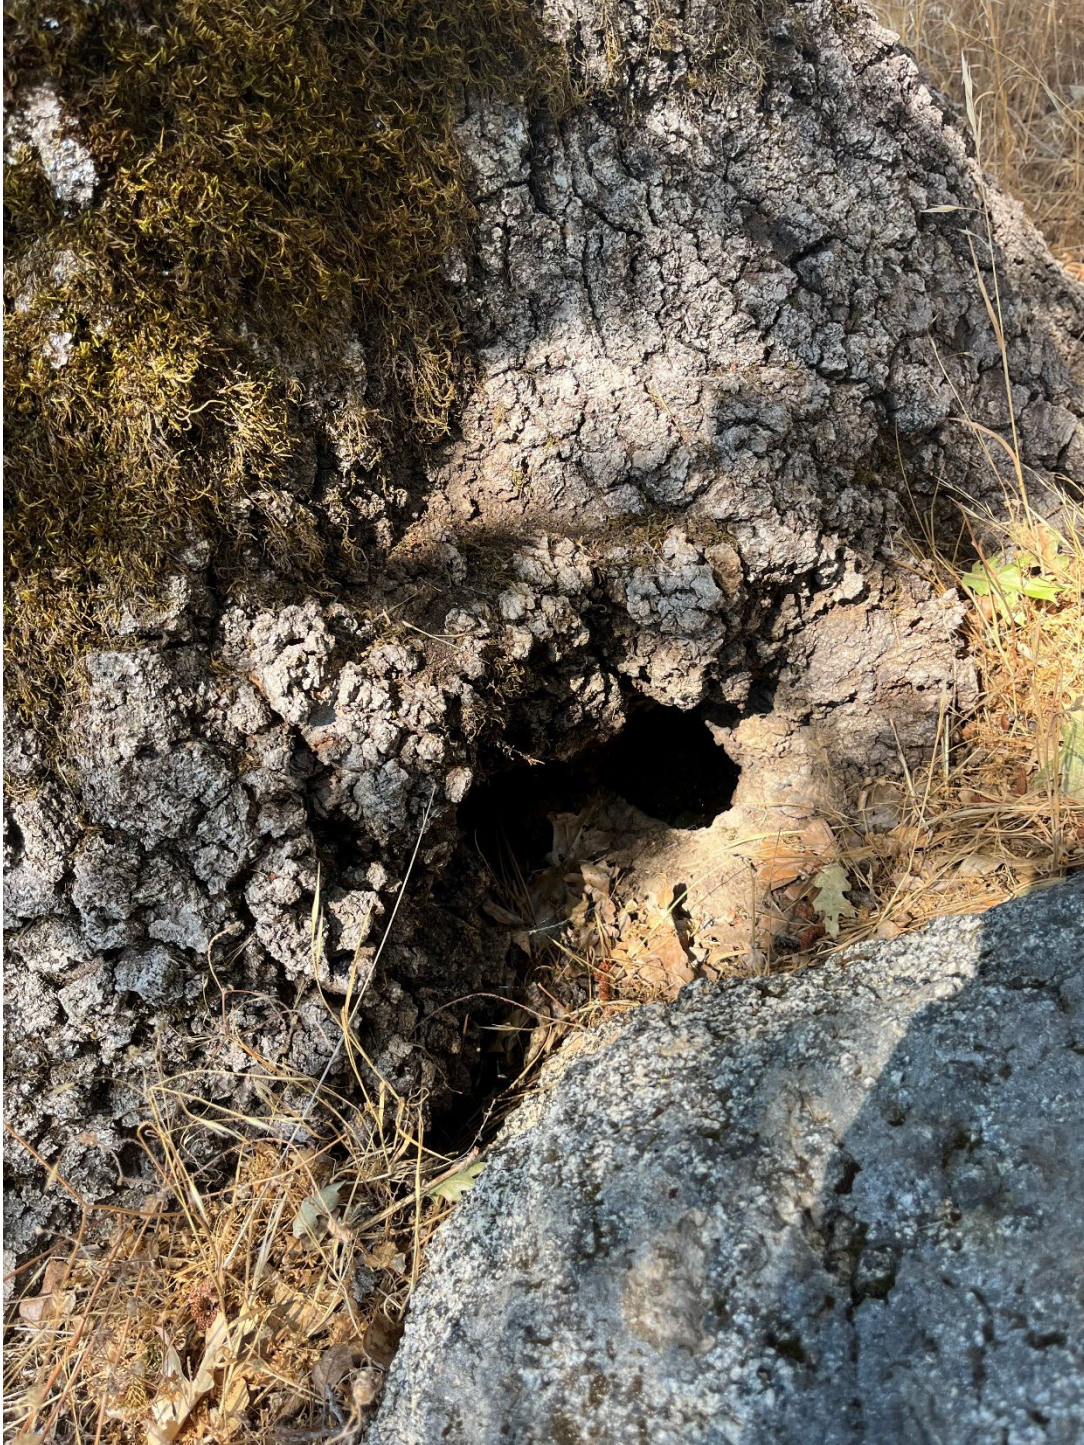
Figure 8 – View of hole at the back side of the base of the tree on August 21, 2024. Photo taken by VM Inspector.
