Preliminary Ignition Investigation Report

Ignition Index:	20241795N	Electric Incident Report (NR/EIR):	N/A
Incident Name:	Lake	Associated CAP:	129911042
Date of Incident:	December 9, 2024	Latitude/Longitude:	37.618261, -122.450116
Region:	Bay Area	County:	San Mateo
Division:	Peninsula	City:	San Bruno
Circuit:	Sneath Lane-Half Moon Bay 60kV	Voltage / Level / kV:	Transmission 60kV
HFTD:	Tier 2	HFRA:	Yes
FPI – Circuit:	R1	FPI – FIA:	R1
EPSS Enabled CPZ	No	EPSS Buffer:	No

Synopsis:

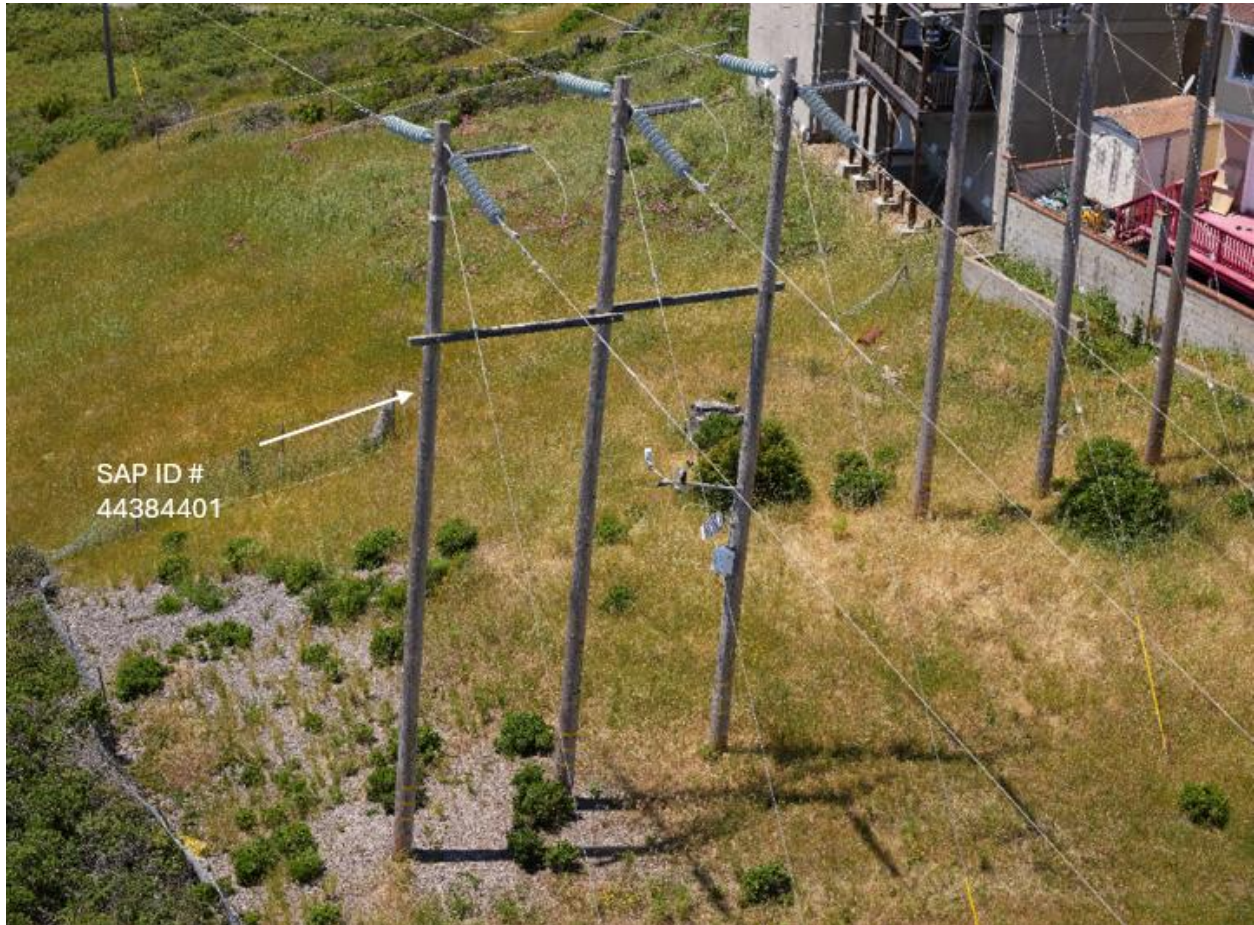
Figure 2 Image of pole SAP ID # 44384401 and associated assets taken during PG&E aerial inspection on May 20, 2024.

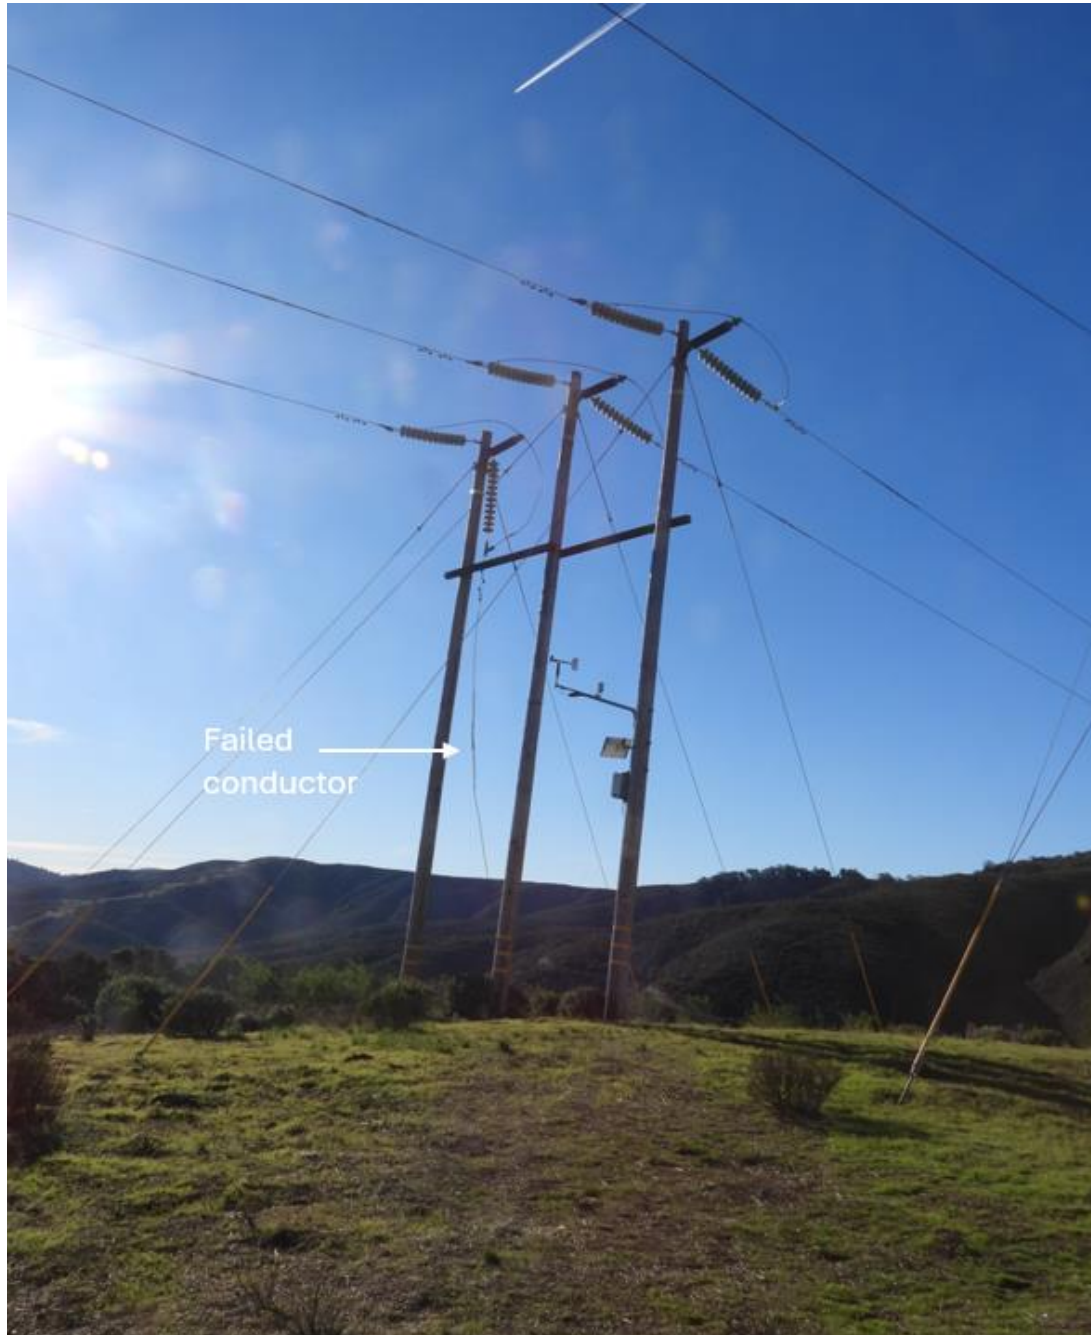
Figure 3 Photo of three-pole transmission structure where failed conductor occurred taken by troubleshooter on date of incident.

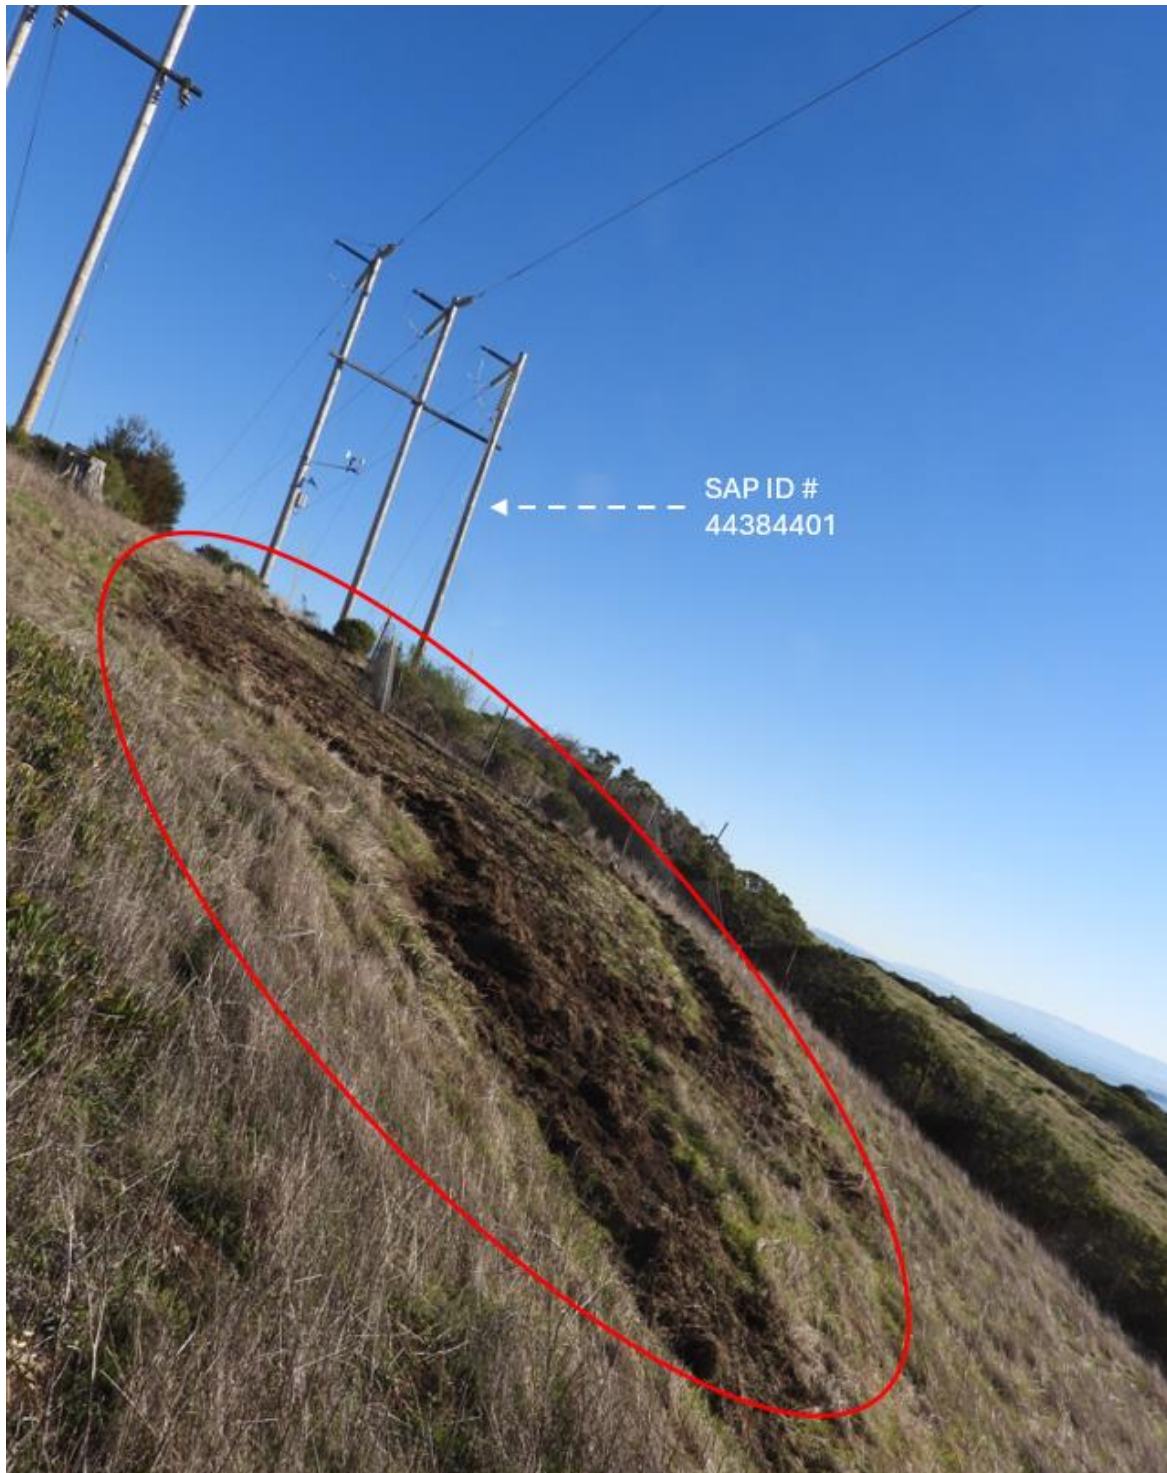
Figure 4 Photo of burn 30 feet x 50 feet burn area taken by troubleshooter on the date of incident.

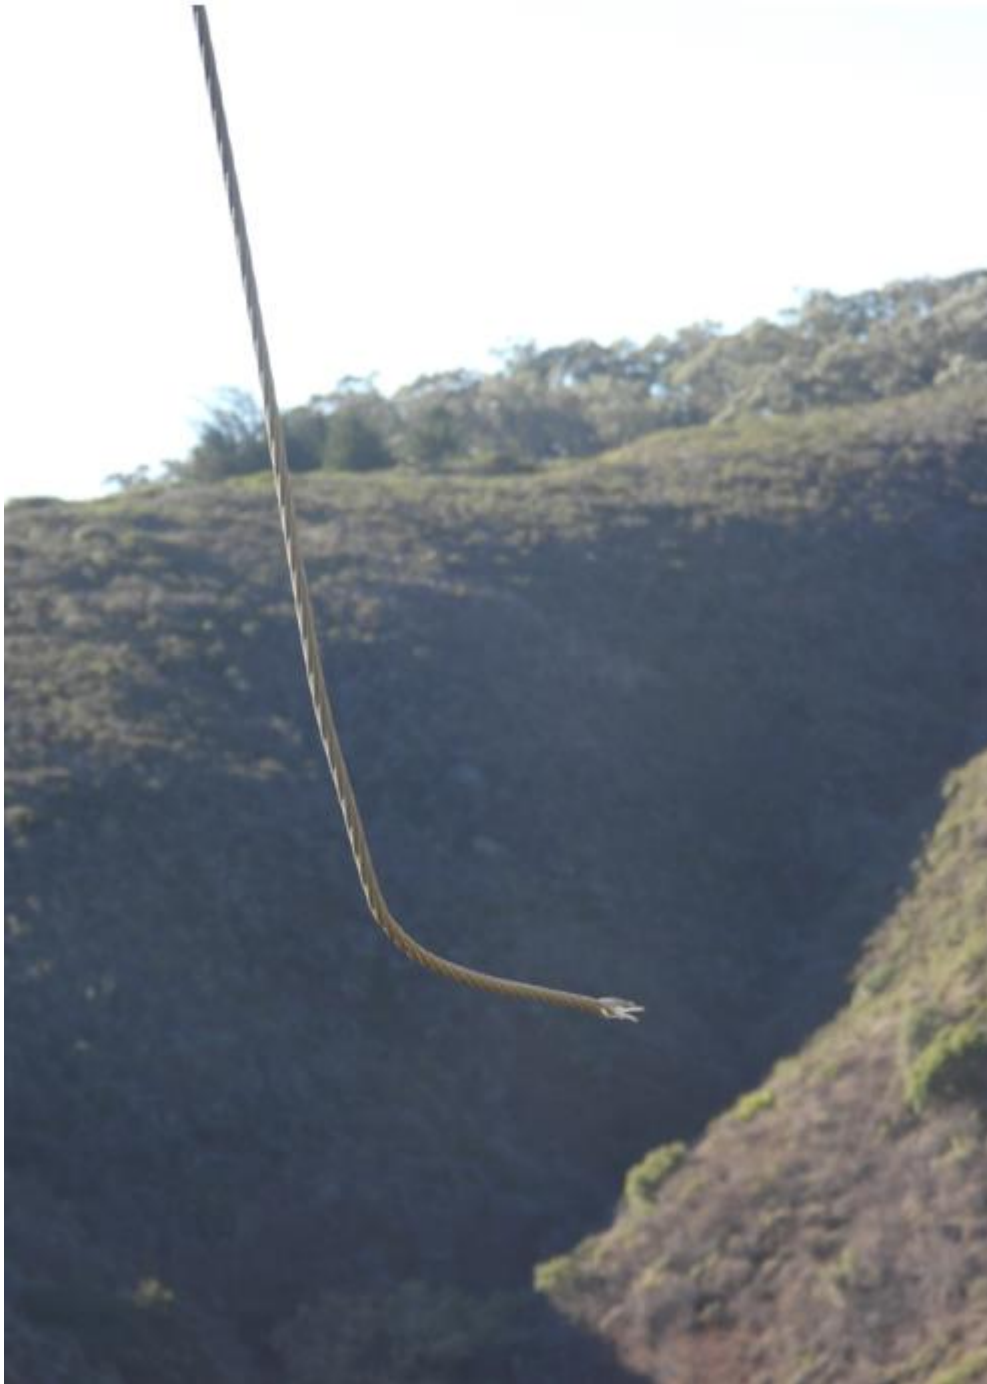
Figure 5 Close up of failed transmission conductor taken by troubleshooter on the date of incident.

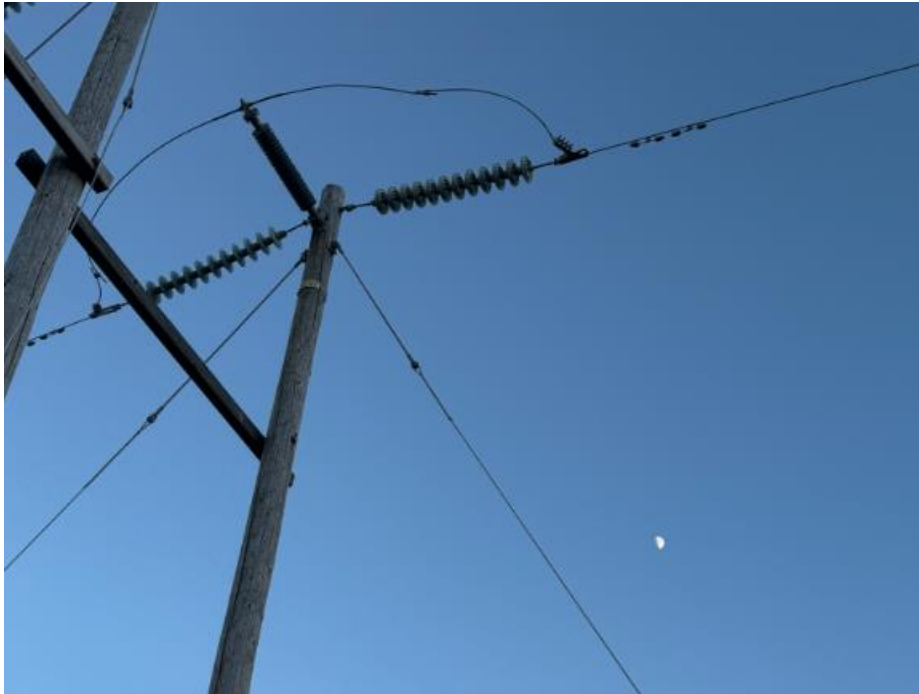
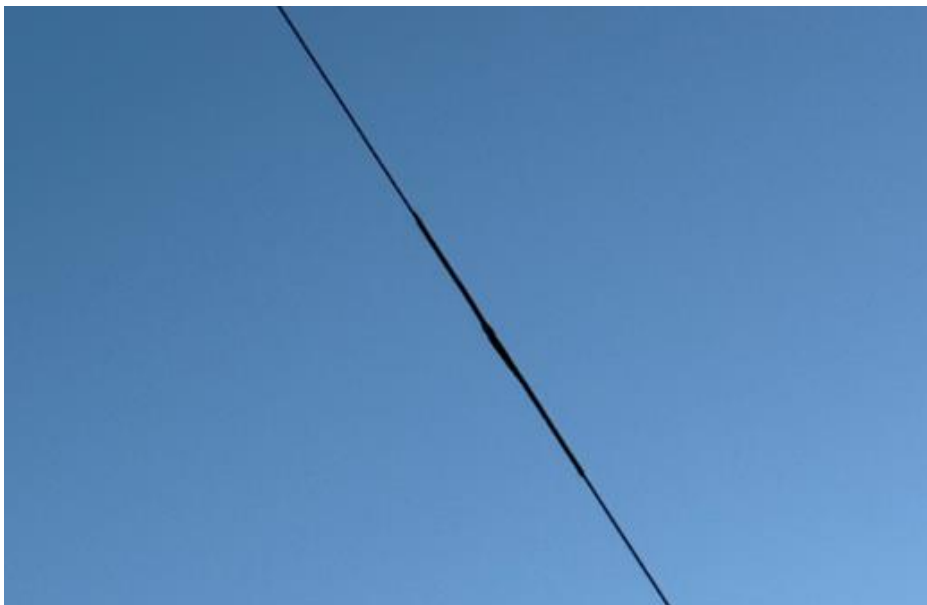
Figure 6 & 7 post-repair photos taken by PG&E contract crew taken on December 10, 2024.

- 0708 hours – PG&E crews repaired broken transmission conductor. A portion of the failed transmission conductor was collected and sent to PG&E's Applied Technology Services (ATS) for further analysis on cause of the failure.

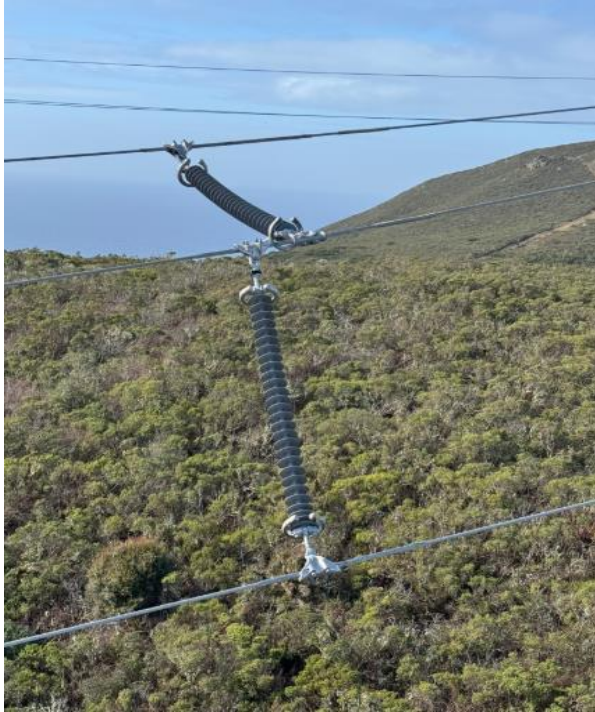
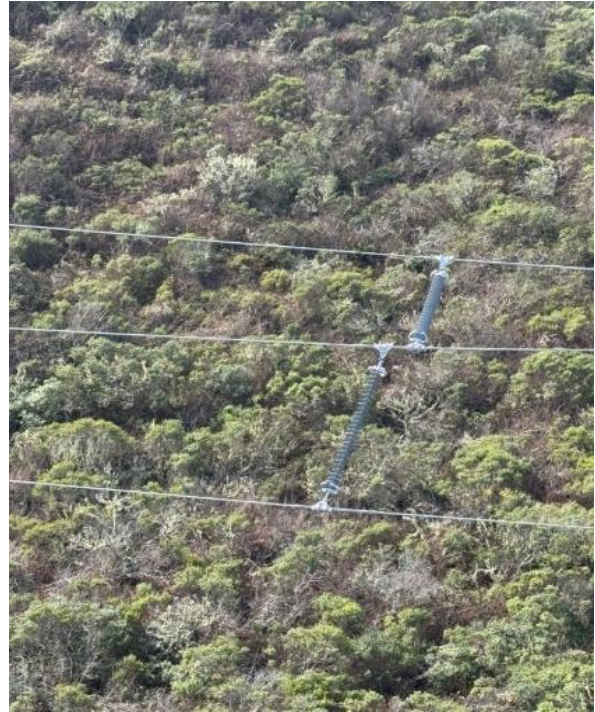
Figure 8 & 9 Photos from LC Notification 129928954 showing spacers that were installed between poles ?01/13 and ?02/0 to temporarily mitigate conductor midspan on December 16, 2024.

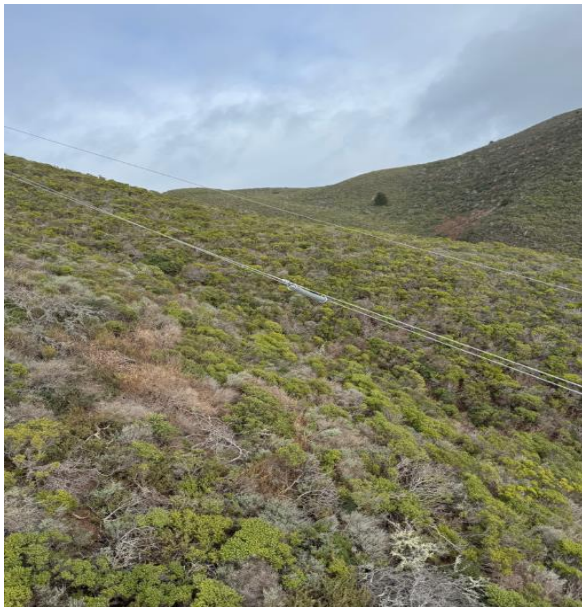
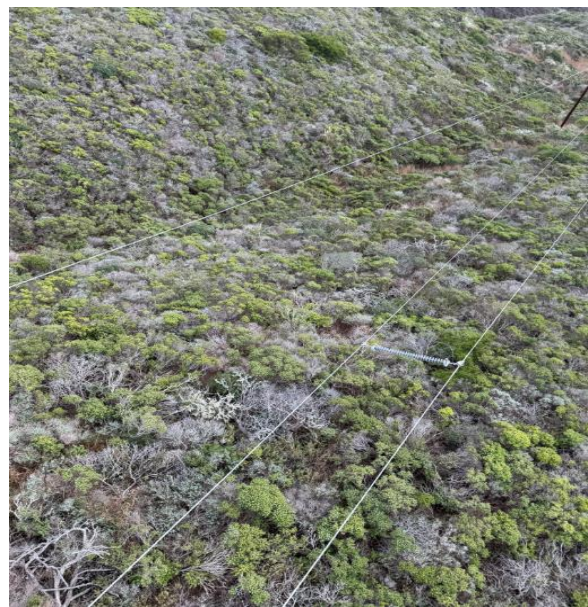
Figure 10 & 11 Photos from LC Notification 129928956 showing spacers that were installed between poles ?4/0 and ?4/1 to temporarily mitigate conductor midspan on December 16, 2024.

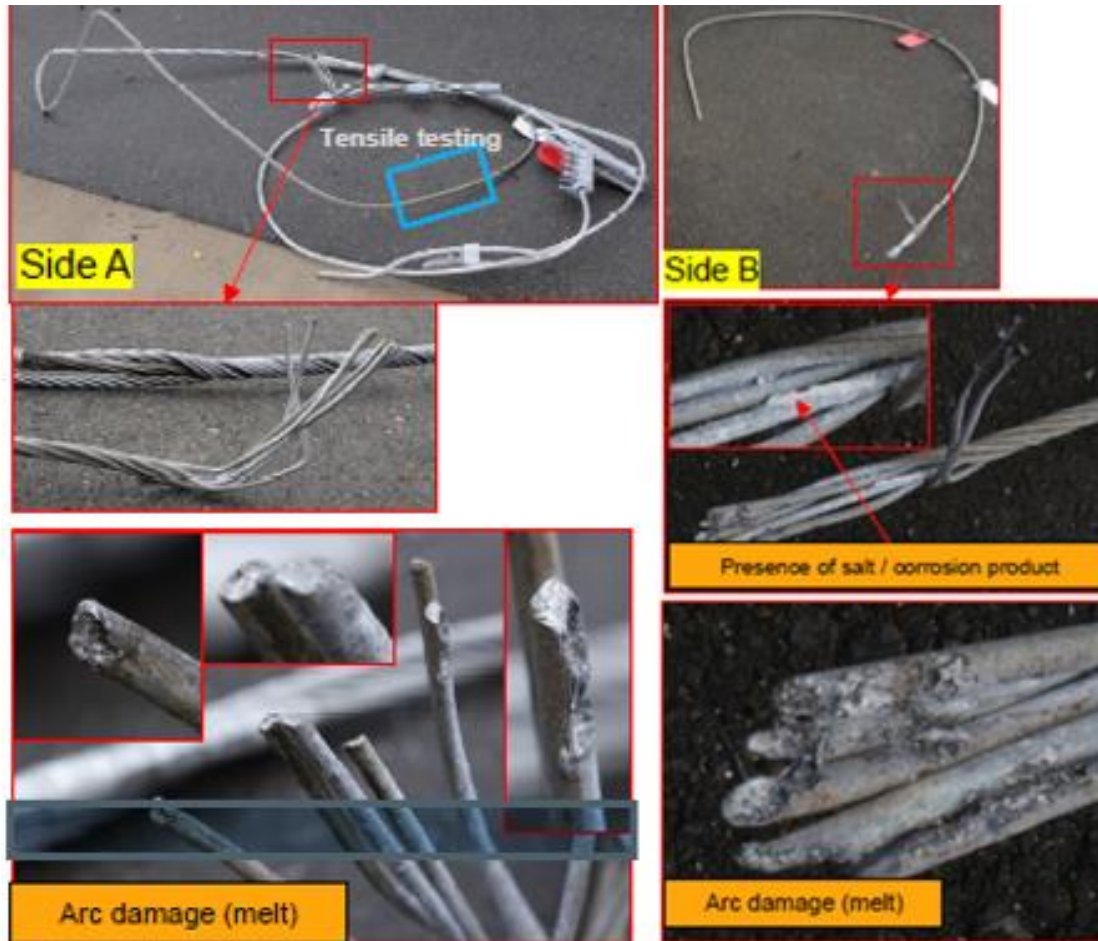
ATS conducted a visual examination and identified melted strands on the failed conductor with a significant presence of corrosion products (See Figure 12). The cause of the failure was not determined; however, ATS identified a L-L fault several spans downstream of the ignition location occurring approximately two minutes prior to the incident. ATS theorizes that this L-L fault created a current surge and likely stressed the corroded conductor, leading to its ultimate failure. Asset Failure Analysis (AFA) engineers completed an Extent of Condition for the event. In addition to ATS' findings, AFA suspects that several L-L faults in the month of November on the span between poles 003/004 – 003/005 of the Sneath Lane-Half Moon Bay 60kV circuit may have also contributed to the weakening of the already corroded conductor. Additional detail from ATS and AFA's analysis can be found below:

Figure 12 Images from ATS report. ATS' visual examination revealed that the failed conductor showed melted strands with a significant presence of corrosion products.
