Preliminary Ignition Investigation Report

Executive Summary

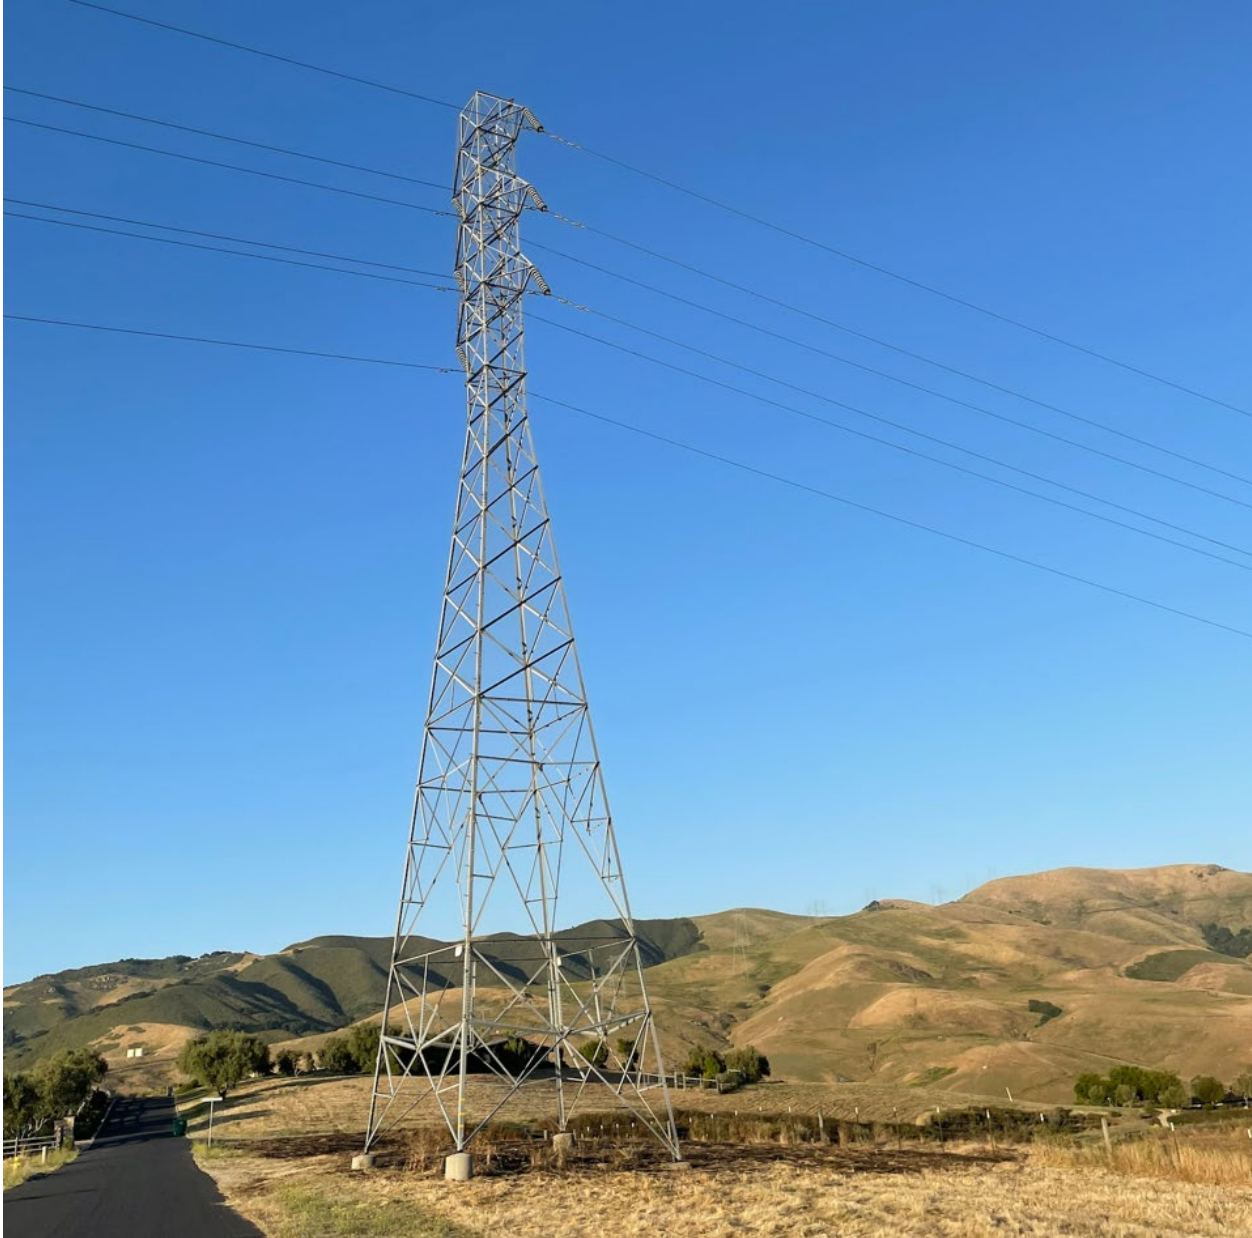
Figure 5 – Photo of tower and fire footprint from troubleshooter.

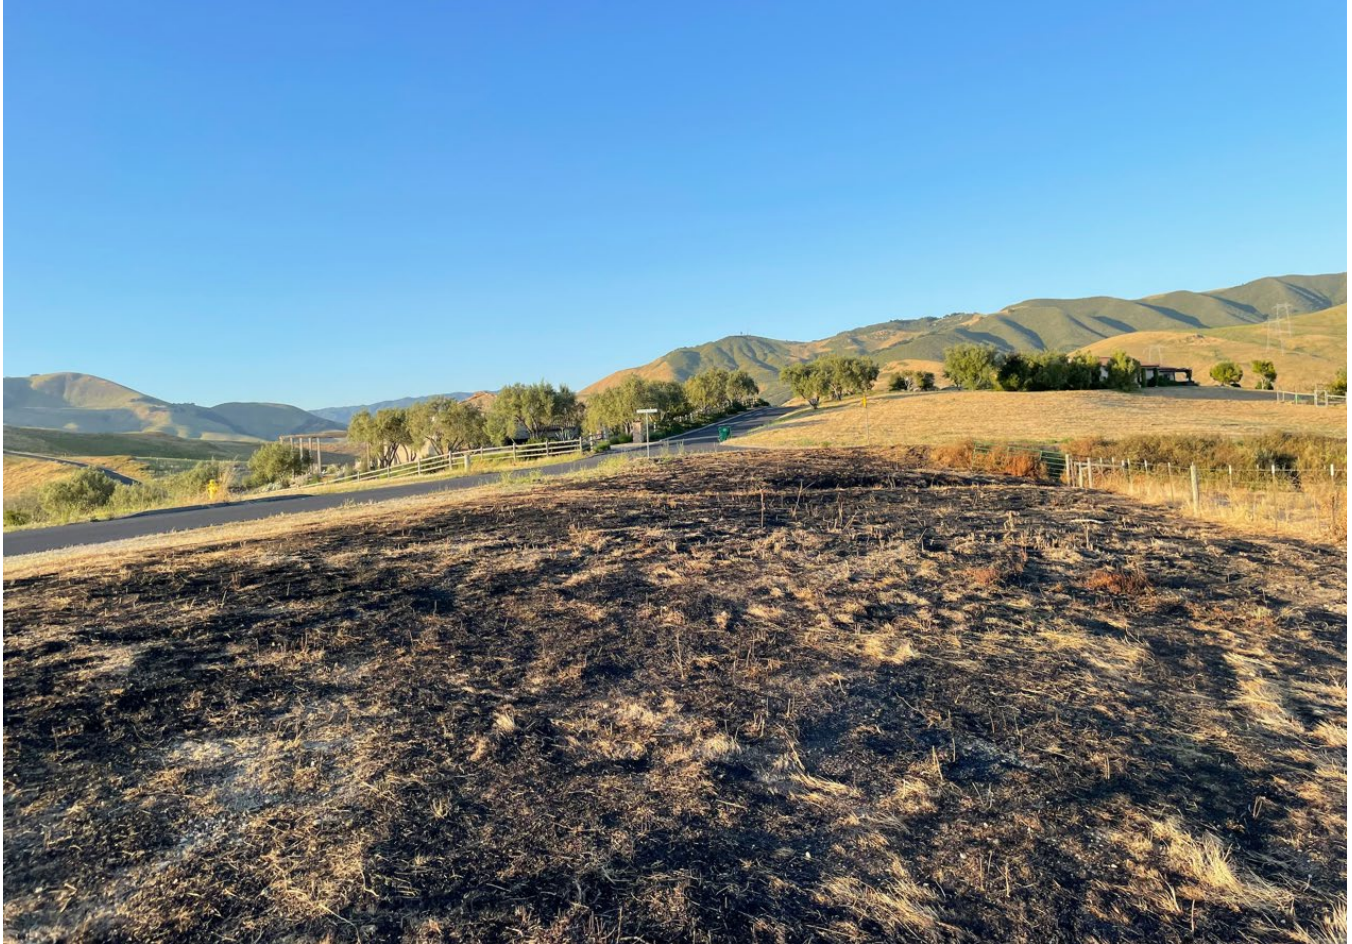
Figure 6 – Photo of fire footprint from troubleshooter.

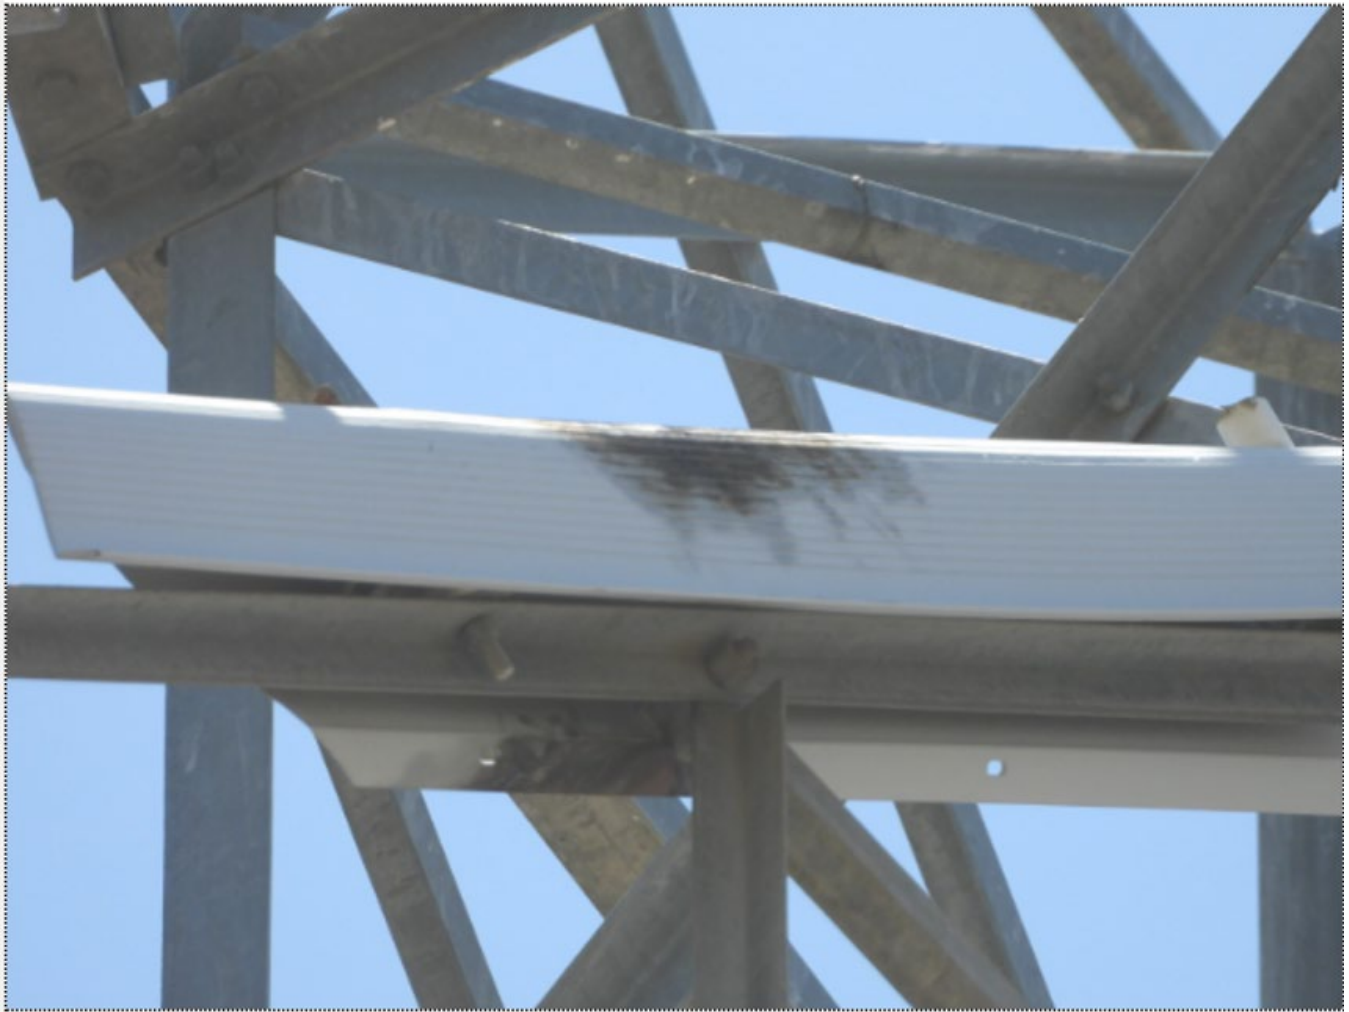
Upon arrival to Tower #1, the troubleshooter met with CAL FIRE who were onsite mopping up a vegetation fire. The troubleshooter patrolled the area and located damage to a bird guard with indications of an arc (See Figures 7 and 8). The conductor also appeared to have an anomaly on it.

Figure 7 – Photo of burn on bird guard from troubleshooter.

A priority 'A' LC notification (#128900417) was created post ignition to change out a bird guard that had flash markings. The tag also included removing one bell from the top and middle phases to maintain clearance. The San Luis Obispo-Santa Maria 115kV transmission circuit took clearance on May 28, 2024, to complete repairs. The repairs were completed same day by a PG&E crew and the San Luis Obispo-Santa Maria 115kV transmission circuit was placed back in service at 2016 hours.

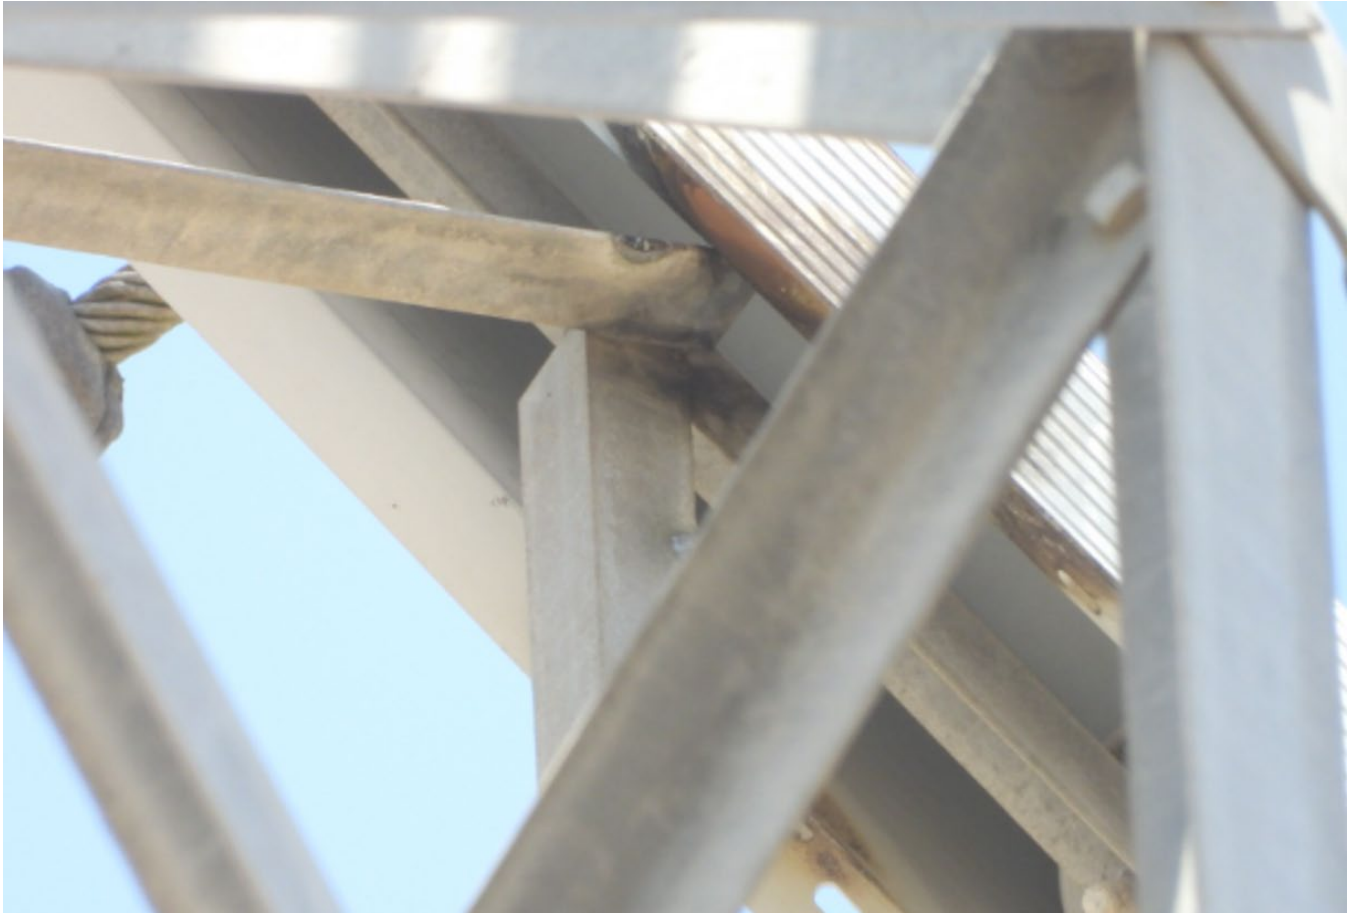
Figure 8 – Photo of arc on bird guard and structure.
