## Preliminary Ignition Investigation Report

Ignition Database Index:	20240167
Electric Incident Investigation (EII) Number:	N/A
Incident Name:	N/A
PG&E Facility Ignition?	Yes
CPUC Reportable Ignition?	Yes
Date & Time of Incident:	March 14, 2024 at approximately 2239 hours
Street Address:	54149 Road 432
City:	Bass Lake
County:	Madera
Latitude/Longitude:	37.321100°, -119.561487°
State Responsibility Area (SRA) / Local Responsibility Area (LRA) / Federal Responsibility Area (FRA)	State Responsibility Area
PG&E Division:	Yosemite
High Fire Threat District (HFTD):	Tier 3
High Fire Risk Area (HFRA):	Yes
EPSS Buffer:	No
Fire Index Area (FIA):	424
Fire Potential Index (FPI) Rating: FIA	R1
Fire Potential Index (FPI) Rating: Circuit	R1
Was there a PSPS event at the time of ignition?	No
Suspected Initiating Event:	Vegetation
Failure Driver:	Contact from Object
Failure Sub-driver:	Contact – Vegetation
Circuit:	Oakhurst 1103
Circuit Protection Zone:	Oakhurst 110377348

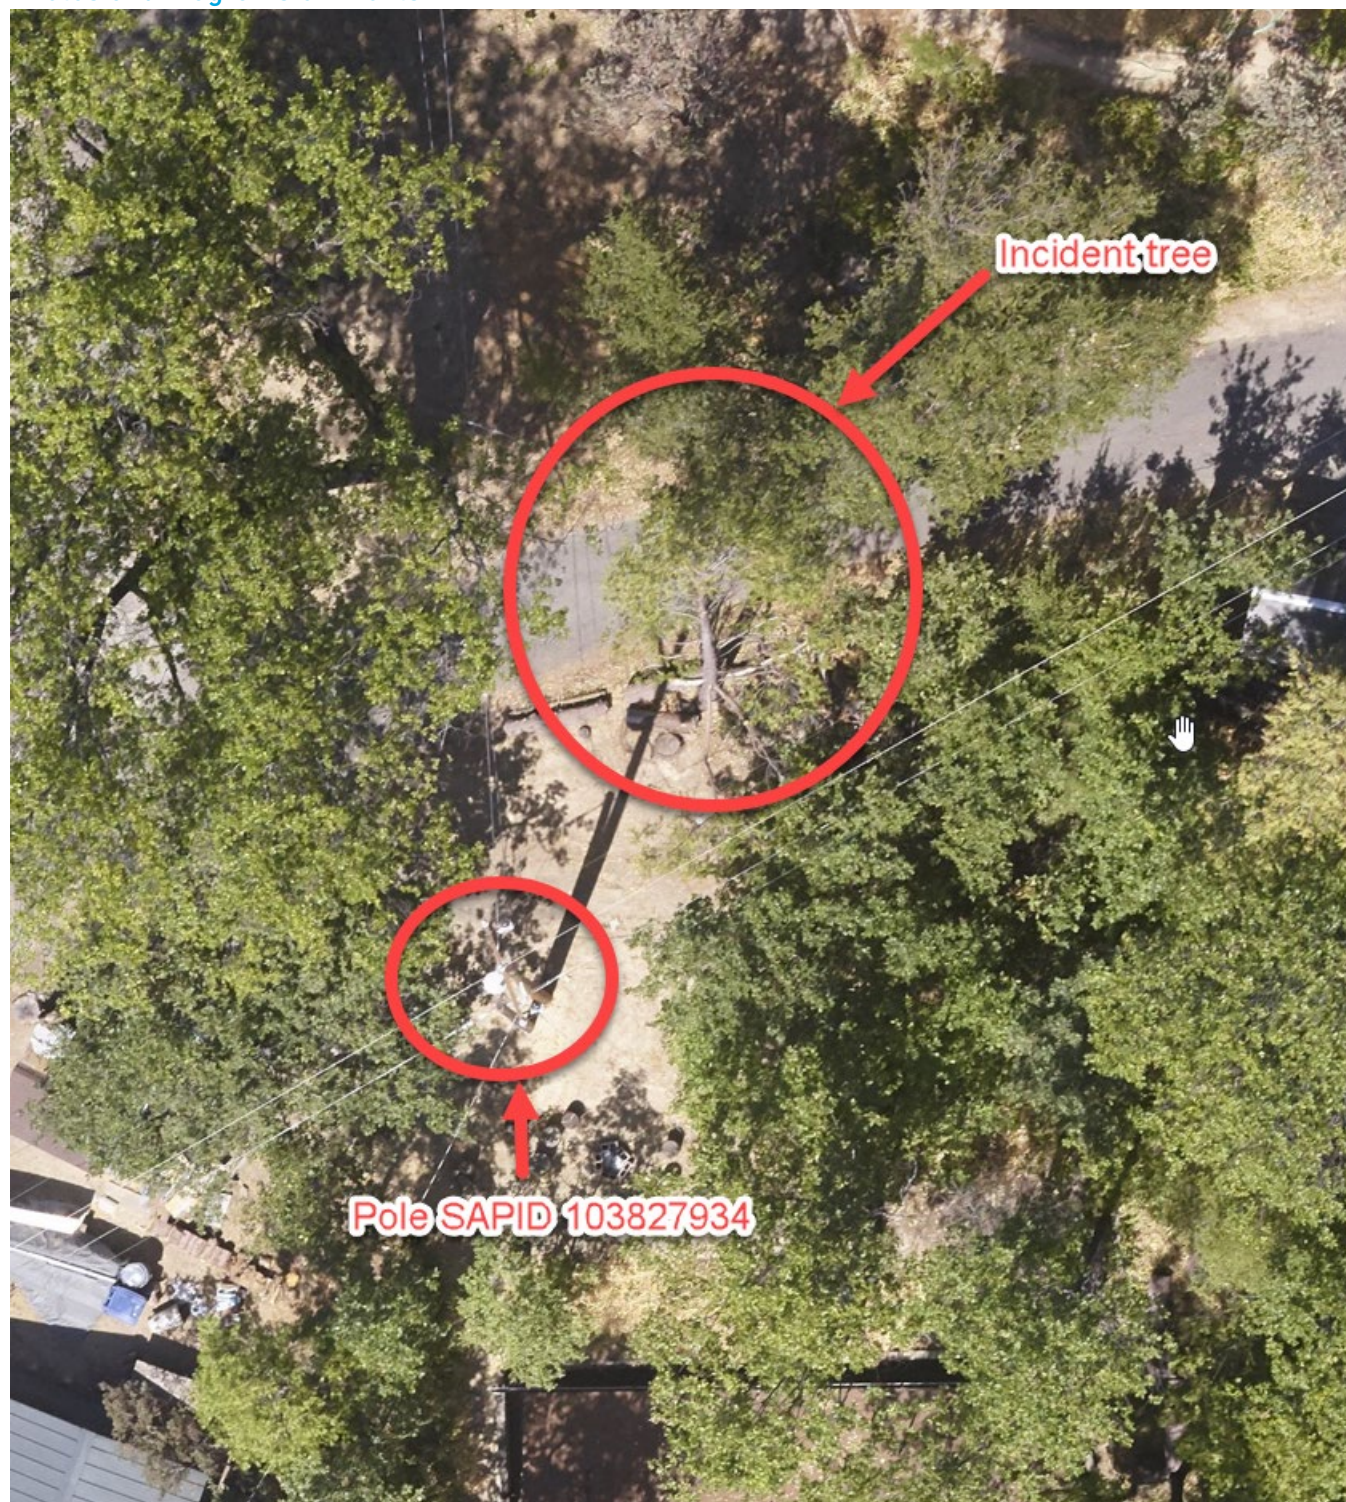
Figure 1: Image of incident tree and incident pole obtained from SharperShape aerial inspection imagery.

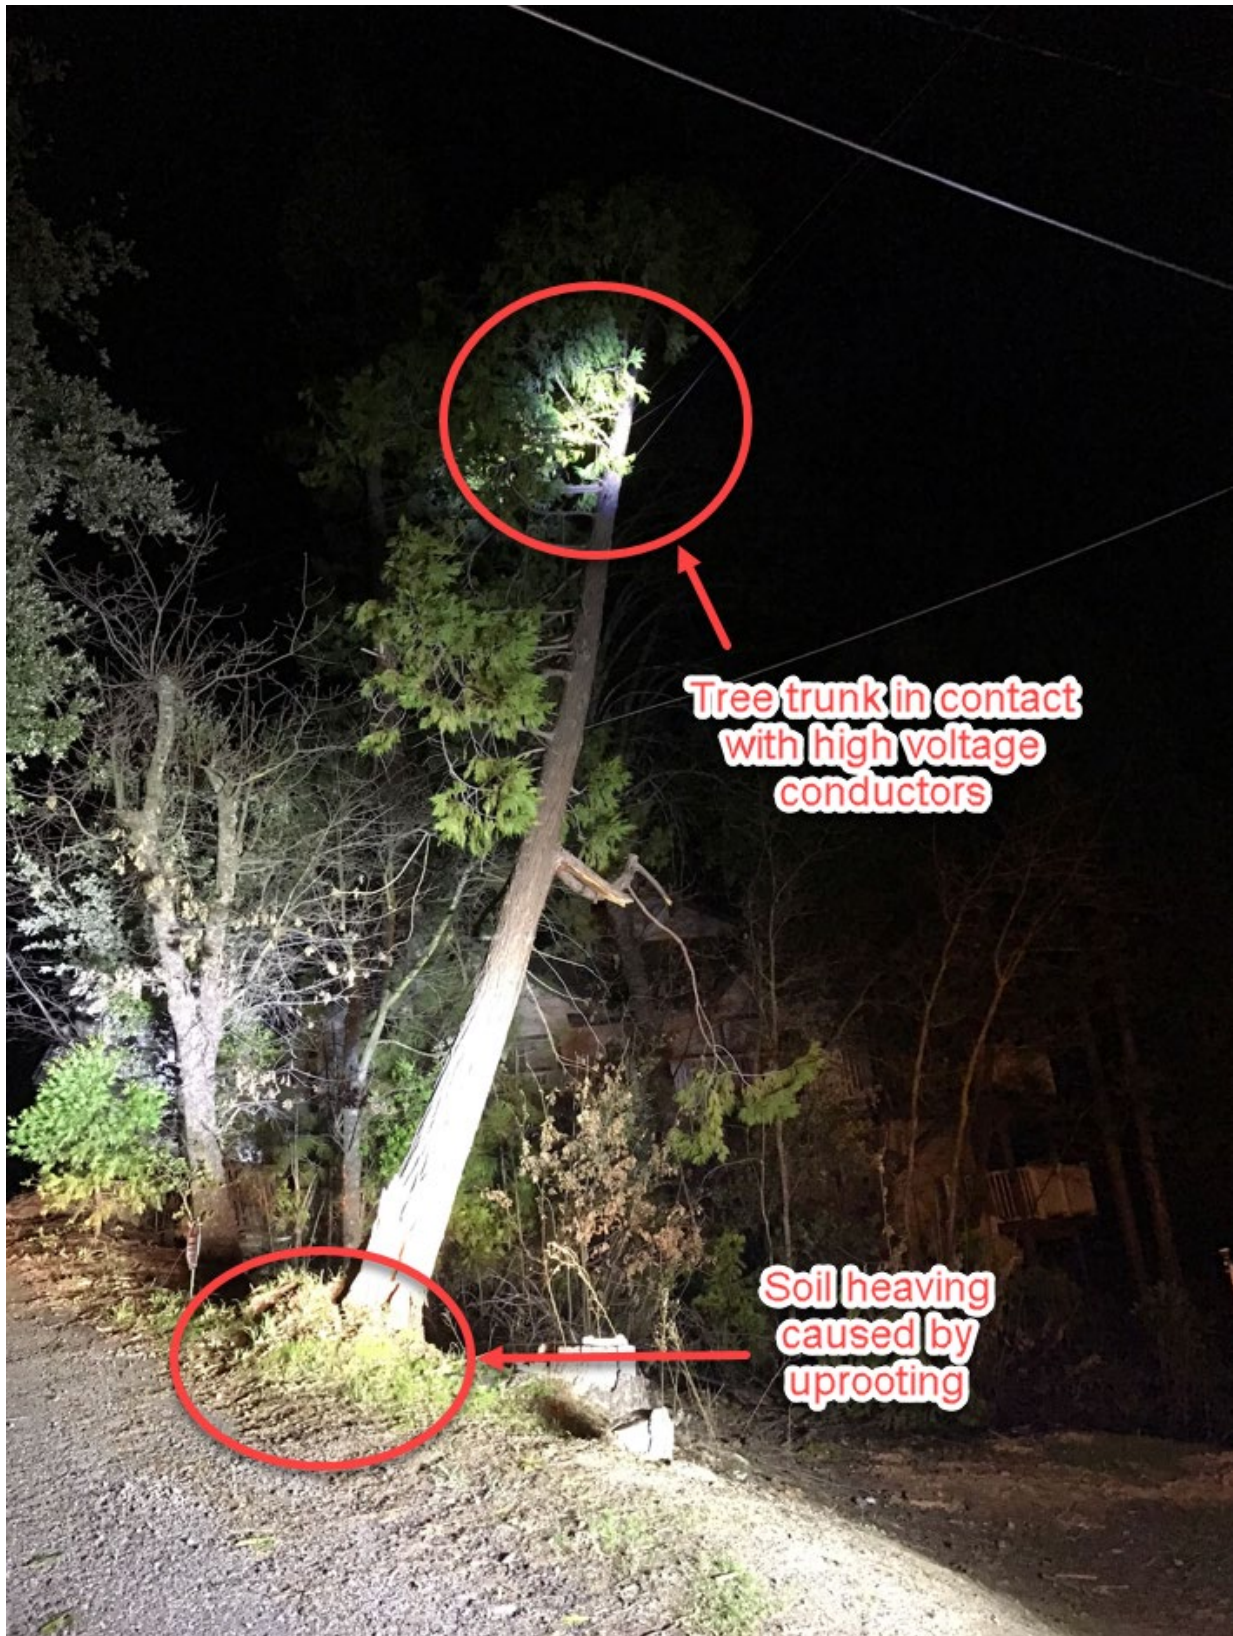
On March 18, 2024, a PG&E vegetation management inspector (VMI) performed a Fire Incident Investigation to assess the incident tree for factors that may have contributed to its failure. The VMI observed that the tree was a 15-inch diameter at breast height (DBH), 60-foot-tall incense cedar (*Calocedrus decurrens*) that uprooted during gusty wind conditions. The tree showed no prior signs of decay or defects that might have indicated that it was at risk of uprooting toward conductors. While at the location of the ignition, the VMI performed an Extent of Conditions (XoC) patrol to identify other trees with similar factors that may have required work. No trees were identified as requiring work during the XoC patrol.

Figure 2: Photo collected by troubleshooter showing soil heaving and tree in contact with conductors.

On March 15, 2024, a PG&E contract tree crew removed the tree from the conductors and a PG&E electric construction crew replaced a 10 foot section of the center phase conductor with 2-ACSR.

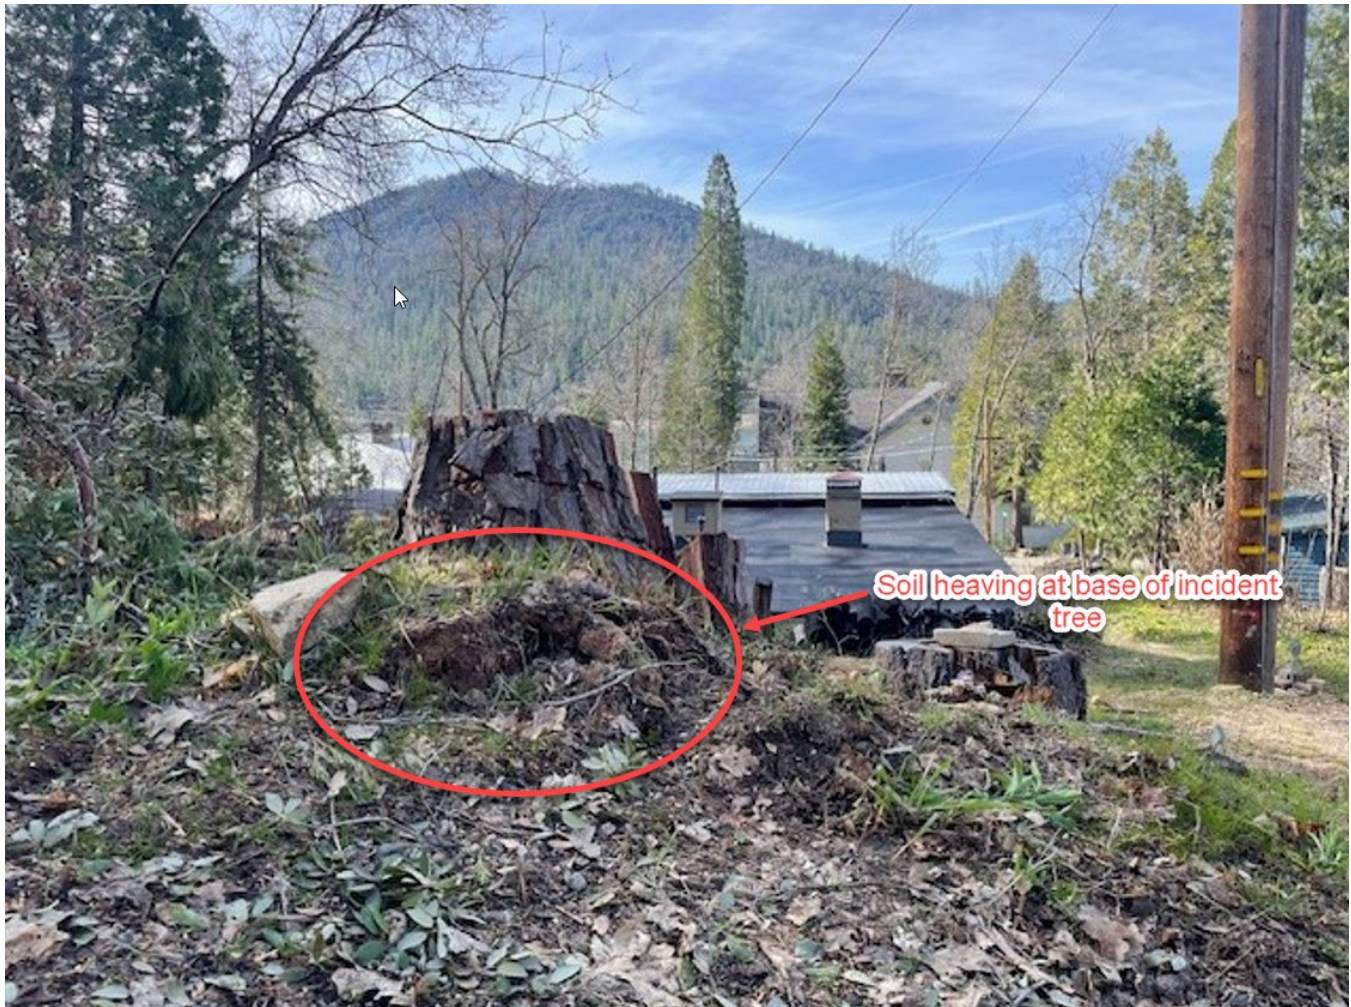
Figure 3: Photo collected by vegetation management inspector showing soil heaving at the base of the incident tree.

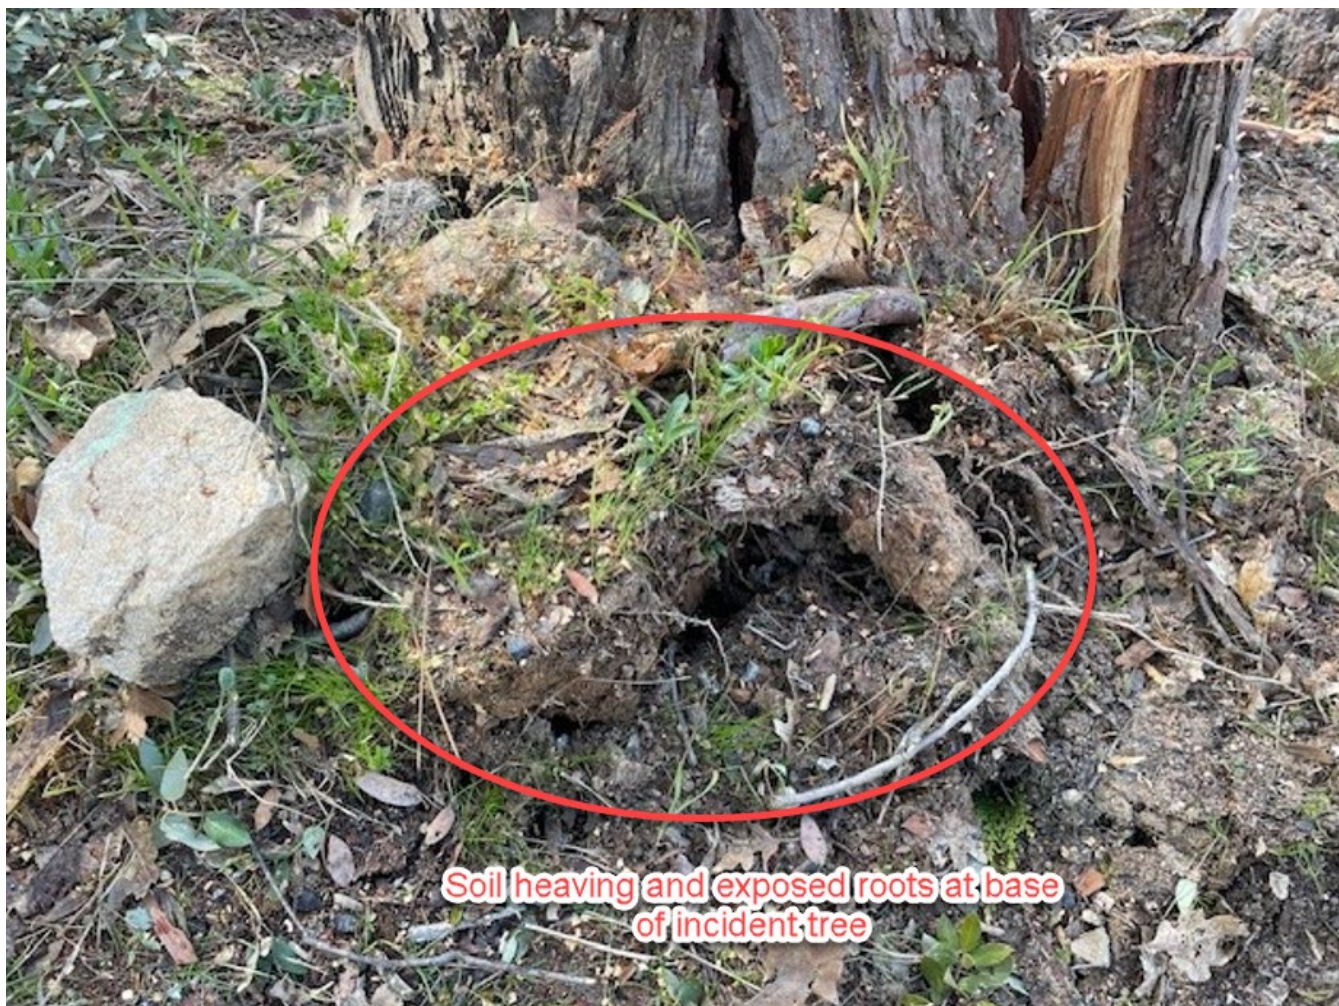
Figure 4: Photo collected by vegetation management inspector showing soil heaving and exposed roots at base of incident tree.

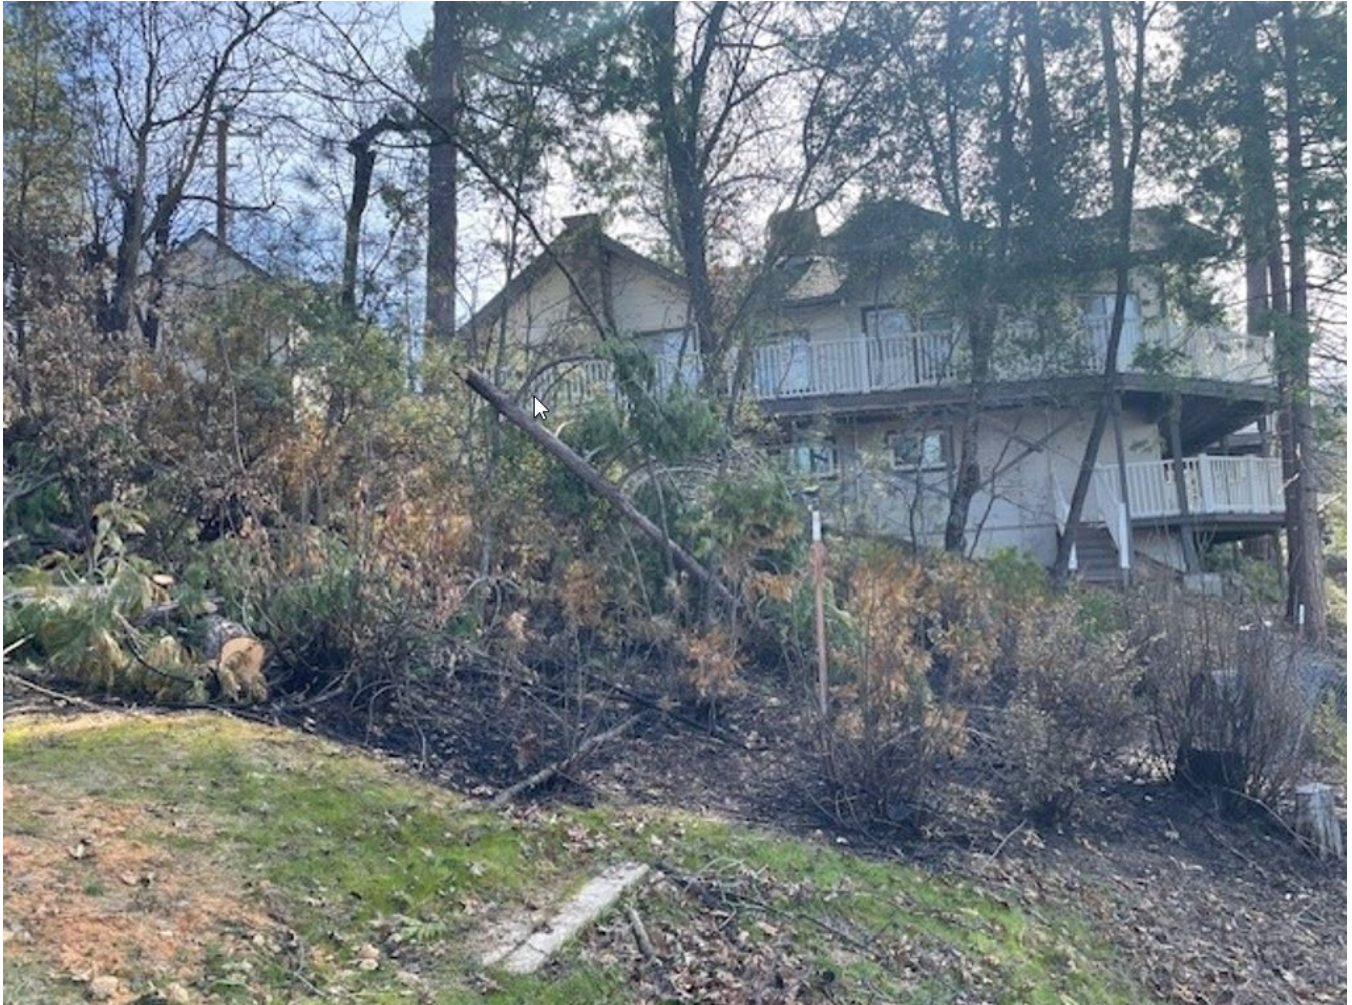
The line-to-ground incident resulted in a fire of approximately 1600 square feet which was extinguished by CAL FIRE. The incident occurred at 2239 hours on March 14, 2024. The initial outage affected 469 customers for 32,830 outage minutes. Once the incident location was isolated, power was restored to 359 customers, leaving

Figure 5: Photo taken by vegetation management inspector of a portion of the fire footprint.
