Preliminary Ignition Investigation Report

Ignition Database Index:	20240431
Electric Incident Investigation (EII) Number:	N/A
Incident Name:	N/A
PG&E Facility Ignition?	Yes
CPUC Reportable Ignition?	Yes
Date & Time of Incident:	May 18, 2024, at 0323 Hours
Street Address:	Near [REDACTED]
City:	Clearlake
County:	Lake
Latitude/Longitude:	[REDACTED]
State Responsibility Area (SRA) / Local Responsibility Area (LRA) / Federal Responsibility Area (FRA)	Local Responsibility Area (LRA)
PG&E Division:	Humboldt
High Fire Threat District (HFTD):	Tier 2
High Fire Risk Area (HFRA):	Yes
EPSS Buffer:	No
Fire Index Area (FIA):	175
Fire Potential Index (FPI) Rating: FIA	R1
Fire Potential Index (FPI) Rating: Circuit	R2
Was there a PSPS event at the time of ignition?	No
Suspected Initiating Event:	Equipment – Overloaded
Failure Driver:	All Types of Equipment / Facility Failure
Failure Sub-driver:	Splice/Clamp/Connector
Circuit:	Highlands 1102
Circuit Protection Zone:	Highlands 1102 LR 75140

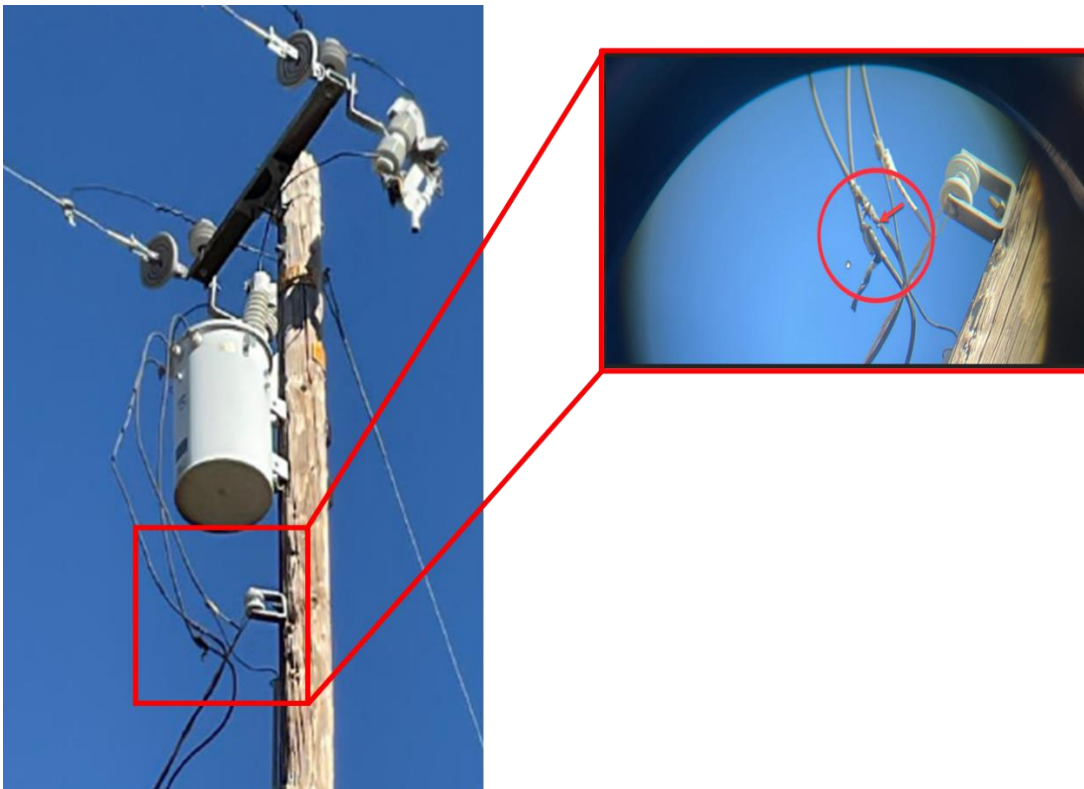
Info / Inspection	Most Recent Date	Findings
Install Date:	1982	45-foot, Douglas Fir, Class 5 wood pole
Inspection:	July 15, 2023	Connector, insulation deteriorated - repair, loose guy- adjust
	June 8, 2020	No anchor, guys, hardware, framing or vegetation conditions reported.
Patrol:	N/A	
Corrective History:	N/A	
Aerial Inspection Records:	July 27, 2019	Aerial view of pole SAP ID 102150165 in Sharper Shape (see Figure's 3 & 4).
VM Inspection:	N/A	
EVM Inspection:	N/A	
Equipment Test:	N/A	
Pole Intrusive Test:	April 15, 2019	No Findings
WSIP Inspection:	May 2, 2019	No compelling abnormal conditions for the pole, equipment and associated spans were noted.

Figure 5 – GO 165 inspection photos from July 15, 2023, showing connector insulation deteriorated and exposed

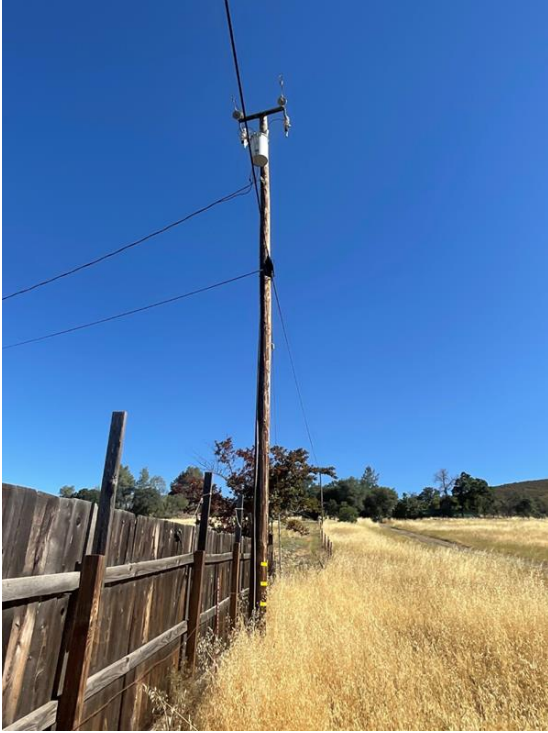
Figure 6 – Compliance inspection photo from July 17, 2023, of subject pole, SAP ID 102150165

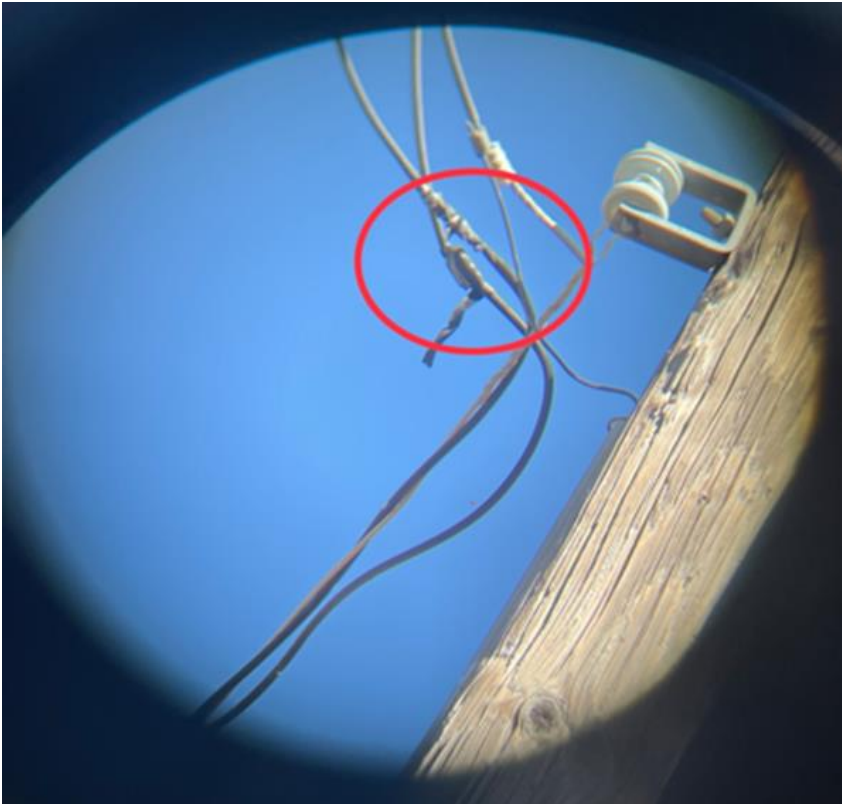
Figure 7 – Compliance inspection photo dated July 17, 2023, of subject pole showing loose electrical tape around connector.

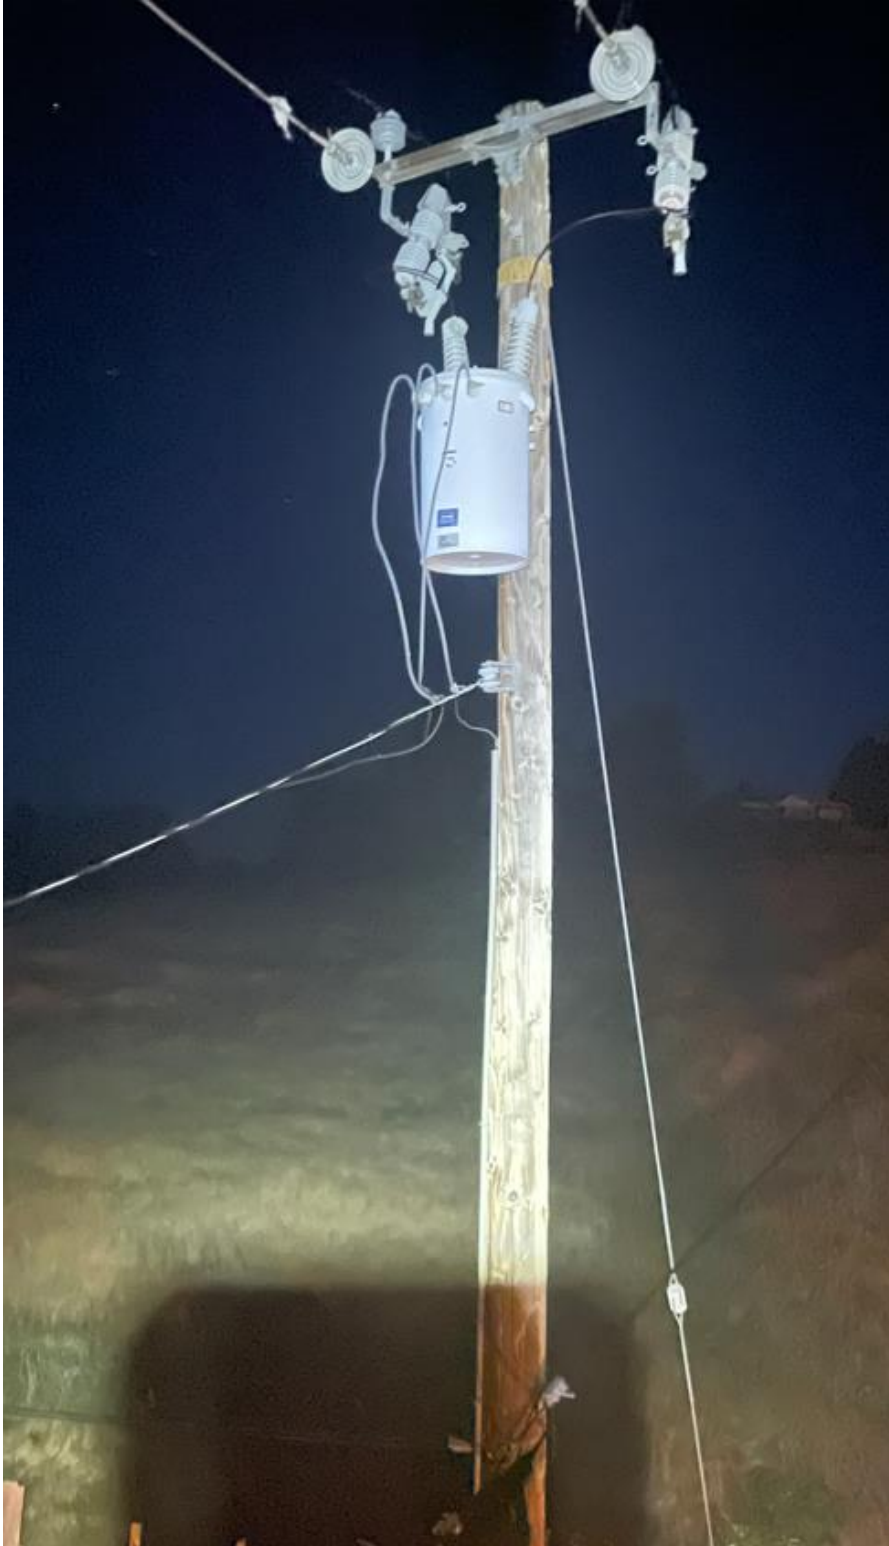
The troubleshooter was dispatched to the outage at approximately 0337 hours and arrived at the ignition location (Pole SAP ID 102150165) at approximately 0412 hours. According to the troubleshooter, the fire was not actively burning upon his arrival, but ensured the fire was fully extinguished. While inspecting the pole, the troubleshooter noticed a secondary connector from the transformer had failed, possibly causing an arc and igniting the vegetation below. The fire footprint was under three meters in size. The troubleshooter replaced the failed connector and restored power to the single affected customer at 0449 hours. The failed connector was collected and sent to Applied Technology Services (ATS) for further failure analysis.

Figure 8 – Photo of subject pole taken by troubleshooter on May 18, 2024.

The responding troubleshooter was able to make corrections to the bad secondary connection onsite, therefore, a corrective notification was not warranted.

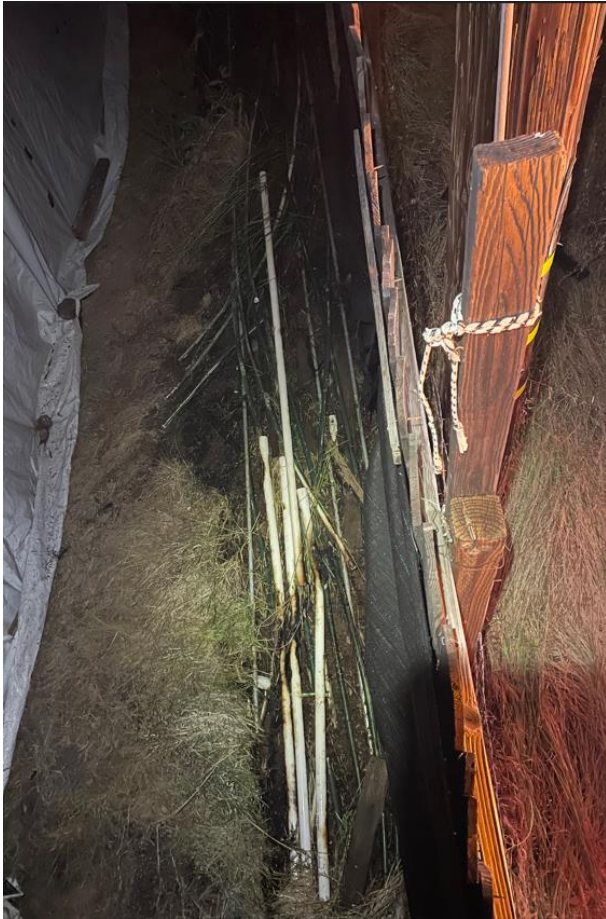
The ignition that occurred on May 18, 2024, burned less than three meters of grass and was extinguished by the troubleshooter. The associated outage affected a single customer. PG&E is not aware of any injuries, fatalities, property damage or significant media attention associated to this ignition event.

Figure 9 – Photo of fire area burned taken by troubleshooter on May 18, 2024.

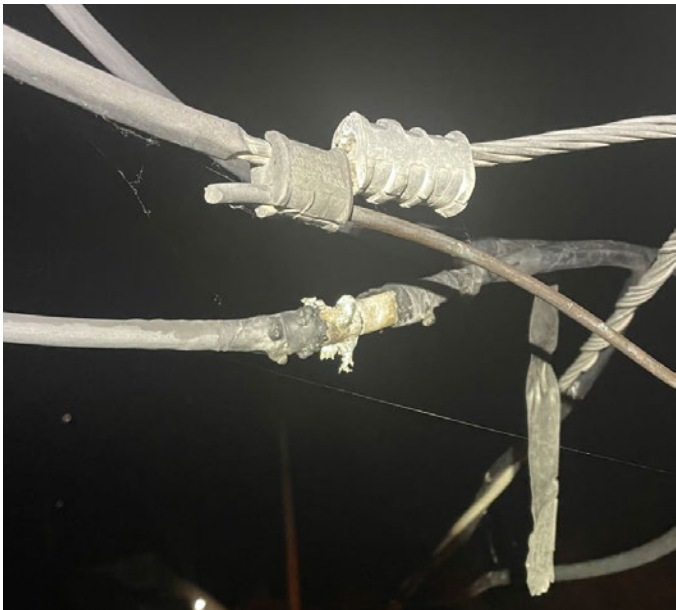
On May 29, 2024, testing of a segment of the hot leg was completed by ATS. Visual examination of the connector indicated overheating patterns and melting of the polymer insulation around the connector. Molten aluminum seeped out of the connector, indicating excessive Joule heating created by electrical overload. ATS reviewed the SmartMeter™ data for the property and discovered that the customers' use continually exceeded the transformer capacity as of December 2023. From this data, it was determined the ignition was likely caused by molten drops stemming from the hot leg connector on the 1/0 Triplex service drop as it was not designed to accommodate the increased load.

Figure 10 – Photo of exposed connector taken by troubleshooter on May 18, 2024, with electrical tape hanging in the background and bare neutral.

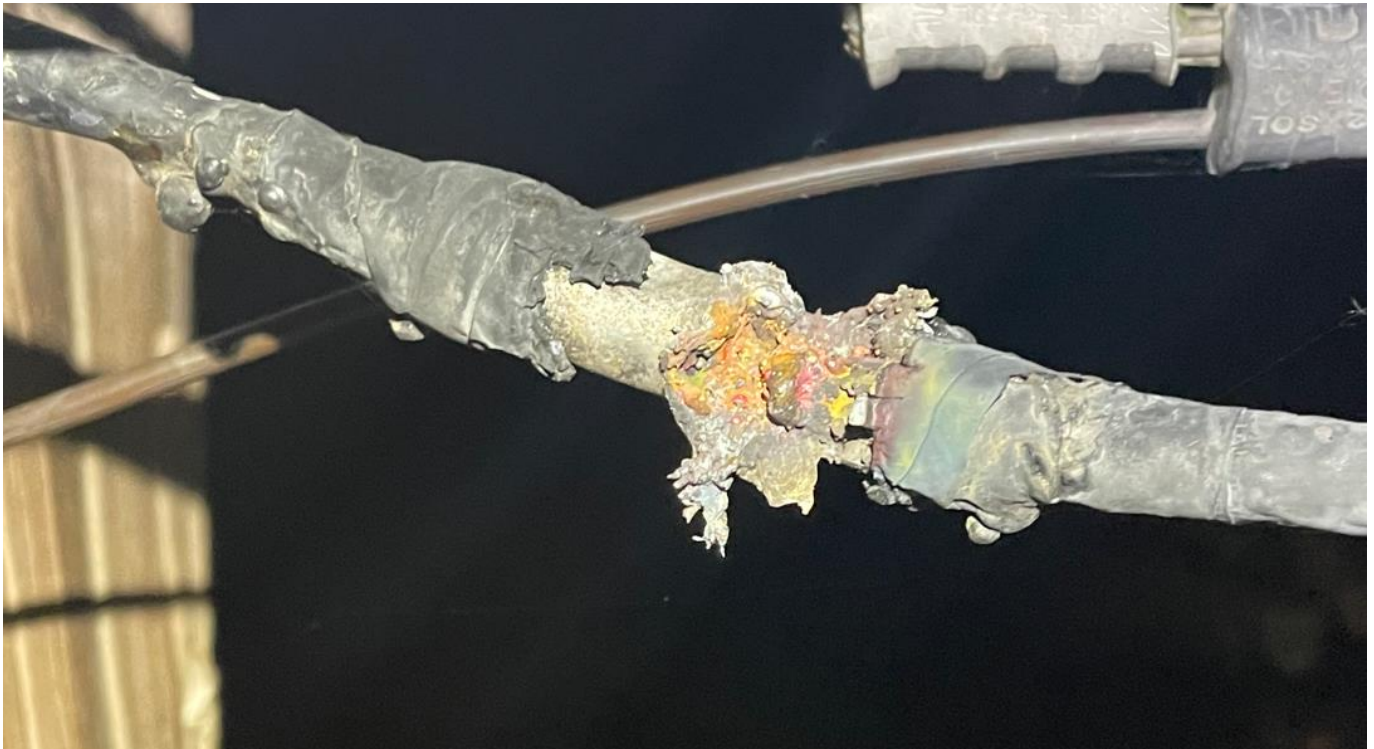
Figure 11 – Close-up photo of exposed connector taken by troubleshooter on May 18, 2024.
