## Preliminary Ignition Investigation Report

<b>Ignition Database Index:</b>	20240448
<b>Electric Incident Investigation (EII) Number:</b>	N/A
<b>Incident Name:</b>	Raney
<b>PG&amp;E Facility Ignition?</b>	Yes
<b>CPUC Reportable Ignition?</b>	Yes
<b>Date &amp; Time of Incident:</b>	May 21, 2024 @ approx. 0605 hours
<b>Street Address:</b>	Near 11962 Raney Road
<b>City:</b>	Columbia
<b>County:</b>	Tuolumne
<b>Latitude/Longitude:</b>	38.0368079824, -120.3863482807
<b>State Responsibility Area (SRA) / Local Responsibility Area (LRA) / Federal Responsibility Area (FRA)</b>	State Responsibility Area
<b>PG&amp;E Division:</b>	Yosemite
<b>High Fire Threat District (HFTD):</b>	Tier 2
<b>High Fire Risk Area (HFRA):</b>	Yes
<b>EPSS Buffer:</b>	No
<b>Fire Index Area (FIA):</b>	348
<b>Fire Potential Index (FPI) Rating: FIA</b>	R1
<b>Fire Potential Index (FPI) Rating: Circuit</b>	R1
<b>Was there a PSPS event at the time of ignition?</b>	No
<b>Suspected Initiating Event:</b>	Vegetation

## Executive Summary

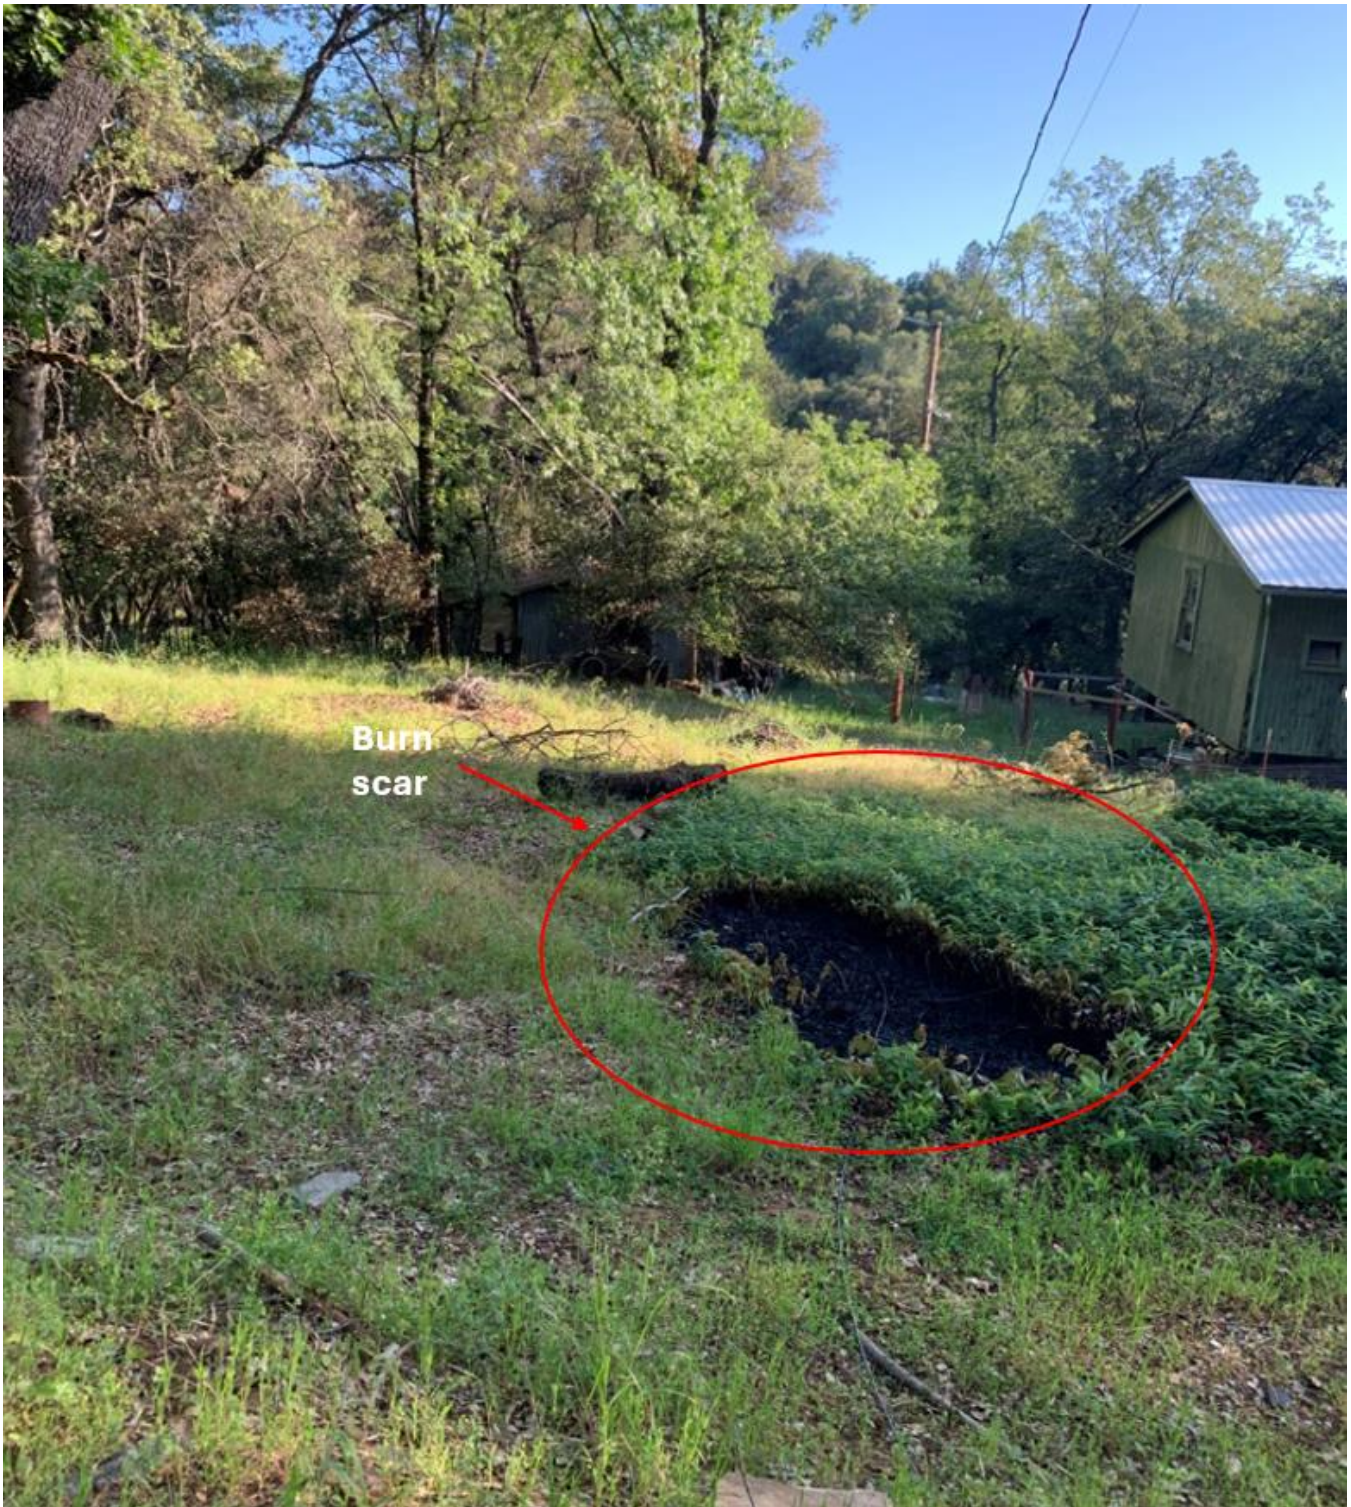
The troubleshooter arrived on scene at approximately 0640 hours and observed a primary overhead wire down, source side, between pole SAP ID # 101050291 and 101050282, which resulted in a vegetation fire measuring between 1-3 meters in size. Initial observations indicates that a tree branch fell, bringing the overhead primary to the ground, causing the ensuing fire. CAL FIRE arrived at the scene to extinguish the fire with an assist from a nearby resident who first noticed the flames. A priority "A" Electric Overhead Tag Notification #128822443 was created on May 21, 2024 because of this incident. A PG&E crew replaced 150 feet of copper conductor damaged by the failed tree branch and 200 feet of AWAC triplex, which melted when struck by the primary wire, prior to falling to the ground. Power was restored to the affected customers on the same day.

*Figure 2 Photo depicting burn area taken by troubleshooter.*

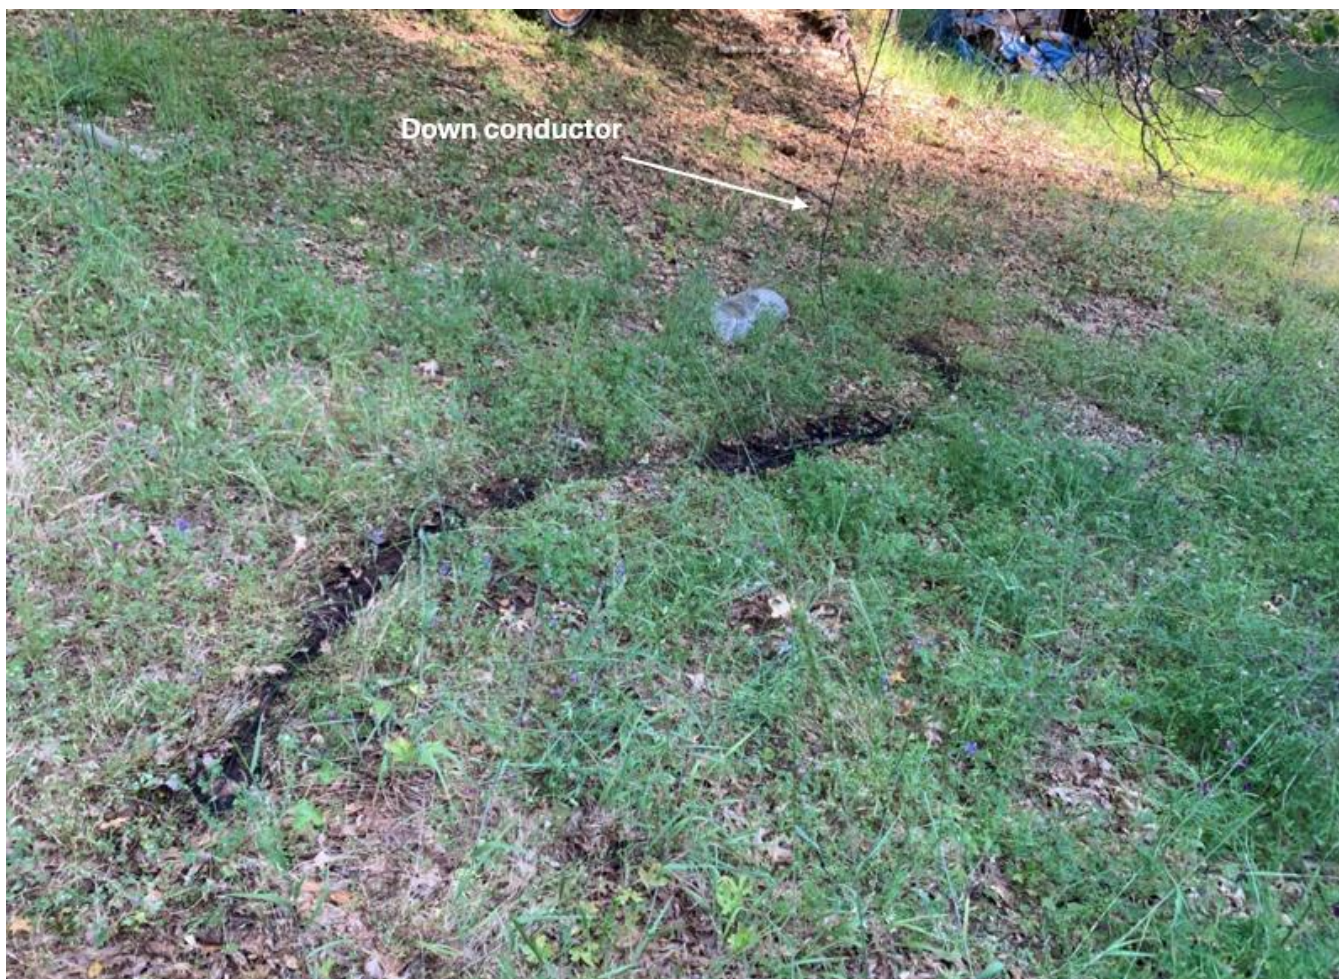
*Figure 3 Photo depicting more evidence of burnt vegetation due to down conductor taken by troubleshooter.*

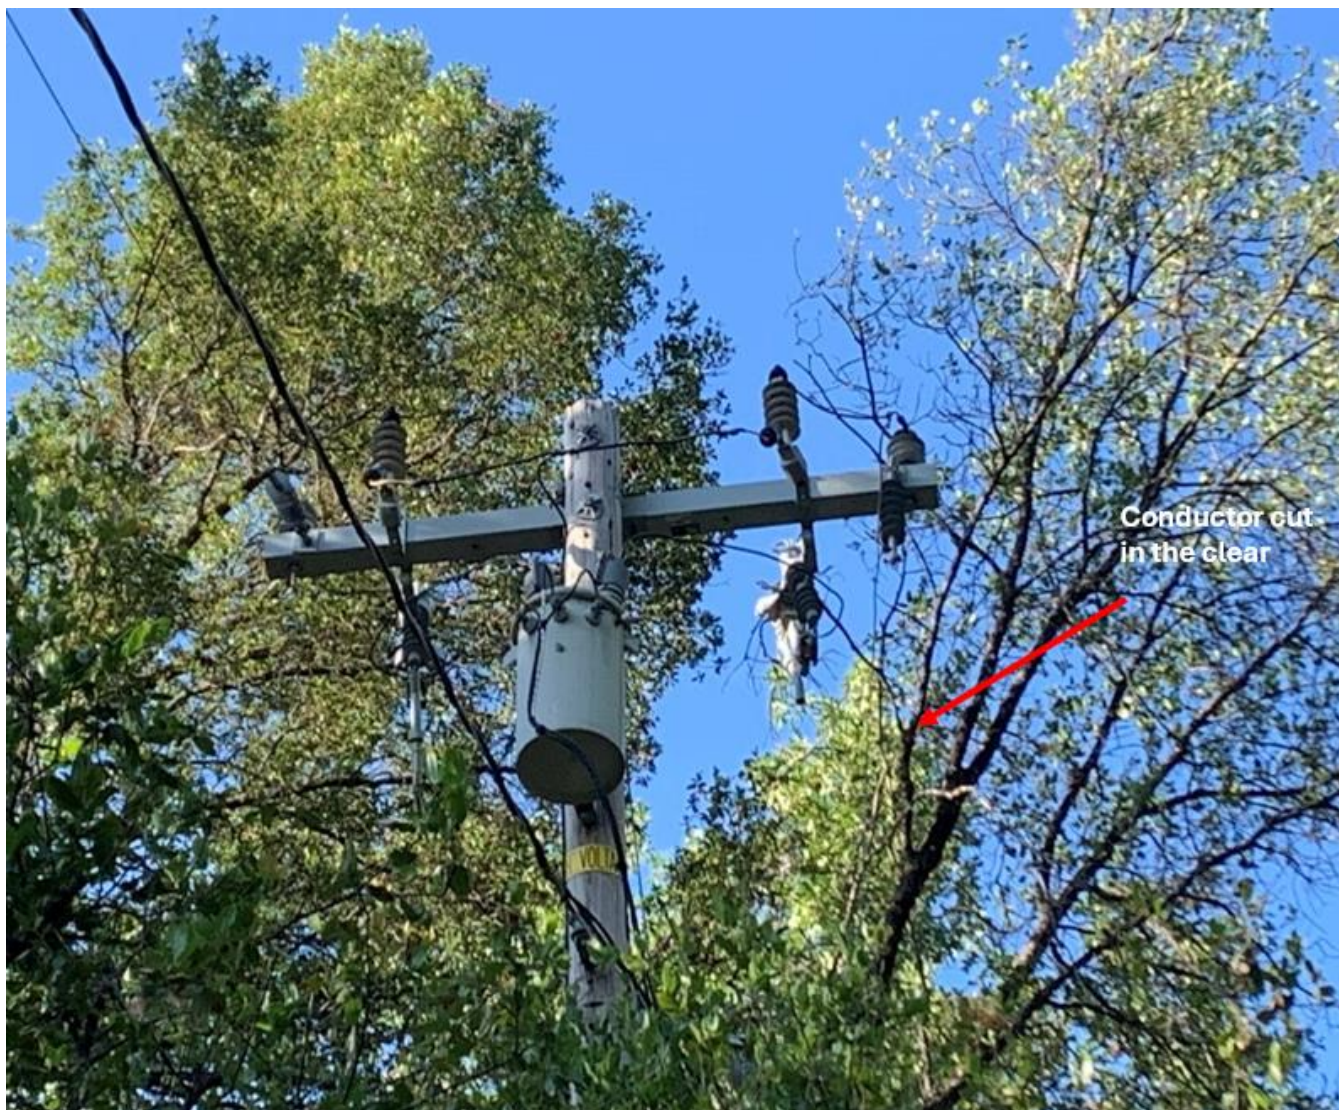
*Figure 4 Photo depicting south phase conductor cut in the clear near SAP Id #101050291 taken by troubleshooter.*

On May 21, 2024, a priority “A” Electric Corrective (EC) Notification # 128822443 was created because of this incident. A PG&E crew replaced 150 feet of copper conductor damaged by the failed tree branch and 200 feet of AWAC triplex, which melted when struck by the primary wire, prior to falling to the ground. All associated work was completed and power was restored power on the same day as the incident.

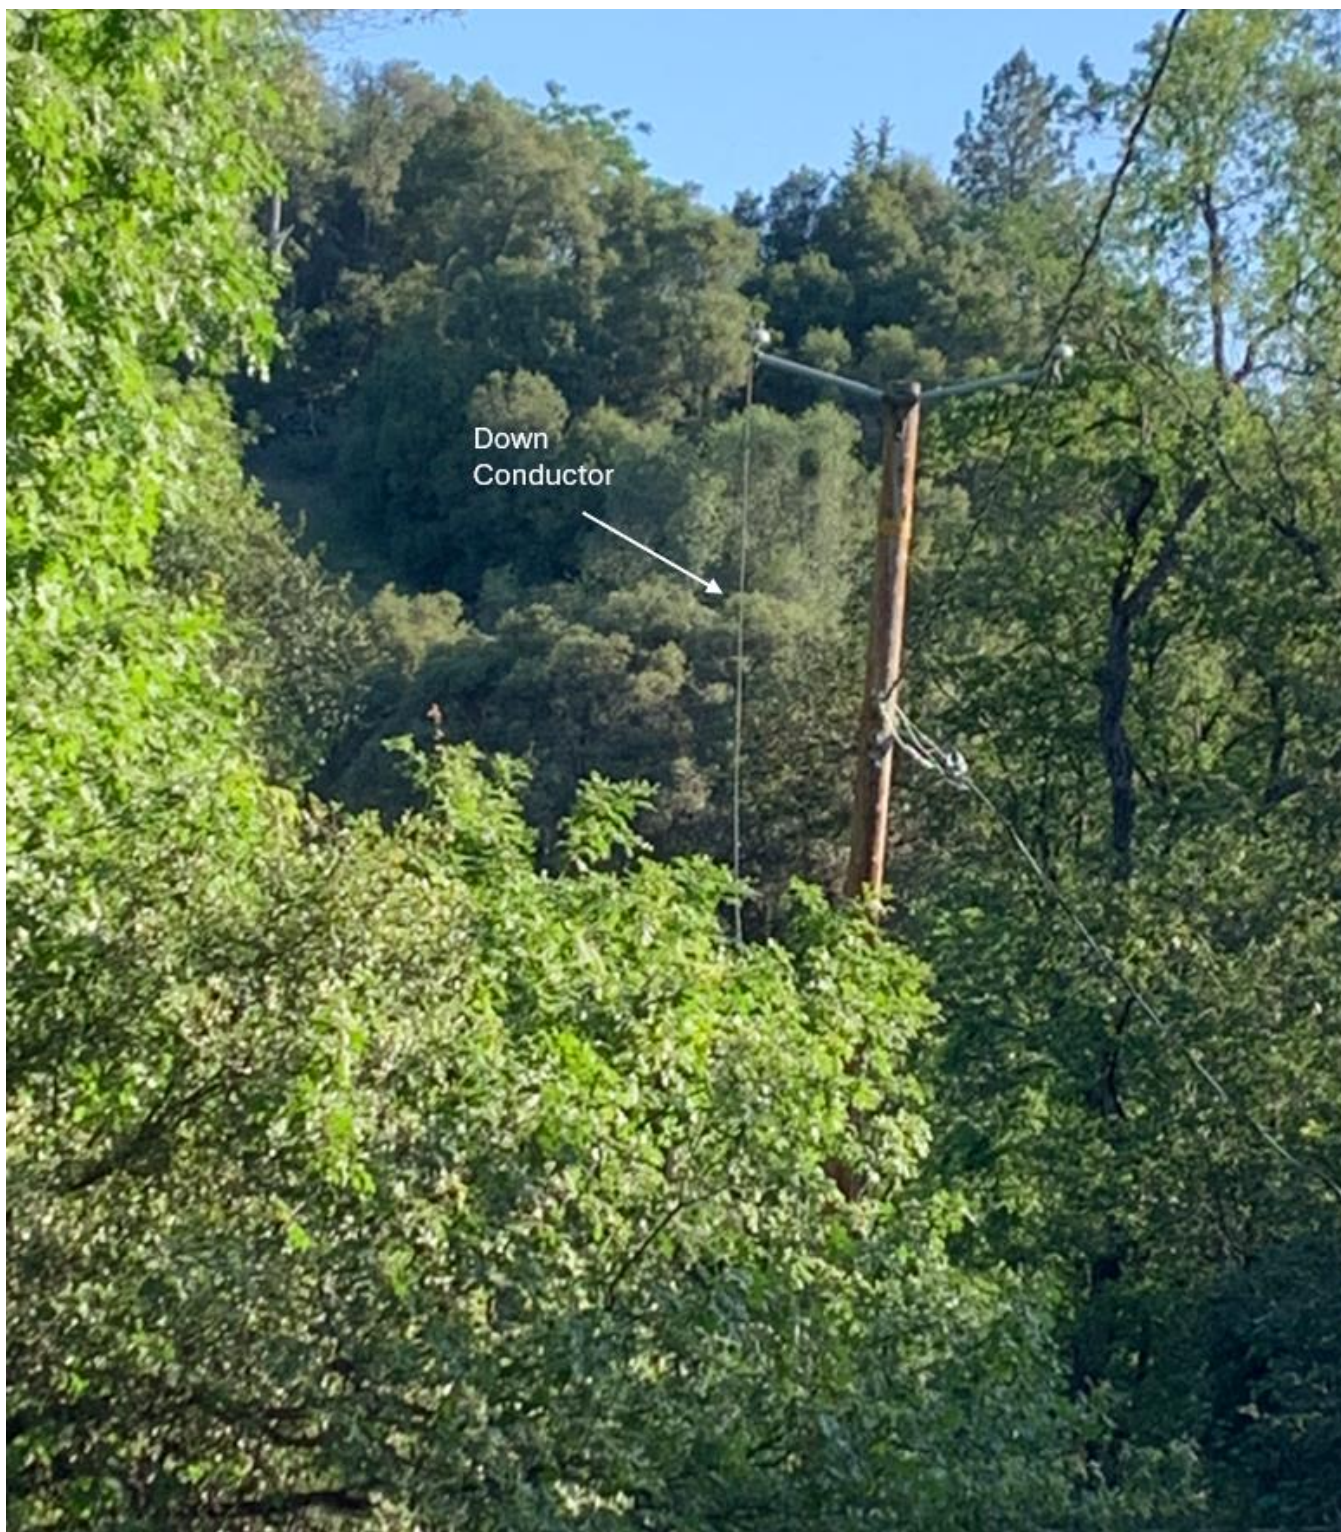
*Figure 5 Photo depicting south phase down conductor on SAP ID # 101050282 taken by troubleshooter.*

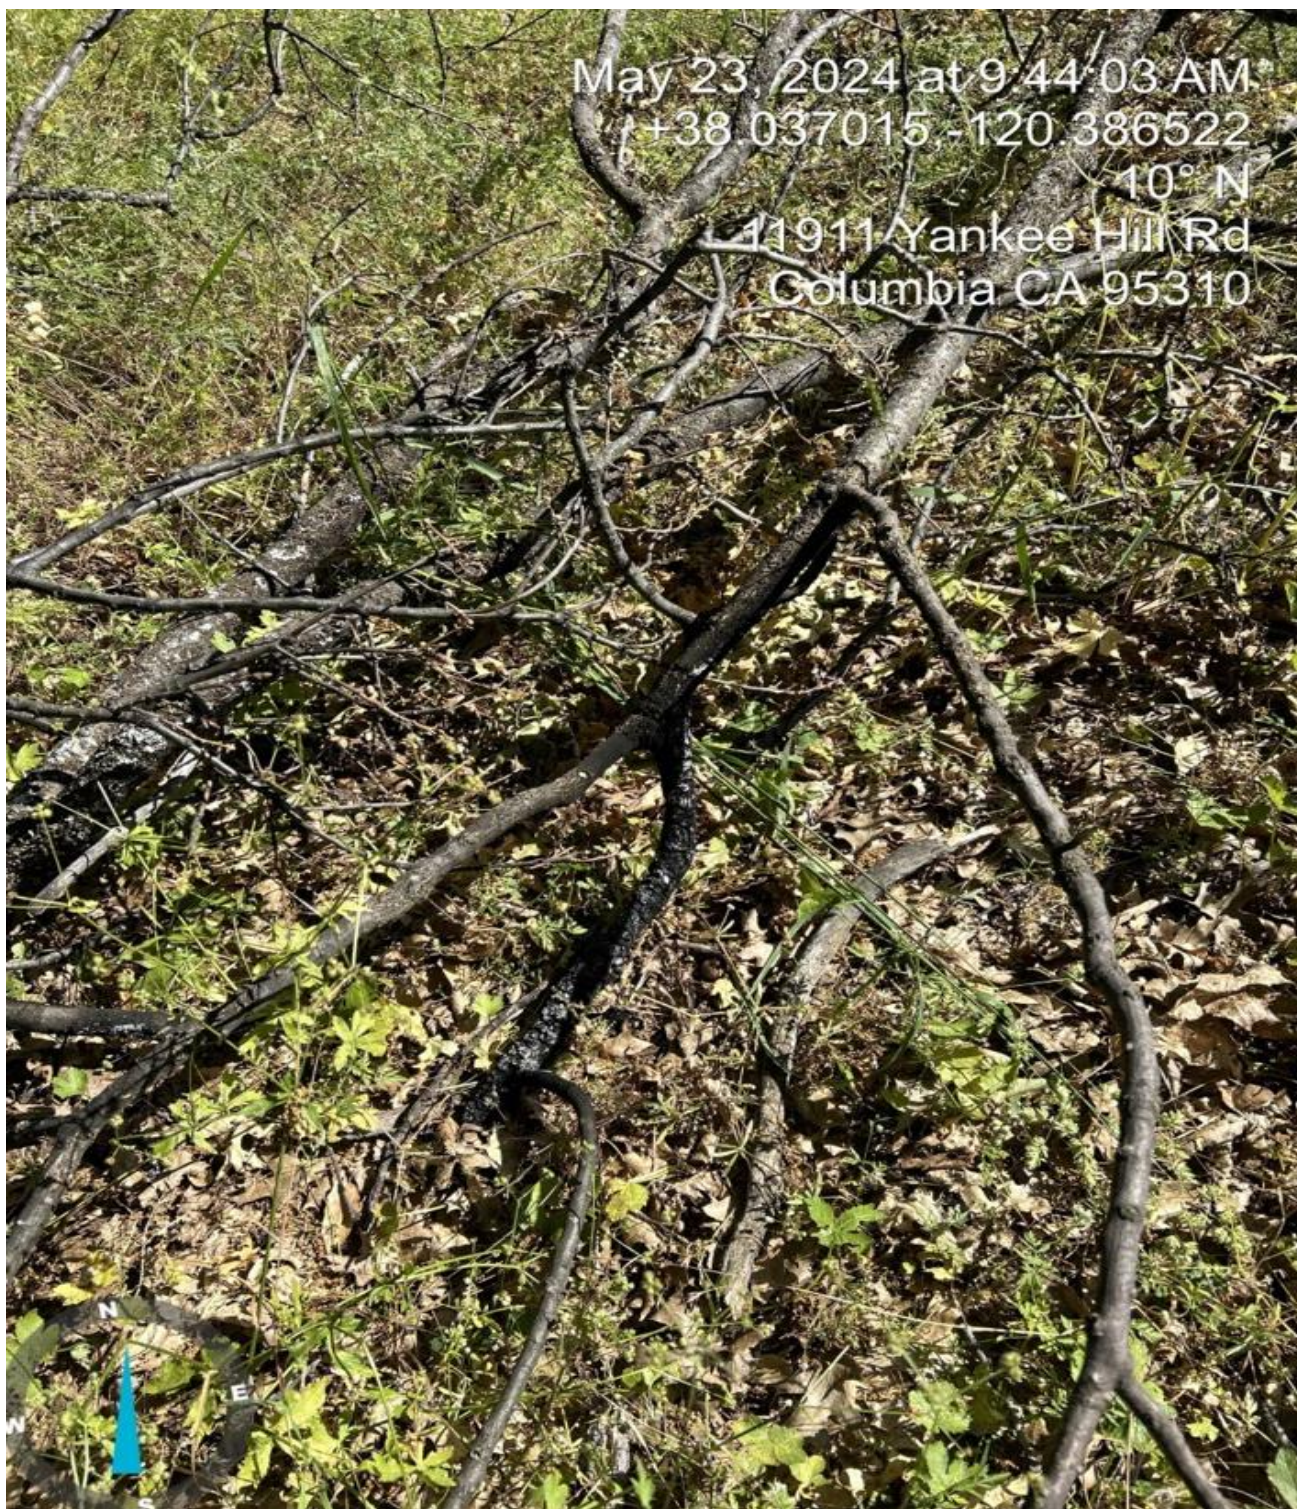
As a result of the incident, Vegetation Management (VM) conducted an inspection of the location on May 24, 2024 and found two fallen limbs with burn marks on the ground near the burn scar. Both limbs were approximately 2 inches in diameter and 8-10 feet long and came from the subject tree; a Black oak, currently 74 feet tall and 113 inches DBH (diameter breast height). The VM Inspector states that the subject tree is a large, mature tree with significant canopy over the power lines (current tree to conductor clearance is 7 feet). The subject tree was last worked on February 17, 2023 (Work Request # YOYO1269415) by a PG&E contract crew (ArborWorks), which included removal of all dead limbs to 25 feet above the conductor and radial trim to 15 feet. The subject tree was last inspected on January 10, 2024 with Second Patrol inspection on June 1, 2024.

*Figure 6 Photo depicting fallen branches in the incident location near the broken conductor with burn marks taken by VM Inspector. Comments on photo were provided by VM.*

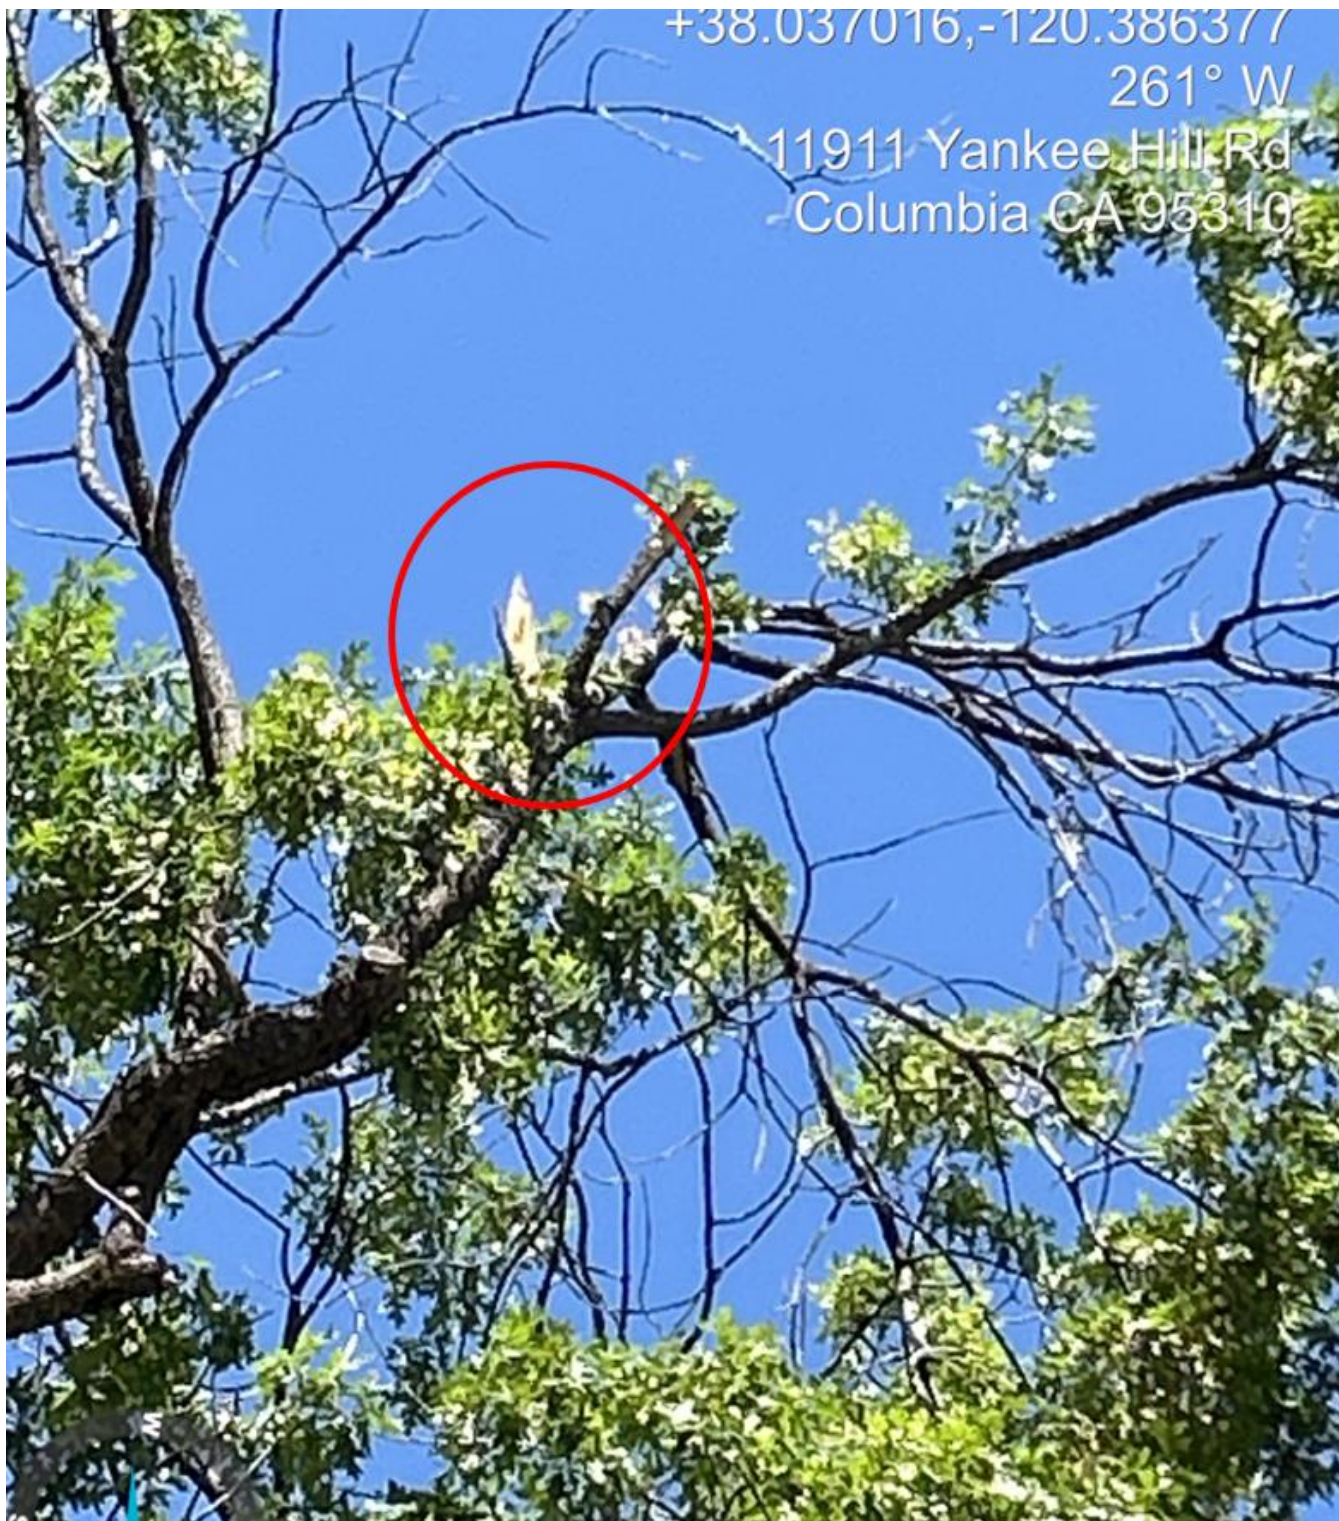
*Figure 7 Photo depicting area on subject tree where branch appeared to have failed. Comments on photo were provided by VM.*
