## Preliminary Ignition Investigation Report

<b>Ignition Database Index:</b>	20240531
<b>Electric Incident Investigation (EII) Number:</b>	N/A
<b>HAWC Incident Name:</b>	Westport – 29 May 2024
<b>PG&amp;E Facility Ignition?</b>	Yes
<b>CPUC Reportable Ignition?</b>	Yes
<b>Date &amp; Time of Incident:</b>	May 29, 2024 at 2113 hours
<b>Street Address:</b>	California Highway 1, south of Pacific Avenue
<b>City:</b>	Westport
<b>County:</b>	Mendocino
<b>Latitude/Longitude:</b>	39.627296, -123.782456
<b>State Responsibility Area (SRA) / Local Responsibility Area (LRA) / Federal Responsibility Area (FRA)</b>	State Responsibility Area
<b>PG&amp;E Division:</b>	Humboldt
<b>High Fire Threat District (HFTD):</b>	Tier 2
<b>High Fire Risk Area (HFRA):</b>	Yes
<b>EPSS Buffer:</b>	No
<b>Fire Index Area (FIA):</b>	140
<b>Fire Potential Index (FPI) Rating: FIA</b>	R1
<b>Fire Potential Index (FPI) Rating: Circuit</b>	R1
<b>Was there a PSPS event at the time of ignition?</b>	No

<b>Suspected Initiating Event:</b>	Vegetation
<b>Failure Driver:</b>	Contact from Object
<b>Failure Sub-driver:</b>	Contact-Vegetation
<b>Circuit:</b>	FORT BRAGG A 1101
<b>Circuit Protection Zone:</b>	LR95294
<b>Nominal Voltag

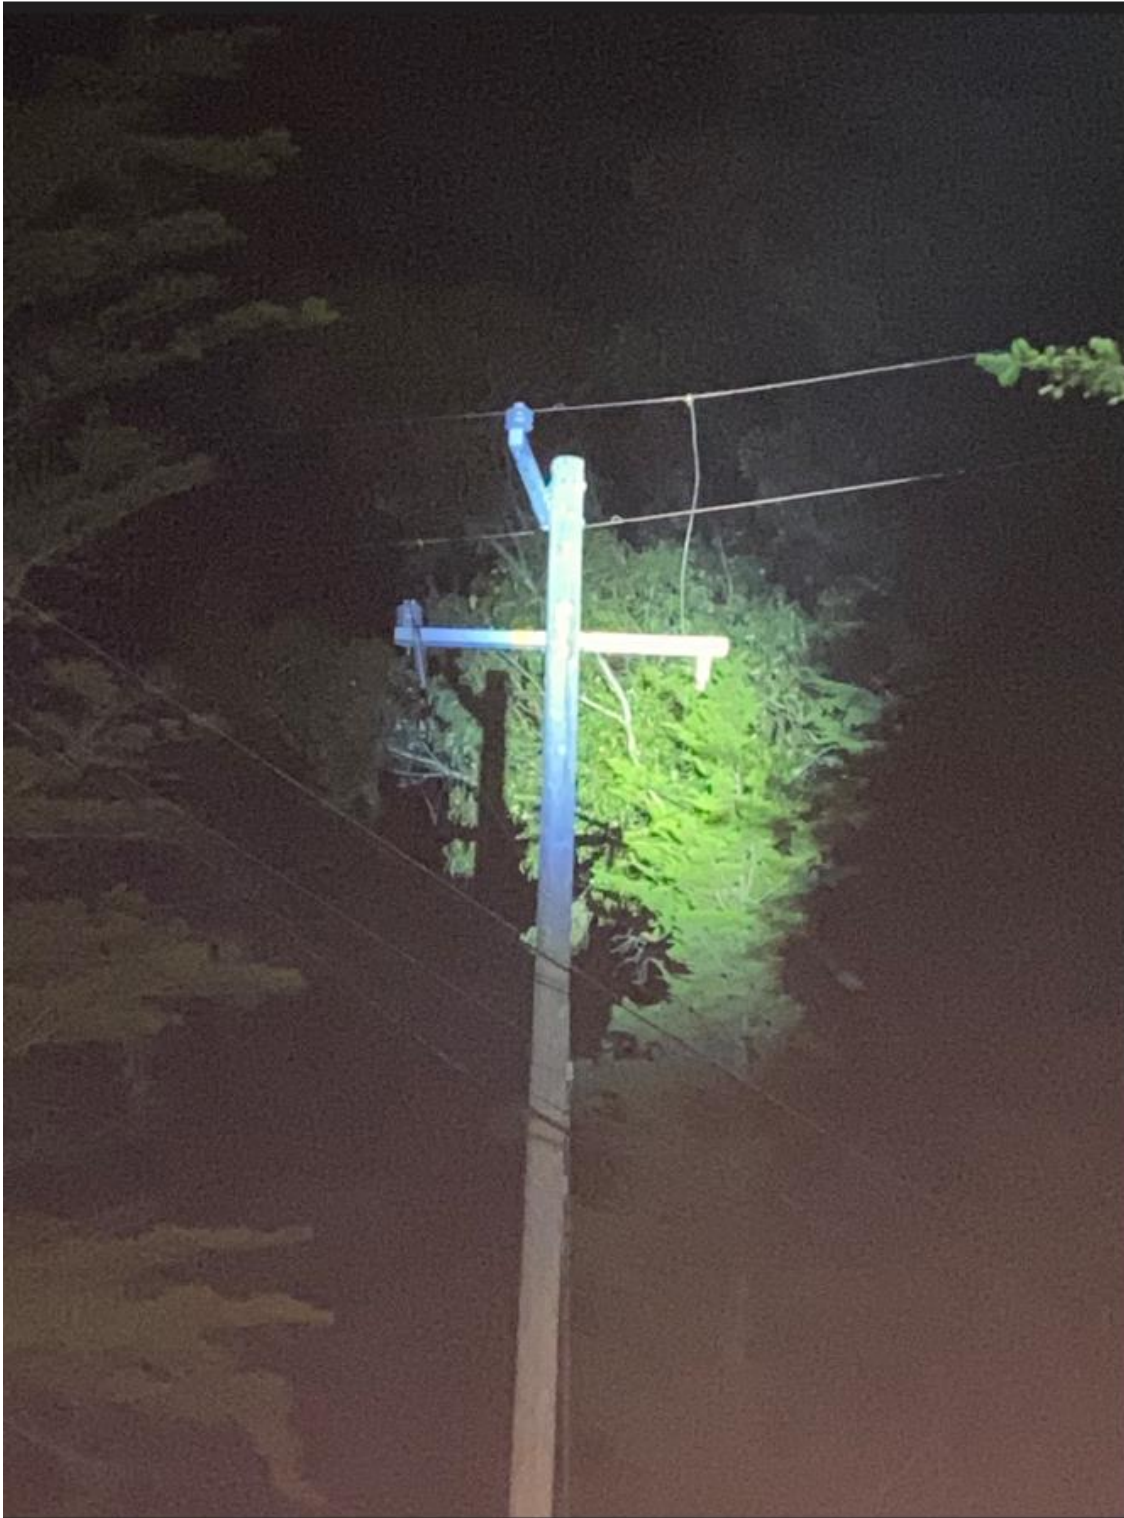
Responding to the pole fire report the Troubleshooter was dispatched at 2120 to a two-phase primary overhead line between SAP#102308474 and SAP# 102308475. Upon arrival at 2151 hours, the crew discovered two blown fuses on 8595. A tree branch had fallen onto the primary line, impacting two spans downstream from fuse 8595. This resulted in arcing and a small vegetation fire under three meters in diameter. First smart meter data indicates NIC power failure alarm at 2034 hours, followed by the first partial voltage alarm at 2039 hours. This line was protected by Line Recloser (LR) 95294. The Single Ground Fault (SGF) data indicated a ground fault at 2043 hours with a current magnitude of less than 6 Amp. This amperage is insufficient to activate the traditional ground fault protection, which is set at 15 Amp. Fuse 8595 functioned as intended, isolating the fault and de-energizing the line before the crew's arrival.

*Photo 2: Photo taken by troubleshooter from SAP 102308474 on ignition date.*

A priority "A" EC tag (#128910568) was created to replace the 400-foot, 6 AWG conductor. The crew completed the replacement on May 30, 2024.

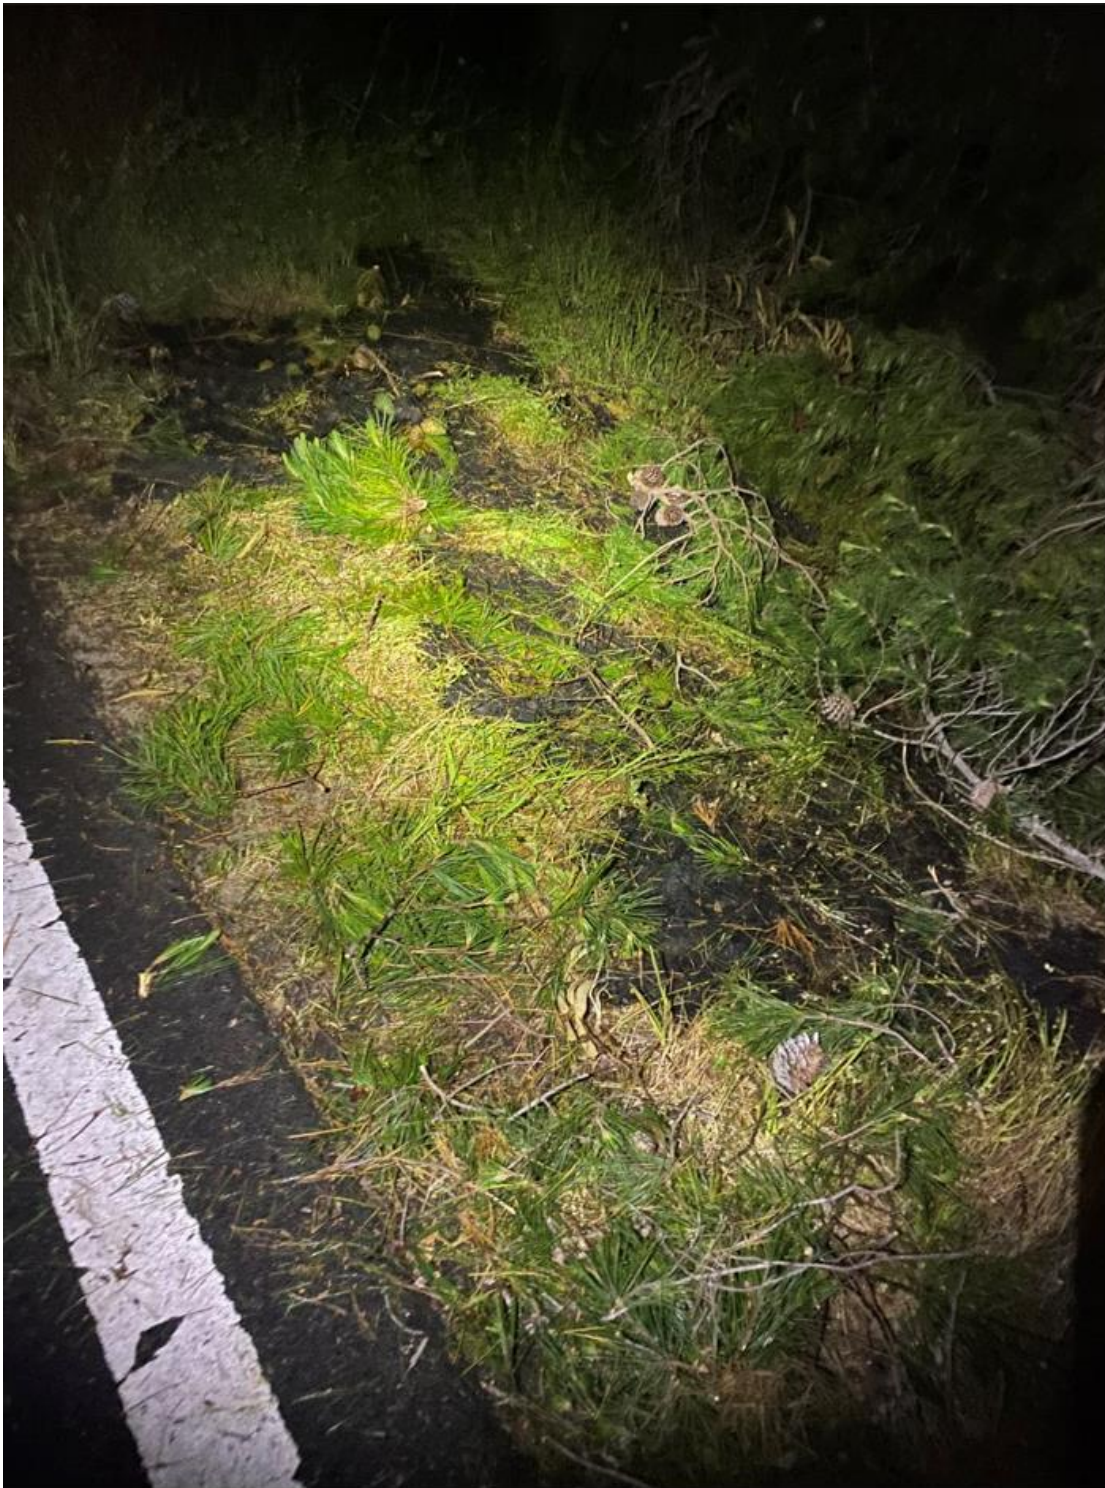
*Photo 3: Photo taken by troubleshooter on ignition date.*

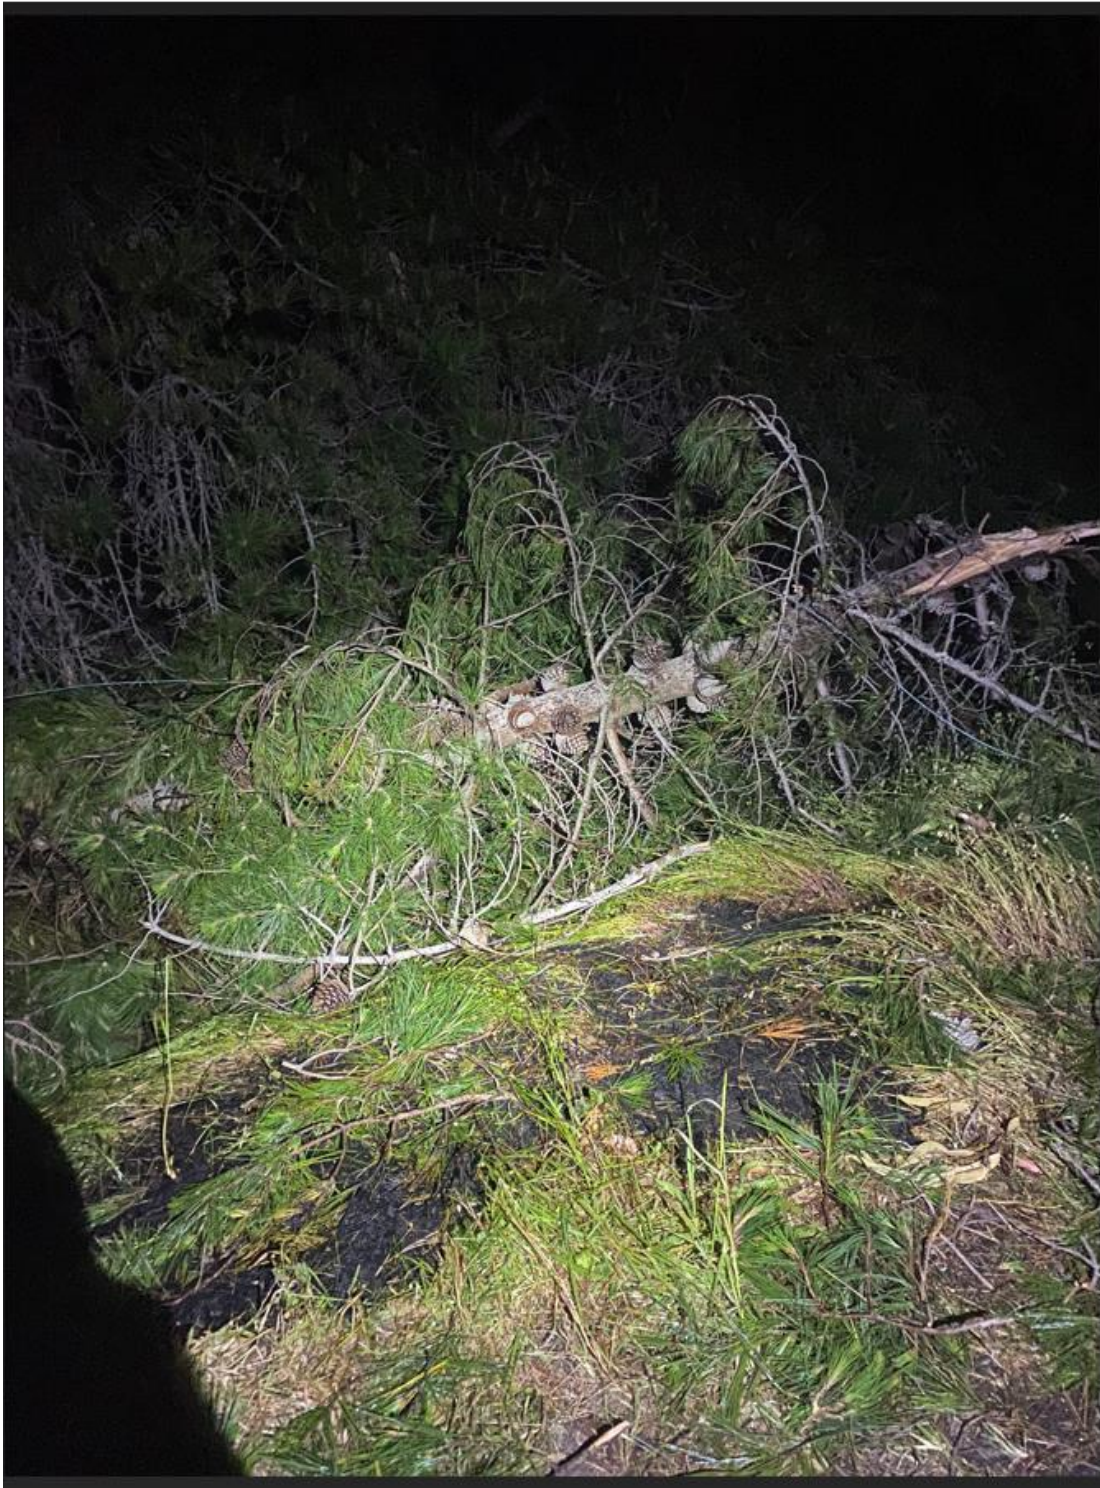
PG&E's Vegetation Management (VM) department performed an Extent of Condition (XoC) patrol on May 31, 2024. They found a fallen pine branch on the ground. The branch measured roughly 17.5 feet long, six inches in diameter, lying on the ground at the point of wire failure. Notably, a recent inspection conducted just 13 days prior to the incident identified the tree as mature and healthy with no signs of major defects or decay. The XoC prescribed the subject tree for additional overhang removal. Additionally, two other Monterey pines were flagged for priority work: one requiring removal and another requiring trimming.

*Photo 4: Photo taken by troubleshooter of the pine branch.*
