Preliminary Ignition Investigation Report

Ignition Database Index:	20240583
Electric Incident Investigation (EII) Number:	N/A
Incident Name:	Warren
PG&E Facility Ignition?	Yes
CPUC Reportable Ignition?	Yes
Date & Time of Incident:	June 5, 2024, at approximately 2023 hours
Street Address:	Near 8186 Warren Road
City:	Valley Springs
County:	Calaveras
Latitude/Longitude:	38.1317372527, -120.9265683852
State Responsibility Area (SRA) / Local Responsibility Area (LRA) / Federal Responsibility Area (FRA)	SRA
PG&E Division:	Stockton
High Fire Threat District (HFTD):	Tier 2
High Fire Risk Area (HFRA):	Yes
EPSS Buffer:	No
Fire Index Area (FIA):	320
Fire Potential Index (FPI) Rating: FIA	R2
Fire Potential Index (FPI) Rating: Circuit	R2
Was there a PSPS event at the time of ignition?	No
Suspected Initiating Event:	Equipment-PG&E
Failure Driver:	All types of equipment/facility failure
Failure Sub-driver:	Cutout failure
Circuit:	Corral 1101
Circuit Protection Zone:	Corral 1101 LR220994

Nominal Voltage:	12kV
Pole SAP Equipment ID:	102040219
Subject to PRC 4292 Veg Pole Clearance:	No
PG&E Equipment associated with ignition:	Cutout
EPSS enabled at time of ignition?	Yes
Fault Type:	Line to Ground

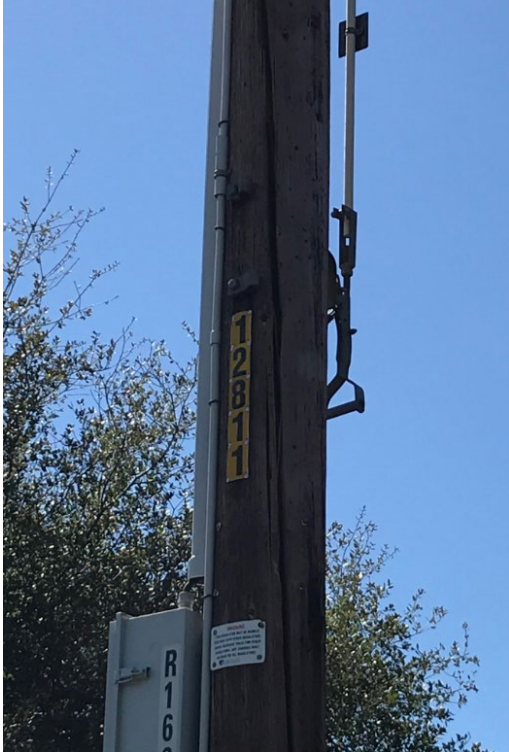
The subject pole has been flagged since 2019 through inspections indicating signs of decay along with a visible deep lateral crack throughout a majority of the pole. The inspection also indicated the cutout was not good and needed replacement. A corrective "E" tag was created on March 16, 2019, stemming from this inspection with a year due date. This tag is still pending and has not been addressed as of date. The next calendar year of 2020, the cutout was identified as damaged and a corrective "E" tag was created to repair the cutout, which was later cancelled noting this was a duplicate tag from the 2019 tag. In 2023, the subject pole was reviewed again as potentially being overloaded due to the large cracks running vertically along the pole. A corrective "E" tag created to test the pole; however, this tag was also cancelled one month after creation citing the original tag created in 2019.

Photo 3: 2019 inspector photo showing large crack in pole.

The history of this location indicates this pole poses an immediate risk of a complete failure and will need to be replaced to prevent further incident.

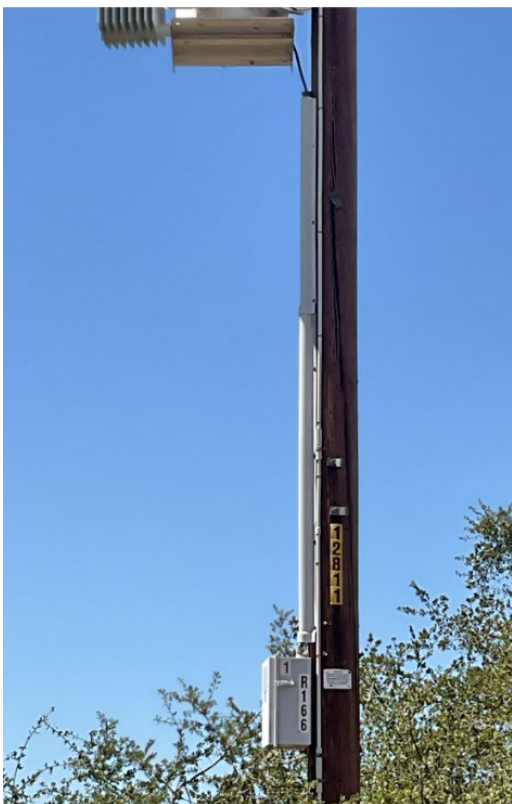
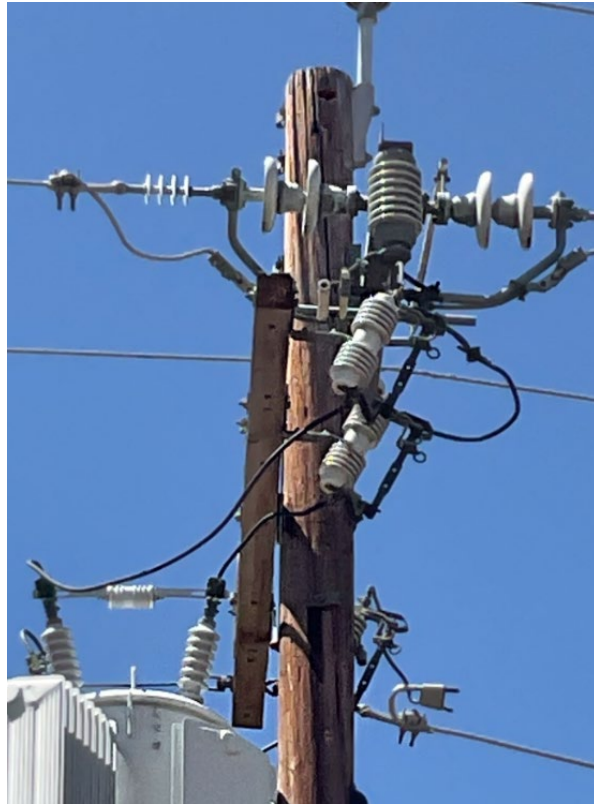
The Asset Failure Analysis team investigated the events of June 5, 2024, as part of their Extent of Condition (XoC). Per AFA engineering, on one phase of regulator R-166, the porcelain cutout bottom jumper connector failed and came out of the bottom of the cutout. The jumper and bottom connector touched the casing of the regulator, causing sparks. AFA advised an infrared (IR) inspection (IR 119946724) was conducted in 2020 as part of a GO165 inspection and identified the excessive heat buildup on the Part 44 cutout.

Photo 4: 2022 inspector photo showing large crack in pole and cutout.

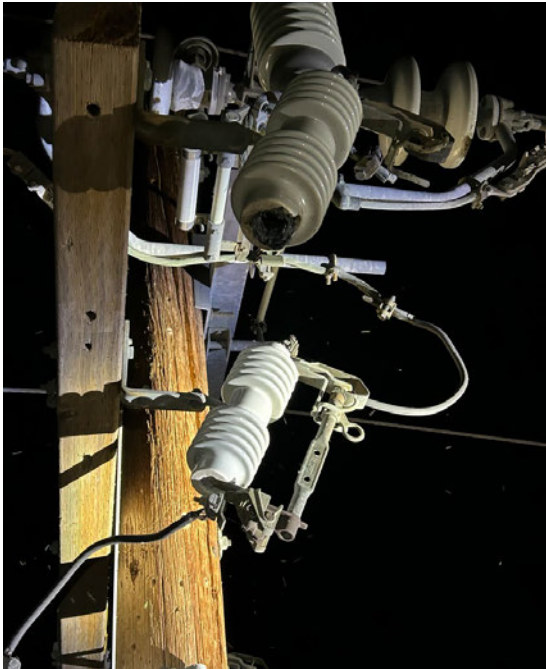
FAS Field Remarks:	Bottom of PT-44 melted off and wire hit reg case causing an outage and small grass fire, bypassed all 3 regs cut jumpers in the clear on NG cutout, worked with DO to energize, voltage is somewhat low, DLT will come out after repairs are made to put regs back to normal.
HAWC Summary:	Resources responded to a report of a vegetation in the area of Hwy 26 & Shelton Rd in Valley Springs in Calaveras County. Irwin notification came in at 2026 hours. The HAWC analyst notified on call PSS and had them call Tman on scene for information. Tman reported there was a 50x20 spot fire and that the fire was out. There were two separate outages reported at the time of the fire; OIS # 2477009 with 1650 customers affected on the EPSS enabled CORRAL 1101 and OIS # 2477026 with 1222 customers affected on the EPSS enabled CORRAL 1103. The fire was in a Tier 2 area. No notifications were made due to quick mitigation of the hazard and limited intel on the fire. Waiting for Tman to show up on scene for intel. No additional outages or impact to assets reported at the time of incident closure. Closing barring any significant changes.

Upon identifying the subject pole, SAP ID 102040219, the troubleshooter called into the Distribution Operator (DO) stating cutout the bottom of a PT-44 melted, disconnecting from the cutout and creating the outage. The failed piece of the Solid Blade hit the regulator (R-166) below which created a spark. The regulator had signs of a flash mark but was not an immediate risk. The troubleshooter and DO agreed to bypass the regulators so the troubleshooter could cut the jumpers to prepare for repairs to the cutout. Shortly after, LR 220994 was closed, restoring service to 1,650 customers at 2251 hours on June 5, 2024.

Photo 5: June 5, 2024, troubleshooter photo of failed cutout.

A corrective tag, EC Notification 129027107 was created on June 5, 2024, by the responding troubleshooter to replace the Part 44 cutout with a Part 57 Solid Blade cutout. This work was completed by a PG&E repair crew on June 6, 2024, where the cutout was replaced with a Part 57 Solid Blade cutout.

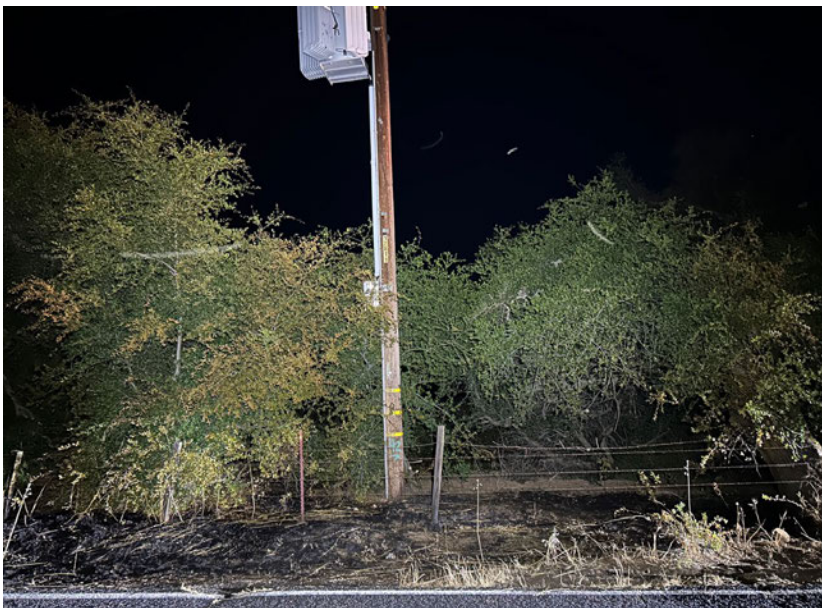
After dispatching three troubleshooters to the EPSS outage, two of the three troubleshooters arrived onsite at 2125 hours and 2129 hours. Both troubleshooters worked the tag and assessed the Incident Location on Warren Road in Valley Springs. When the troubleshooters arrived at the Incident Location, they observed a fire that burned an area approximately 30 feet in diameter around the subject pole. The fire had been extinguished by the Valley Springs Fire Department.

Photo 6: June 5, 2024, troubleshooter photo of fire footprint

Barriers that were Assessed as Opportunities			
Pole Clearing Program	Limit fire spread potential near poles for a PG&E equipment involved ignition event within State Responsibility Areas, poles with non-exempt equipment, and selected poles outside of the regulations of PRC 4292. Clear 10-ft radius around subject poles from 0-8 feet above ground level.	N/A	Opportunity to extend pole clearing into Tier 2/Tier 3 areas to prevent ignitions. This pole was not cleared at base.

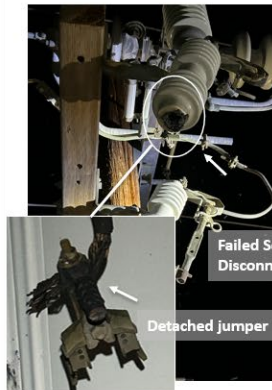
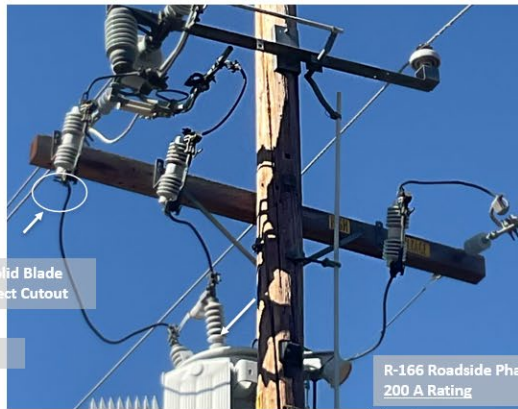
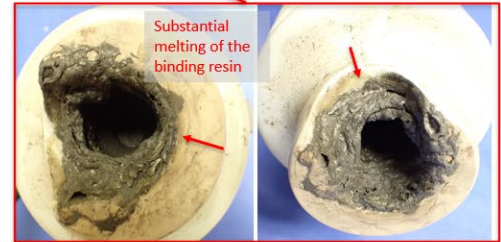
ATS received the failed PT-44 cutout (SAP Equipment: 102040219 attached to Regulator R-166 ID: 220994) on June 12, 2024. ATS engineering confirmed the ignition was caused by the dripping of hot material due to the energized jumper contacting the grounded structure. Visual inspection of the material showed detachment of

the bottom side jumper from the solid-disconnect porcelain cutout likely due to overheating and melting of the potting resin. Historical loading on the subject phase indicated a noticeable rise that likely exceeded the rated capacity of the regulator and cutout. This most likely caused elevated temperatures on the solid disconnect resulting in glass transition of the potting resin and detachment of the contact pin (*see photo 7*).

Epoxy resins commonly used as cutout potting material	Bisphenol-A (BPA) Melting point: 157 °C +	Cycloaliphatic Epoxy Melting point: 85 °C ++
---	--	---

Photo 7: Findings of testing conducted by ATS.
