Preliminary Ignition Investigation Report

Ignition Database Index:	20240608
Electric Incident Investigation (EII) Number:	N/A
Incident Name:	Madrone
PG&E Facility Ignition?	Yes
CPUC Reportable Ignition?	Yes
Date & Time of Incident:	June 7, 2024 at 1521 hours
Street Address:	[REDACTED], Napa
City:	Napa
County:	Napa
Latitude/Longitude:	[REDACTED]
State Responsibility Area (SRA) / Local Responsibility Area (LRA) / Federal Responsibility Area (FRA)	State Responsibility Area
PG&E Division:	North Bay
High Fire Threat District (HFTD):	Tier 2
High Fire Risk Area (HFRA):	Yes
EPSS Buffer:	No
Fire Index Area (FIA):	180
Fire Potential Index (FPI) Rating: FIA	R1
Fire Potential Index (FPI) Rating: Circuit	R2
Was there a PSPS event at the time of ignition?	No
Suspected Initiating Event:	Vegetation
Failure Driver:	Contact from object
Failure Sub-driver:	Contact - Vegetation
Circuit:	Silverado 2102
Circuit Protection Zone:	Silverado 2102714
Nominal Voltage:	21kV
Pole SAP Equipment ID:	103805719

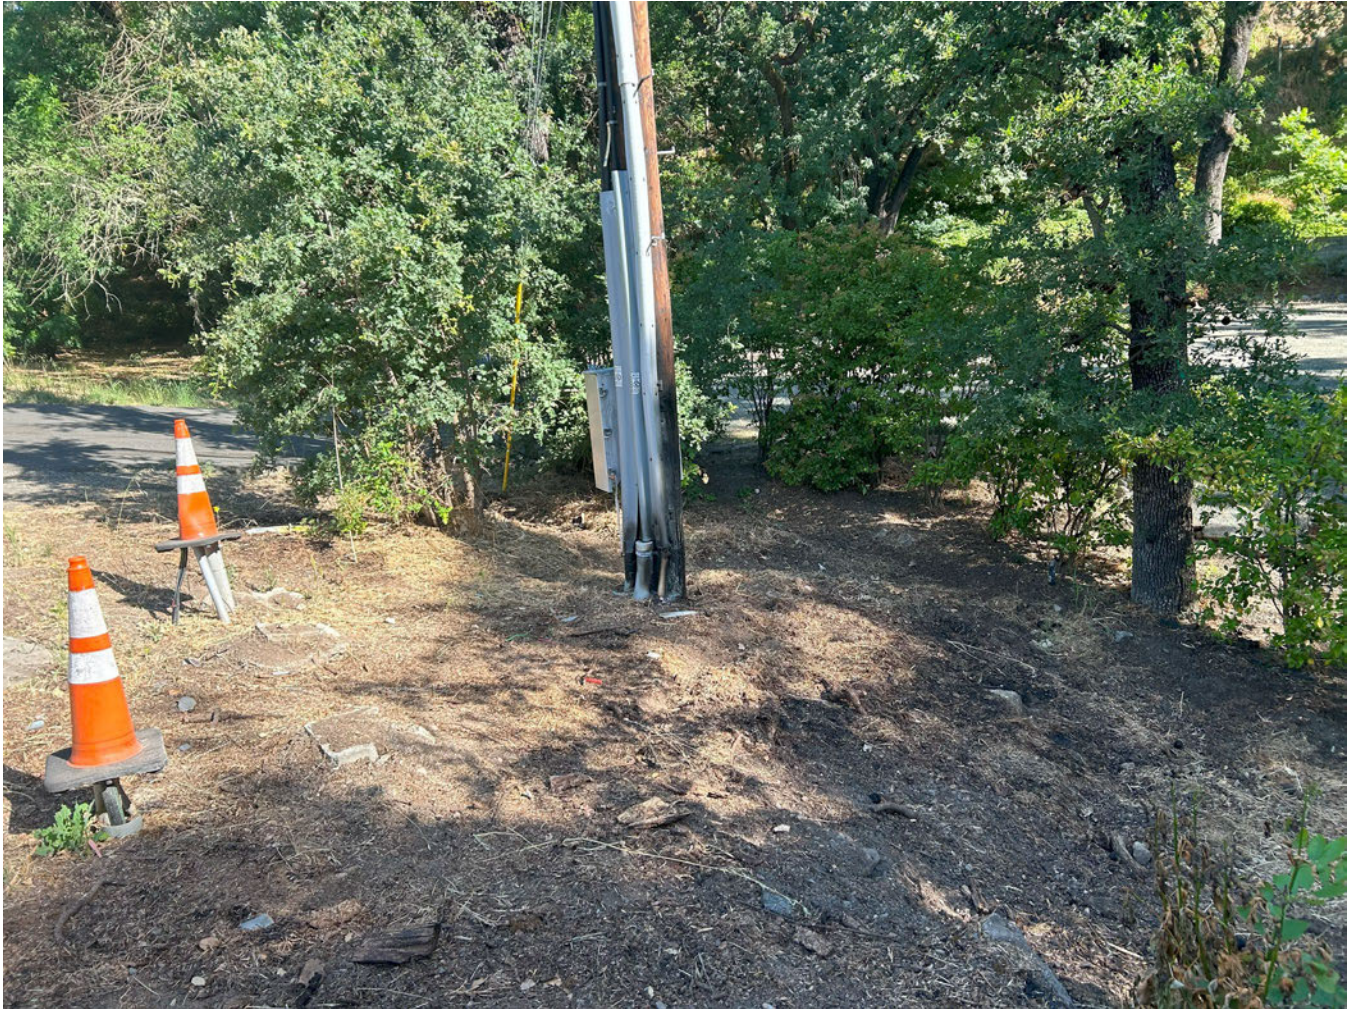
The ignition resulted in an approximately 10-foot by 10-foot grass fire. No private property damaged. A riser cover at the base of Pole #1 was slightly damaged by the fire but was not replaced. 1,118 customers lost power in the initial outage at 1521 hours on June 7, 2024. At 1737 hours, LR 714 was closed, restoring nine customers. At 1744 hours, LR 589596 was closed, restoring 728 customers. At 0039 hours on June 8, 2024, LR 714 was opened for repairs, de-energizing nine customers. At 0107 hours, LR 714 was closed, restoring 28 customers. At 0132 hours, switch 914108 was closed, restoring the remaining 362 customers.

Figure 2: Fire footprint around Pole #1. Photo collected by PG&E ignition investigator.

EC 'A' priority notification 129037666 was submitted on June 7, 2024 to repair one span (80 feet) of 4/0 AL TPX conductor at Pole #1. A PG&E repair crew completed the notification on June 7, 2024.

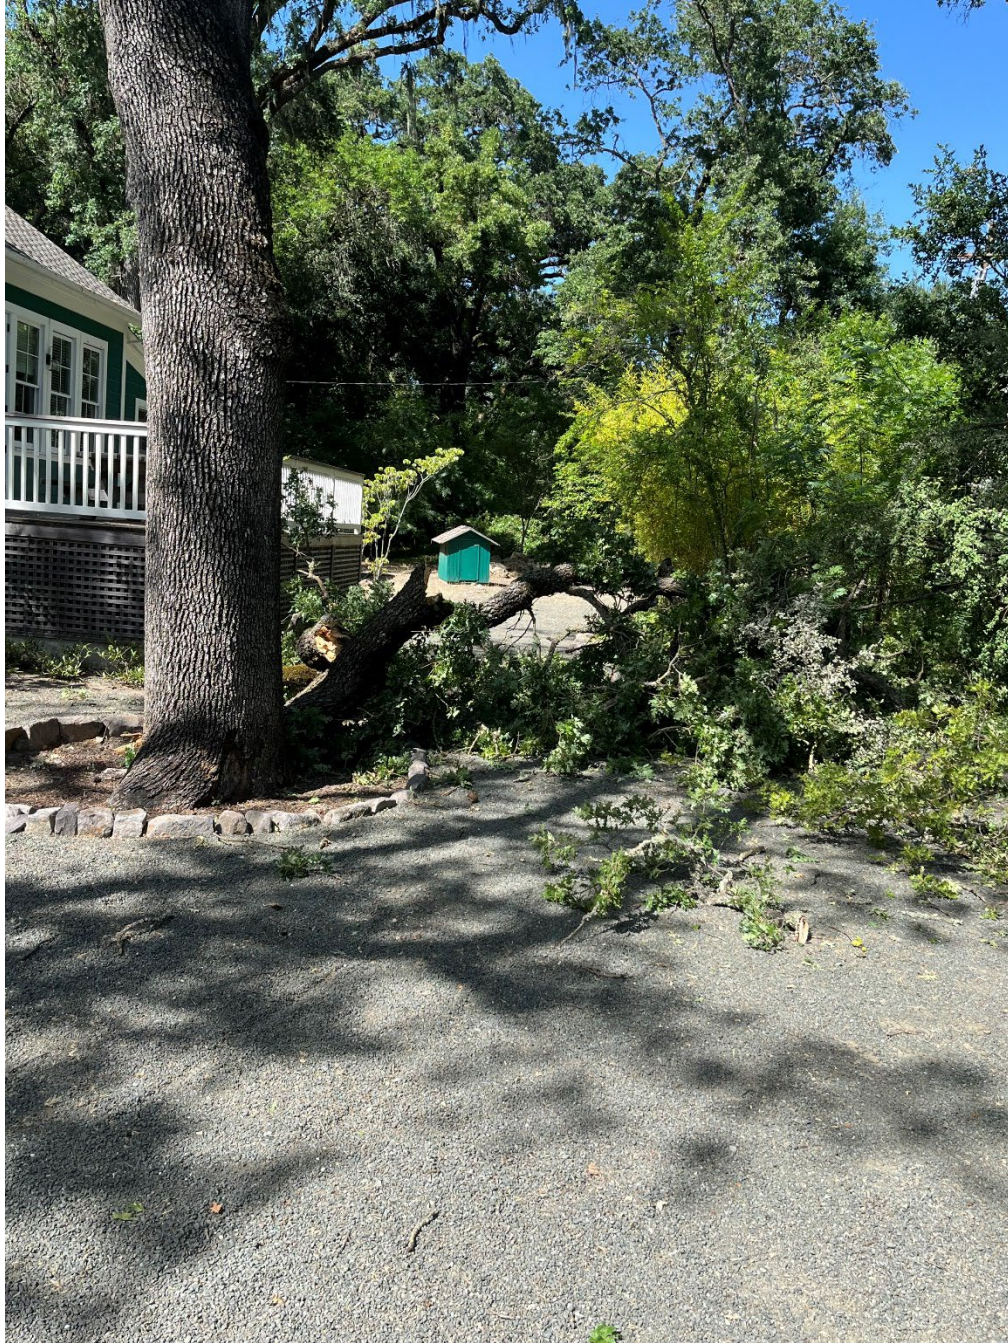
On June 12, 2024, a PG&E vegetation management inspector (VMI) performed a Fire Incident Investigation and Extent of Conditions (XoC) patrol at the Incident Location. During the investigation, the VMI identified the Incident Tree as a 43-inch diameter at breast height (DBH), 90-foot tall valley oak (*Quercus lobata*). A large, 13-inch diameter branch from high in the tree's canopy broke and fell onto conductors, causing both line-to-line and line-to-ground faults. While the tree showed evidence of prior utility pruning, no defects or decay to indicate a failure cause were observed at the point of failure. During the XoC patrol, the VMI inspected five spans in every direction but did not identify any trees of similar species or concern that warranted work. The last routine maintenance inspection performed by Vegetation Management (VM) was performed on May 31, 2023, and the last Second Patrol inspection was performed on April 8, 2024. No work was prescribed for the Incident Tree during either inspection. VM records indicate that the Incident Location had not been inspected under the Enhanced Vegetation Management (EVM) program. The last work prescribed for the Incident Tree was for side pruning and it was completed on May 24, 2022.

Figure 3: Incident Tree with failed limb at base. Photo collected by PG&E troubleshooter.

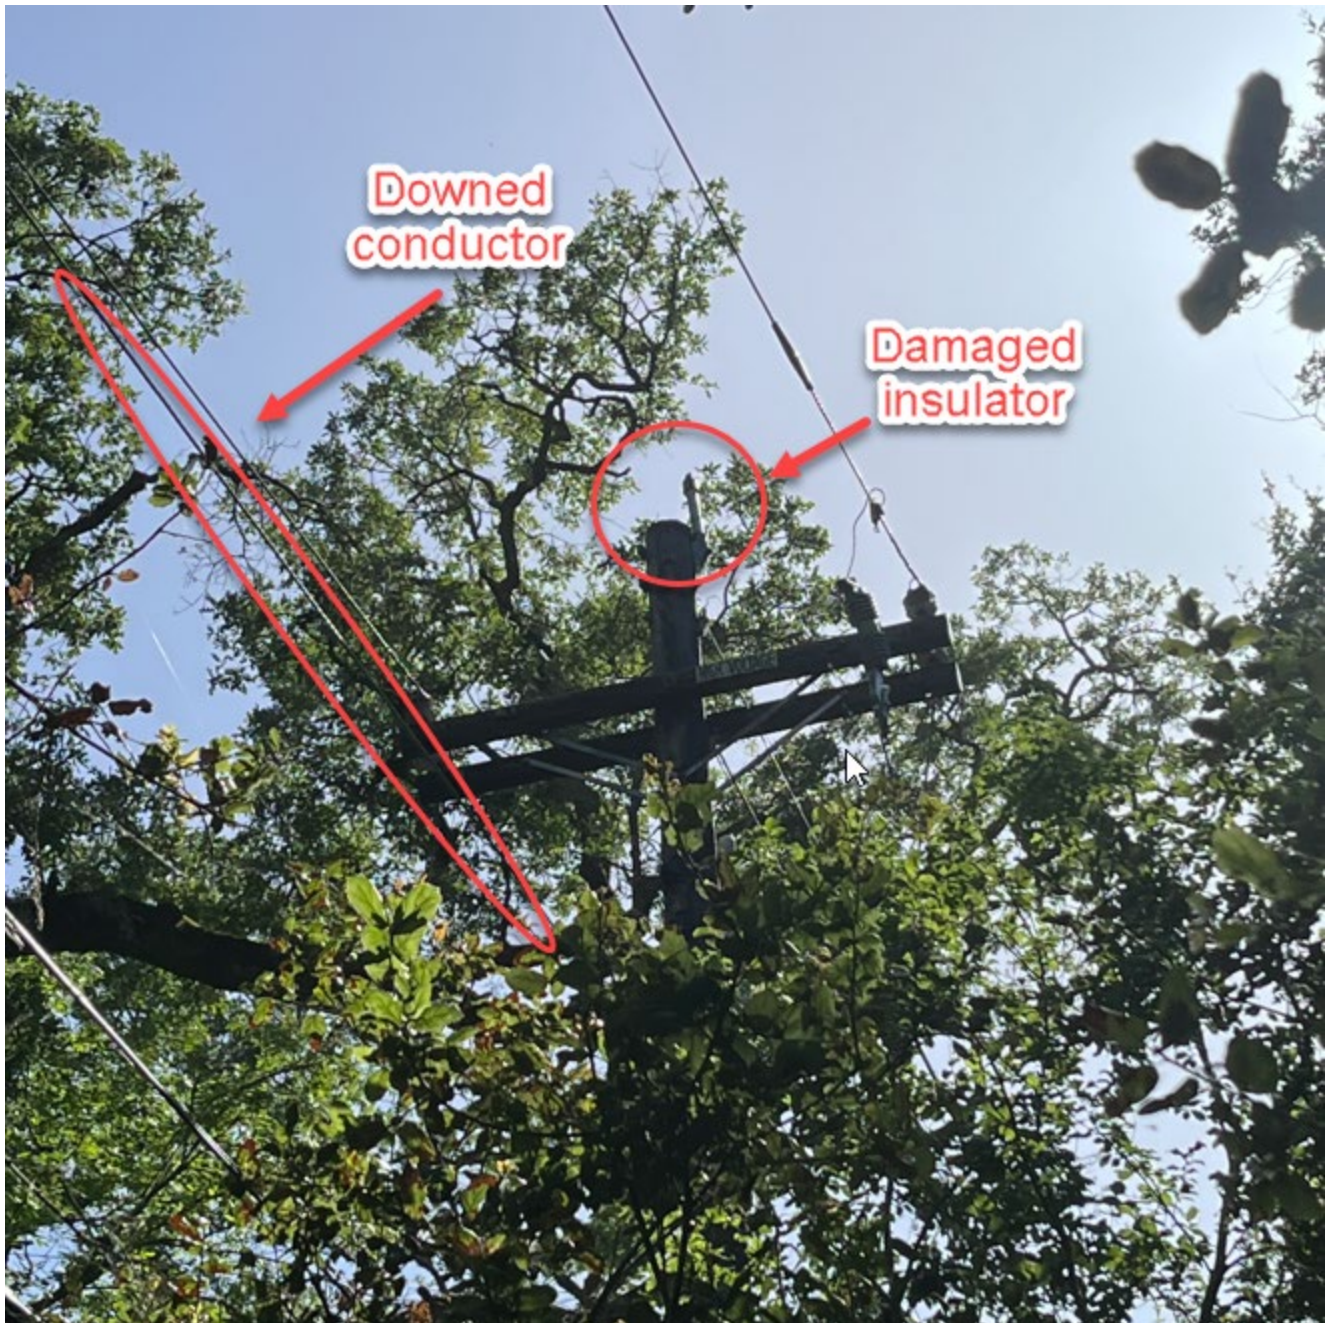
Figure 4: Photo of damaged Pole #2. Photo collected by troubleshooter.

EC 'A' priority notification 129037667 was submitted on June 7, 2024 to replace a broken kingpin and tie wires at Pole #2. A PG&E repair crew completed the notification on June 7, 2024.

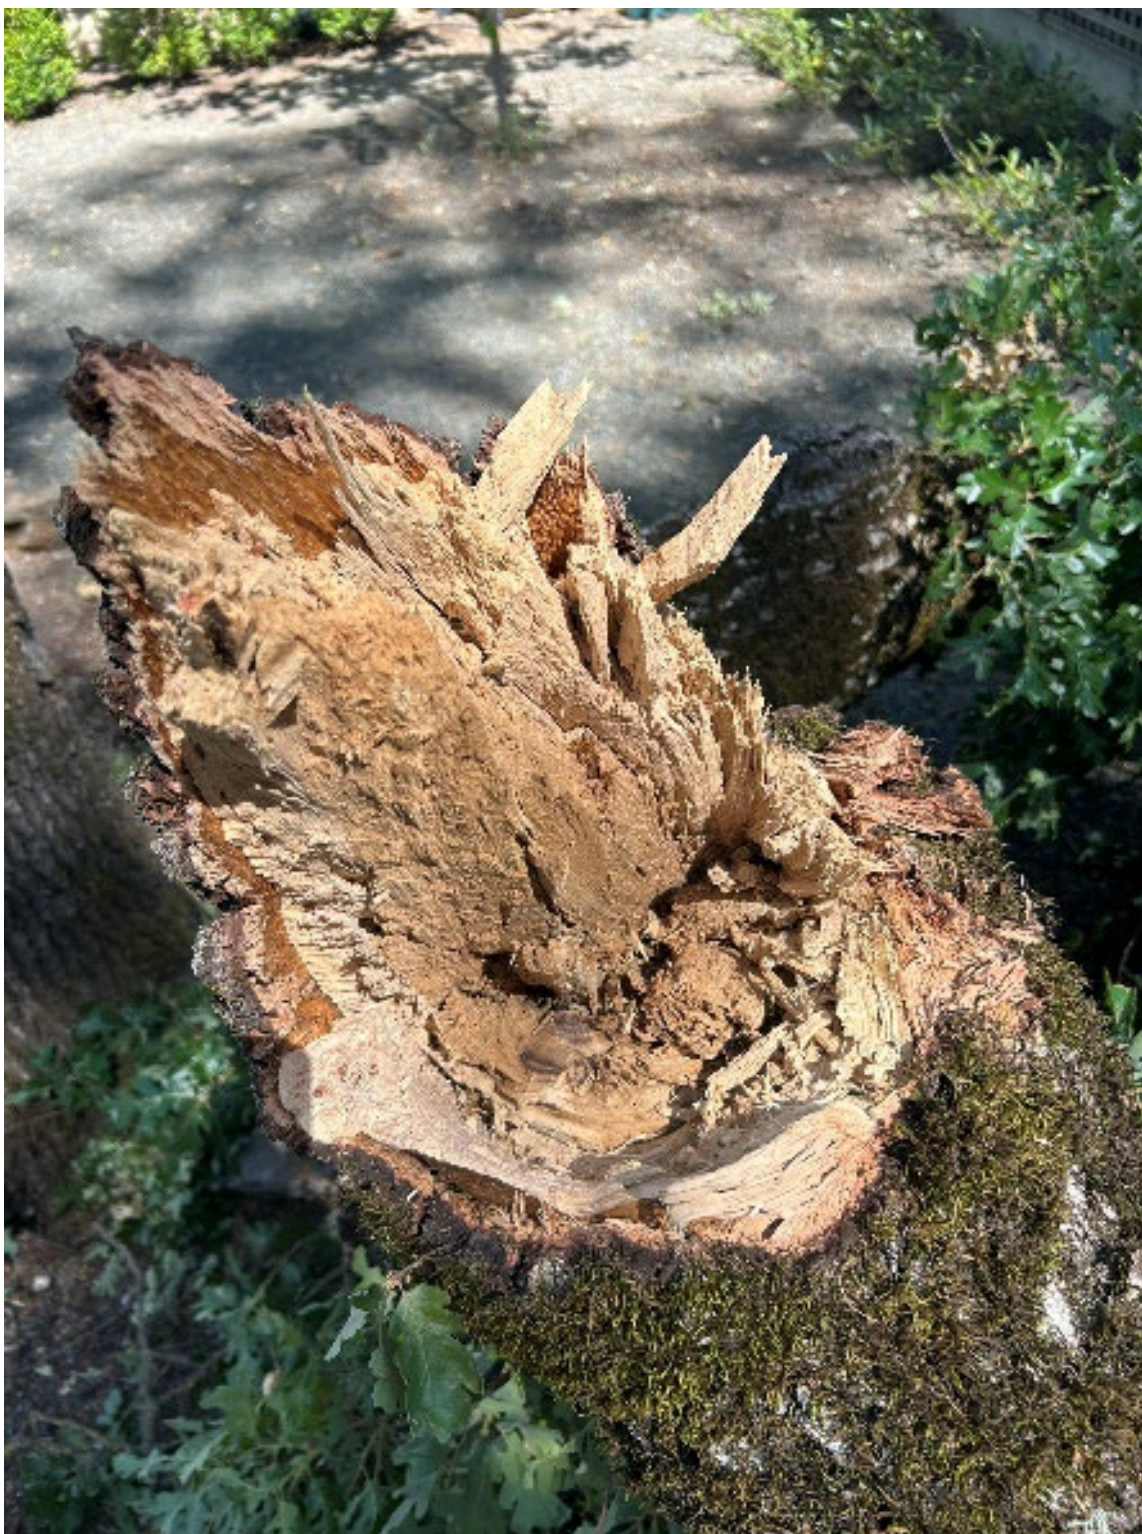
Figure 5: Photo showing the broken end of the branch that caused the ignition. No defect or decay is present in the broken end. Photo collected by VMI.
