Preliminary Ignition Investigation Report

Ignition Database Index:	20240753
Electric Incident Investigation (EII) Number:	N/A
Incident Name:	Morro - 25 Jun 2024
PG&E Facility Ignition?	Yes
CPUC Reportable Ignition?	Yes
Date & Time of Incident:	June 25, 2024 @ 2013 hours
Street Address:	In the vicinity of [REDACTED], Lewis Highway 41 and Toloso Road.
City:	Atascadero
County:	San Luis Obispo
Latitude/Longitude:	35.456902, -120.687541
State Responsibility Area (SRA) / Local Responsibility Area (LRA) / Federal Responsibility Area (FRA)	Local Responsibility Area (LRA)
PG&E Division:	Los Padres
High Fire Threat District (HFTD):	Tier 2
High Fire Risk Area (HFRA):	Yes
EPSS Buffer:	No
Fire Index Area (FIA):	575
Fire Potential Index (FPI) Rating: FIA	R3
Fire Potential Index (FPI) Rating: Circuit	R4
Was there a PSPS event at the time of ignition?	No
Suspected Initiating Event:	Utility work / Operation
Failure Driver:	Utility work / Operation
Failure Sub-driver:	Equipment failure - Other

Circuit:	Atascadero 1103
Circuit Protection Zone:	Atascadero 1103440856
Nominal Voltage:	12kV
Pole SAP Equipment ID:	SAP Pole ID: 101932126
Subject to PRC 4292 Veg Pole Clearance:	No
PG&E Equipment associate

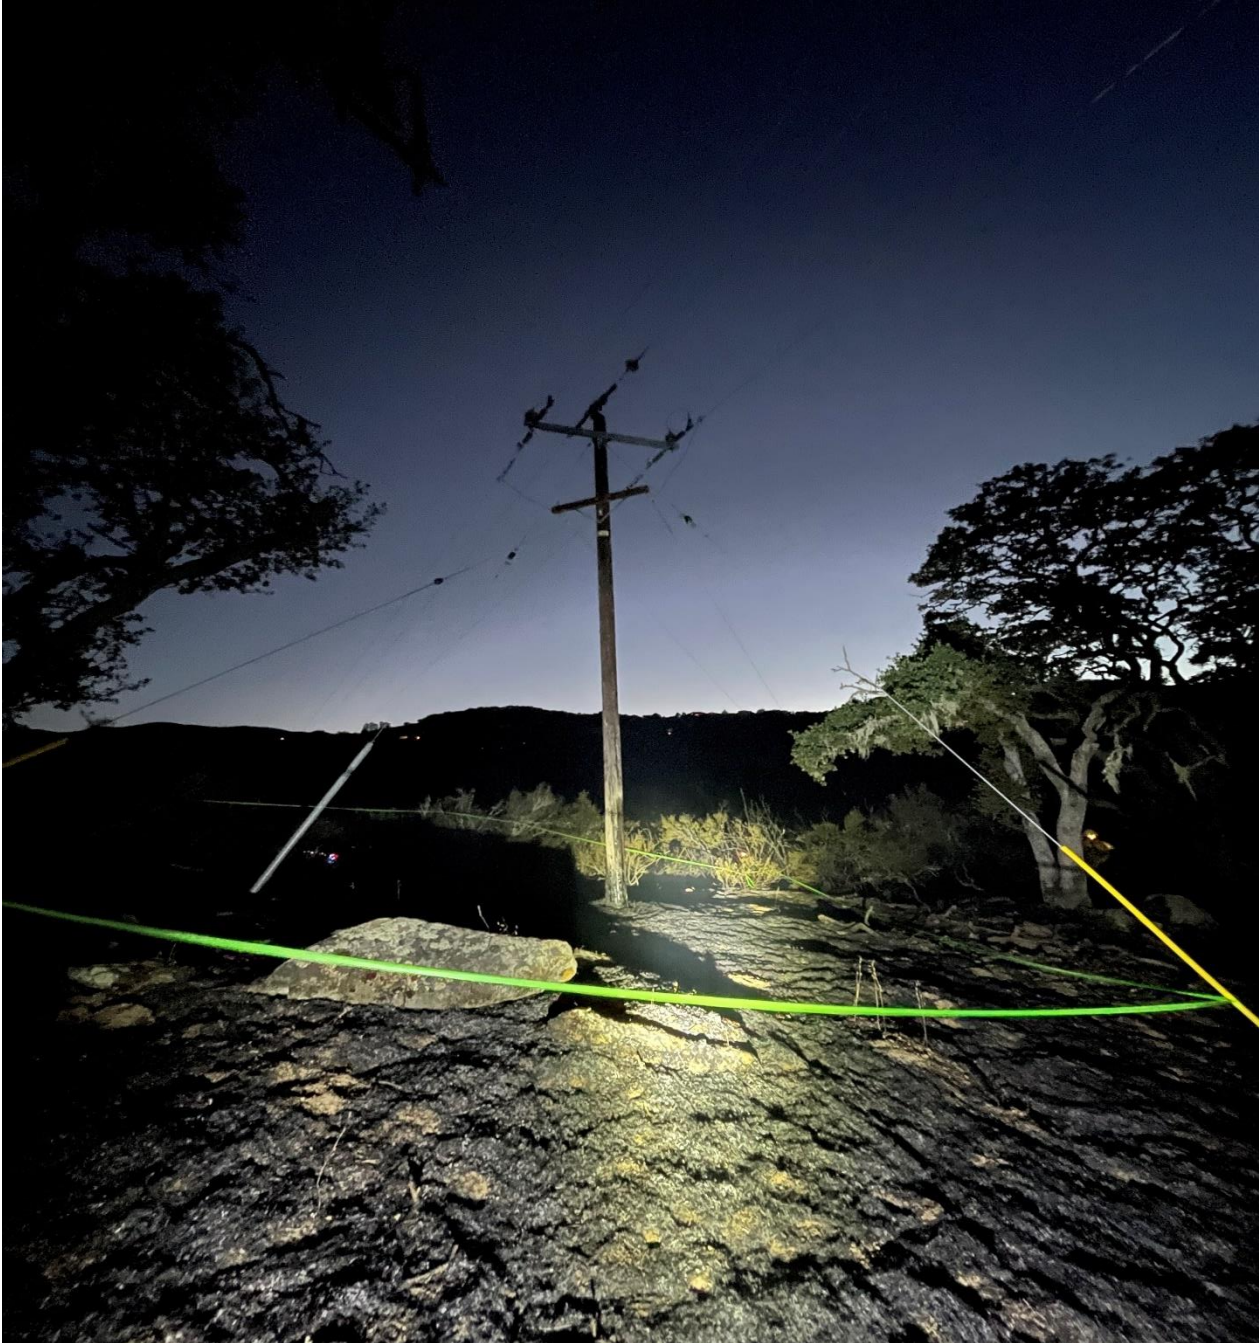
The fire is listed as the "Morro - 25 Jun 2024" fire in the Hazard Awareness Wildfire Command (HAWC) fire activity report. The ensuing fire had spread to about 100-foot by 100-foot spot (based on the HAWC summary) in size and was suppressed by the Atascadero Fire Department on June 25, 2024, (see Figure 6).

Figure 3 - 100-foot by 100-foot fire burn scar area at (SAP Pole ID: 101932126). Picture taken by the troubleshooter on June 25, 2024

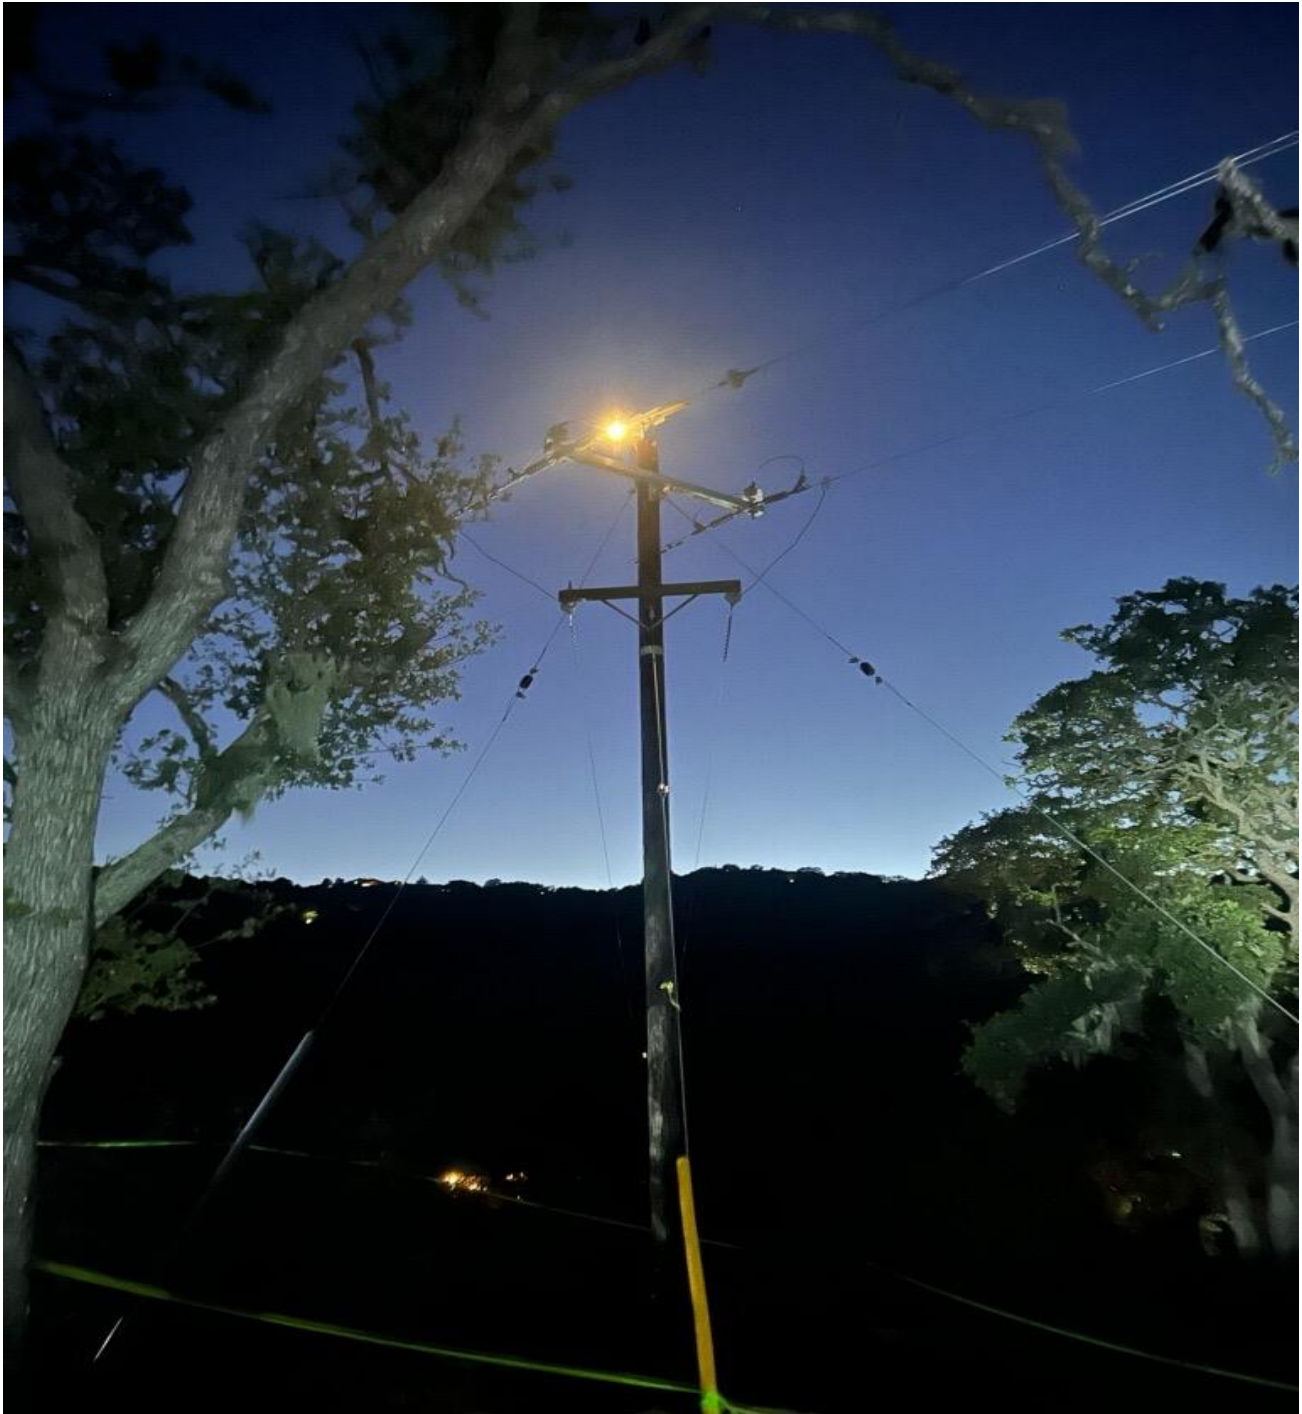
The PG&E troubleshooter arrived on the scene at approximately 2041 hours and observed a fire on the side of the mountain. The troubleshooter indicated that the fire department showed him videos of our equipment sparking and requested that the Distribution Operator (DO) de-energize. Arcing was visible at the jumper on the dead-end bolted clamp shoe attached to the insulator at the top of the line-and-buck pole (SAP Pole ID: 101932126), (see Figures 3, 4, 5, and 6).

Figure 4 – Arcing and burnt jumper at the dead-end strain bolted clamp shoe attached to the insulator at the top of the line-and-buck pole (SAP Pole ID: 101932126). Picture taken by the troubleshooter on June 25, 2024.

The PG&E repair crew arrived onsite at 2302 hours to replace all cross-arms and associated hardware on SAP Pole ID: 101932126. All repair work was completed by the PG&E Crew at 0445 hours on June 26, 2024.

LC priority "A" Tag (#129127893) was created to replace all cross-arms and associated hardware on SAP Pole ID: 101932126. All repair work was completed by the PG&E Crew at 0445 hours on June 26, 2024.

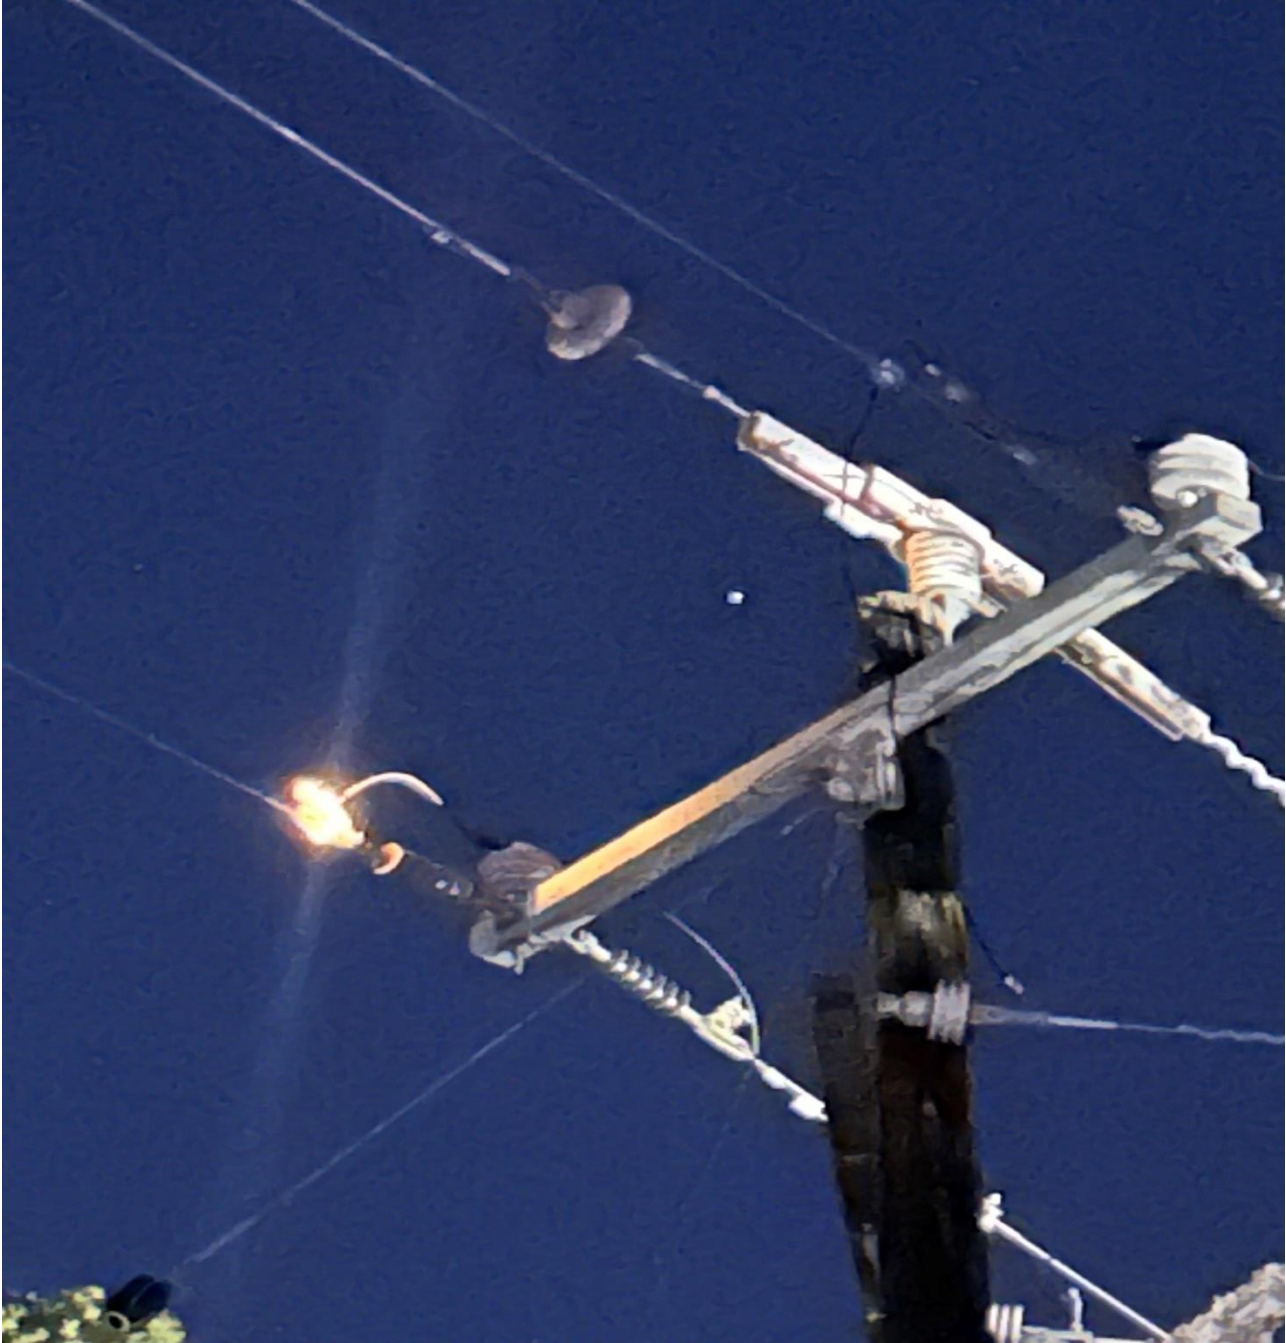
Figure 5 – Close-up view of the arcing and burnt jumper at the dead-end strain bolted clamp shoe attached to the insulator. Picture taken by the troubleshooter on June 25, 2024

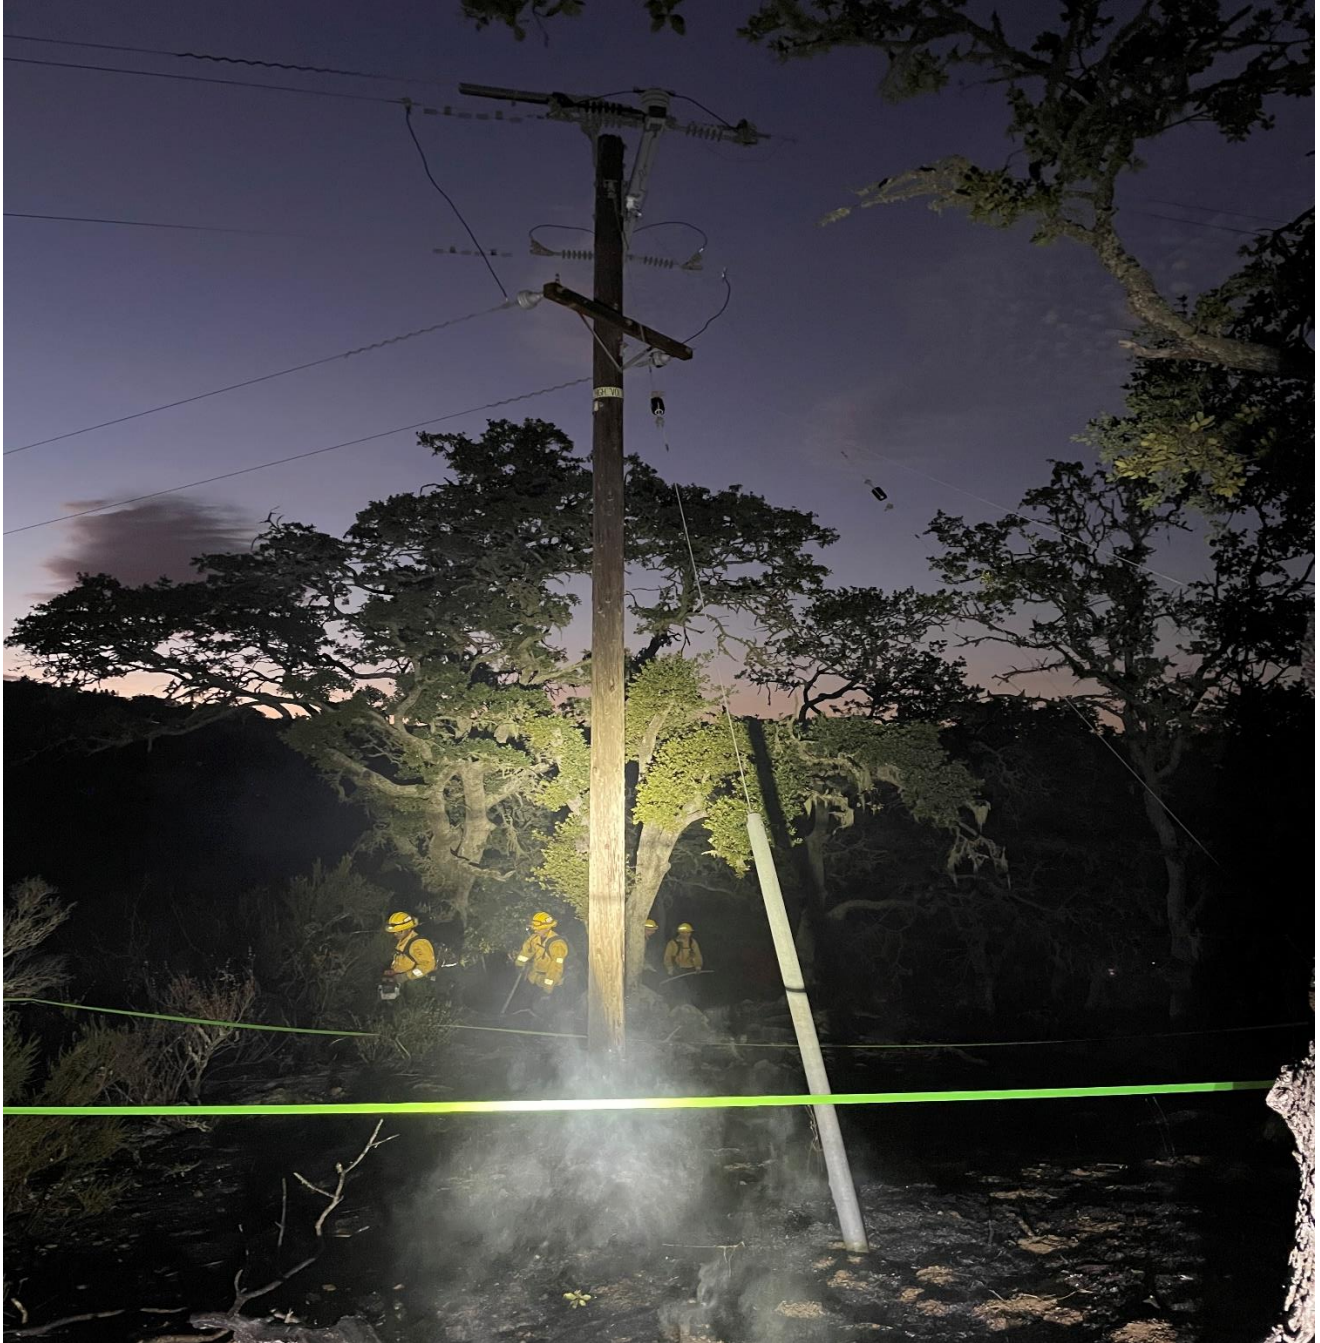
Figure 6 – The Atascadero Fire Department was on site to control and suppress the less than 10-acre fire, picture taken by the troubleshooter on June 25, 2024.

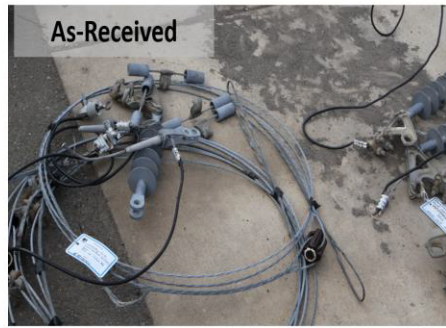
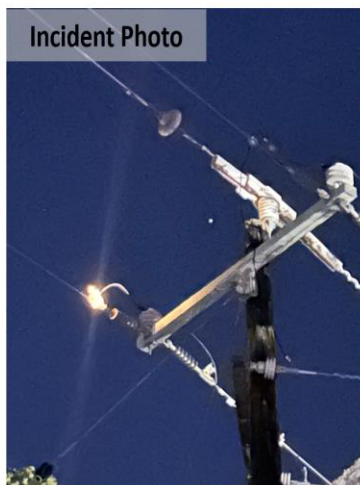
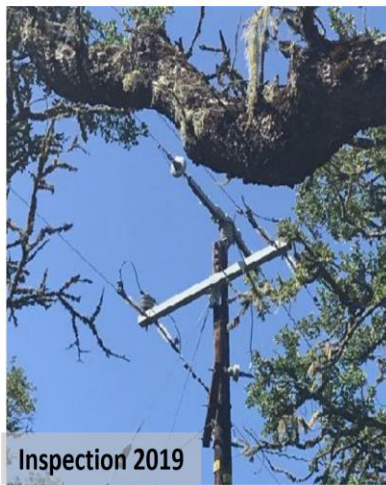
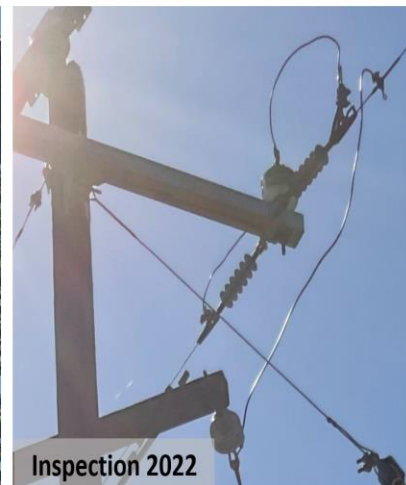
H-Connector

While the direct cause of the failure cannot be determined, per ATS analysis, the ignition was caused by the dripping of molten material from a failed H-connector, connecting the Copper jumper to an Aluminum Conductor Steel-Reinforced (ACSR) conductor. Inspection of the collected material shows significant thermal damage and loss of material on the connector, mostly concentrated around the aluminum conductor.

The cross-arm was rebuilt in 2019 by a contractor with new insulators, connectors, and jumpers. The connector subsequently failed five years later. The suspected cause is most likely poor workmanship. This type and size of connector need four crimps instead of the three that were done. H-type connectors are a very reliable connector when installed properly, but there has been an uptick in failures over the past few years that have been attributed to workmanship issues. Most of these new failures have failed within five years of installation.

The fire was ignited by molten material dripping from a failed H-connector that linked the copper jumper to the Aluminum Conductor Steel-Reinforced (ACSR) conductor. An inspection of the collected materials revealed extensive thermal damage and material loss on the connector, particularly around the aluminum conductor. Although workmanship in the form of inadequate crimping may have contributed to the failure, it is not known if it was a direct cause of the failure. The sister connectors did not exhibit problems like corrosion, loose connection, or the ingress of foreign materials hindering the electrical flow, (see Figures 7 and 8). The exact cause of the failure remains unknown at this time.

Figure 7 - The vegetation fire was ignited by molten material dripping from a failed H-connector that linked the copper jumper to the Aluminum Conductor Steel-Reinforced (ACSR) conductor.

Asset Failure Analysis (AFA) has recommended tailboarding crews with a 5MM to ensure that the entire restoration, construction, and contract teams are aware of the uptick in ignition incidents and some of the misses that led to the ignition regarding H-type connector installation (proper number of crimps), cable preparation, and proper taping. Also, a reminder that the preferred method is fired wedges and of the distribution standards 041010, [here](#).

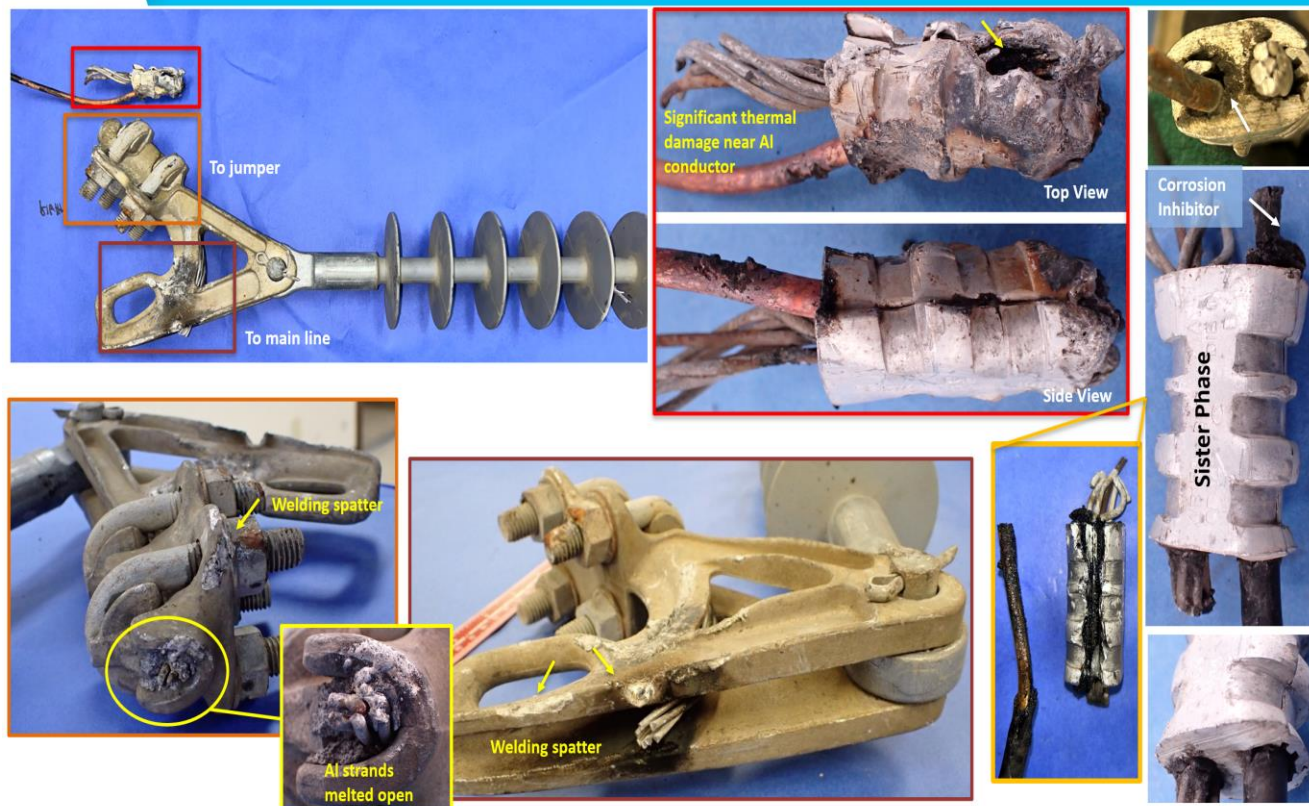
Figure 8 - An inspection of the collected materials revealed extensive thermal damage and material loss on the connector, particularly around the aluminum conductor.

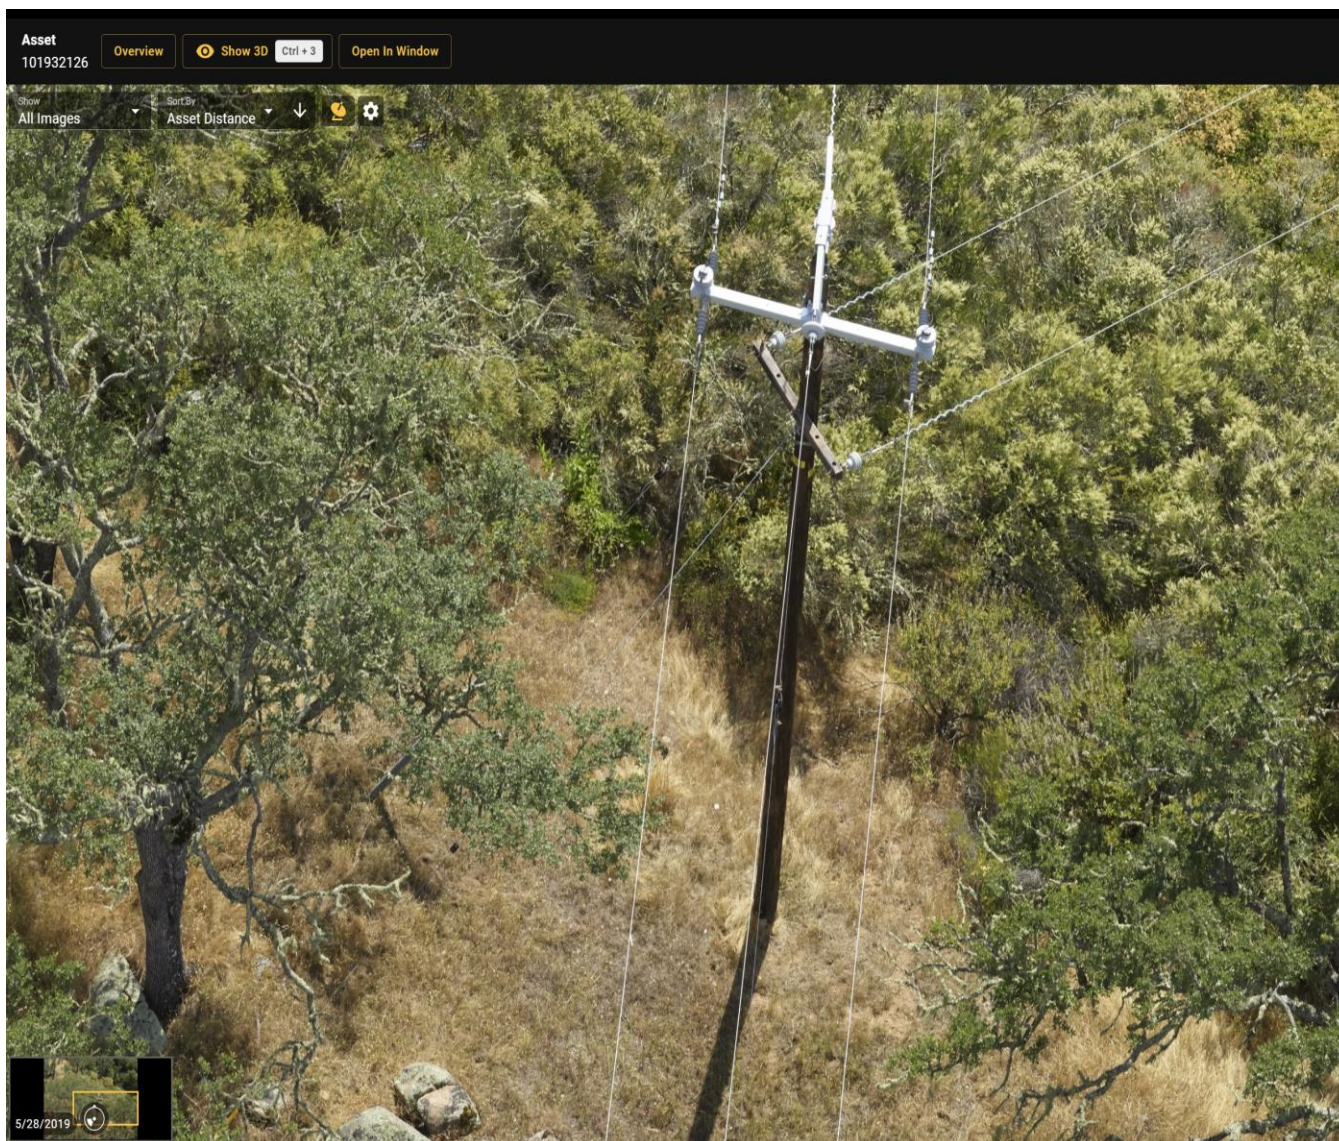
Figure 9 - SAP Pole ID: 101932126 (Incident Pole), picture taken from Shaper Shape dated May 28, 2019
