## Preliminary Ignition Investigation Report

| Ignition Database Index: | 20240770N |
| Suspected Initiating Event: | Transformer failure |
| Circuit: | Flint 1101 |

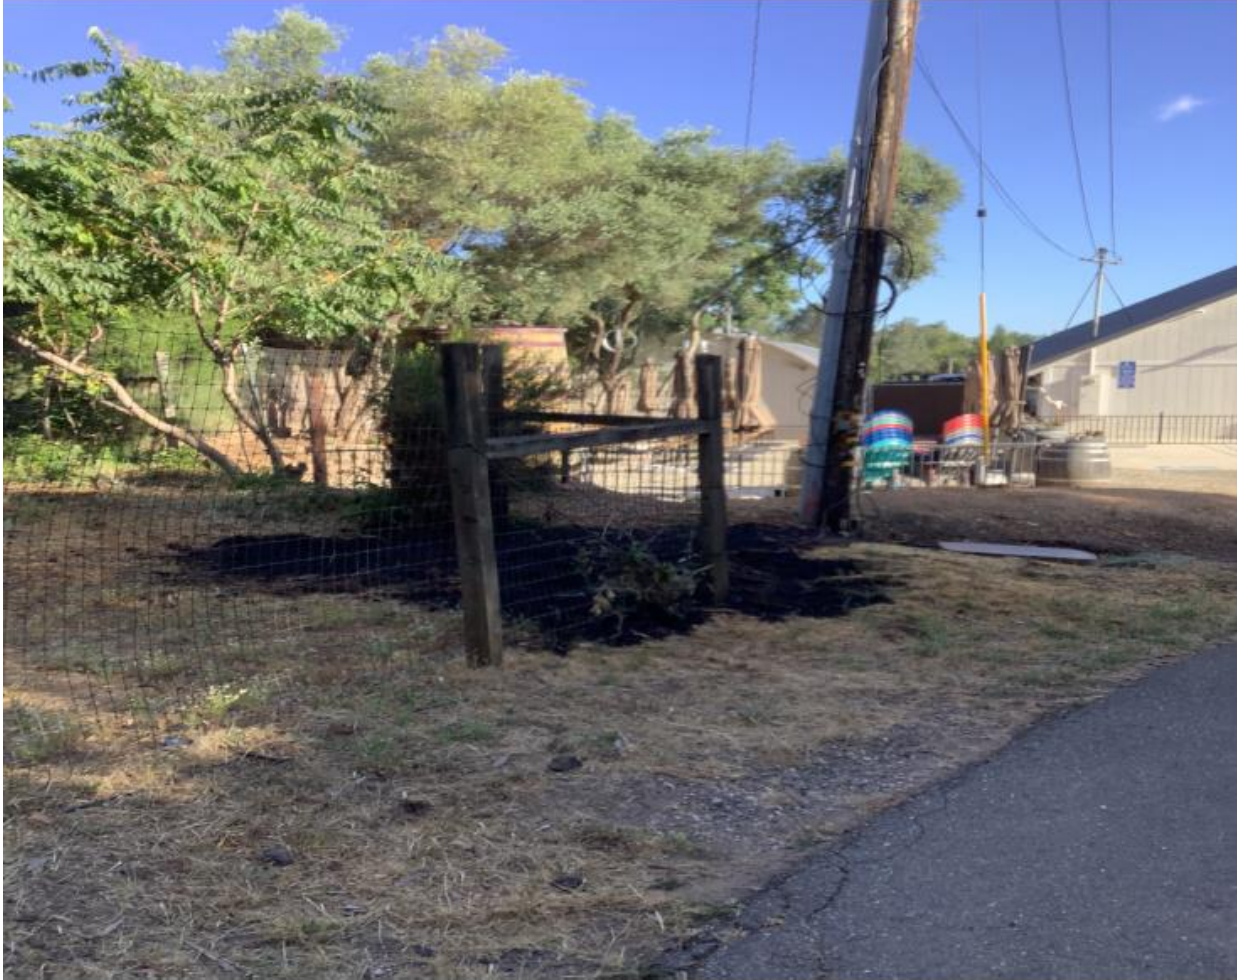
The ignition was isolated to the vegetation at the base of Pole #1 resulting in a fire the size of 10-feet X 12-feet. There was no report of injuries, fatalities, media coverage, or property damage. The incident happened on a three-phase distribution overhead circuit impacting 88 customers for a total of 684 customer minutes.

*Figure 2 SAP Pole ID 100045817 with burn scar at the base of the pole. Photo taken by troubleshooter on June 27, 2024.*

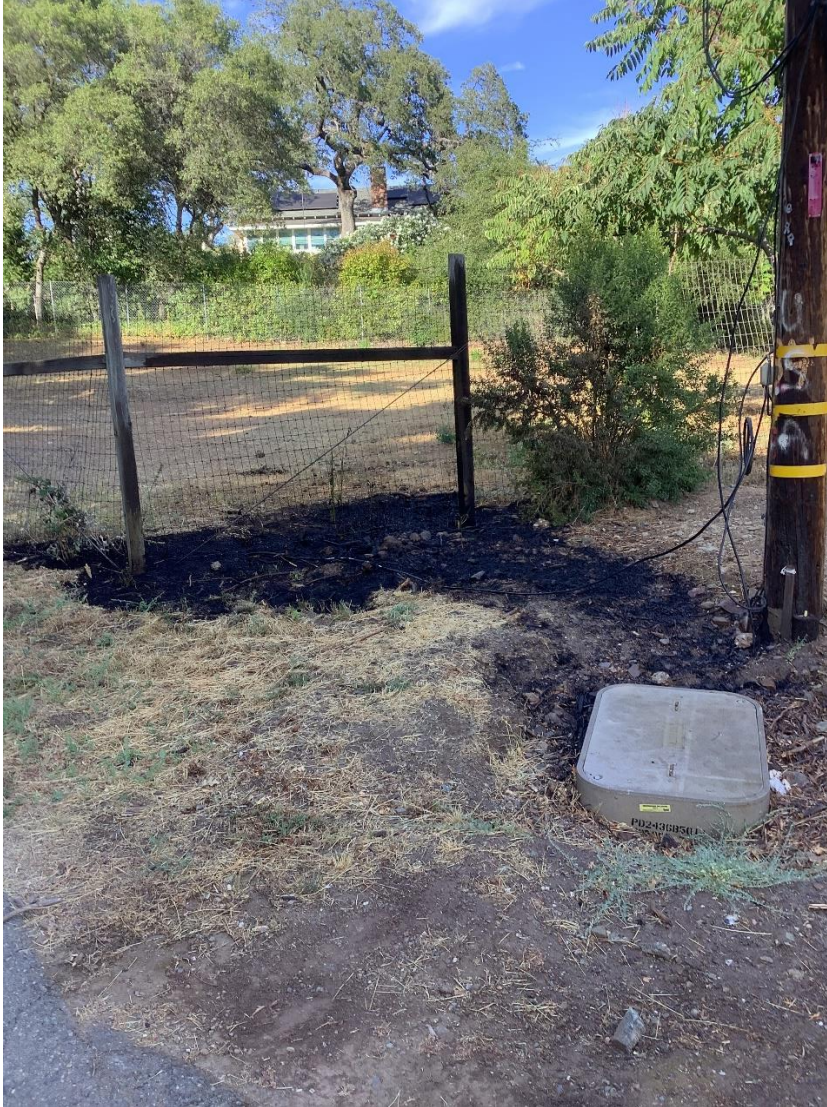
Figure 4: Burn scar at the base of Pole #1. Photo taken by troubleshooter on June 27, 2024.

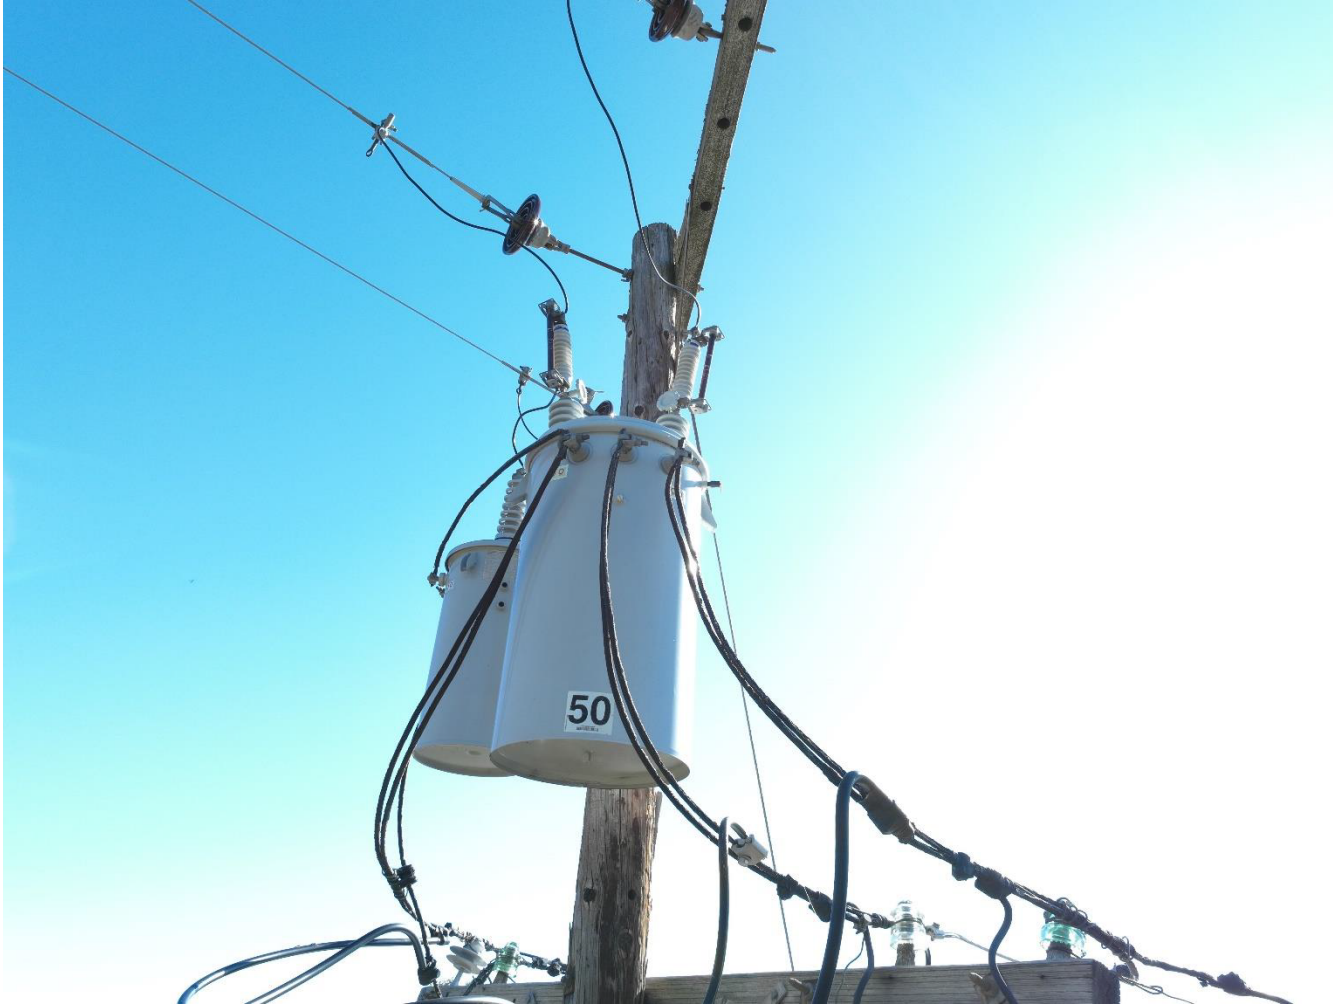
| Inspection: | June 12, 2024 | Identified replacement of broken pole, cross arm, and burnt conductor. EC tag #129075910 created. |

*Figure 5 Aerial inspection photo taken during 2024 overhead inspection. Drone photo taken on June 12, 2024, 14 days before failure.*

EC Priority 'A' Tag (#129139547) to replace open delta bank, crossarm, and install cut outs was completed the following day, June 28, 2024.
