## Preliminary Ignition Investigation Report

<b>Ignition Database Index:</b>	20240860
<b>Electric Incident Investigation (EII) Number:</b>	N/A
<b>Incident Name:</b>	Schow – 05 Jul 2024
<b>PG&amp;E Facility Ignition?</b>	Yes
<b>CPUC Reportable Ignition?</b>	Yes
<b>Date &amp; Time of Incident:</b>	July 5, 2024 @ 1555 hours
<b>Street Address:</b>	27150 Schow Road
<b>City:</b>	Willits
<b>County:</b>	Mendocino
<b>Latitude/Longitude:</b>	39.467718 / -123.369611
<b>State Responsibility Area (SRA) / Local Responsibility Area (LRA) / Federal Responsibility Area (FRA)</b>	State Responsibility Area (SRA)
<b>PG&amp;E Division:</b>	Humboldt
<b>High Fire Threat District (HFTD):</b>	Tier 3
<b>High Fire Risk Area (HFRA):</b>	Yes
<b>EPSS Buffer:</b>	No
<b>Fire Index Area (FIA):</b>	154
<b>Fire Potential Index (FPI) Rating: FIA</b>	R4
<b>Fire Potential Index (FPI) Rating: Circuit</b>	R4
<b>Was there a PSPS event at the time of ignition?</b>	No
<b>Suspected Initiating Event:</b>	Vegetation

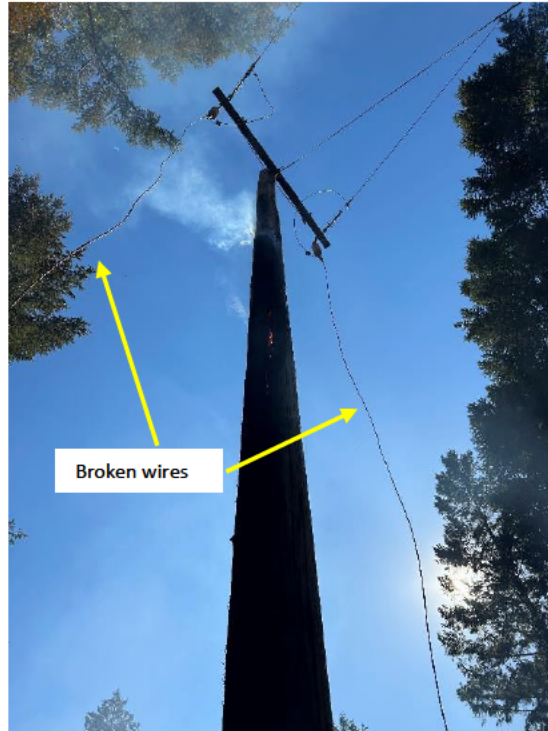
The tree falling on the Willits 1103 distribution circuit resulted in both phases of 4-ACSR primary overhead conductor to fall to the ground and ignite a ground vegetation fire that spread to approximately 0.25 acres. The fire burnt the Incident Pole and surrounding vegetation and damaged the crossarms and anchor. Other than these items and the downed wires, there was no damage to surrounding property, no individuals were injured, and there was no reported media exposure. The outage associated with this event affected 460 customers for approximately two-hours, eight customers for approximately three-hours, and three customers for approximately twenty-two hours.

Figure 3 Photograph of burnt Incident Pole and broken wires. Photograph Source: Troubleshooter 2 (dated July 5, 2024)

Corrective Notification EC-129175992 Priority A was created on July 5, 2024, to replace the Incident Pole, crossarms, and anchor and to repair the downed #4 ACSR conductors. Repairs were completed on July 6, 2024.

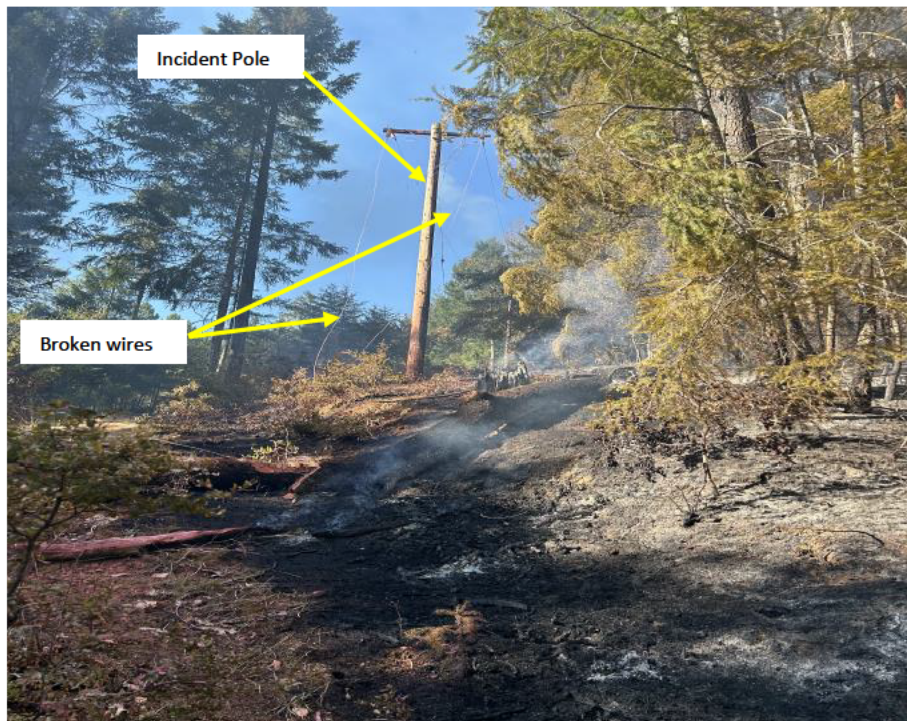
Figure 4 Photograph showing broken wires, Incident Pole, fallen trunk and smouldering vegetation. Photograph Source: EC# 129175992 (dated July 5, 2024)

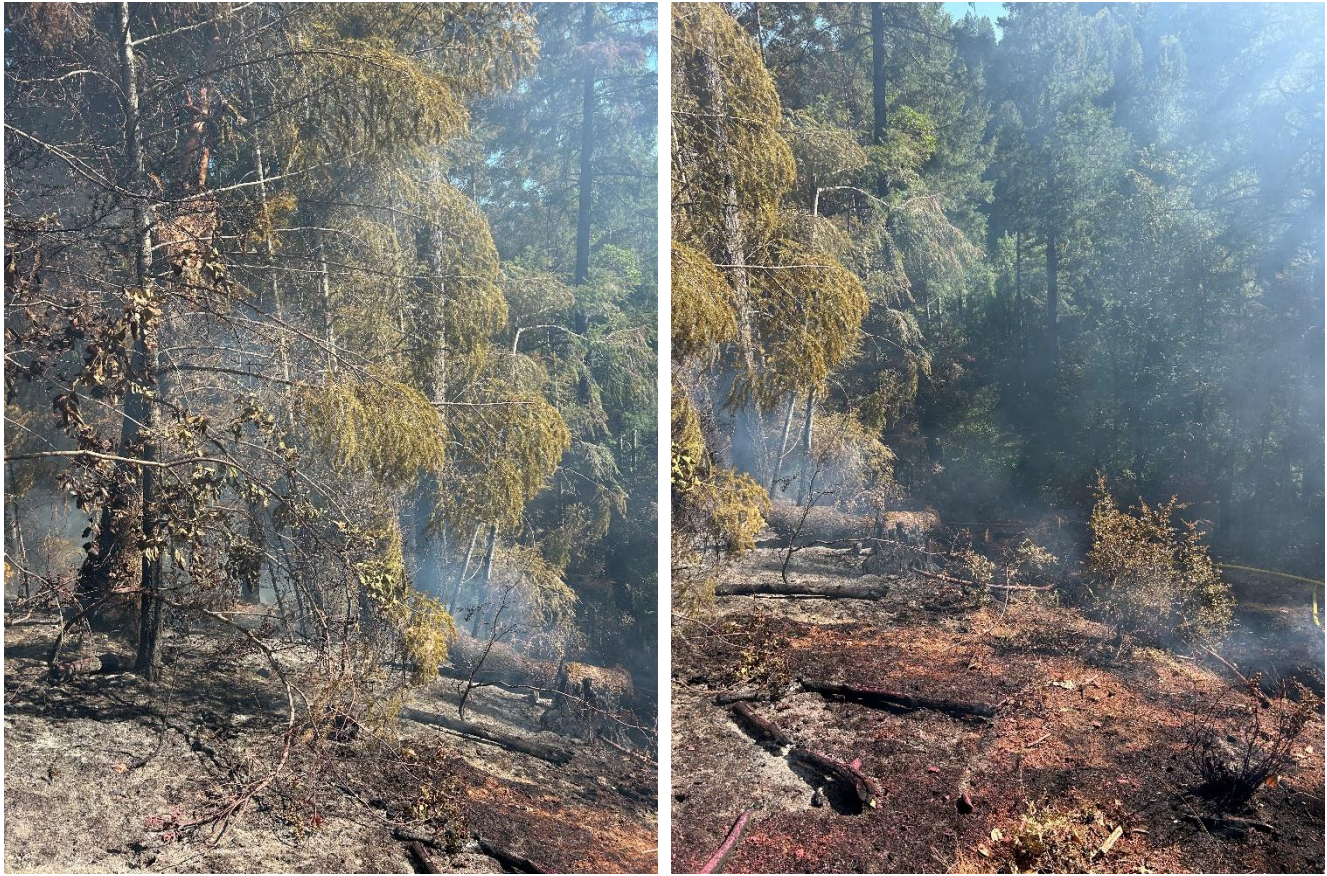
*Figure 5 Photographs showing burned vegetation. Photograph Source: Troubleshooter 2 (dated July 5, 2024)*

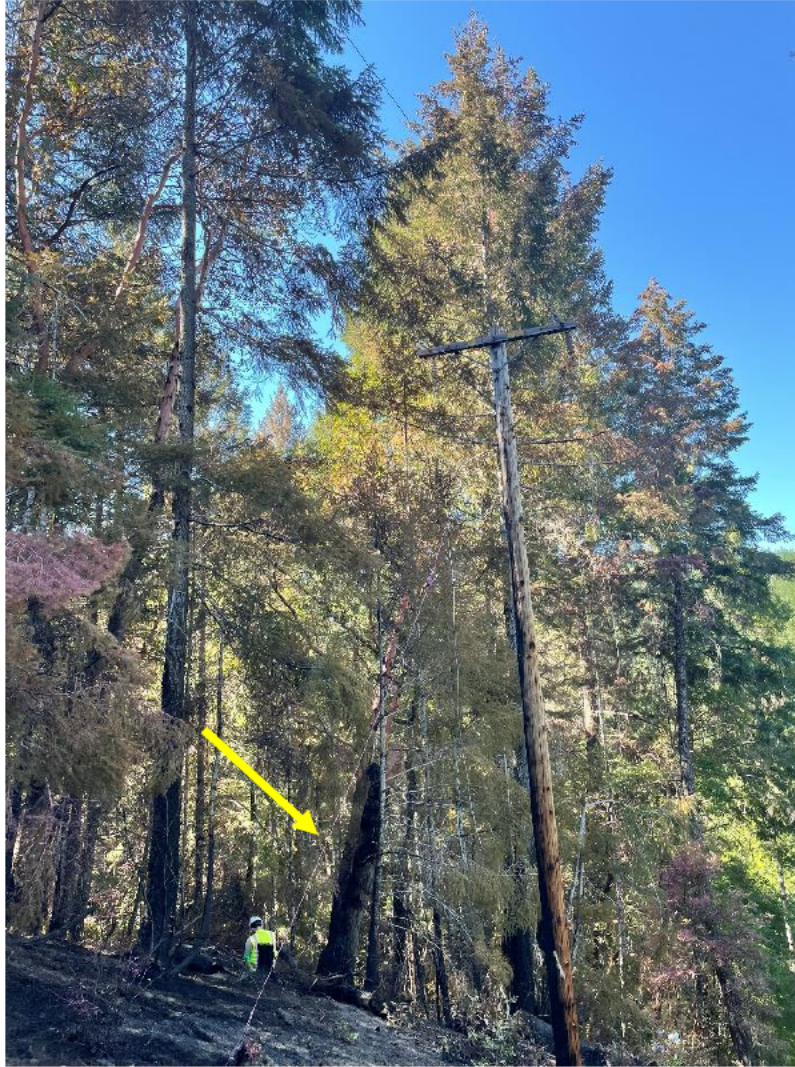
On July 6, 2024, Vegetation Management (“VM”) examined the Incident Location and observed that the Incident Tree, a 65-foot-tall black oak, had a trunk failure approximately 20-feet above the ground (see Figure 6). The failed trunk was on the ground within the burned area. Slightly above the failure point, there was an approximate six-inch diameter wound of unknown origin present on the burned trunk. Discussion with VM revealed the trunk failed at a point which did not have sound wood, proximate to the large wound, indicating the tree had internal decay emanating from the area of the wound<sup>1</sup>. Figure 7 shows the condition of the broken trunk after the fire and the locations of the wound and unsound wood. The presence of the wound and associated internal decay would have contributed to structural weakness in the trunk and were likely contributing factors to the tree failure and subsequent ignition. VM performed an Extent of Conditions Patrol investigation (XoC) in the vicinity of the Incident Pole; the patrol did not identify any trees requiring priority mitigation work.

*Figure 6 Remaining tree stump of Incident Tree (indicated) and surrounding burnt vegetation. Photograph Source: VM Incident Report (dated July 6, 2024)*

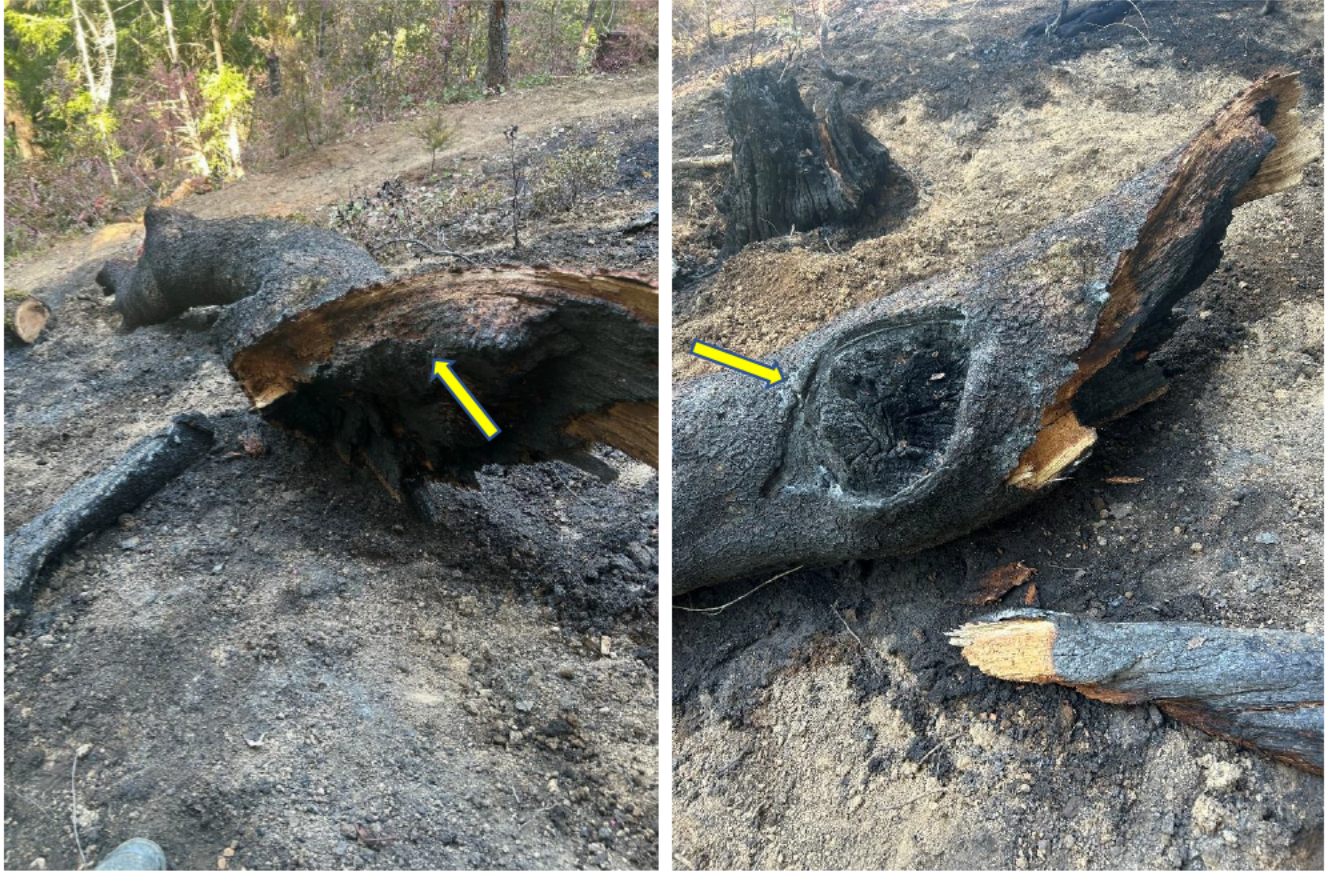
<sup>1</sup> Electronic Communication with Vegetation SME on August 21, 2024. The VM Incident investigation report findings do not align with the photographic documentation provided with the report.

Figure 7 Views of failed trunk. Arrow in the left photograph points to location of apparent internal degradation. Arrow in right photograph indicates location of tree “wound” above failure location. Photograph Source: VM Incident Report (dated July 6, 2024)
