Preliminary Ignition Investigation Report

Ignition Database Index:	20240862
Electric Incident Investigation (EII) Number:	N/A
Incident Name:	Upland – 05 Jul 2024
PG&E Facility Ignition?	Yes
CPUC Reportable Ignition?	Yes
Date & Time of Incident:	July 5, 2024 @ 1420 hours
Street Address:	██████████
City:	Kentfield
County:	Marin
Latitude/Longitude:	██████████
State Responsibility Area (SRA) / Local Responsibility Area (LRA) / Federal Responsibility Area (FRA)	State Responsibility Area (SRA)
PG&E Division:	North Bay
High Fire Threat District (HFTD):	Tier 3
High Fire Risk Area (HFRA):	Yes
EPSS Buffer:	No
Fire Index Area (FIA):	190
Fire Potential Index (FPI) Rating: FIA	R3
Fire Potential Index (FPI) Rating: Circuit	R2
Was there a PSPS event at the time of ignition?	No
Suspected Initiating Event:	Vegetation
Failure Driver:	Contact from object
Failure Sub-driver:	Contact - Vegetation
Circuit:	San Rafael 1107
Circuit Protection Zone:	San Rafael 11071166
Nominal Voltage:	12kV

Executive Summary

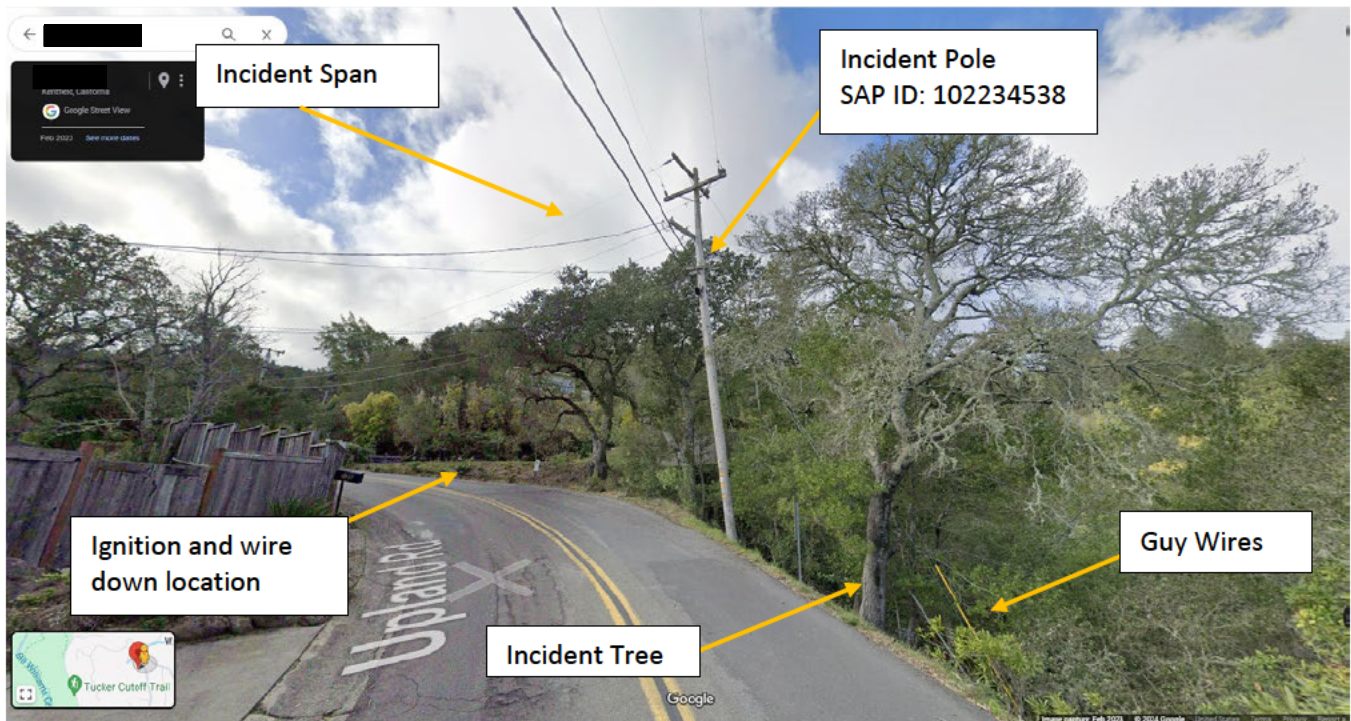
Figure 4 View of Incident Location prior to incident. The Incident Tree and guy wires are visible in the photograph. Source: Google Maps image dated February 2023.

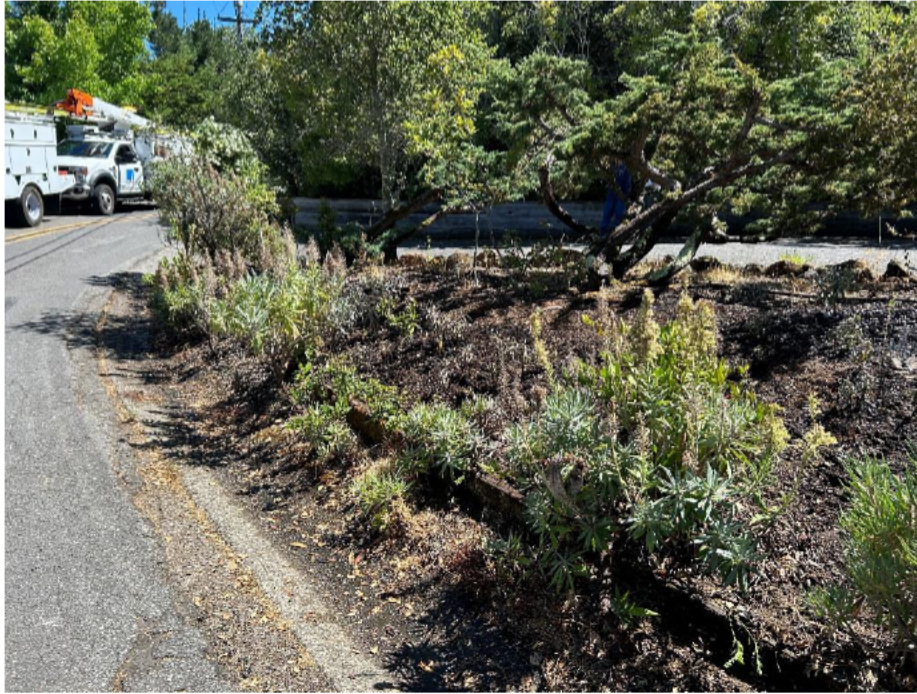
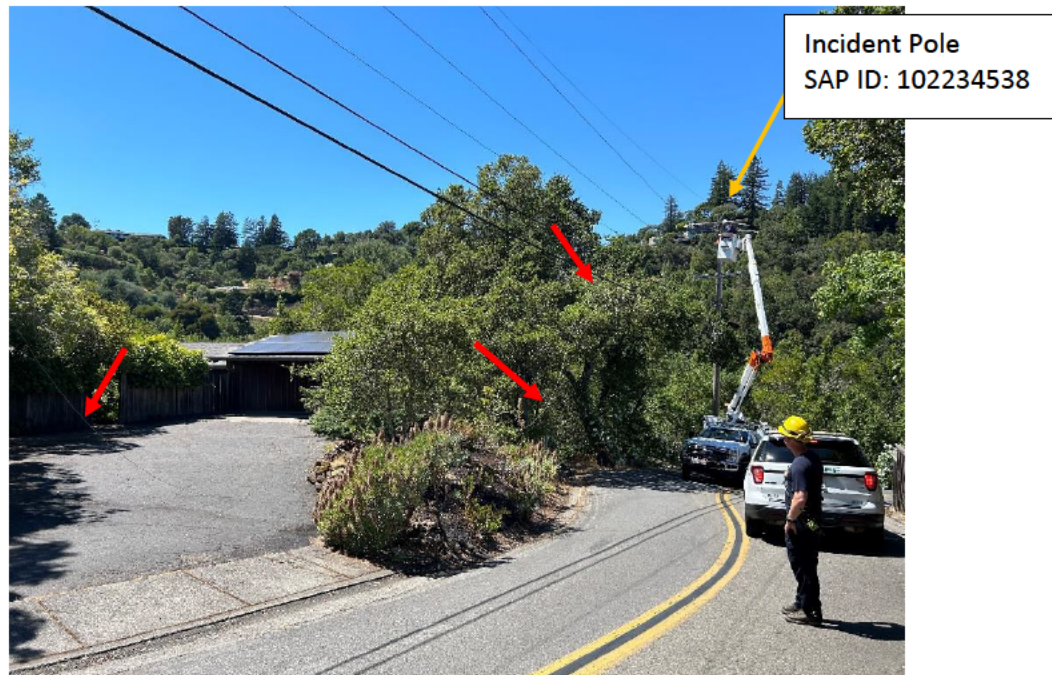
By 1450 hours, both troubleshooters arrived to the Incident Location and observed MCFD clearing hot spots from a small vegetation fire (Figure 5), a single hot phase of #6 solid copper primary overhead conductor broken¹ ("Incident Conductor") and the source side on the ground between wood pole SAP ID 102234538 ("Incident Pole", source side) and wood pole SAP ID #102234530 ("Pole 2", load side) ("Incident Span"), a broken guy wire, and arc marks on the adjacent primary conductor and a secondary line². Both fuses of Fuse Cutout 4979 had blown. Troubleshooter #1 discovered a tree ("Incident Tree"), located load side of the Incident Pole on top of the broken guy wires for the Incident Pole.³ Troubleshooter #2 speculated the Incident Tree had fallen on the guy wires and pulled the Incident Pole causing one conductor on the Incident Span to break underneath a tap guard located about two feet from a dead-end insulator at Pole 2 (Figure 6).

Vegetation contact with a guy wire caused one phase wire down, damaged the Incident Pole guy wire and ignited a small ground vegetation fire that spread to approximately 200 square feet. There was no other damage to surrounding property, no individuals were injured, and there was no reported media exposure. The outage associated with this event affected 2,816 customers for approximately one hour, 46 customers for approximately five-and-a-half hours.

Figure 5 Views of burnt vegetation caused by downed Incident Conductor and downed wire (red arrows in bottom photograph indicate location). Source: Troubleshooters images taken on July 5, 2024.

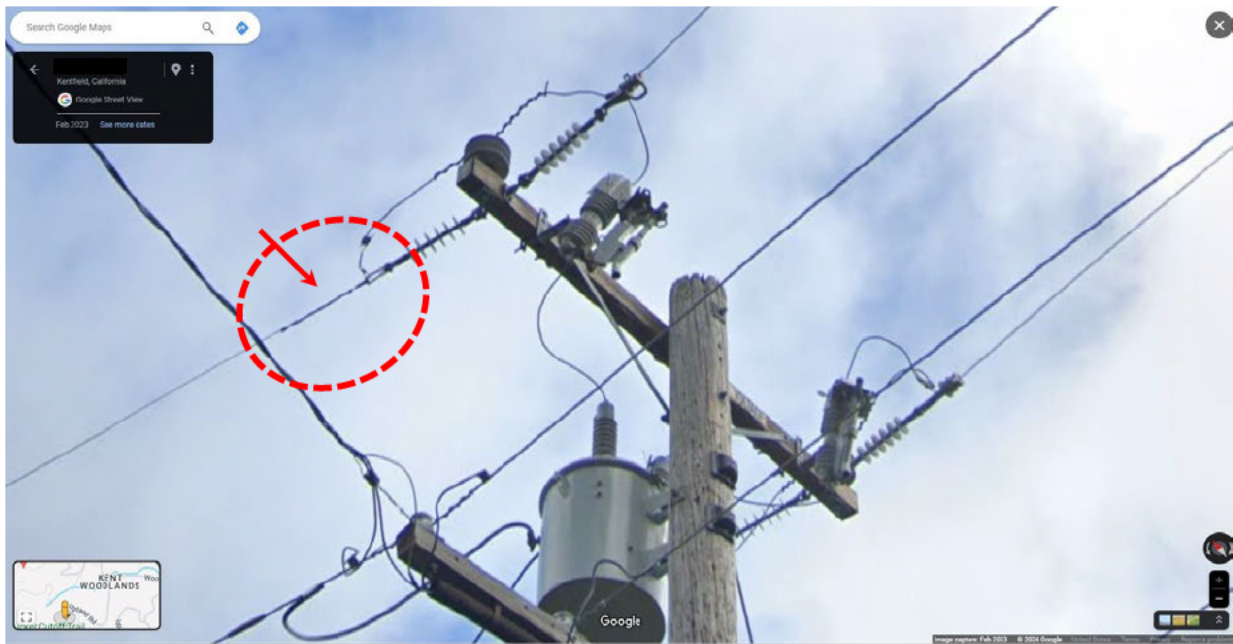
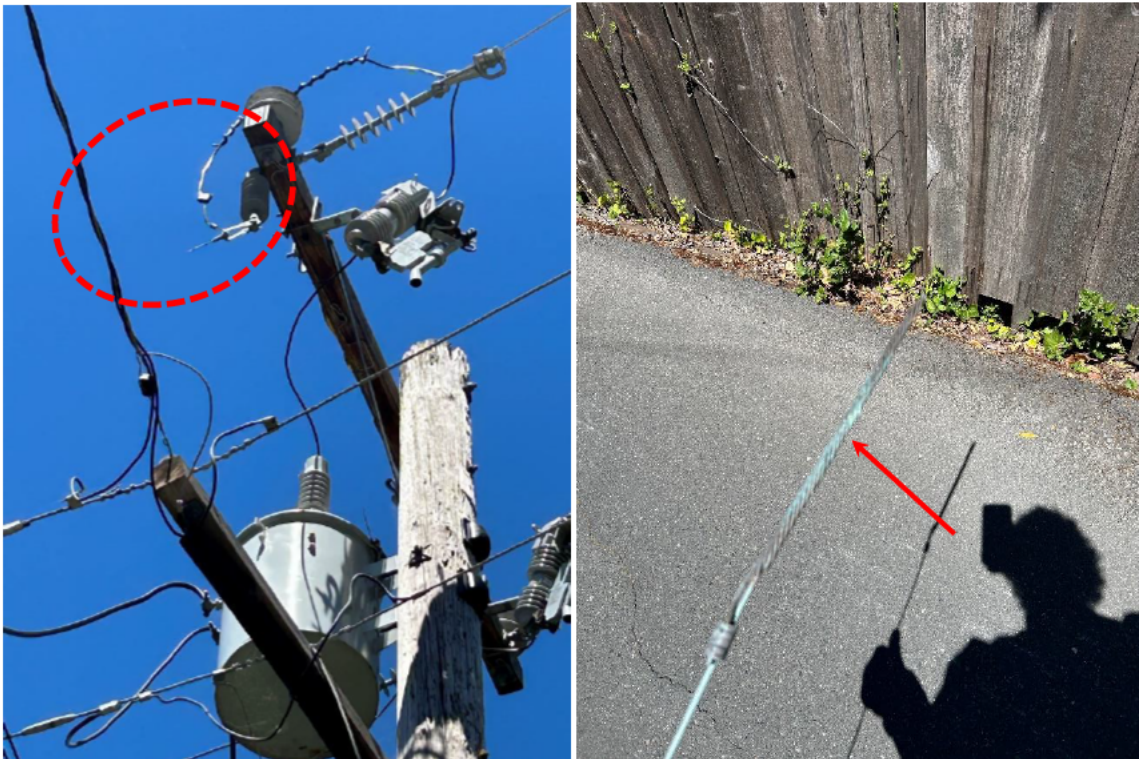
¹ The Incident Conductor was observed to have failed underneath a tap guard located about two feet from a dead-end insulator at Pole 2; the Incident Conductor was cut at the Incident Pole to remove it from the roadway as part of making the Incident Location safe. Verbal Communication with Troubleshooter #2 on August 19, 2024

Figure 6 Location where Incident Conductor broke at Pole 2 prior to the incident (top, source Google Maps, February 2023) and after the incident (bottom, Source: EC # 129175534). The failure location is indicated with a circle and the tap guard is indicated with arrows in the photographs.

Corrective Notification EC 129175534 was created to replace the guy wire as well as the damaged primary conductors. Replacement of the guy wire and both phases of 6-solid copper primary conductor were completed on July 5, 2024.

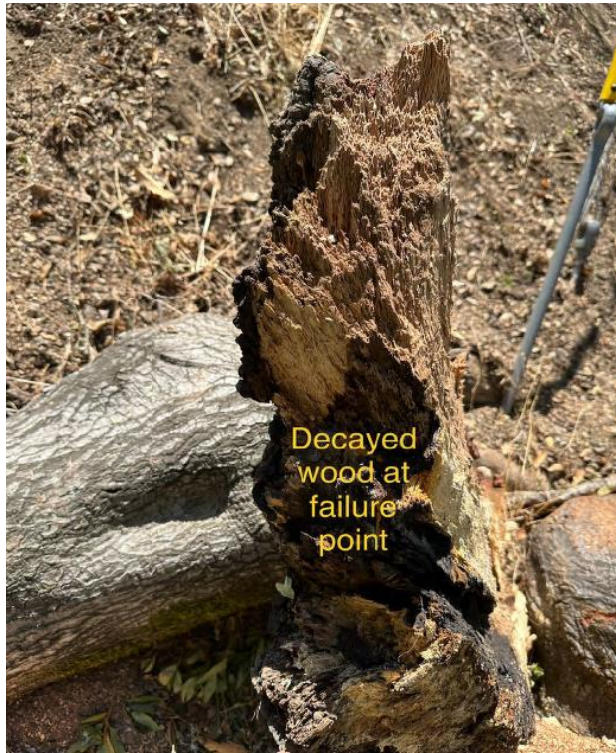
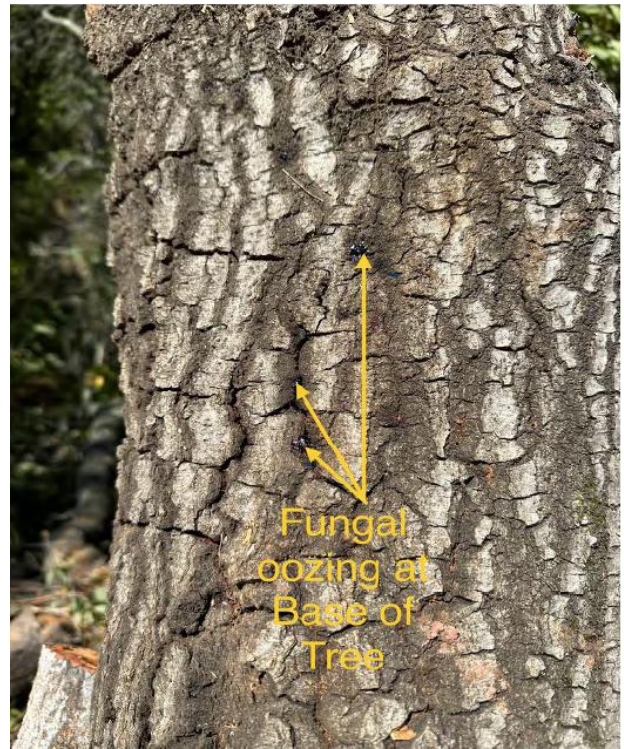
On July 9, 2024, Vegetation Management ("VM") patrolled the Incident Location and observed burnt vegetation covering an area approximately 15-feet by 20-feet directly beneath the Incident Span. VM identified the Incident Tree as a 35-foot-tall coast live oak with a trunk growing close to guy wires at the Incident Pole. VM observed the Incident Tree having a small amount of foliage on the branches, decayed wood at the failure point, and black fungal discharge on the bark at the base of the tree (Figure 7). VM determined the Incident Tree broke at the base (at soil level and below) and had fallen downhill across the guy wires due to advanced decay and was in declining health at the time of the incident (Figure 8). Given that the decay would not have been visible from the exterior, it could not have been identified by the Vegetation Management program.⁴ VM also performed an extent of condition patrol in the vicinity of the Incident Pole on the same day and did not identify any trees requiring priority mitigation work.

Figure 7 View of decayed wood at failure point (left) and black fungal oozing on bark (right). Source: VM Incident Report, images taken on July 9, 2024.

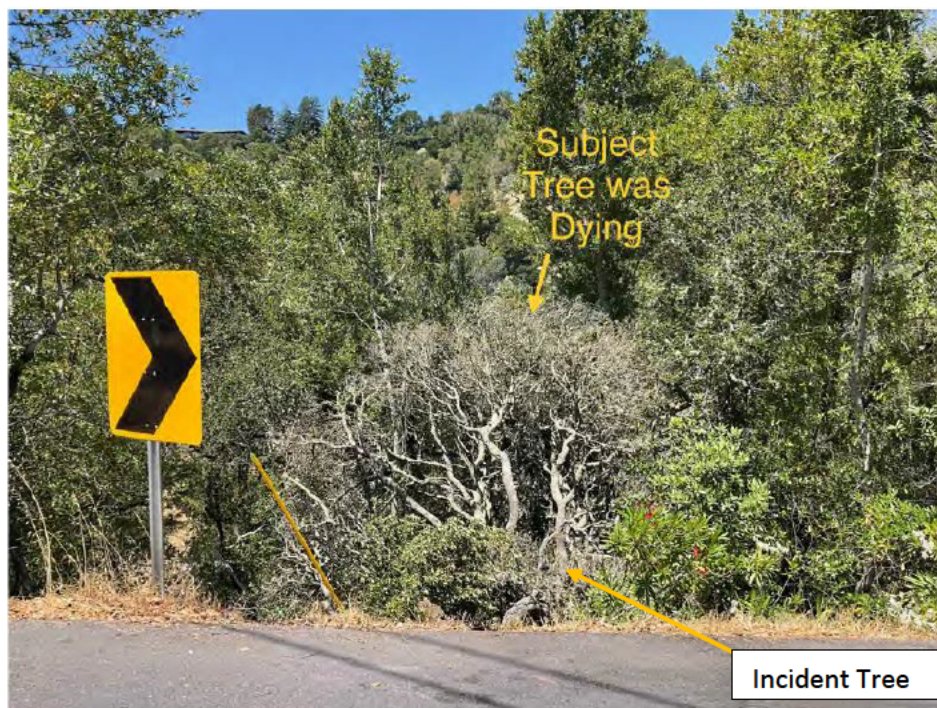
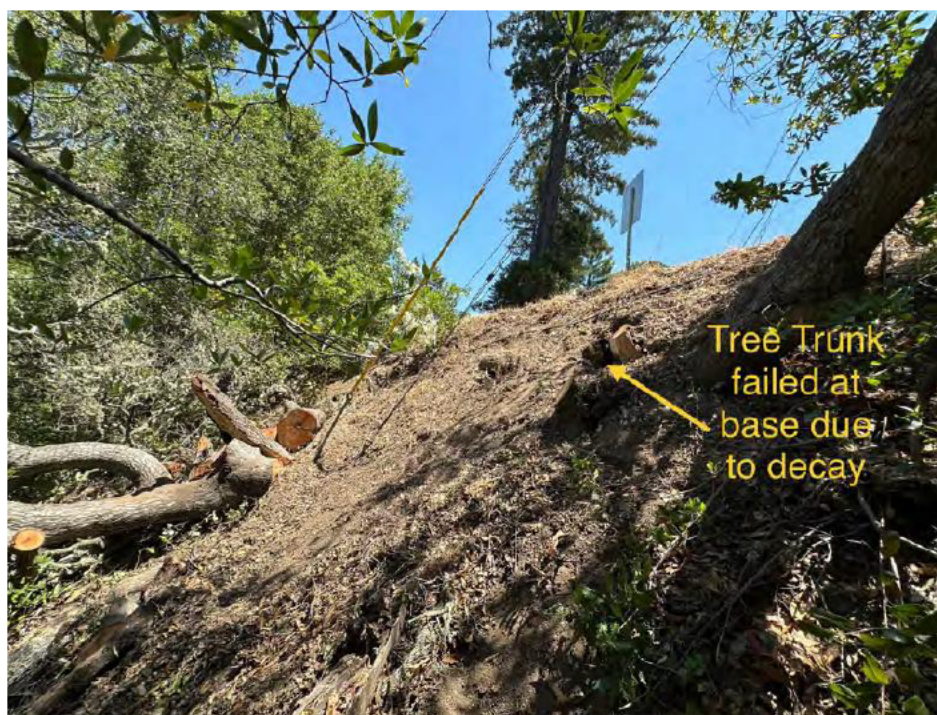
Pole SAP Equipment ID:	102234538
Subject to PRC 4292 Veg Pole Clearance:	No
PG&E Equipment associated with ignition:	Conductor - Primary (#6 Solid Cu)
EPSS enabled at time of ignition?	Yes
Fault Type:	Line-to-Ground
Wire Down (Primary)?	Yes
Lead Agency/Agency Having Jurisdiction:	Kentfield Fire Department
Fire Size:	3 meters – 0.25 Acres
FAS Field Remarks:	“Found 2 of 2 fuses blown at cutouts 4979. Large Live Oak tree broke off at base near ██████████ and fell onto down guys of primary corner pole.

Figure 8 View of fallen tree (top) and remaining tree trunk (bottom). Source: VM Incident Report, images taken on July 9, 2024.

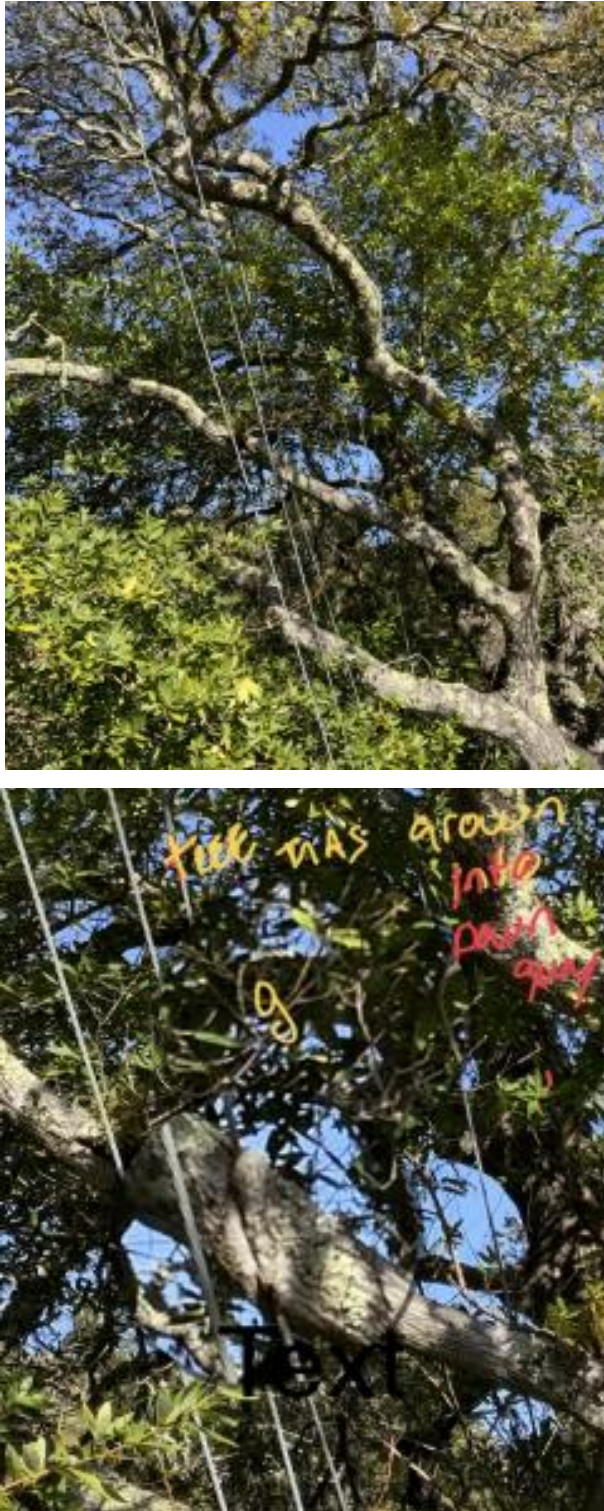
On February 7, 2019, a Wildfire Safety Inspection Program (WSIP) overhead inspection identified vegetation overgrowth issues with the incident guy wires and created a priority E tag (EC 117170692) with a due date of

November 6, 2019 to trim trees growing around the Incident Pole guy wires.⁵ Subsequent Field Safety Reassessments (FSRs) extended the due date multiple times while also noting the need for trimming overgrowth affecting the guy wires.⁶ Figure 9 shows vegetation overgrowth on the guywires in March 2021. This work was overdue at the time of the incident, but it is unclear whether this tree work would have uncovered the tree's condition and prompted additional actions that may have prevented the tree failure and subsequent ignition. The guy wire overgrowth condition was not identified during the January 2024 VM annual patrol.⁷

⁶ No EV notification was created to address vegetation overgrowth issues with the guy wires; thus, VM was unaware of this condition and did not schedule tree work.

⁷ Per discussion with VM SME, the tree overgrowth condition should have been identified (per TD-7102P-01. Section 3.1, Item 1 which requires identification of vegetation that may fall into or otherwise impact PG&E facilities), and the overgrowth condition reported (per TD-7102P-09 – Reporting Abnormal Field Conditions for Vegetation Management).

Figure 9 Photographs of guywire overgrowth on March 25, 2022. Source: EC Notification 11717069, 2021 FSR.

- Development of a five-minute meeting for VM inspectors to reinforce inspection of the entire facility, including guy wires, reiterate abnormal vegetation conditions associated with guy wires, and remind VM inspectors of reporting requirements when abnormal conditions are encountered. CAP #00129510249 has been submitted to track to completion.

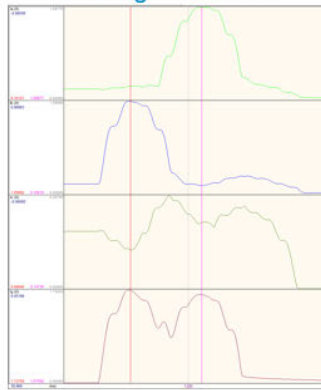
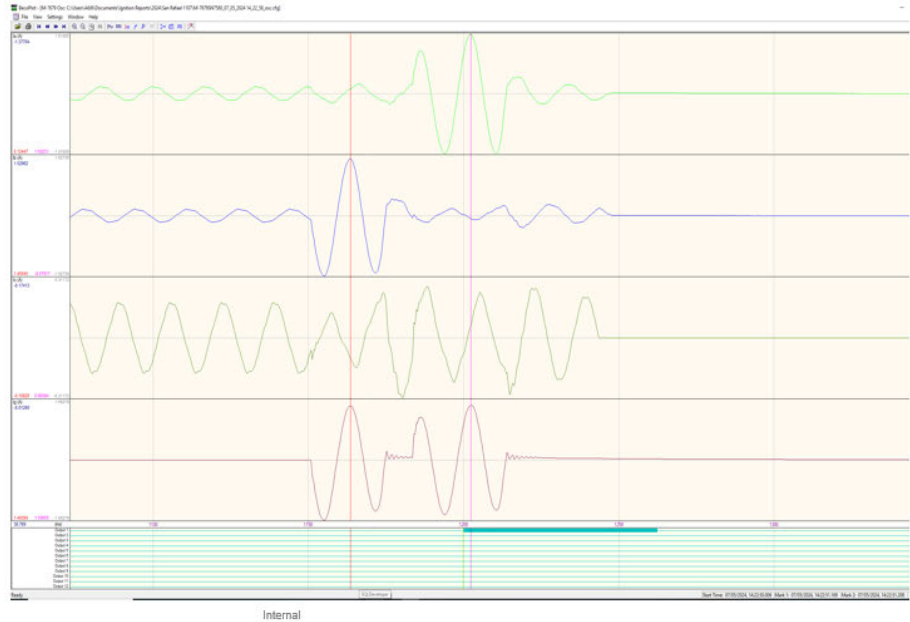
Distribution Protection Engineering reviewed the oscillography for LR 1166 (see Figure 10) and identified a B phase-to-ground fault shortly followed by an A-phase-to-ground fault at 1422 hours. These faults caused LR 1166 to open to clear the fault on ground instantaneous overcurrent (fault magnitude: A: 1067A, B: 1057A, G: 1128A) and both fuses on FUCO 4979 to operate.⁸ LR 1166 responded to clear the fault after 50ms, within the EPSS response time of 100ms or less for high-current fault conditions. The protective device operated as expected.

The oscillography captured from LR 1166 (see figure 10) is consistent with both conductors coming into contact with a ground at two different times. However, it is unclear what the point of ground was. The specific sequence of events that resulted in the ignition event could not be determined at this time.

- Fault Amps:
 - A: 1067A rms
 - B: 1057A rms
 - G: 1128A rms
- LR response time: 50ms
- LR clearing time: 97ms

Figure 10 LR 1166 Oscillography showing fault load at time of incident. Source: EPSS investigation report.
