Preliminary Ignition Investigation Report

Ignition Database Index:	20240869
Electric Incident Investigation (EII) Number:	N/A
Incident Name:	Kanaka – 05 Jul 2024
PG&E Facility Ignition?	Yes
CPUC Reportable Ignition?	Yes
Date & Time of Incident:	2024-07-05 @ 19:18
Street Address:	
City:	Jamestown
County:	Tuolumne
Latitude/Longitude:	
State Responsibility Area (SRA) / Local Responsibility Area (LRA) / Federal Responsibility Area (FRA)	SRA
PG&E Division:	Yosemite
High Fire Threat District (HFTD):	Tier 2
High Fire Risk Area (HFRA):	Yes
EPSS Buffer:	No
Fire Index Area (FIA):	320
Fire Potential Index (FPI) Rating: FIA	R4
Fire Potential Index (FPI) Rating: Circuit	R4
Was there a PSPS event at the time of ignition?	No
Suspected Initiating Event:	Vegetation
Failure Driver:	Contact from object
Failure Sub-driver:	Contact – Vegetation
Circuit:	PEORIA 1701
Circuit Protection Zone:	PEORIA 170190090
Nominal Voltage:	0 – 750V
Pole SAP Equipment ID:	101030403
Subject to PRC 4292 Veg Pole Clearance:	Yes

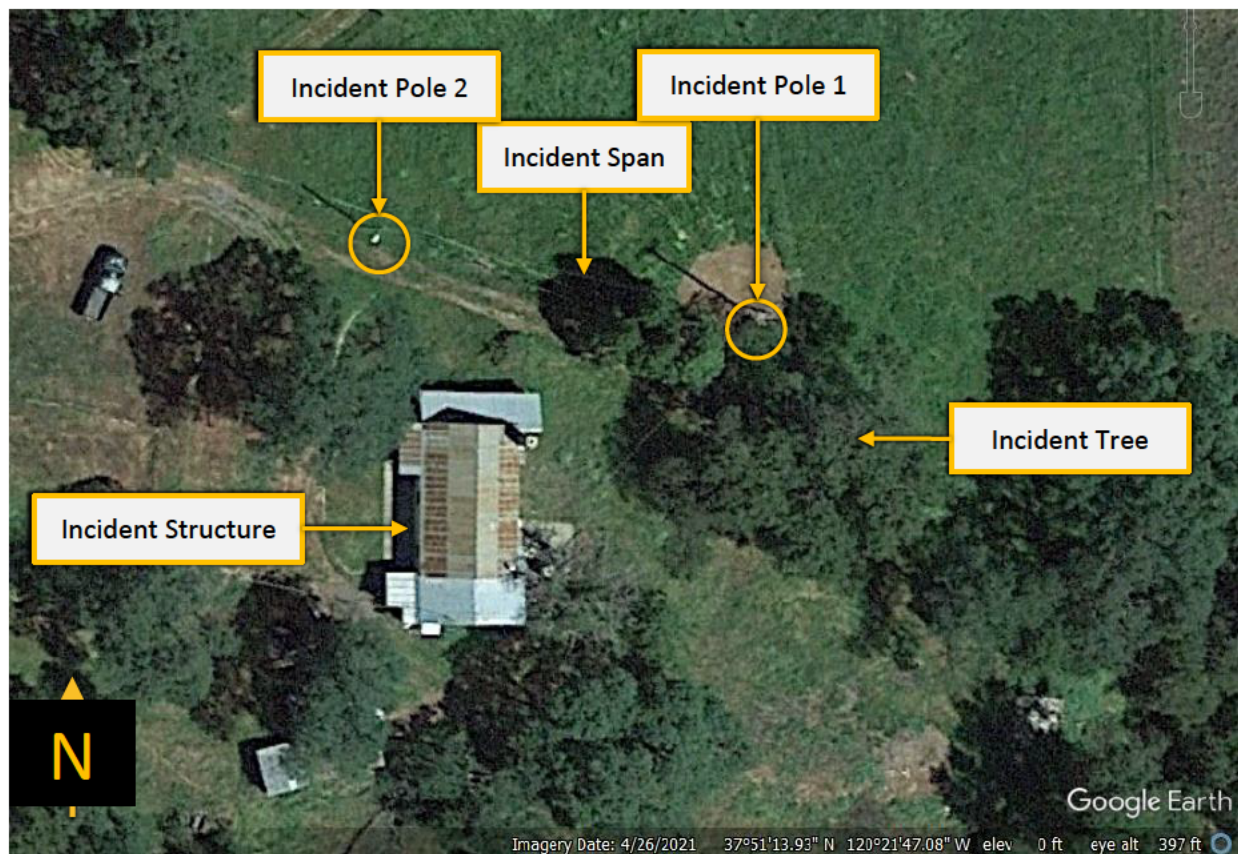
Figure 2. Publicly available overhead image of the Incident Location showing the Incident Span, Incident Pole 1, Incident Pole 2, Incident Tree, and Incident Structure (image from April 2021, provided by Google Earth, accessed August 5, 2024).

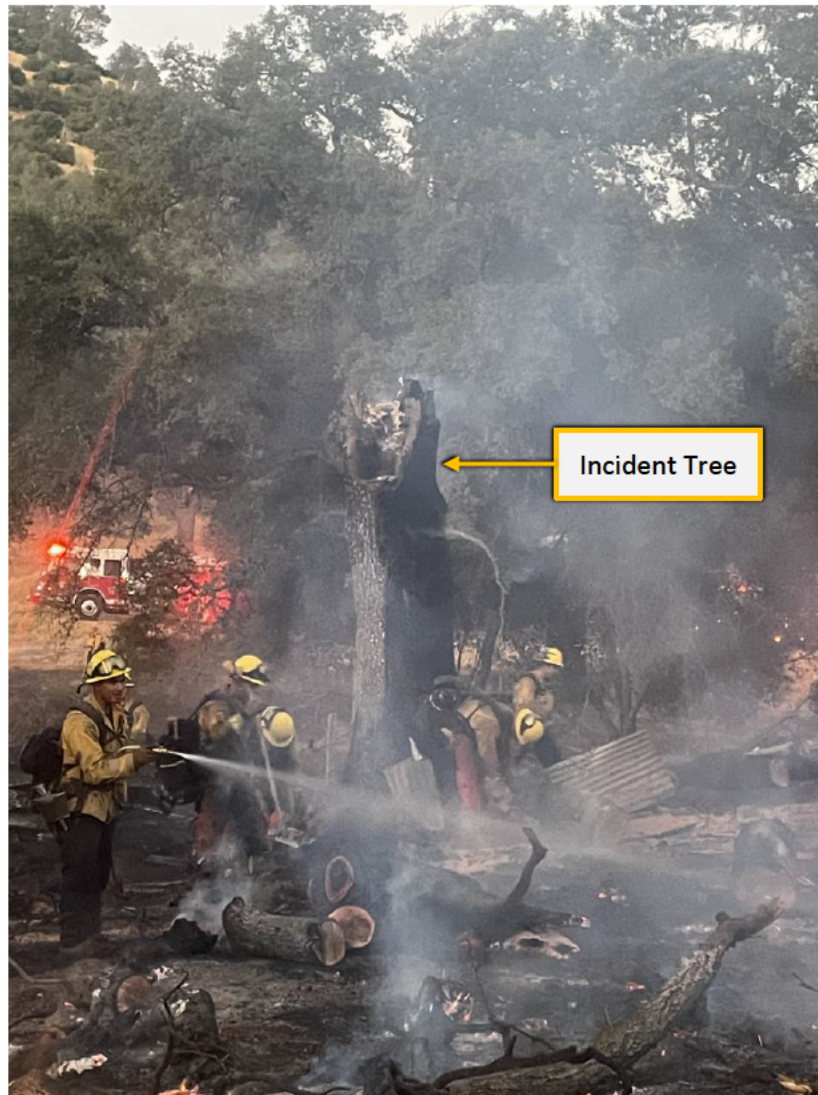
Figure 4. Incident photo showing the remaining trunk of the Incident Tree and CAL FIRE spraying the charred ground with water (taken July 5, 2024).

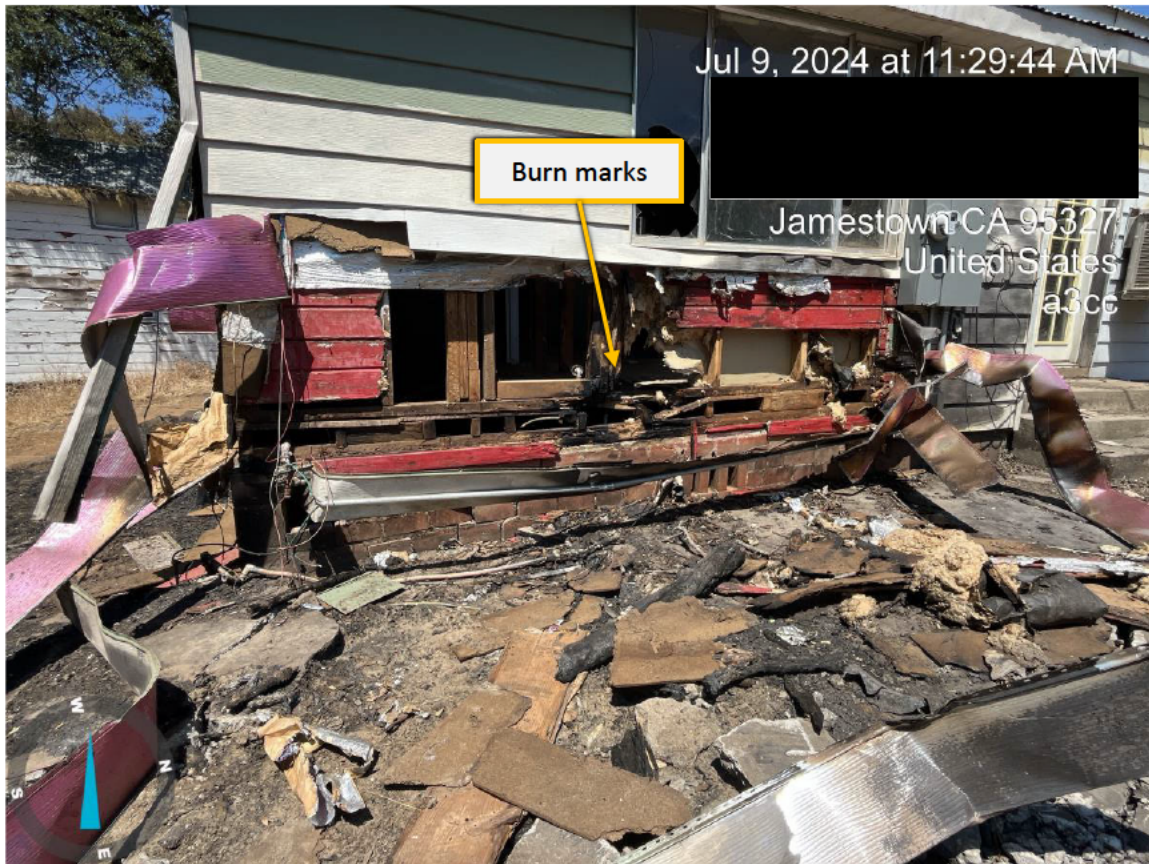
On July 9, 2024, Vegetation Management (“VM”) patrolled the Incident Location and observed approximately 1.5 acres of burned grass and trees, and exterior fire damage at the southeast corner of the Incident Structure (Figure 5). VM reported that the Incident Tree was an interior live oak at least 50 feet tall that failed mid-trunk toward Incident Pole 1. VM reported that the Incident Tree was green at the time of failure, with rot present within the trunk and where large limbs tore out, however, it is unclear whether the defects would have been visible during the time of inspection in March 2024. The same day, VM performed an extent of condition patrol, observed no trees out of compliance, and marked seven trees for removal that exhibited fire damage or rot indicators.

Figure 5. Vegetation Management Incident Report. Photo shows the southeast corner of the Incident Structure with a section of siding removed and evidence of burn marks (taken July 9, 2024).

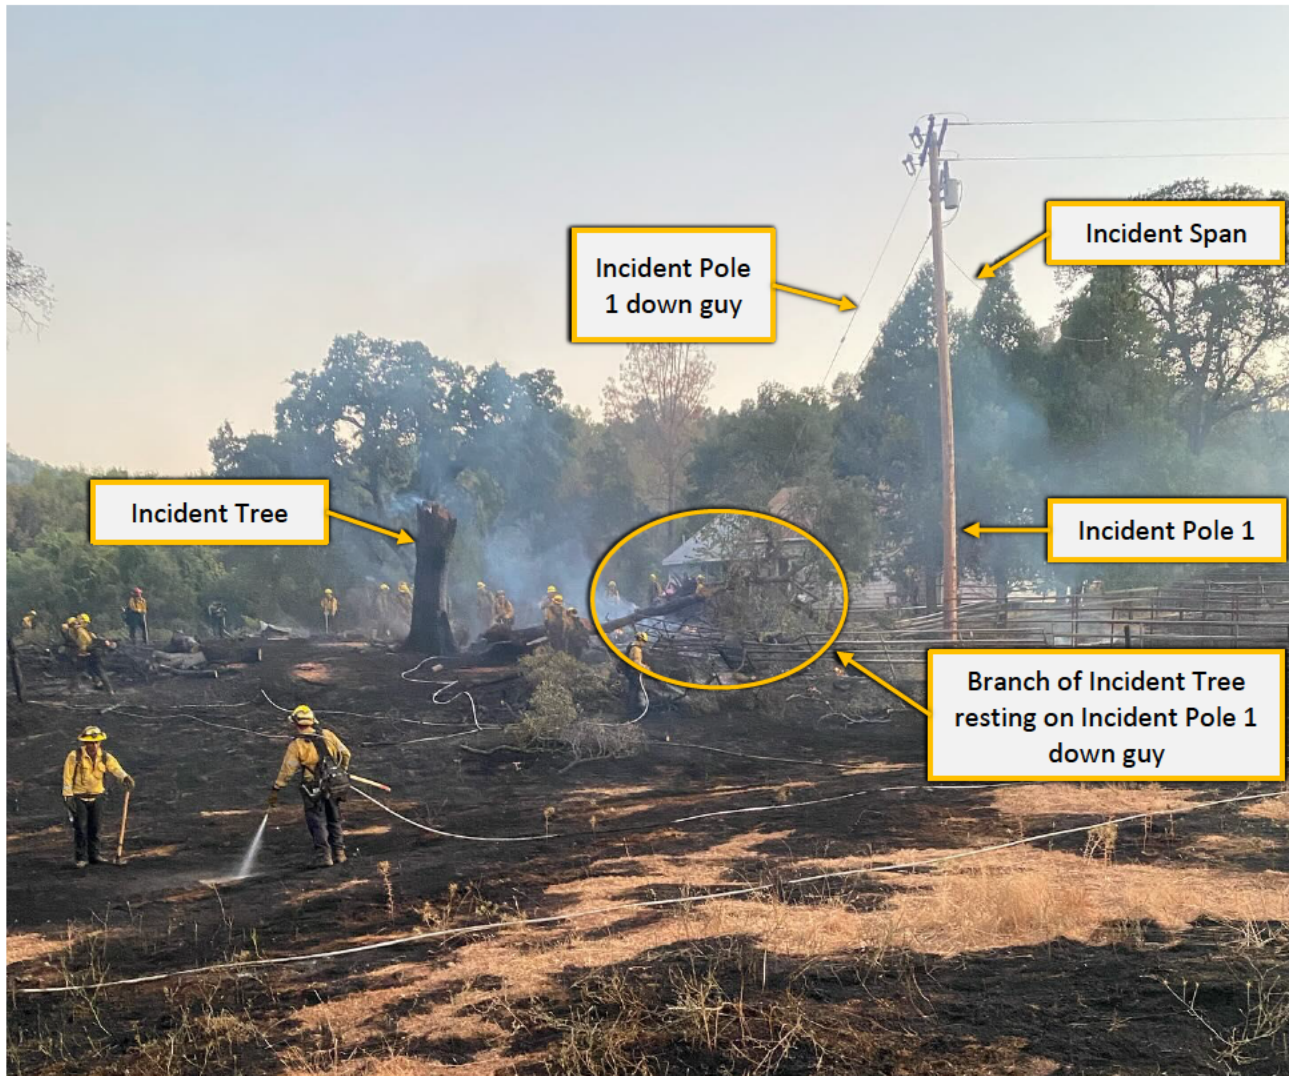
On July 5, 2024, at 1950 hours, CAL FIRE notified PG&E of a vegetation fire and wires down at 13006 Kanaka Drive¹ in Jamestown, California. Concurrently, a PG&E Troubleshooter overheard CAL FIRE radio messages and proceeded to the reported address.² While enroute, the troubleshooter observed CAL FIRE at [REDACTED] [REDACTED] (“Incident Location”, Figure 1 and Figure 2) near the EPSS-enabled, two-phase Peoria 1701 17kV Overhead Distribution Circuit (Figure 3) located within a Tier 2 HFTD and HFRA. Upon arrival, the troubleshooter observed CAL FIRE clearing the vegetation fire; the charred remains of a fallen tree (“Incident Tree”, Figure 4); burn marks, removed siding, and a melted electrical meter on the east exterior wall of a structure on the property (“Incident Structure”, Figure 5); and a single phase insulated service drop (“Incident Span”, Figure 2 **Error! Reference source not found.**) broken and on the ground, still energized, between wood pole SAP ID 101030403 (“Incident Pole 1”, source side) and a wood light pole (“Incident Pole 2”, load side). The Incident Tree appeared to have struck the down guy to Incident Pole 1, causing the Incident Span to break at the load-side connection to Incident Pole 2 (Figure 6).

Figure 6. Publicly available incident photo showing Incident Tree, branch of the Incident Tree resting on an Incident Pole 1 down guy, Incident Pole 1, and Incident Span posted to the Tuolumne County Fire Department's social media account (posted July 9, 2024; accessed August 29, 2024).
