# Preliminary Ignition Investigation Report

<b>Ignition Database Index:</b>	20240875N
<b>Electric Incident Investigation (EII) Number:</b>	N/A
<b>Incident Name:</b>	Rocky - 06 Jul 2024
<b>PG&amp;E Facility Ignition?</b>	Yes
<b>CPUC Reportable Ignition?</b>	Yes
<b>Date &amp; Time of Incident:</b>	July 6, 2024, at 0351 hours <sup>1</sup>
<b>Street Address:</b>	Old Gulch Road and Rocky Road
<b>City:</b>	San Andreas
<b>County:</b>	Calaveras
<b>Latitude/Longitude:</b>	38.1753471926, -120.5895900754
<b>State Responsibility Area (SRA) / Local Responsibility Area (LRA) / Federal Responsibility Area (FRA)</b>	State Responsibility Area (SRA)
<b>PG&amp;E Division:</b>	Stockton
<b>High Fire Threat District (HFTD):</b>	Tier 2
<b>High Fire Risk Area (HFRA):</b>	Yes
<b>EPSS Buffer:</b>	No
<b>Fire Index Area (FIA):</b>	320
<b>Fire Potential Index (FPI) Rating: FIA</b>	R4
<b>Fire Potential Index (FPI) Rating: Circuit</b>	R4
<b>Was there a PSPS event at the time of ignition?</b>	No

<b>Suspected Initiating Event:</b>	Vegetation
<b>Failure Driver:</b>	Contact from Object
<b>Failure Sub-driver:</b>	Contact – Vegetation
<b>Circuit:</b>	Calaveras Cement 1101
<b>Circuit Protection Zone:</b>	Calaveras Ce

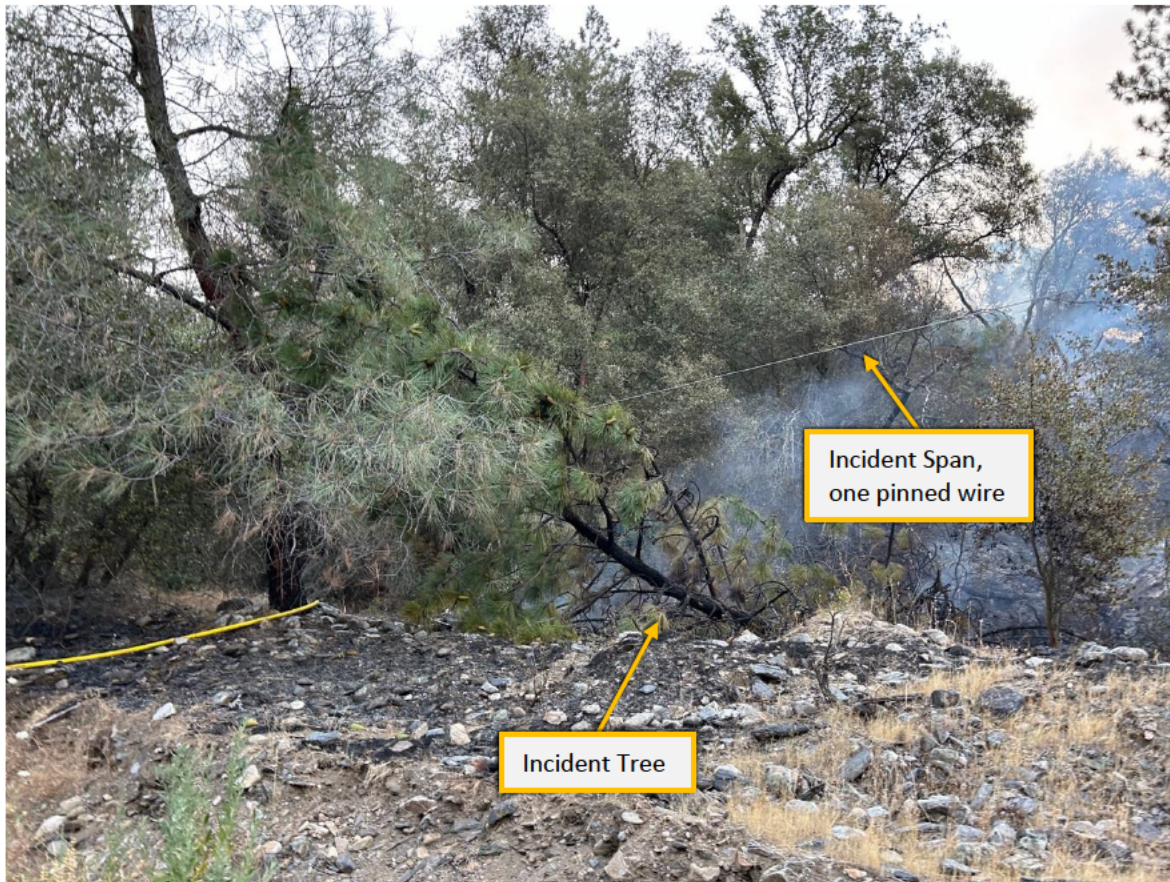
By 0551 hours, Troubleshooter #1 arrived at the Incident Location and observed CAL FIRE on-site. Troubleshooter #1 observed that an uprooted tree ("Incident Tree") had fallen into three phases of 2-ACSR primary overhead conductors ("Incident Span") spanning between fiberglass pole SAP ID 104174502 ("load-side pole") and wood pole SAP ID 101280385 ("source-side pole"). The Incident Tree broke two of three wires and was leaning on the third wire (Figure 2, Figure 3, Figure 4).<sup>3</sup>

Figure 2. Incident photo of fallen ponderosa pine tree (taken July 6, 2024).

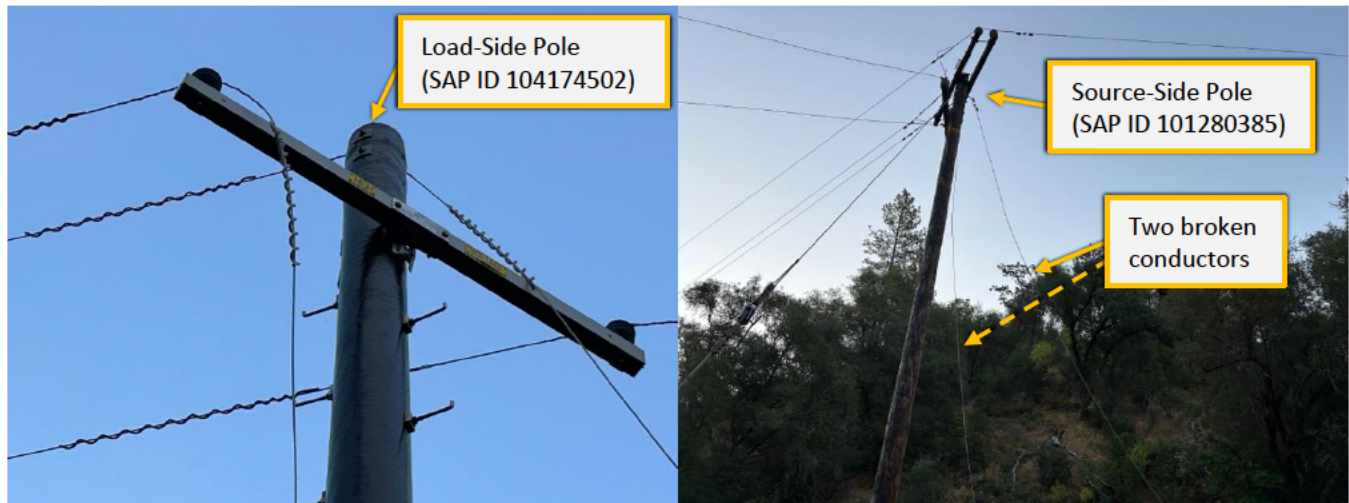
Figure 3. Incident photos of the load-side and source-side poles of the Incident Span (taken July 6, 2024).

At 0634 hours, Troubleshooter #1 created electric corrective (EC) notification no. 129177054 to replace a broken crossarm and 100 feet of wire on all three phases at the load-side pole. At 0928 hours, Troubleshooter #1 created EC notification no. 129177172 to replace a broken crossarm at the source-side pole. At 0915 hours, a PG&E repair crew began restoration work. At 0949 hours, Troubleshooter #1 completed a patrol of the Calaveras Cement 1101 12kV line between SW L3467 and Fuse Cutout (FUCO) L1193 (Figure 5, Figure 6) and reported no additional abnormalities. At 1000 hours, Troubleshooter #2 closed SW L3467 for the repair crew to begin work. By 1506 hours, the PG&E repair crew completed all repairs and restored service to all remaining impacted customers.

Type	Number	Description	Priority	Date Identified	Due Date
EC Notification	129177054	Replaced crossarm on pole 104174502 (load-side pole) and 100 ft of wire on all three phases	A	July 6, 2024	N/A
EC Notification	129177172	Removed crossarm on pole 101280385 (source-side pole)	A	July 6, 2024	N/A

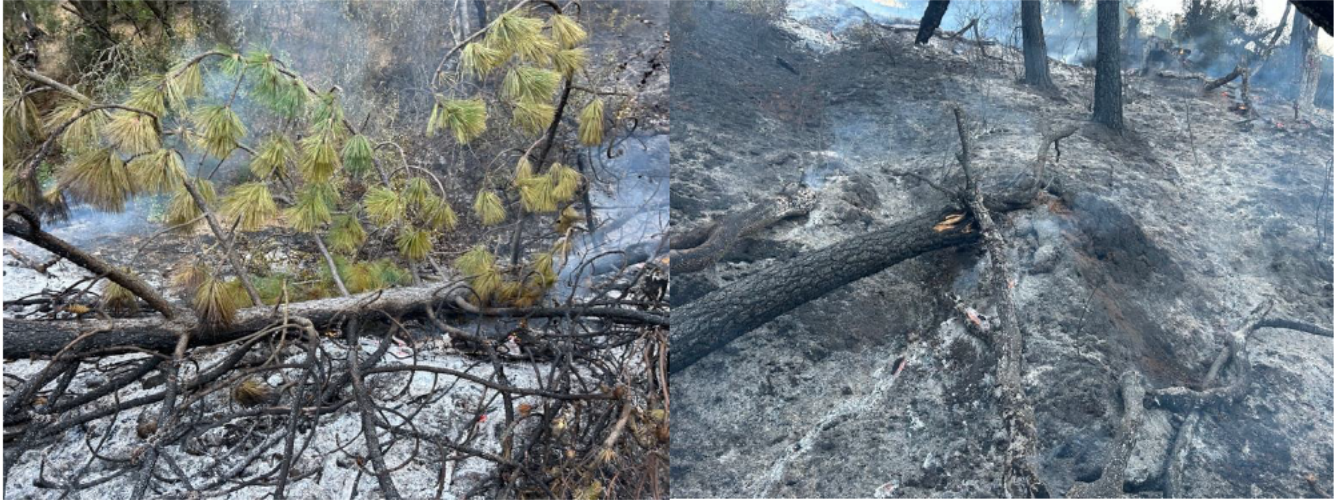
The treefall event ignited a 4.5-acre fire near the load-side pole of the Incident Span. The fire was suppressed by CAL FIRE. The incident resulted in a sustained outage that affected 880 customers for a total duration of 105 minutes, 54 customers for a total duration of 6 hours and 25 minutes, and 116 customers for a total duration of 11 hours and 15 minutes.

Figure 4. Incident photos showing fallen ponderosa pine tree and burn area (taken July 6, 2024).

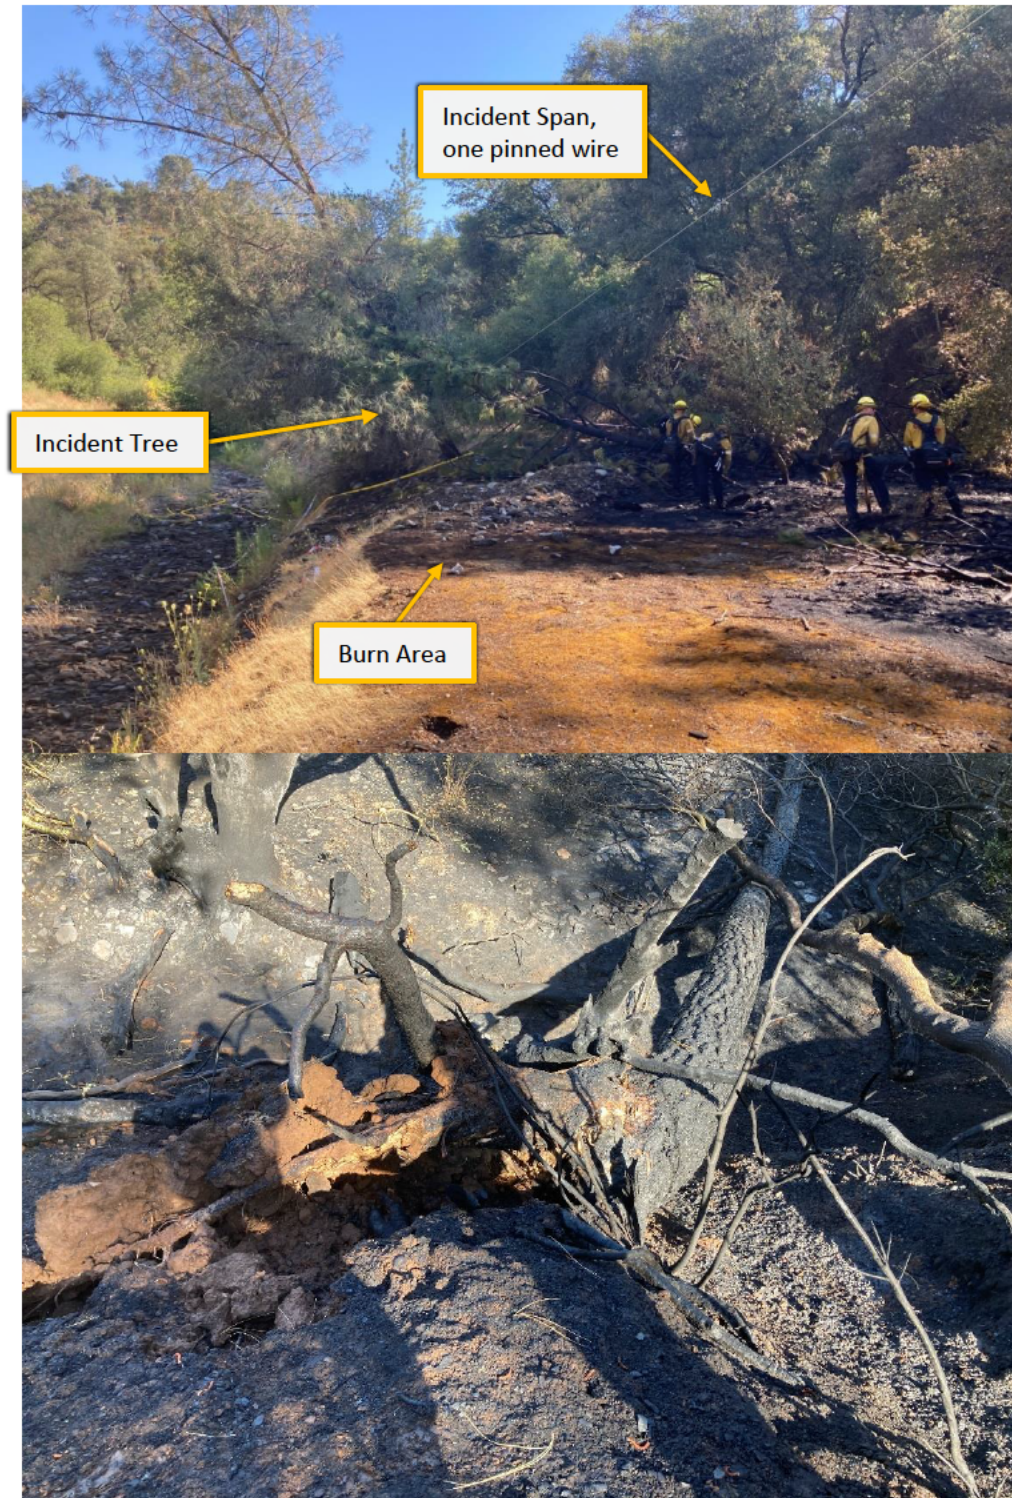
On July 8, 2024, PG&E Vegetation Management ("VM") patrolled the Incident Location and observed that the fallen tree was an approximately 80-foot tall ponderosa pine with a 16-inch diameter at breast height (DBH). The tree was located to the east of the conductors of the Incident Span (Figure 7, Figure 8), with a tree-to-conductor clearance of approximately 50 feet. Based on their observations, VM determined that the potential causal factors contributing to the tree uprooting included:

1. The tree was growing on a 50% slope with poor soil conditions.
2. The tree canopy grew primarily on the conductor side due to competition with surrounding ponderosa pine trees.
3. The tree had a heavy cone load at the time of the incident.
4. The excessive heat from the days leading to the ignition incident may have increased stress on the tree.

Figure 7. Photos of fallen tree on Incident Span (top) and close-up of tree roots (bottom) (Vegetation Management, taken July 6, 2024).

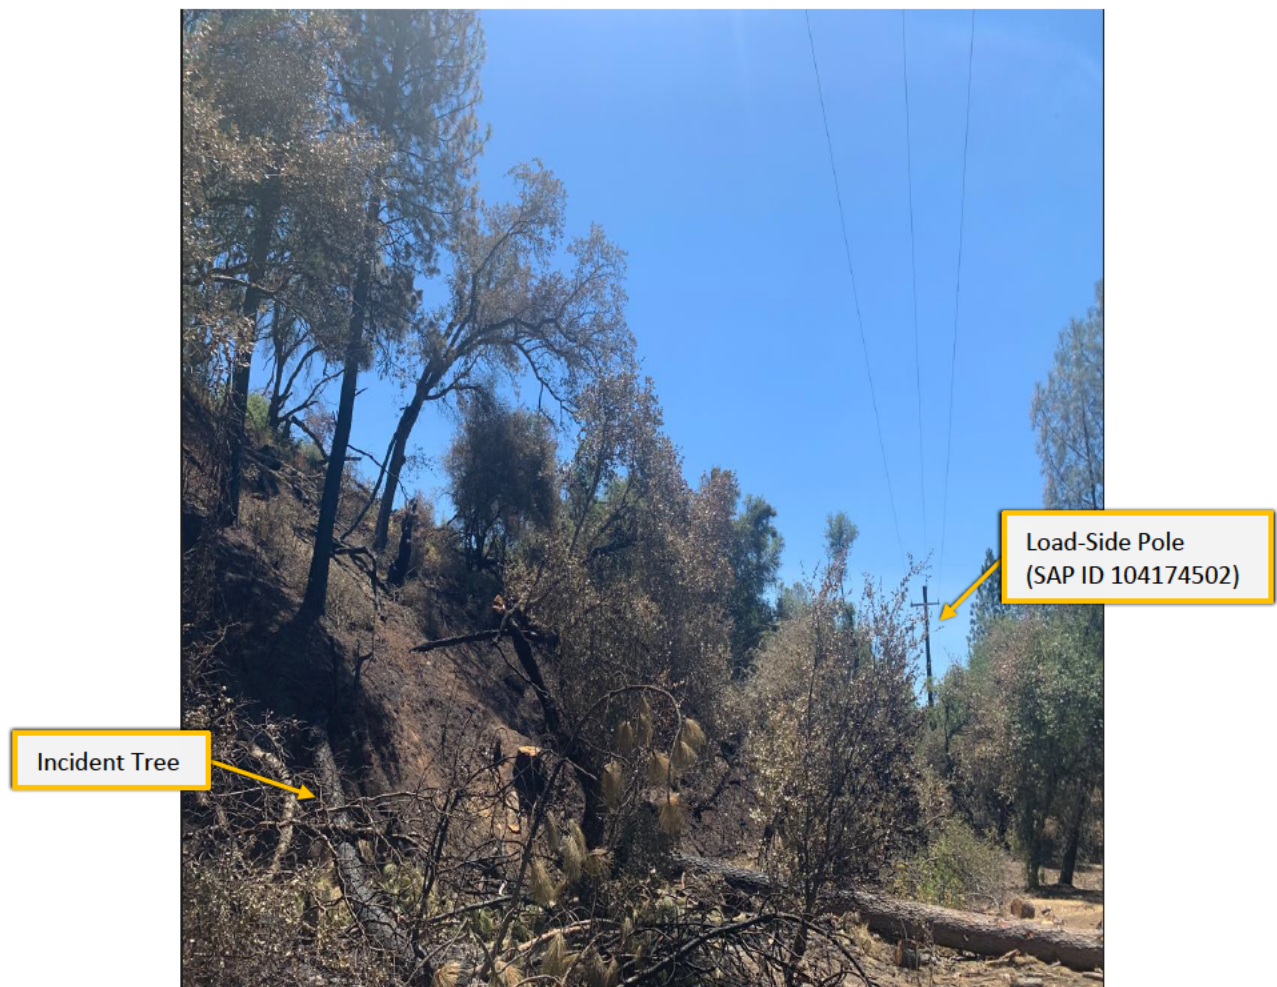
Since the Incident Tree likely did not have any visible defects and the failure mode was uprooting, it is unlikely that past Limited Visual Assessment (Level 1)<sup>4</sup> inspections during Annual and Second Vegetation Management Patrols would have identified conditions that would have been required to prescribe mitigation. Even in light of the 50% slope, it is unclear whether the Basic Assessment (Level 2)<sup>5</sup> protocol would have led to prescribing mitigation at the Incident Tree in the absence of other obvious visual defects.

Figure 8. Photo of ignition site with Incident Tree and load-side Pole (Vegetation Management Incident Extent of Condition (XoC) Patrol Report).

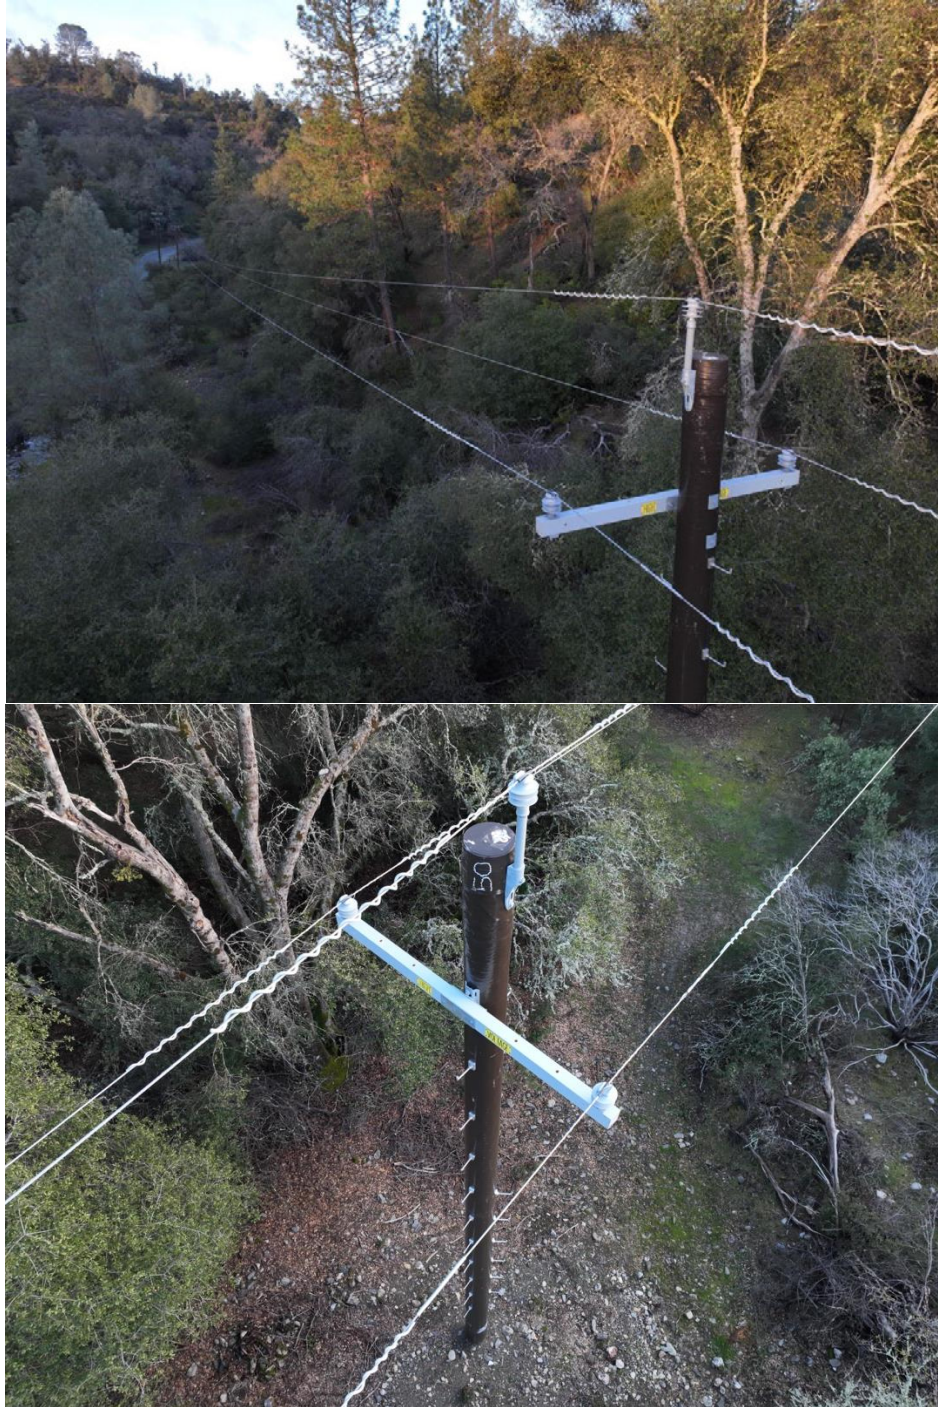
EC notification no. 126486820 was pending at the time of this ignition incident. The notification flagged birdcaging<sup>7</sup> near a splice on one phase of the Incident Span.

<b>Load Side Structure</b>	104174502	
<b>Info / Inspection</b>	<b>Most Recent Date</b>	<b>Findings</b>
Install Date:	May 8, 2023	45-foot Class 3 fiberglass pole
Inspection:	June 30, 2023	Inspector noted birdcaging at a splice on the primary conductors, created EC notification no. 126486820. No issues found with pole, framing, or vegetation (Figure 10).
	May 14, 2020	Last enhanced GO165 inspection for ancestor pole SAP ID 101280386.
Corrective History:	June 30, 2023	EC notification no. 126486820 (priority E) created to repair birdcaging at a compression splice on the primary conductors. Current pole was installed May 8, 2023, but due to outdated photos from iHawk taken on April 5, 2023, pole was re-flagged for replacement. Work was not complete at the time of the ignition incident.
Aerial Inspection Records:	January 31, 2024	"Conductor bird caging at splice." (Figure 11) No other abnormal conditions noted.

Figure 11. Pre-incident photos of load-side pole (SAP ID 104174502) from recent aerial inspection (taken January 23, 2024).

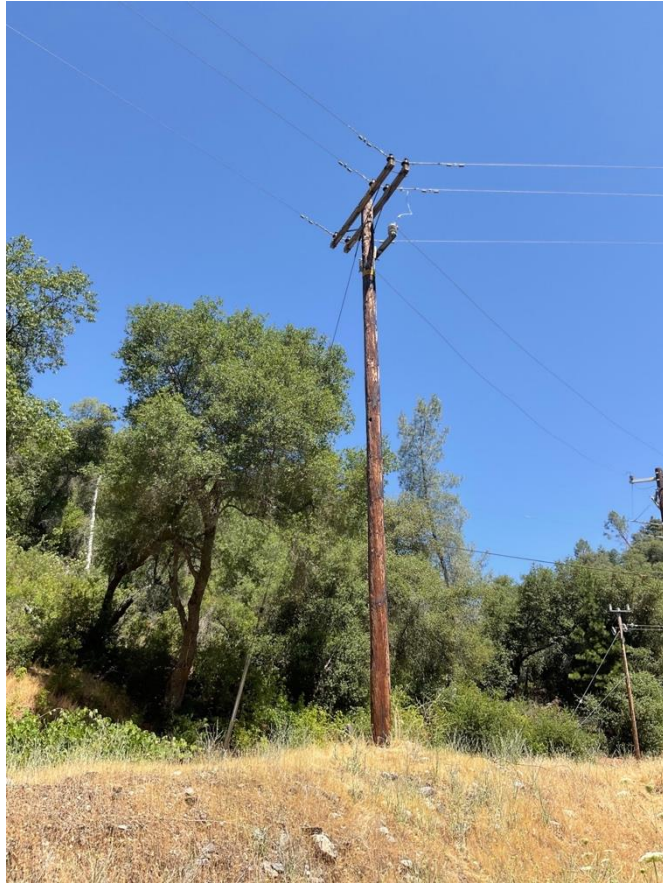
<b>Source Side Structure</b>	101280385	
<b>Info / Inspection</b>	<b>Most Recent Date</b>	<b>Findings</b>
Install Date:	1947 (GIS installation date)	40-ft Class 4 Douglas Fir pole
Inspection:	June 30, 2023	Inspector added comments to the open EC notification no. 119027625 (Figure 12).
	June 4, 2018	-
Corrective History:	May 13, 2020	EC notification no. 119027625 (priority E) created to fix incorrectly installed connector on armor rod and a cracked insulator on the phase closest to the road. August 28, 2020: Connectors installed on armor rod. July 29, 2022: Field Safety Assessment, noted a tap installed on armor rod and small crack on road phase insulator.

June 30, 2023: Field Safety Assessment, noted damage to insulator, splice, tie wire, pole (woodpecker), armor rod, and guy insulator. November 26, 2023: Work completed.
Aerial Inspection Records:	March 20, 2024	No abnormal conditions observed
VM Inspection:	May 21, 2024	Span inspection (OneVM-035626). No findings at the Incident Span.
Pole Intrusive Test:	May 28, 2014	Passed, top/bottom condition: fair Notification no. 203312020
WSIP Inspection:	February 7, 2019	No findings

*Figure 12. Pre-incident photo of source-side pole (SAP ID 101280385) from recent inspection (taken June 30, 2023).*
