## Preliminary Ignition Investigation Report

Ignition Database Index:	20240881
Electric Incident Investigation (EII) Number:	N/A
Incident Name:	N/A
PG&E Facility Ignition?	Yes
CPUC Reportable Ignition?	Yes
Date & Time of Incident:	July 6, 2024 at 1732 hours
Street Address:	[REDACTED]
City:	Forest Ranch
County:	Butte
Latitude/Longitude:	[REDACTED]
State Responsibility Area (SRA) / Local Responsibility Area (LRA) / Federal Responsibility Area (FRA)	SRA
PG&E Division:	North Valley
High Fire Threat District (HFTD):	Tier 3
High Fire Risk Area (HFRA):	Yes
EPSS Buffer:	No
Fire Index Area (FIA):	280
Fire Potential Index (FPI) Rating: FIA	R4
Fire Potential Index (FPI) Rating: Circuit	R4
Was there a PSPS event at the time of ignition?	No
Suspected Initiating Event:	Vegetation
Failure Driver:	Contact from Object
Failure Sub-driver:	Contact - Vegetation
Circuit:	Oro Fino 1102
Circuit Protection Zone:	Oro Fino 110265932
Nominal Voltage:	750 V
Pole SAP Equipment ID:	104117211

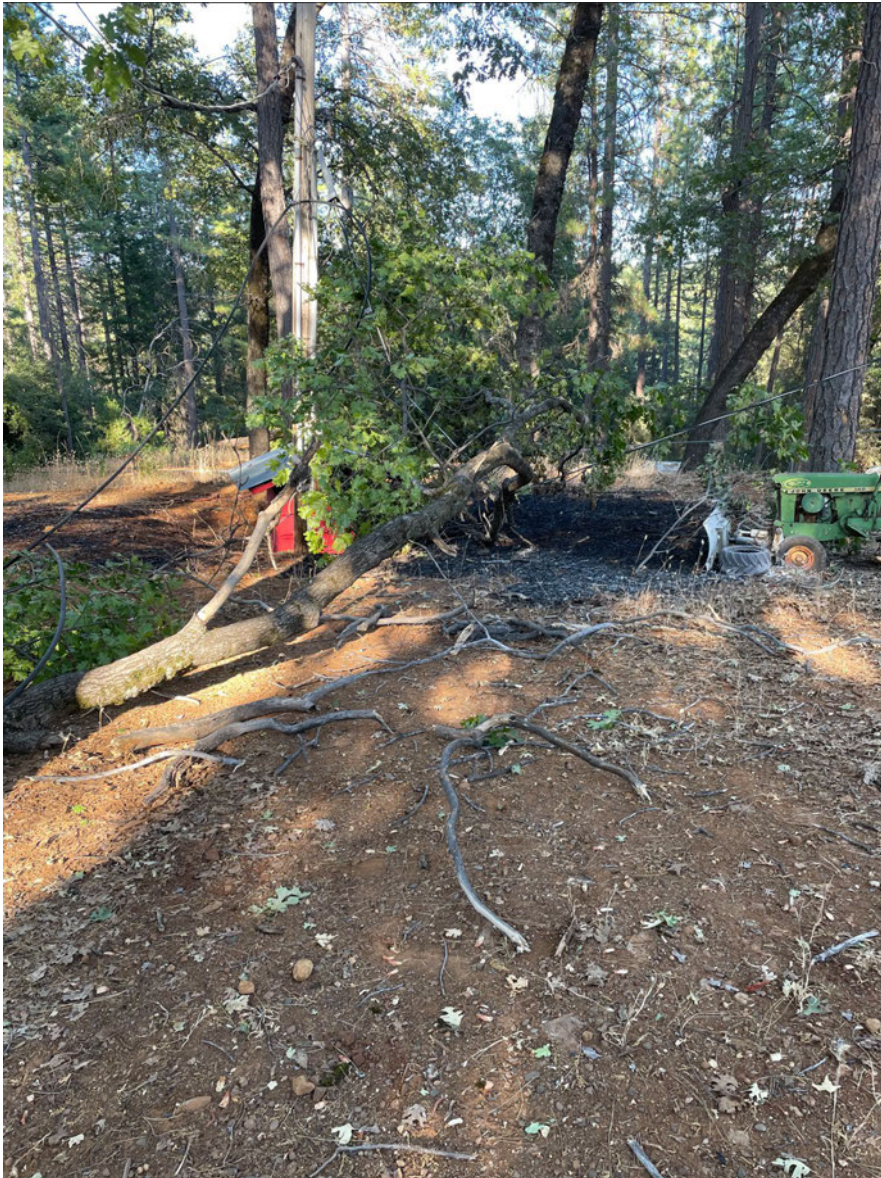
<b>Fire Size:</b>	10' x 20'
<b>FAS Field Remarks:</b>	Cust tree branch fell on service at cust owned pole causing service to break and damaged cust weatherhead. Started small veg fire approx 10 by 20 fire suppressed made safe and cleared service. Created disconnect tags for both meters and cust will need to make repairs before we can reconnect
<b>HAWC Summary:</b>	No HAWC Alert or ID
<b>Injuries / Fatalities / Property Damage / Media Attention:</b>	No/No/Yes/No
<b>Weather Conditions:</b>	The high temperature for the day near the Incident Locaion was 104.5°F at 16:30 and the low temperature was 83.1° at 02:30. The relative humidity was as high as 44% at 06:40 and as low as 17% at 11:00. The strongest wind speed was 10.9 mph out of the W at 14:50.
<b>Red Flag Warning (RFW) / High Wind Warning (HWW):</b>	No/No
<b>911 Standby Relief Time:</b>	36 minutes
<b>OIS #:</b>	TR7142846
<b>ILIS #:</b>	N/A
<b>FAS #:</b>	T006440662

*Figure 1 Troubleshooter Photo taken on July 6, 2024, showing the customer pole, the service line, the small red pump structure, and the tree branch on the service conductor.*

No corrective work identified for PG&E assets. Two disconnect tags were created for the two smart meters, requiring customer repair work prior to PG&E restoring service.

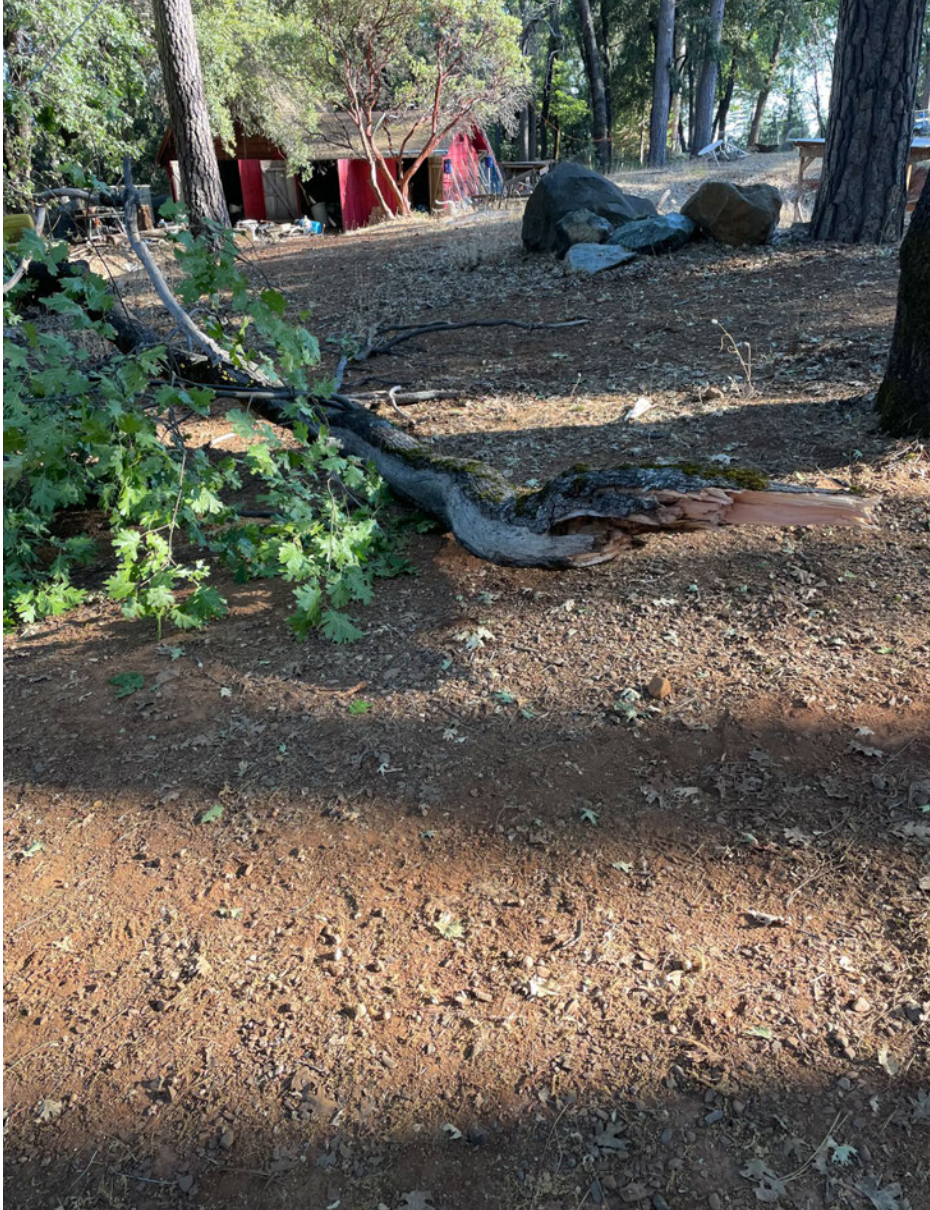
On the afternoon of July 9, 2024, in response to this incident, a contract vegetation management inspector visited the Incident Location and identified the failed limb as coming from a 64-foot tall black oak tree (Diameter at Breast Height 30"). The subject tree was rooted 26 feet away from the service conductor and was last inspected two and a half months earlier on April 23, 2024. The detached limb was 11-inches in diameter and had broken off the tree from a height of 40 feet from the base of the tree. The branch orientation at the site of the failure indicates that the limb was hanging directly over the service line prior to failure (see Figure 10). The larger supporting stem exhibits a large, external decaying wound associated with a previous major limb failure. Foliage in the remaining tree exhibits low vigor.

*Figure 2 Troubleshooter photo taken July 6, 2024 showing the break surface of the fallen branch.*

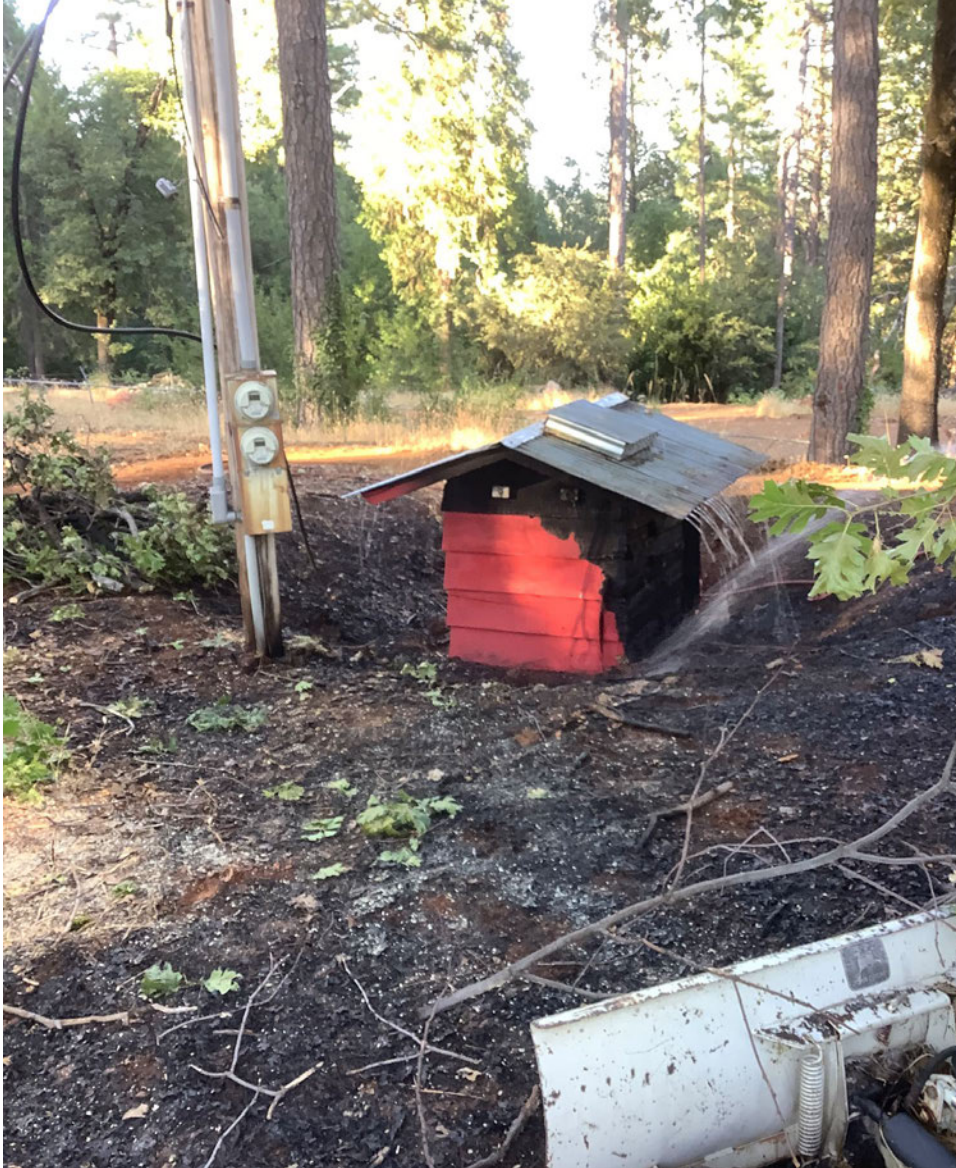
The fire was limited to a 10-foot by 20-foot area of burned leaves and brush. The small wood structure housing the pumping equipment and the customer-owned pole was also slightly burned.

*Figure 3 Troubleshooter Photo taken July 6, 2024 showing the small pump structure and the customer pole with the 2 PG&E SmartMeters™.*

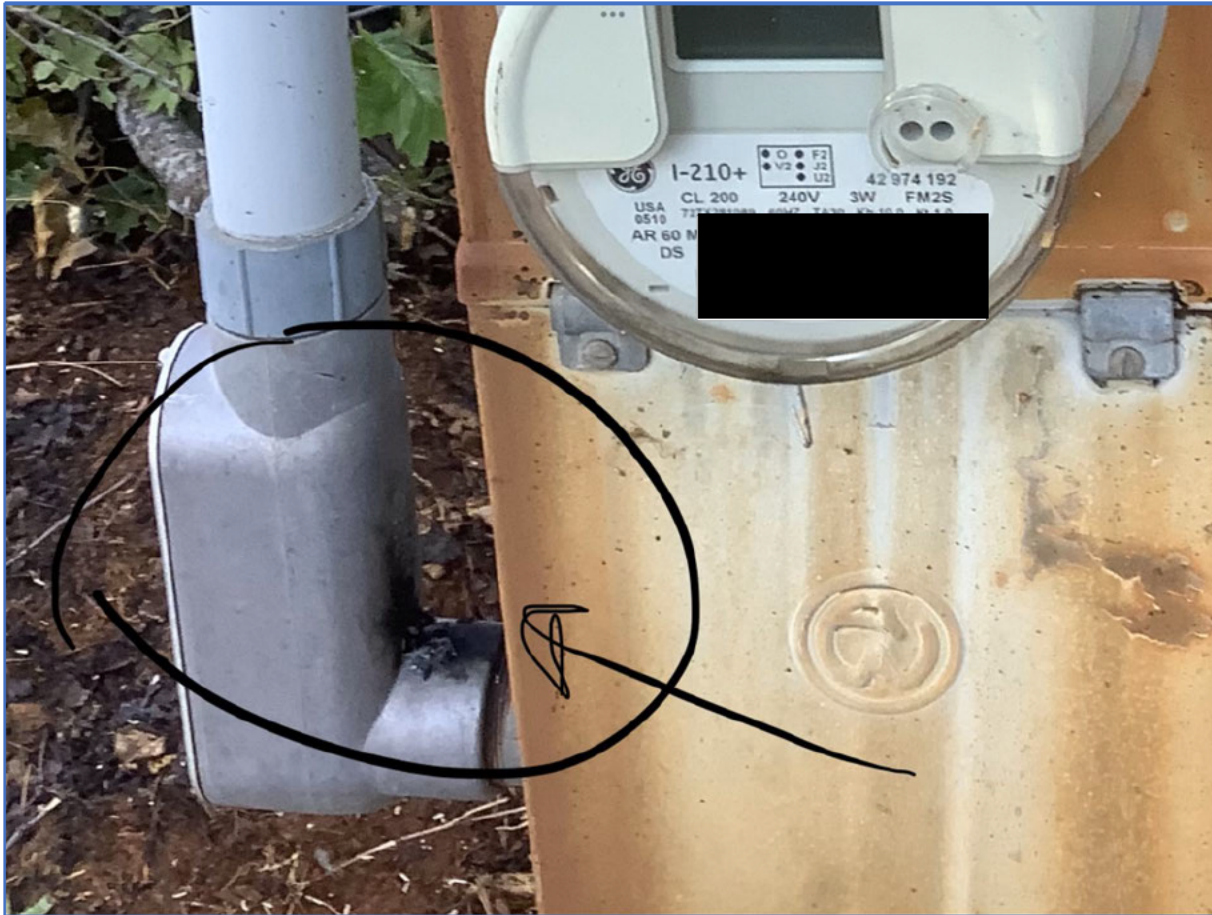
Figure 4 Photo by Troubleman on July 6, 2024 indicating observed arcing marks next to the meter panel.

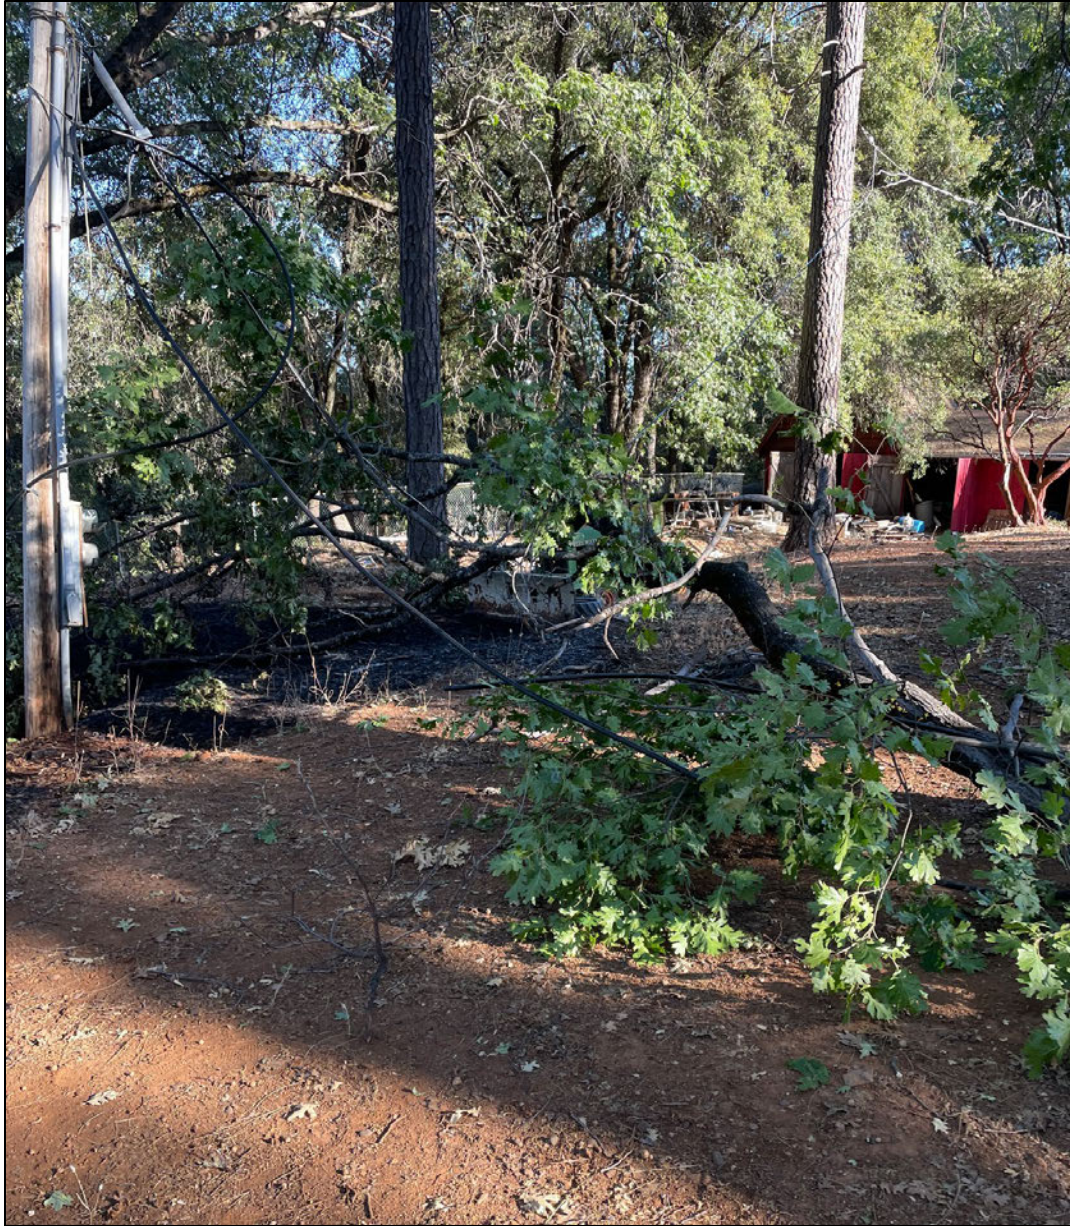
Hazard	Vegetation Contact	Sub-Hazard	Fallen Branch
Target	Fallen tree branch causing broken conductor		
Barrier	Expected vs. Observed Performance	Why did the barrier not prevent the ignition event? (See <a href="#">ICF Codes</a> )	Opportunity
Barriers that were Assessed as Opportunities			
Service Breakaway Disconnect for Overhead Services	Expected Performance: Service conductor breakaway may have prevented sparking and ignition. Observed Performance: Barrier did not exist		Tree connects were not equipment with service conductor breakaways.

*Figure 5 Troubleshooter Photo taken July 6, 2024 showing the customer pole with the 2 PG&E SmartMeters™ and one of the two tree-connects.*

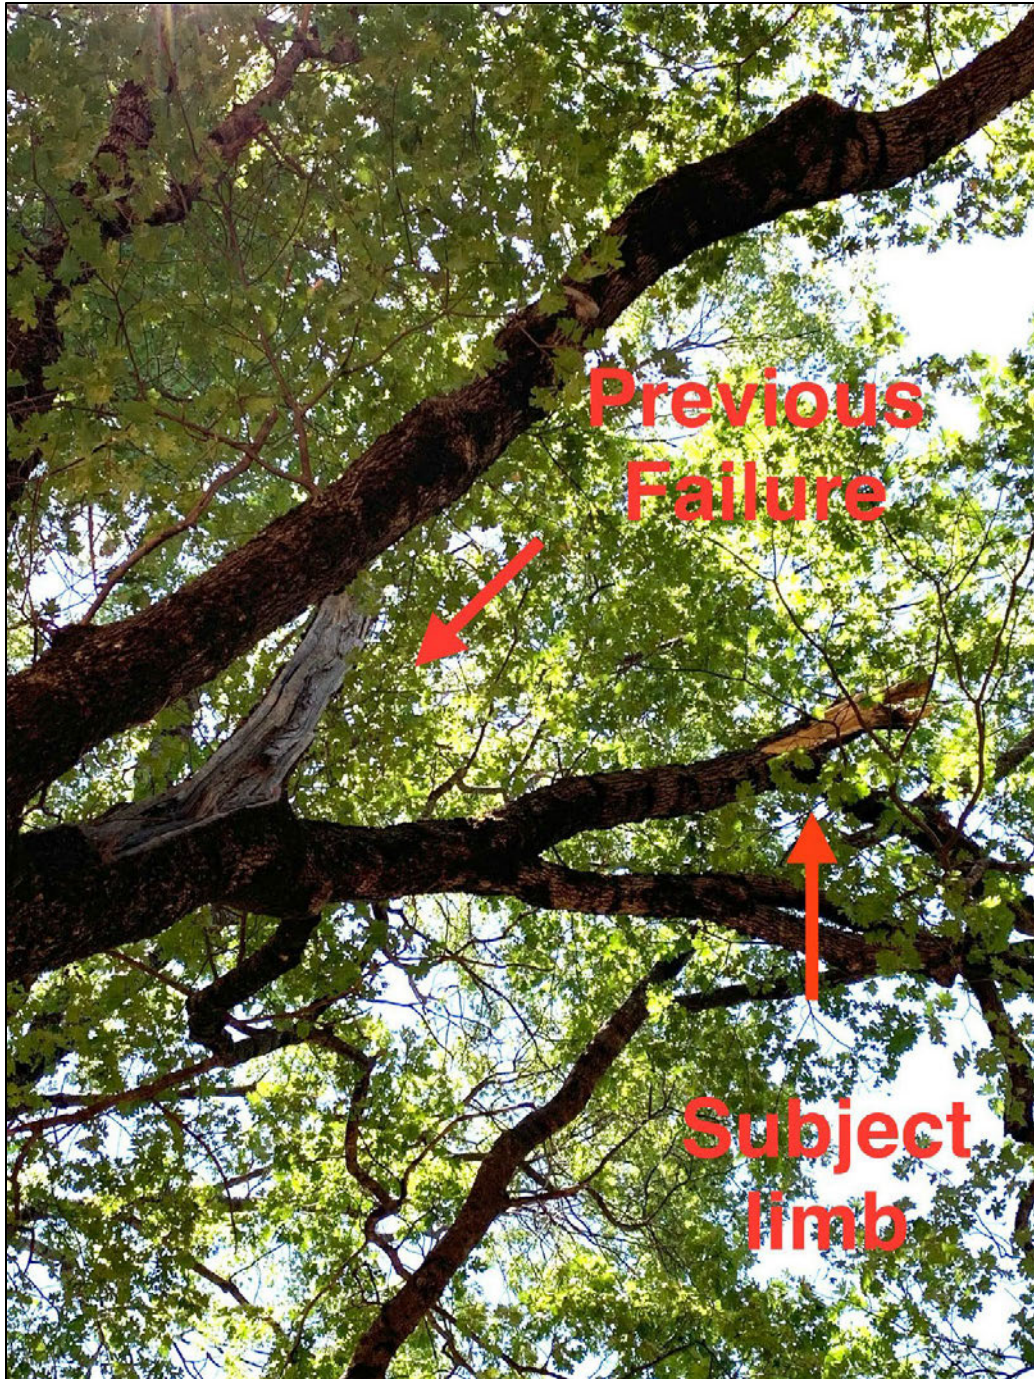
Figure 6 Photo #5 from the Vegetation Management Site Inspection Report on July 9 showing the location of the fresh limb break (Marked as Subject Limb), and the previous limb failure point (Marked as Previous Failure).

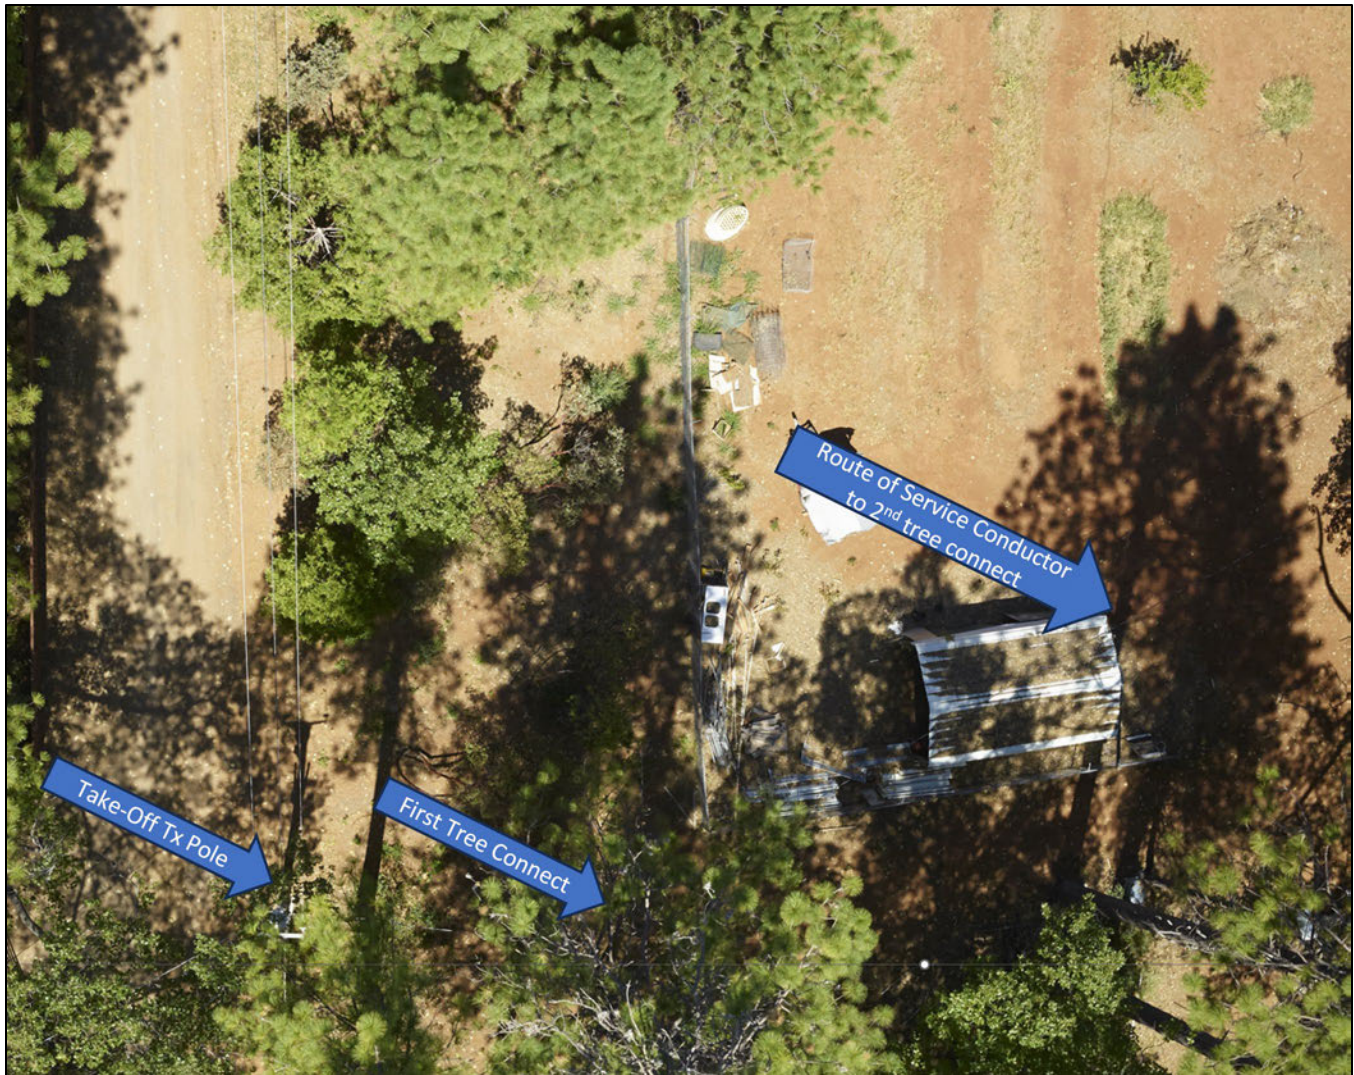
Figure 8 2019 Sharper Shape image showing the route of the service conductor from the Take-Off Tx Pole. 2nd Tree connect is outside of this view to the right.

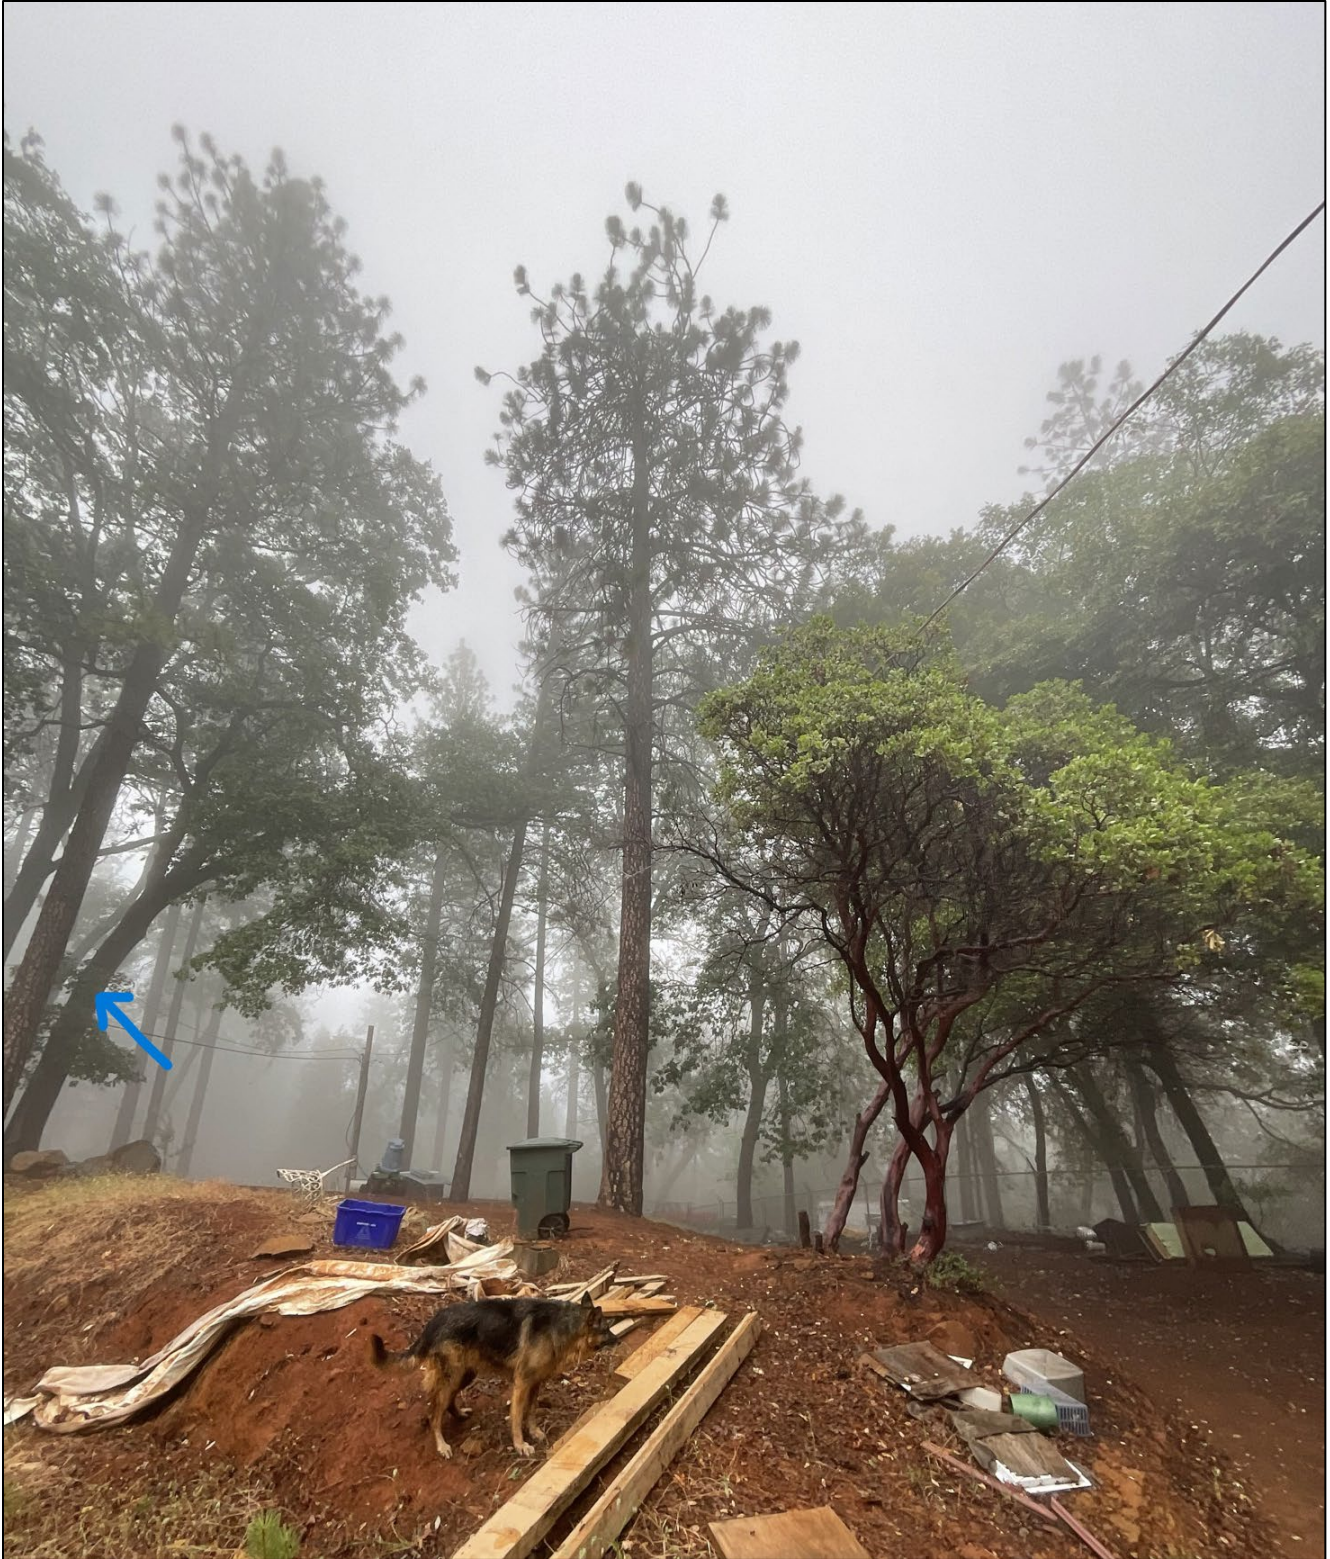
Figure 9 Photo from map correction tag 123814441 on June 10, 2022, showing the last tree connect, the customer pole and the small pump structure. The blue arrow is pointing to the subject tree.

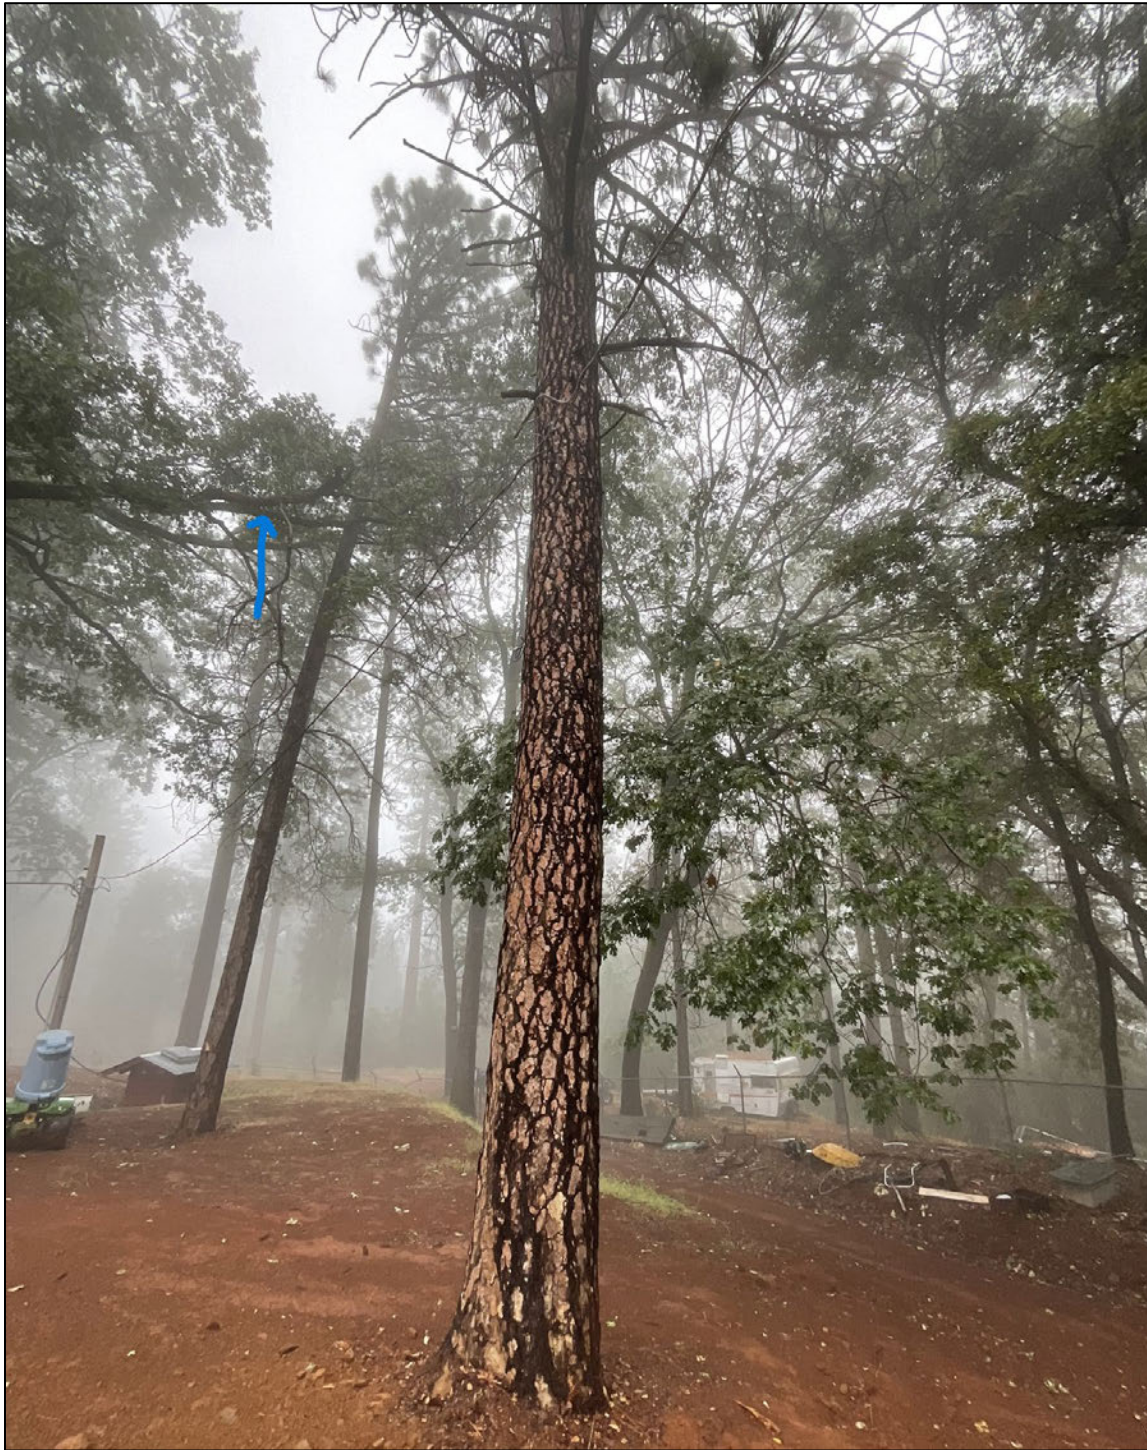
Figure 10 Photo from map correction tag 123814441 on June 10, 2022, showing the last tree connect, the customer pole and the small pump structure. The blue arrow is indicating the branch that broke free and fell.
