## Preliminary Ignition Investigation Report

<b>Ignition Database Index:</b>	20240905
<b>Electric Incident Investigation (EII) Number:</b>	NR240709A
<b>Incident Name:</b>	Hook – 09 Jul 2024
<b>PG&amp;E Facility Ignition?</b>	Yes
<b>CPUC Reportable Ignition?</b>	Yes
<b>Date &amp; Time of Incident:</b>	July 9, 2024 1846 hours
<b>Street Address:</b>	17985 Hooker Creek Road
<b>City:</b>	Cottonwood
<b>County:</b>	Tehama
<b>Latitude/Longitude:</b>	40.3182, -122.3316
<b>State Responsibility Area (SRA) / Local Responsibility Area (LRA) / Federal Responsibility Area (FRA)</b>	State Responsibility Area (SRA)
<b>PG&amp;E Division:</b>	North Valley
<b>High Fire Threat District (HFTD):</b>	Tier 2
<b>High Fire Risk Area (HFRA):</b>	Yes
<b>EPSS Buffer:</b>	N/A
<b>Fire Index Area (FIA):</b>	246
<b>Fire Potential Index (FPI) Rating: FIA</b>	R3
<b>Fire Potential Index (FPI) Rating: Circuit</b>	R3
<b>Was there a PSPS event at the time of ignition?</b>	No
<b>Suspected Initiating Event:</b>	Equipment – PG&E

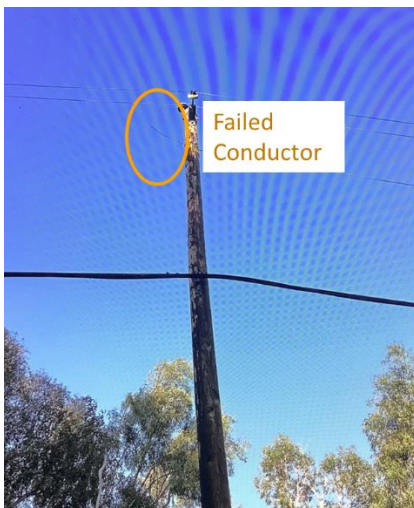
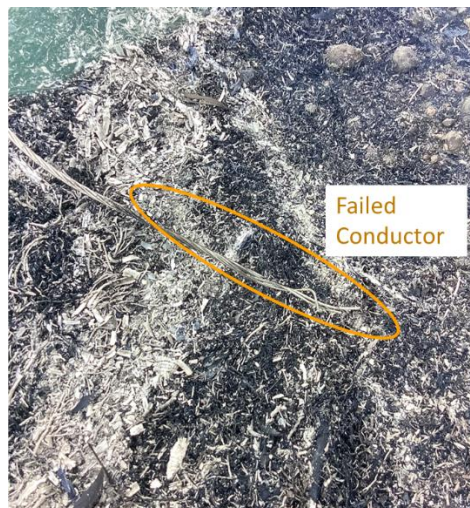
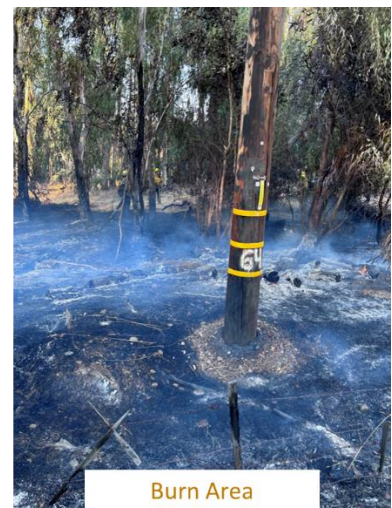
At 1926 hours, Troubleshooter #1 arrived at 17185 Hooker Creek Road (“Incident Location”) and reported a wire down four spans north of capacitor bank C251 (see Figure 1. EDGIS map of Cottonwood 1103 Circuit up to Fuse Saver 182930., Figure 3). Troubleshooter #1 cut a jumper on pole SAP ID 101510120 to enable the Distribution Control Center (“DCC”) to restore power to 160 customers once a patrol was complete up to that jumper. At 1939 hours, Troubleshooter #3 reported that Troubleshooters #2 and #3 patrolled the line from the Fuse Saver 182930 up to LR 1616 and that no trouble was found between the Incident Location and LR 1616. The troubleshooters did not identify branches on the ground or a bird that might have caused the wire to come down.

Figure 3. Incident photos taken July 9, 2024 showing failed conductor from Pole SAP ID 101510120 (left), failed conductor on ground (center), and burn area around pole (right).

Priority A EC Notification #129193940 was created on July 9, 2024, to replace one span of #4 ACSR conductor. A PG&E crew replaced 200 feet of all three phases of conductor and reframed the tri-kit structure to a crossarm on the day of the incident.

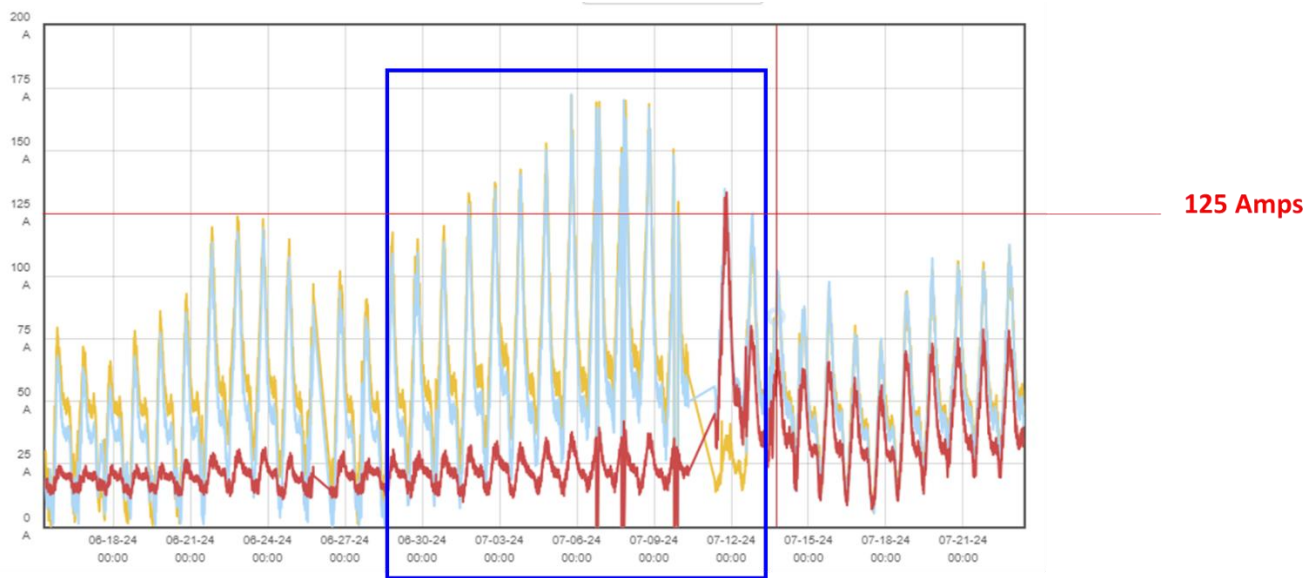
From July 6 to July 7, 2024, LR 1616 opened three times likely due to overload based on ILIS records and comments from DCC<sup>1</sup>. In each of these cases, no trouble was found. The controller on LR 1616 was upgraded on July 10, 2024, the day after the incident, which wiped sequence of events data from the device. However, Distribution System Protection reviewed current readings from the SCADA data historian and identified the highest recorded current magnitude on phase A as 171.9 Amps and 172.5 Amps on Phase C, which may have crossed EPSS pickup targets (see Figure 4) on the days prior to the incident. On the day of the incident, the highest recorded current was approximately 150 Amps.

Figure 4. Current at LR 1616 in from July 5 to July 10, 2024. Conductor is designed for maximum of 125 Amps and LR 1616 was set to trip at 180 Amps.

- Submitted CAP 129518492 for overdue tag non-conformance identifying the broken conductor at the likely point of failure.
- North Valley Distribution Planning Engineers have a project planned to reconductor the overloaded section of the Cottonwood 1103 Circuit to be completed before summer 2025. No CAP was created for this as the project has already been approved.

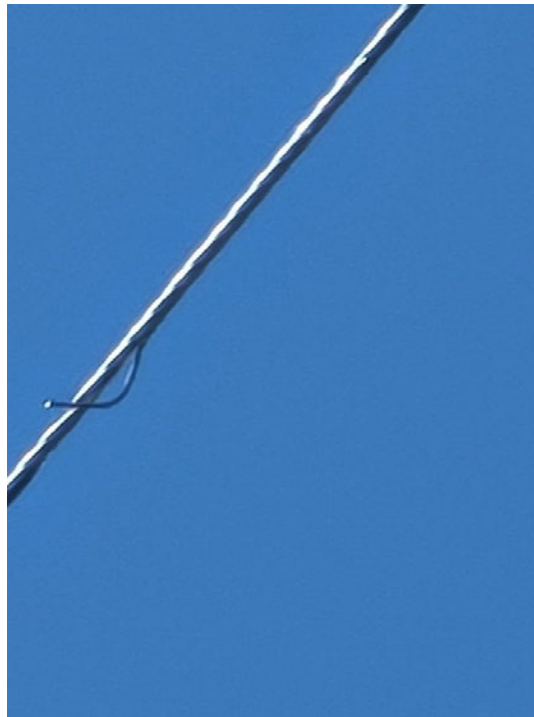
There was an outstanding tag (Priority E EC Notification #126390579) on pole SAP ID 101510120 created during the Distribution Enhanced Inspection on June 16, 2023, for a broken/damaged conductor. Repair was required by June 14, 2024, so was overdue at the time of the incident. The EC notification noted that a conductor on the “field side” had one strand broken (see Figure 5). The inspection and EC notification did not identify where along the span the strand of conductor was broken, however, StreetSmart imagery from July 8, 2022, shows a reflection off of the same conductor that separated during this incident (see Figure 6). This reflection is in the same approximate location that the conductor failed (see Figure 3).

Figure 5. Photo from EC Notification #126390579 created on June 16, 2023, showing broken strand on conductor between subject poles.

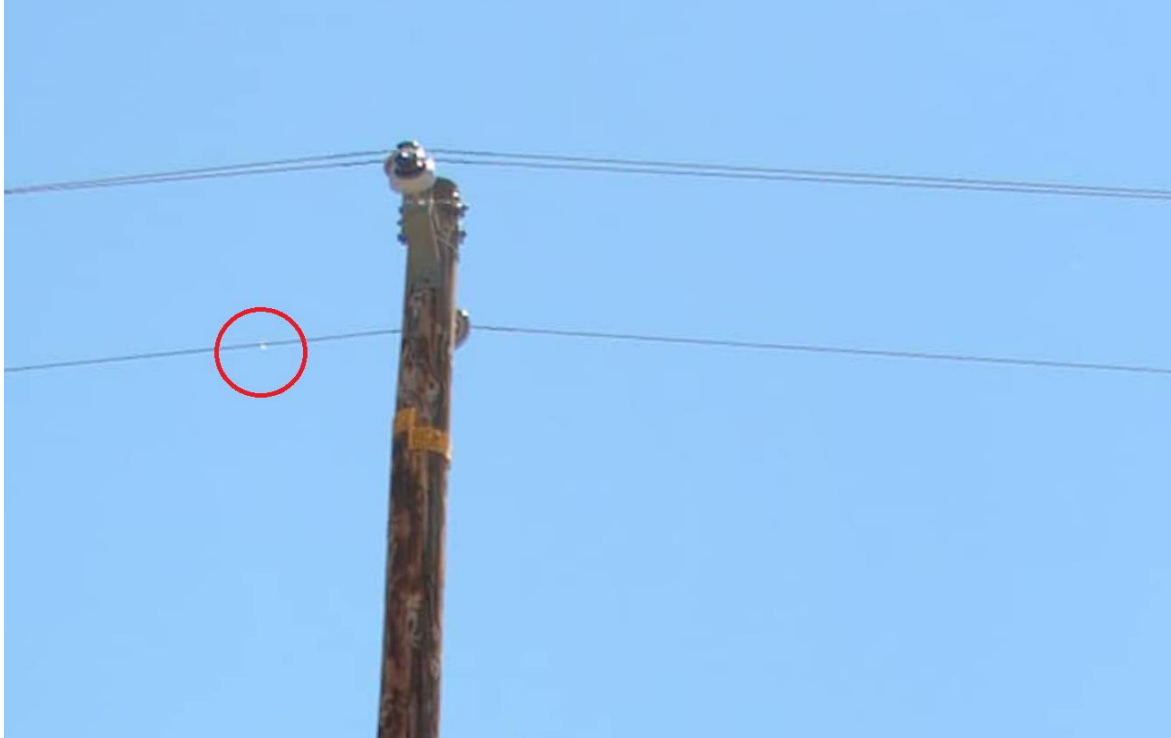
Figure 6. StreetViewer image of pole SAP ID 101510210 from July 8, 2022, showing reflection on conductor. This defect is at the same approximate location on the same span where the conductor broke in this incident.

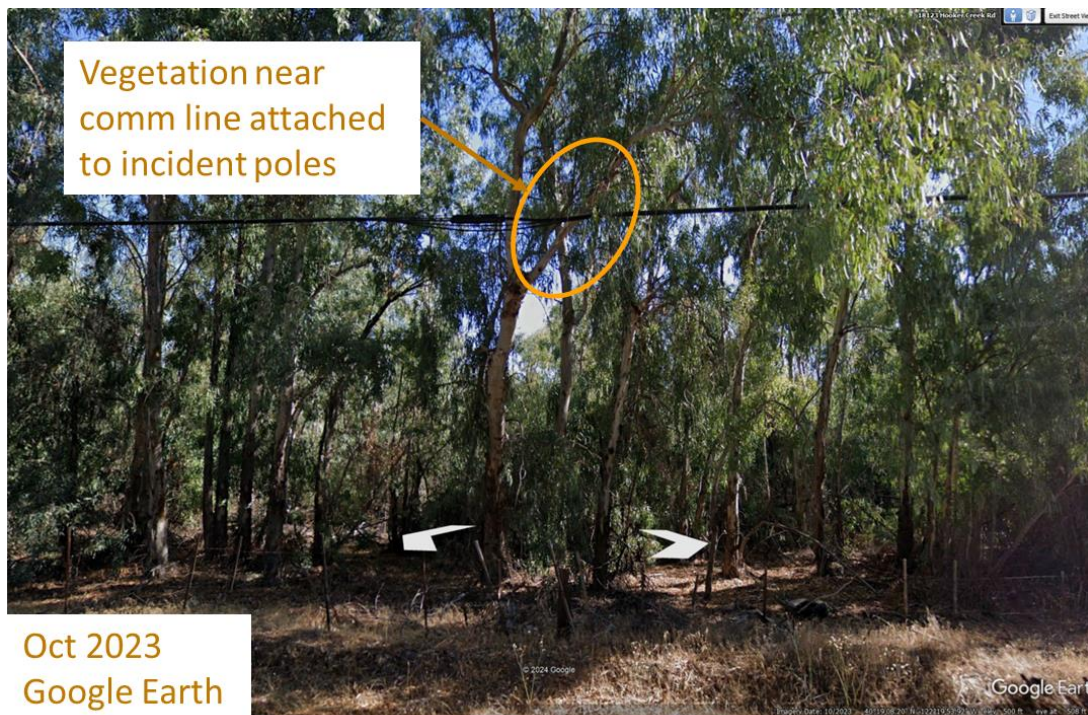
Troubleshooter #3 reported that there may have been a eucalyptus branch north of pole SAP ID 101510125 in contact with a communication line that could have caused “load shock” on the pole (see Figures 2 and 7). An Asset Management Specialist from PG&E Vegetation Asset Strategy and Analytics visited the Incident Location on July 24, 2024 to look for potential for vegetation issues on the communication line. The weather on July 24 was 102°F with sustained wind of 20 mph and gusts up to 30 mph. The Asset Management Specialist observed negligible movement in pole SAP ID 101510125 of the attached conductors given higher winds at the time onsite than on the day of the incident. The Asset Management Specialist assessed that there would be minimal chance for a load shock event to occur in the location that it did.

Figure 7. Vegetation near communication line north of pole SAP ID 101310125.

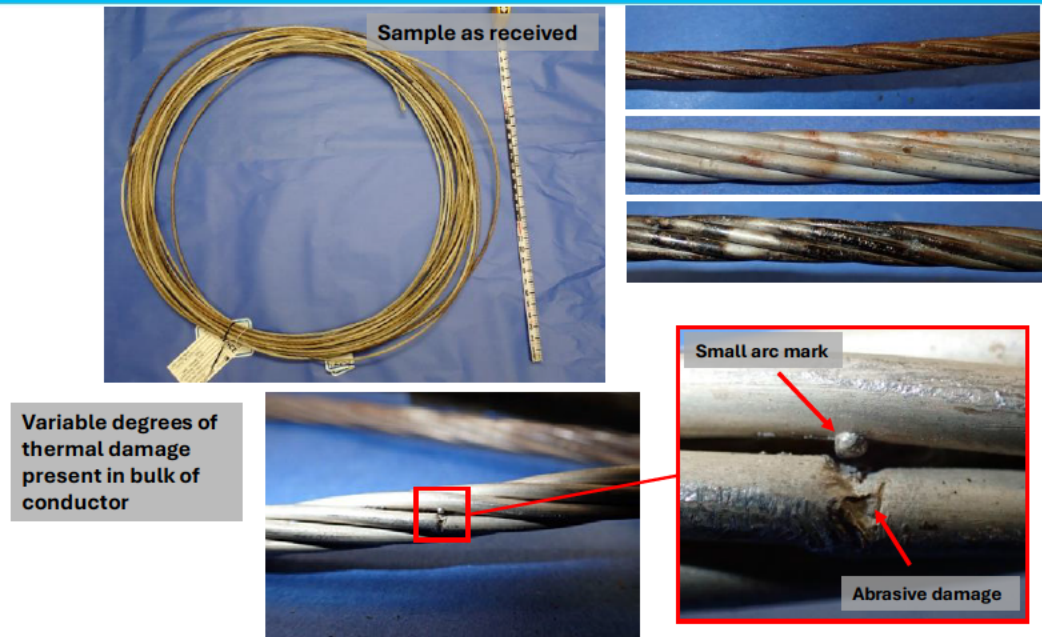
Applied Technology Services (“ATS”) received 200 feet of conductor collected by the repair crew and conducted an initial visual examination to document the failed component. CAL FIRE retained a section of conductor, which is suspected to have included the failed ends of conductor. The portion of conductor that ATS received showed variable degrees of thermal damage, likely from the failed conductor laying in burning vegetation (see Figure 8).

Figure 8. ATS Visual Inspection and Documentation.
