## Preliminary Ignition Investigation Report

<b>Ignition Database Index:</b>	20240909N
<b>Electric Incident Investigation (EII) Number:</b>	N/A
<b>Incident Name:</b>	Springs
<b>PG&amp;E Facility Ignition?</b>	Yes
<b>CPUC Reportable Ignition?</b>	Yes
<b>Date &amp; Time of Incident:</b>	July 09, 2024 @1844 hours
<b>Street Address:</b>	approximately 0.4 mile south of 3900 Deerwood Dr
<b>City:</b>	Ukiah
<b>County:</b>	Mendocino
<b>Latitude/Longitude:</b>	39.18382, -123.15567
<b>State Responsibility Area (SRA) / Local Responsibility Area (LRA) / Federal Responsibility Area (FRA)</b>	State Responsibility Area
<b>PG&amp;E Division:</b>	Humboldt
<b>High Fire Threat District (HFTD):</b>	Tier 2
<b>High Fire Risk Area (HFRA):</b>	Yes
<b>EPSS Buffer:</b>	No
<b>Fire Index Area (FIA):</b>	154
<b>Fire Potential Index (FPI) Rating: FIA</b>	R4
<b>Fire Potential Index (FPI) Rating: Circuit</b>	R4
<b>Was there a PSPS event at the time of ignition?</b>	No
<b>Suspected Initiating Event:</b>	Contact from Object

## Executive Summary

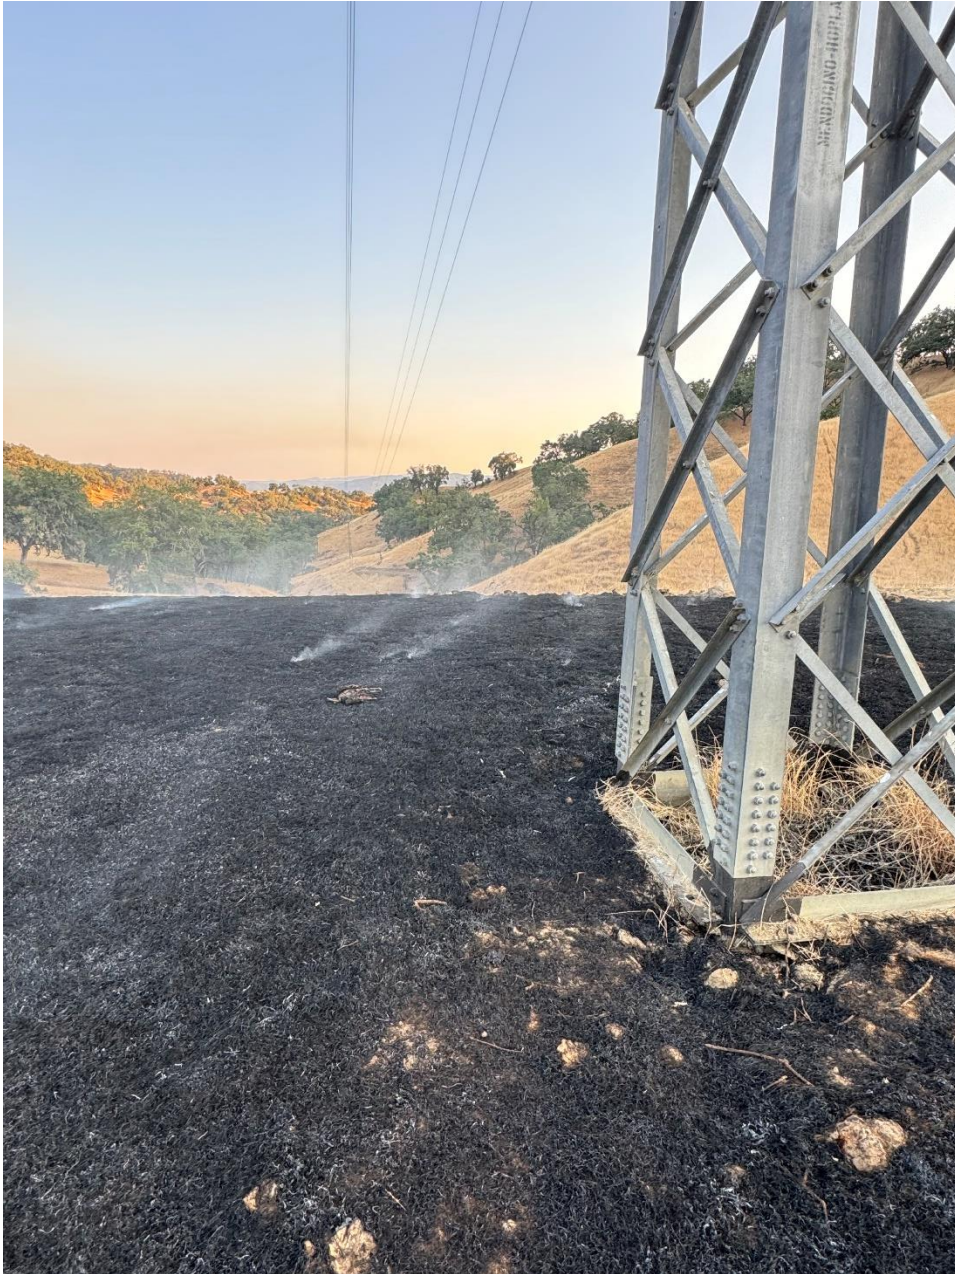
*Figure 2 Photo of burn scar with raven in center of photo, the base of Tower #1 to the right. Photo taken by troubleshooter on July 9, 2024.*

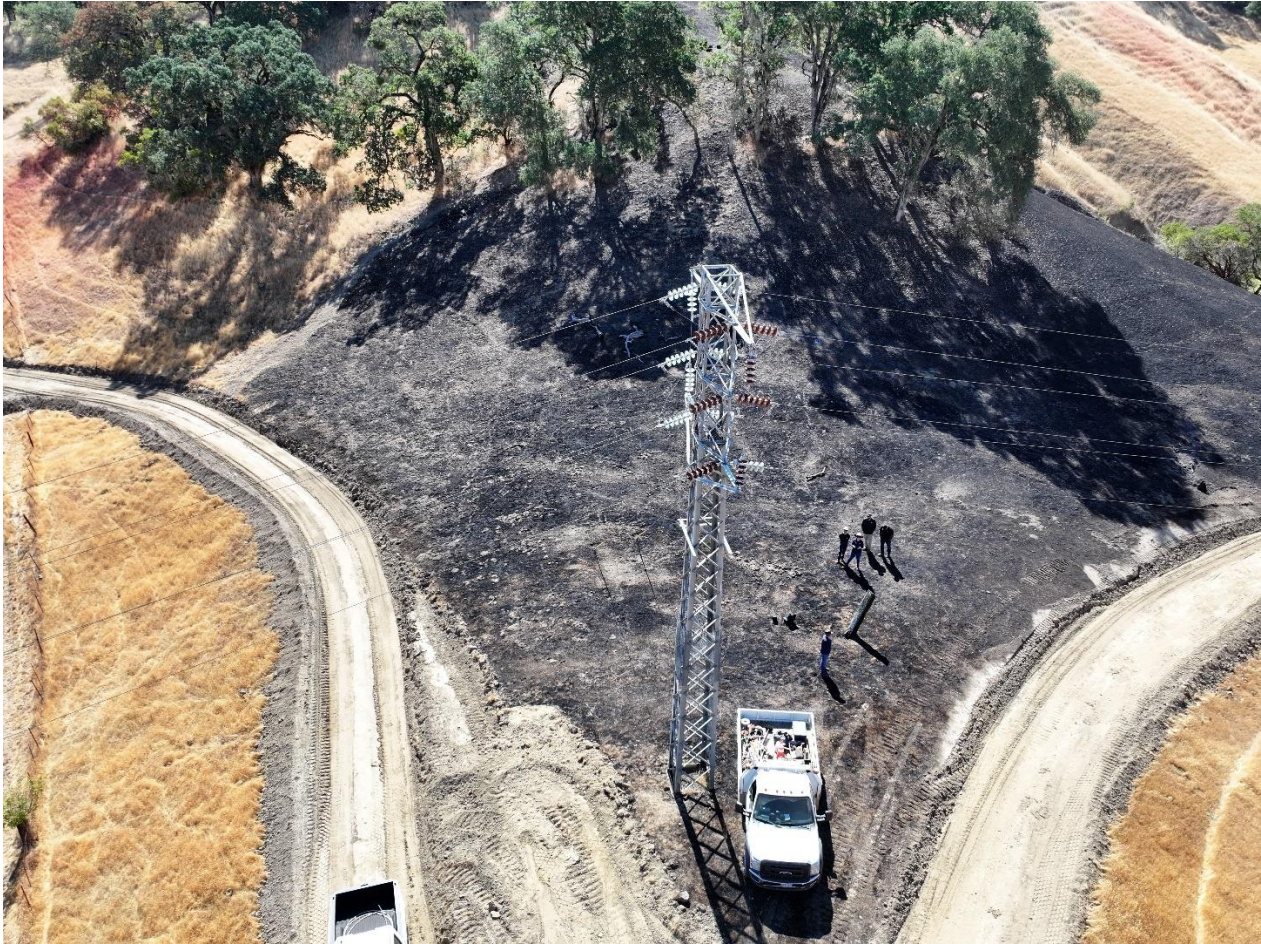
*Figure 3 Aerial/drone photo of burn scar (facing west) taken by Ignition Investigator on July 17, 2024. Tower #1 pictured in center.*

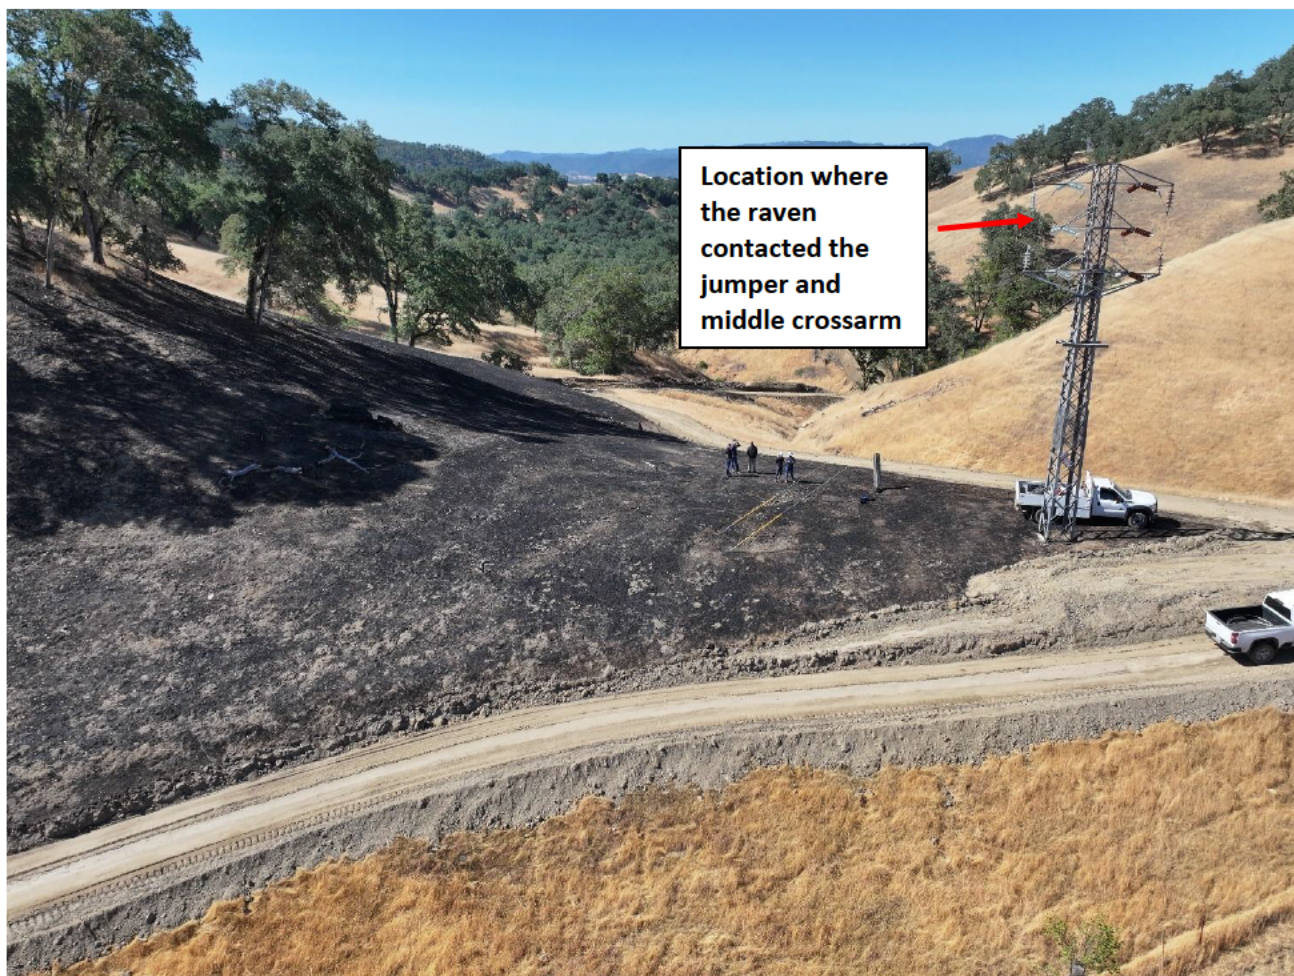
An electric program manager and PG&E's avian subject matter expert (SME) analyzed the incident. They concurred that the raven made contact with the jumper directly above the middle crossarm while either landing or taking flight from the middle crossarm (See Figure 4, 6, and 7). The arc flash marks (See Figure 7) observed are indicative of where the bird was landing or taking off from. A Bird Incident Report<sup>3</sup> was created on July 18, 2024, for the incident. The Mendocino-Philo JCT-Hopland 60kV transmission line is currently under construction<sup>4</sup>. It is being redesigned with new support structures, line orientation, and all new hardware. Bird mitigation protection is being considered in the new design package. It was a hot and dry day on July 9, 2024, near the Incident Location. The high temperature for the day was 100.3°F at 1550 hours and the low temperature was 56.2°F at 0620 hours. The relative humidity was as high as 78% at 0640 hours and as low as 25% at 1410 hours. The strongest wind speed was 11.5 miles per hour (mph) out of the northwest at 1820 hours. The National Weather Service issued an Excessive Heat Warning that was in effect for the location at the time of the incident.

*Figure 4 Aerial/drone photo of burn scar (facing north) taken by Ignition Investigator on July 17, 2024.*

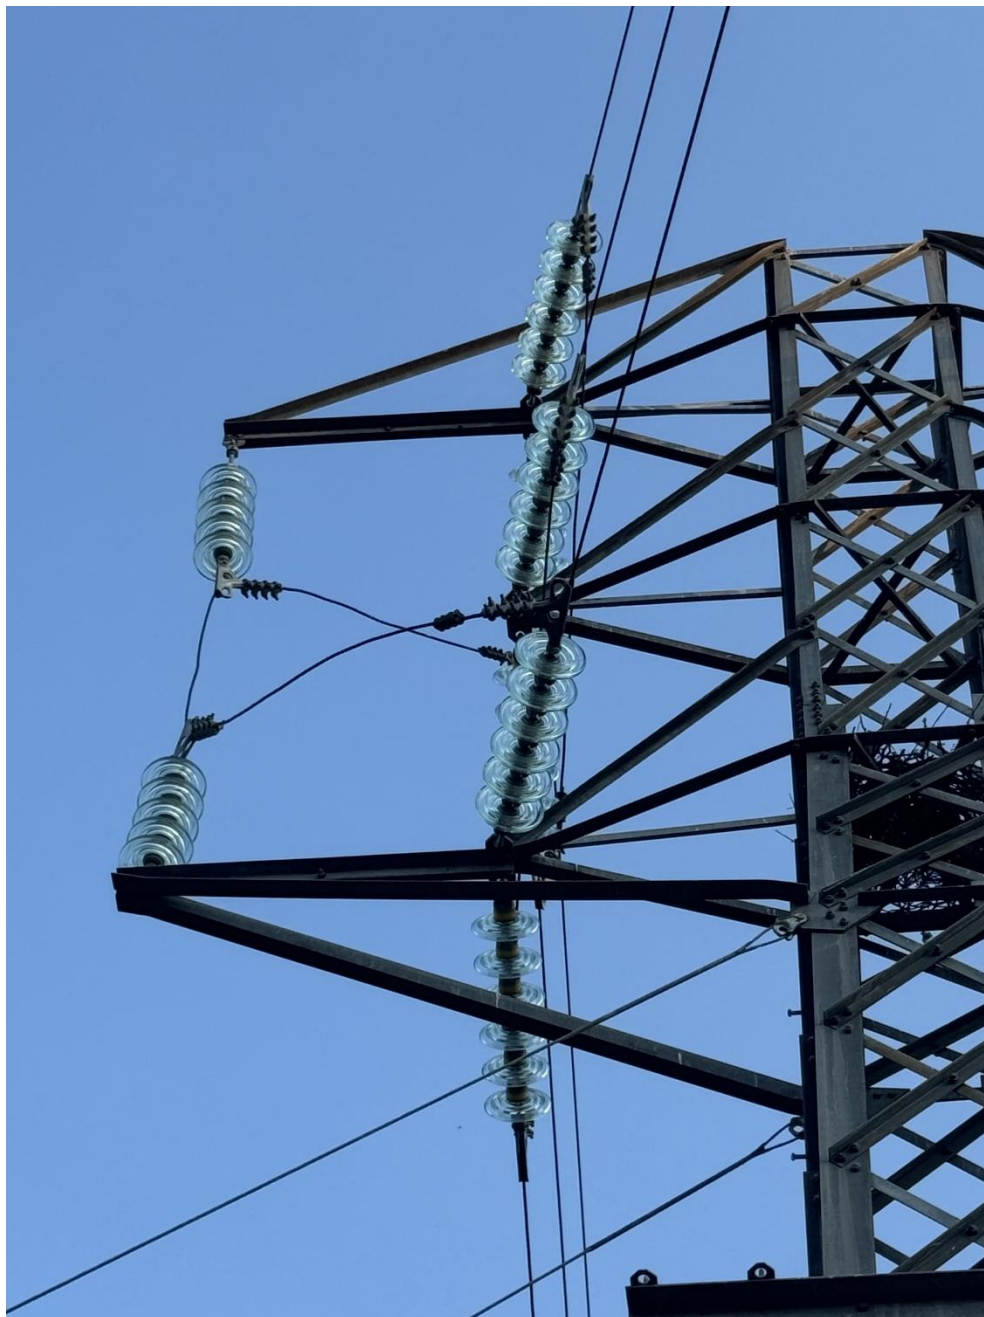
*Figure 5 SAP ID 40820915 – Tower 005/006 with bird nest next to middle, steel crossarm. Photo taken by troubleshooter on July 9, 2024.*

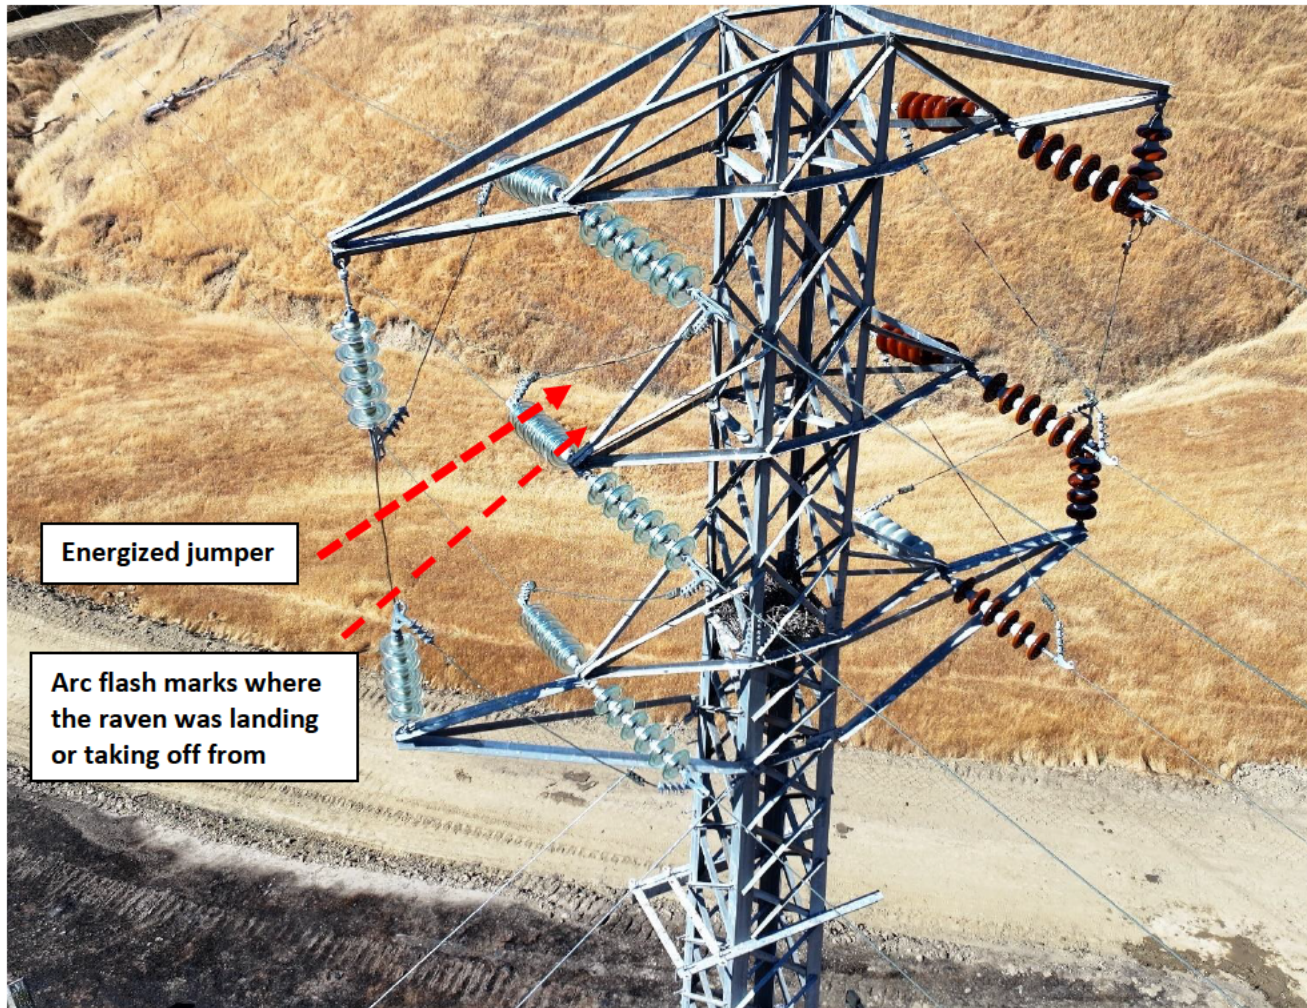
*Figure 6 Aerial/drone photo of SAP ID 40820915 - Tower 005/006 showing arc marks from bird contact. The middle crossarm is where the raven was landing or taking off from when they made contact with the energized jumper above. Photo taken by Ignition Investigator on July 17, 2024.*

- The Mendocino-Philo JCT-Hopland 60kV transmission line is currently under construction. It is being redesigned with new support structures, line orientation, and all new hardware. Bird mitigation protection is being considered in the new design.

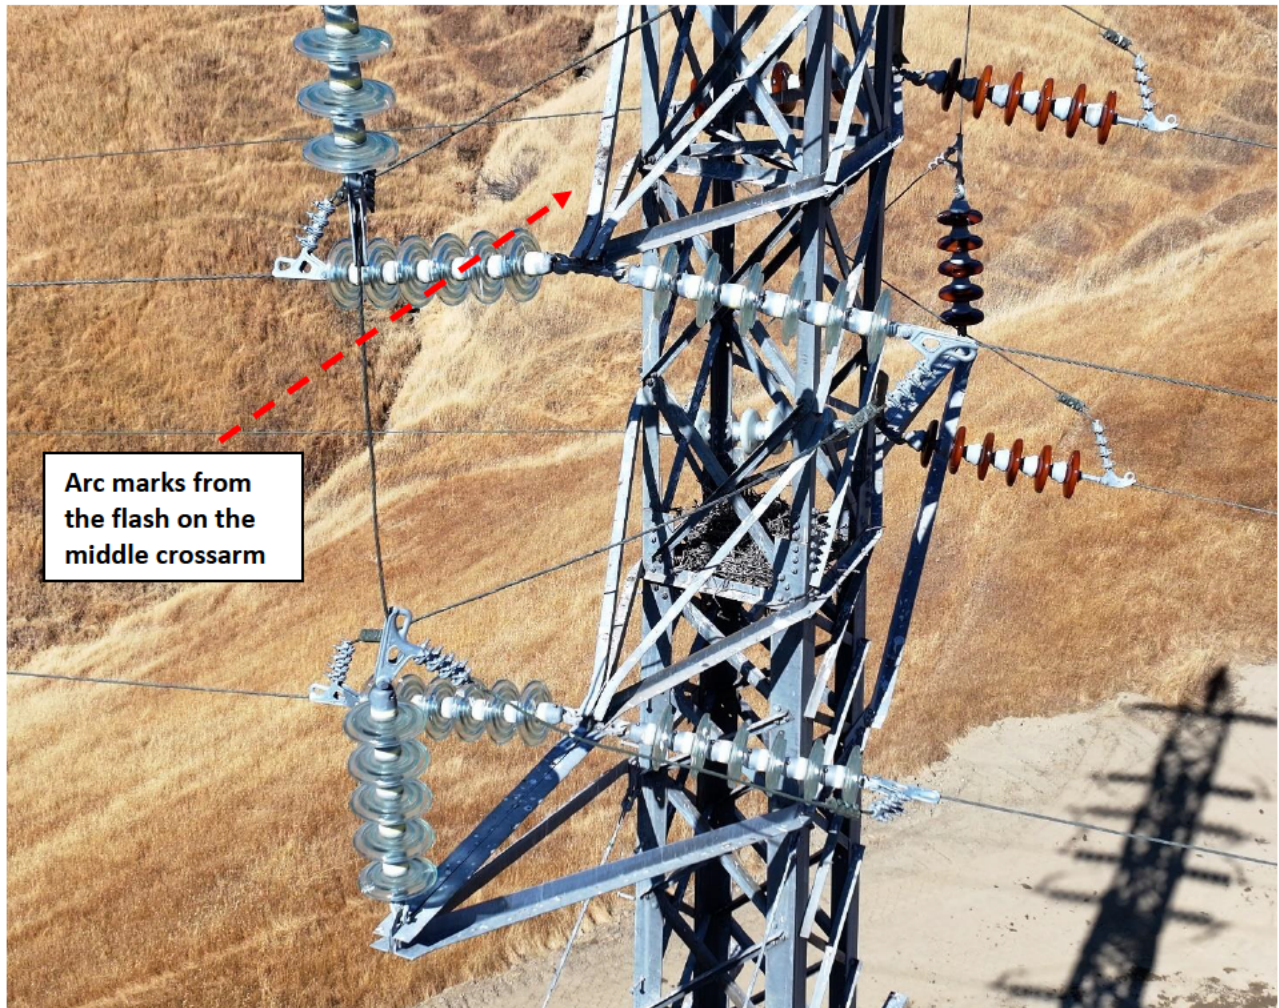
*Figure 7 Aerial/drone photo of SAP ID 40820915 - Tower 005/006, closer view of arc marks from the flash on the middle crossarm. Photo taken by Ignition Investigator on July 17, 2024.*

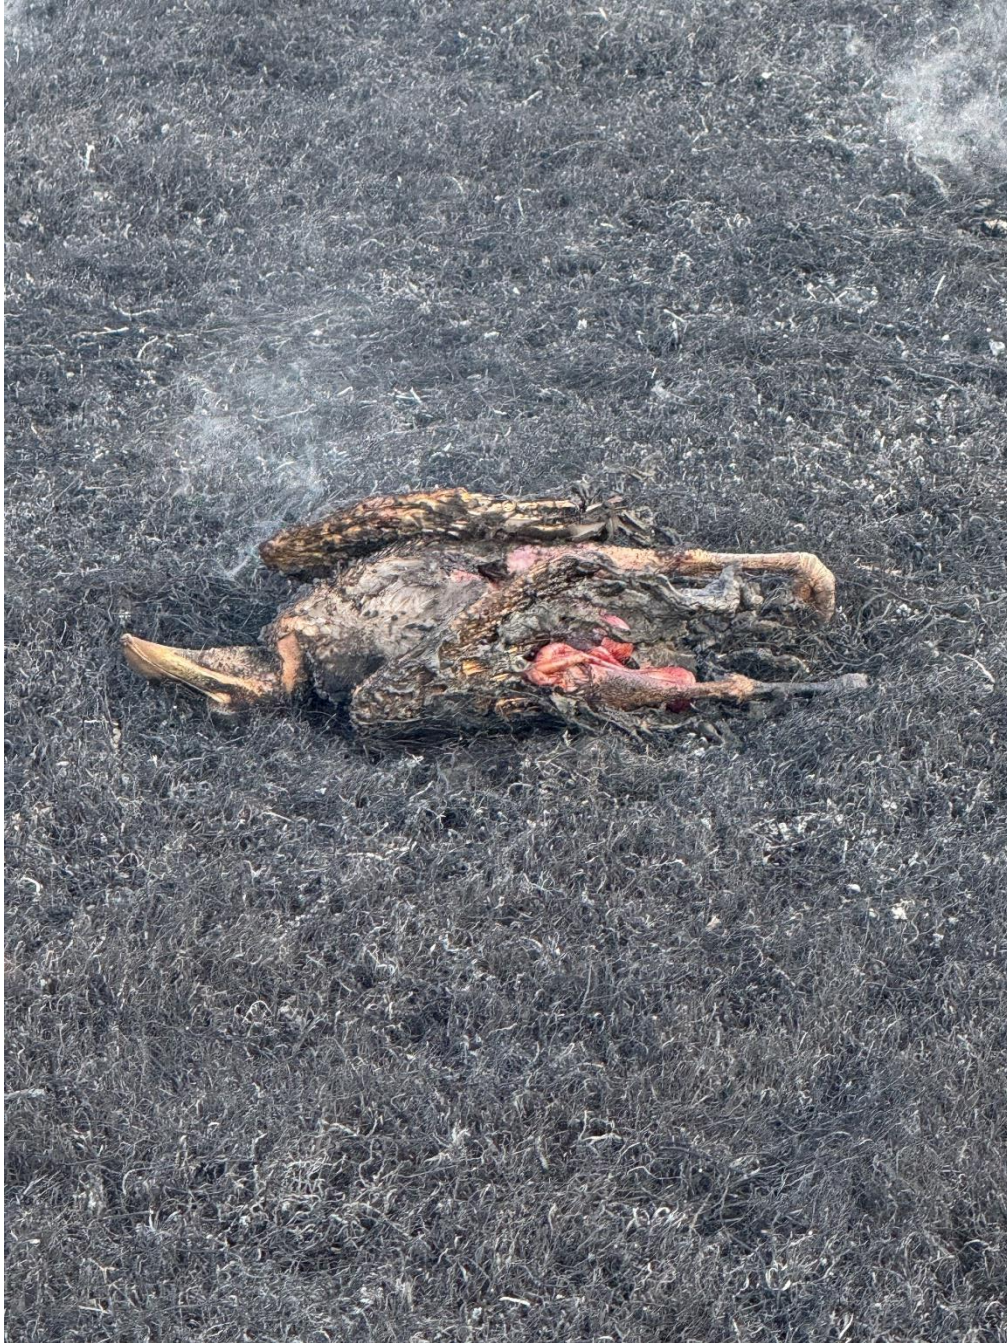
*Figure 8 Photo of flashed raven found at the base of SAP ID 40820915 - Structure 005/006. Photo taken by troubleshooter on July 9, 2024.*
